**NIST NCSTAR 1-5A
Federal Building and Fire Safety Investigation of
the World Trade Center Disaster**

**Visual Evidence, Damage Estimates,
And Timeline Analysis**

(Chapter 9 - Appendix C)

FIRE BEHAVIOR IN WORLD TRADE CENTER 2

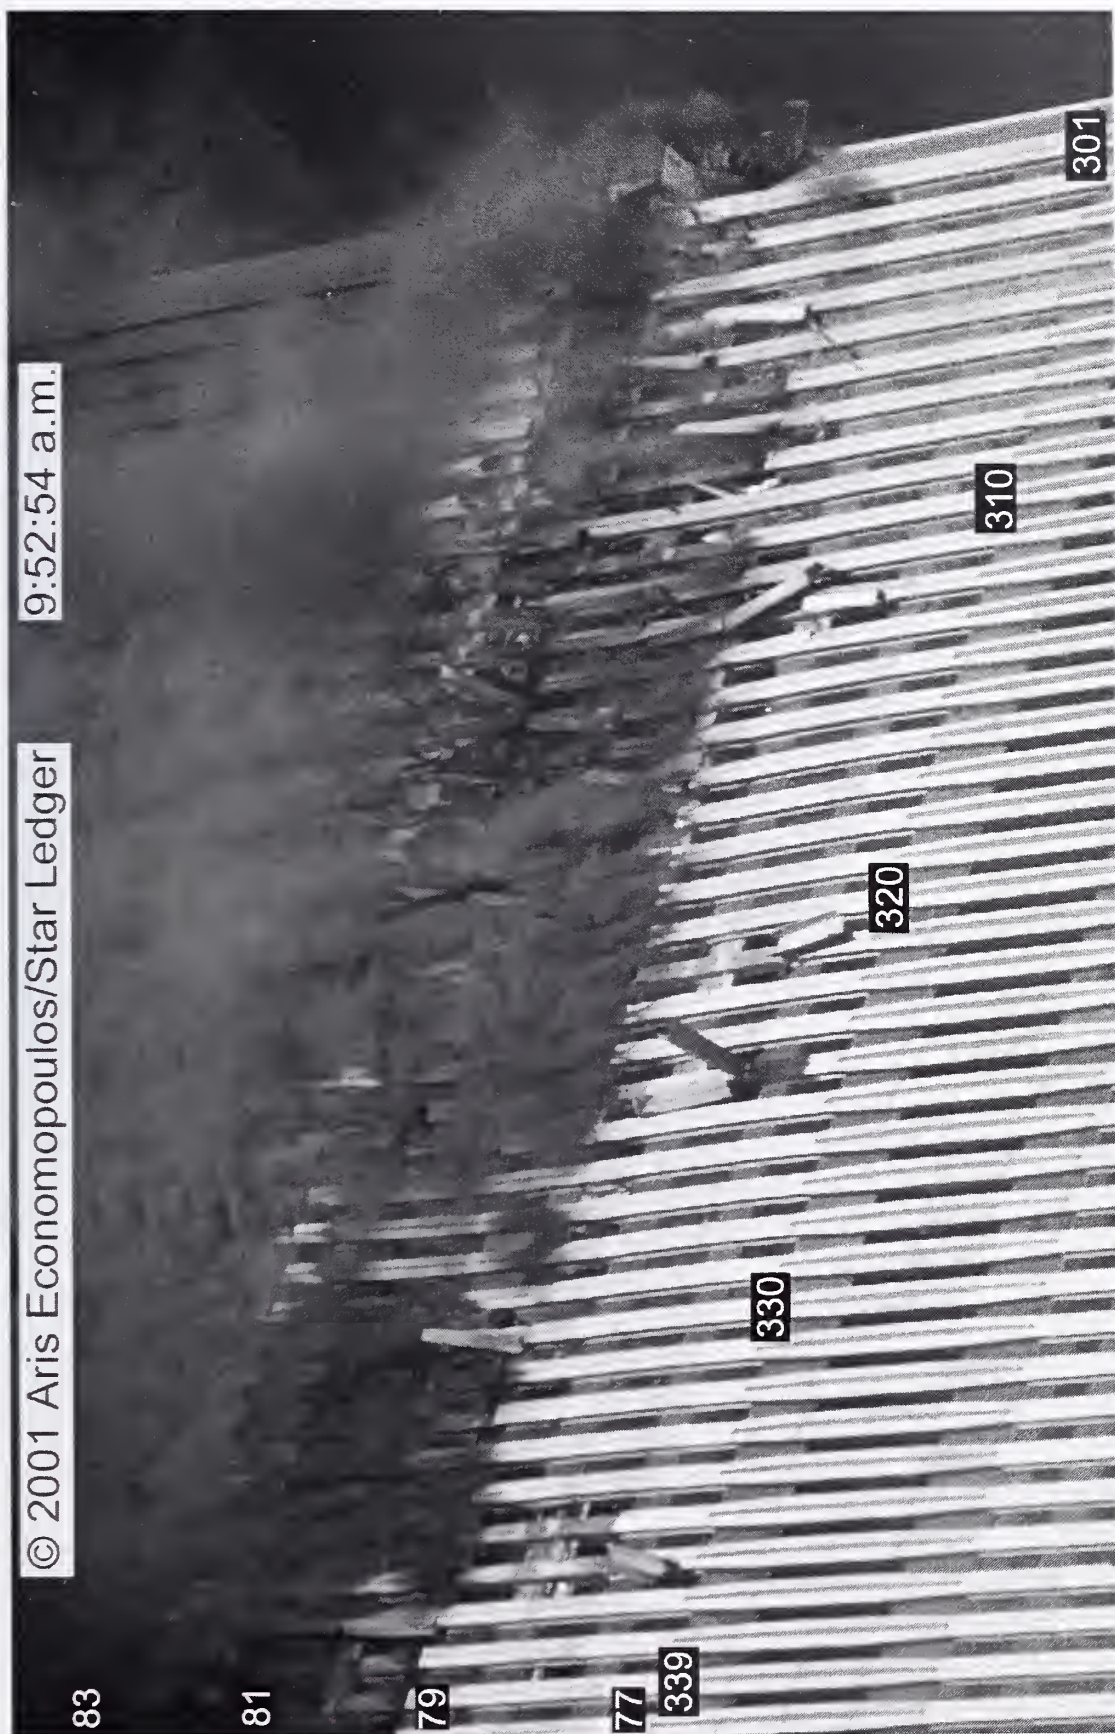
In Figure 9–67 heavy smoke was flowing from windows 79-314 to 79-320 on the 79th floor, and flames were extended from a number of these windows. In Figure 9–80 relatively light smoke is coming from windows 79-319 to 79-321, and there is no indication of external flaming. Apparently, the fires present in this area roughly 5½ min earlier have died down considerably. Carets at the tops of the covers for columns 79-312 to 79-324 indicate the relative local intensities of the fire that burned in this area earlier. In the photograph taken at 9:47:10 a.m. (Figure 9–67) the most intense burning at the northern edge of the 82nd floor was in windows 82-306 and 82-307. At the later time flames are only visible in window 82-303. On the other hand, the flames on the northern edge of the 81st floor are clearly more intense at the later time. Overall, the number and intensities of the fires on the east face appear to be at their lowest levels since the aircraft impact 50 min earlier.

Figure 9-80. This cropped photograph shows a view of the east face of WTC 2 at 9:52:54 a.m. The intensity levels have been adjusted, and column and floor numbers have been added.

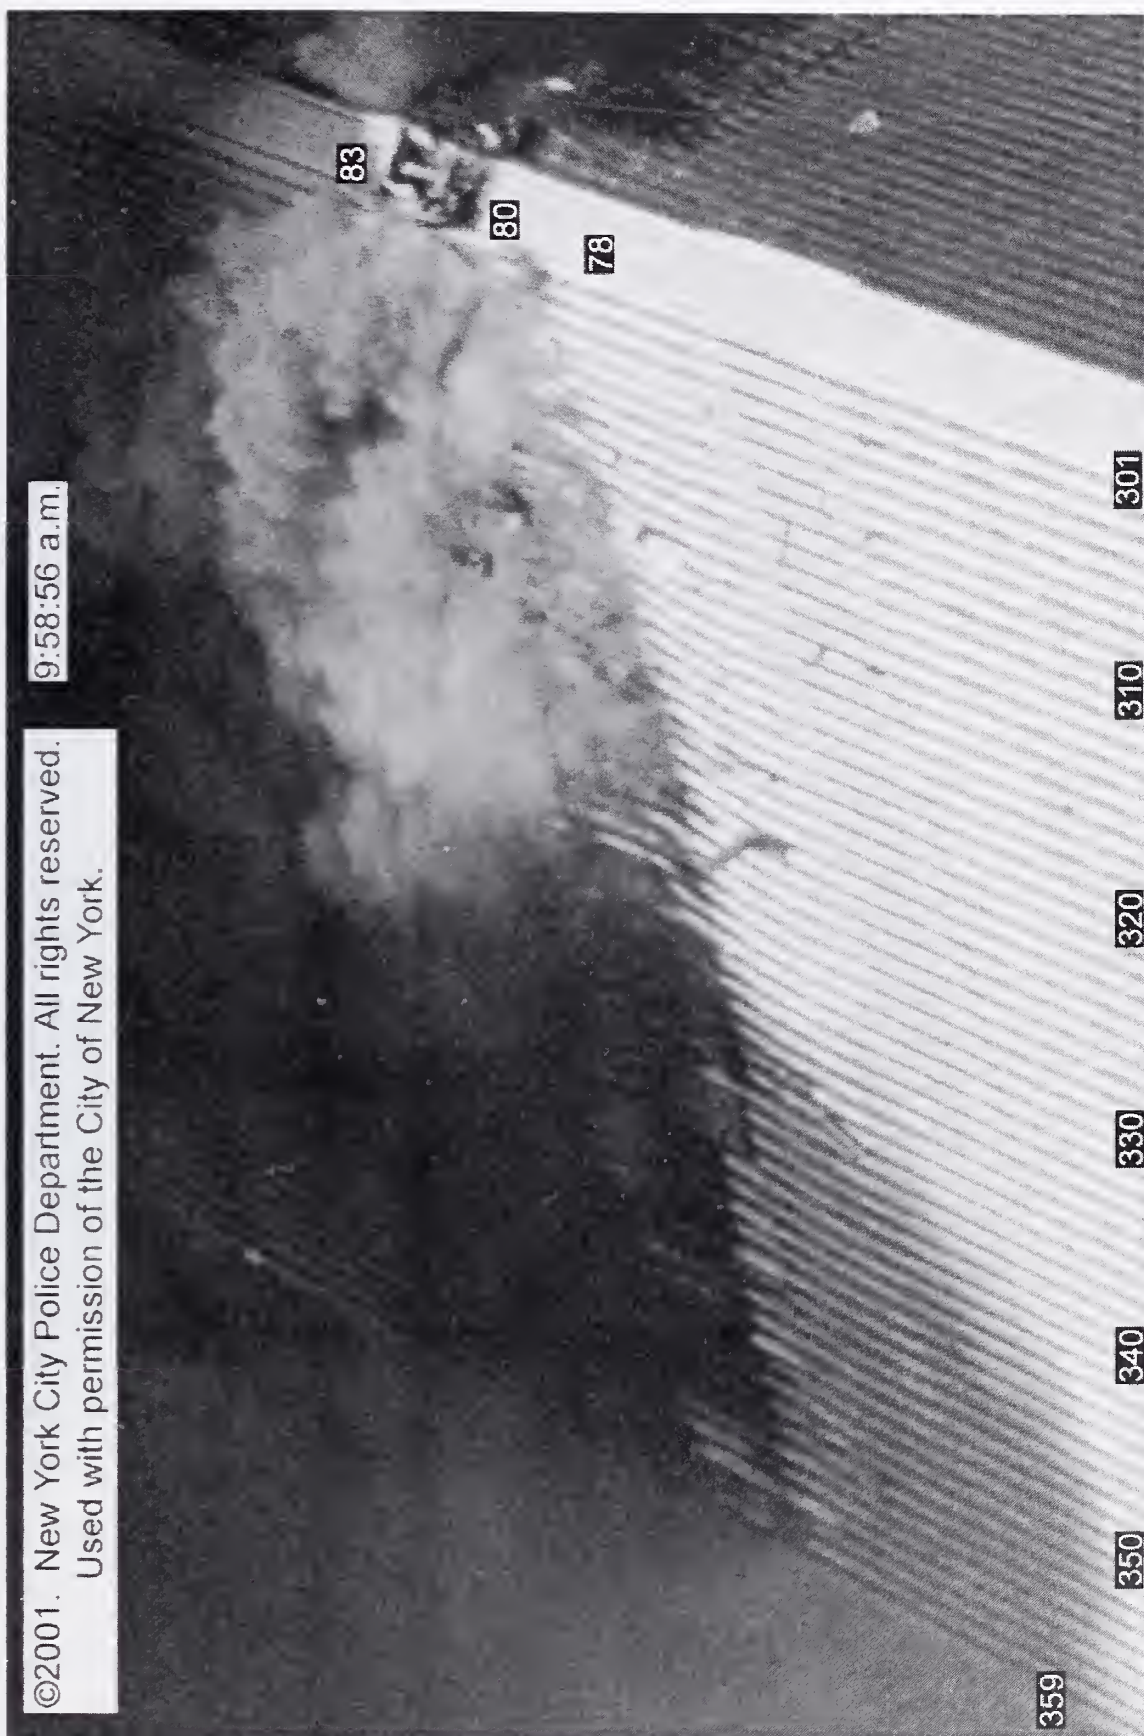
Figure 9-83. This cropped image shows the east face of WTC 2 at 9:58:56 a.m. The intensity levels have been adjusted, and column and floor numbers have been added.
