NATIONAL BUREAU OF STANDARDS REPORT

10 676

THE EFFECTS OF THE FAIRBANKS ALASKA FLOOD  
ON RESIDENTIAL CONSTRUCTION

7. AUTHOR(S) William C. Cullen		8. Performing Organ. Report No.	
9. PERFORMING ORGANIZATION NAME AND ADDRESS NATIONAL BUREAU OF STANDARDS DEPARTMENT OF COMMERCE WASHINGTON, D.C. 20234		10. Project/Task/Work Unit No. 4216247	11. Contract Grant No.

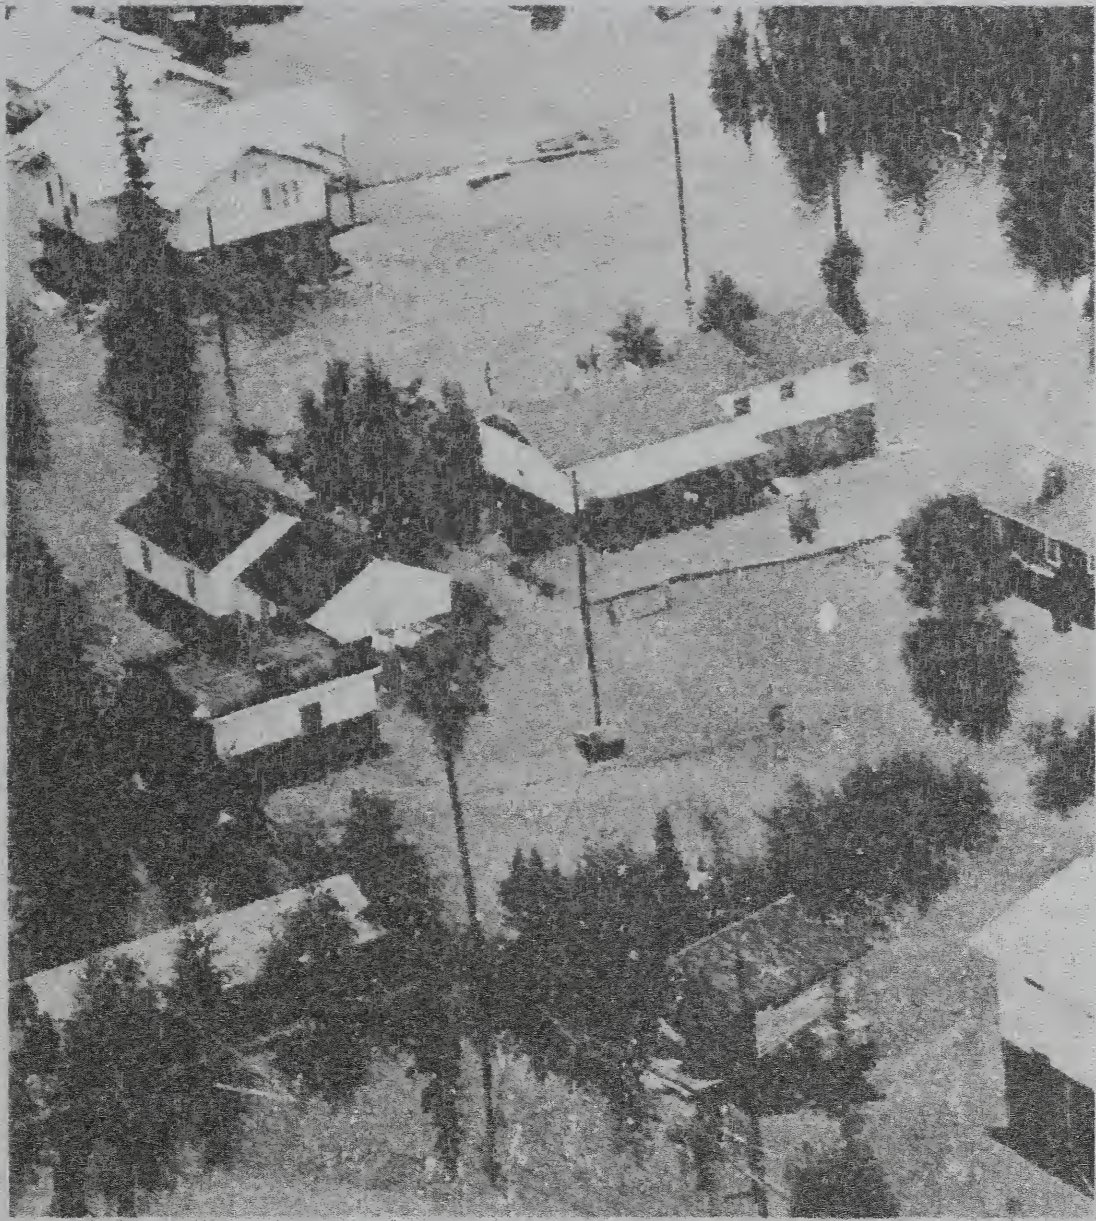
*Figure 1 The Diastrous Fairbanks, Alaska flood of August 1967*

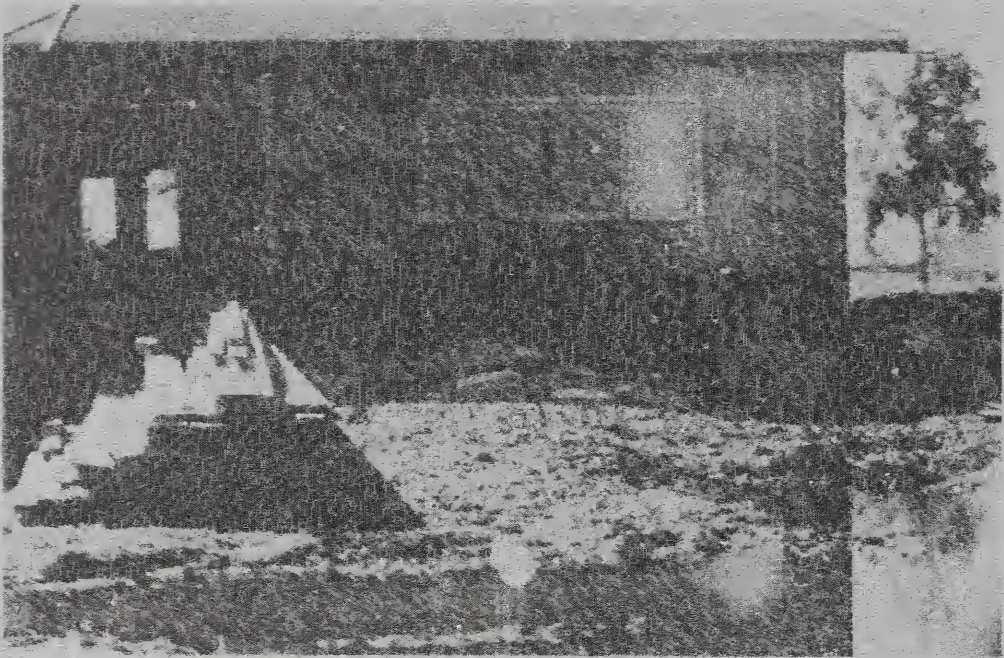
Figure 2. Typical residential construction in Fairbanks, Alaska. Note the high water mark of the flood.

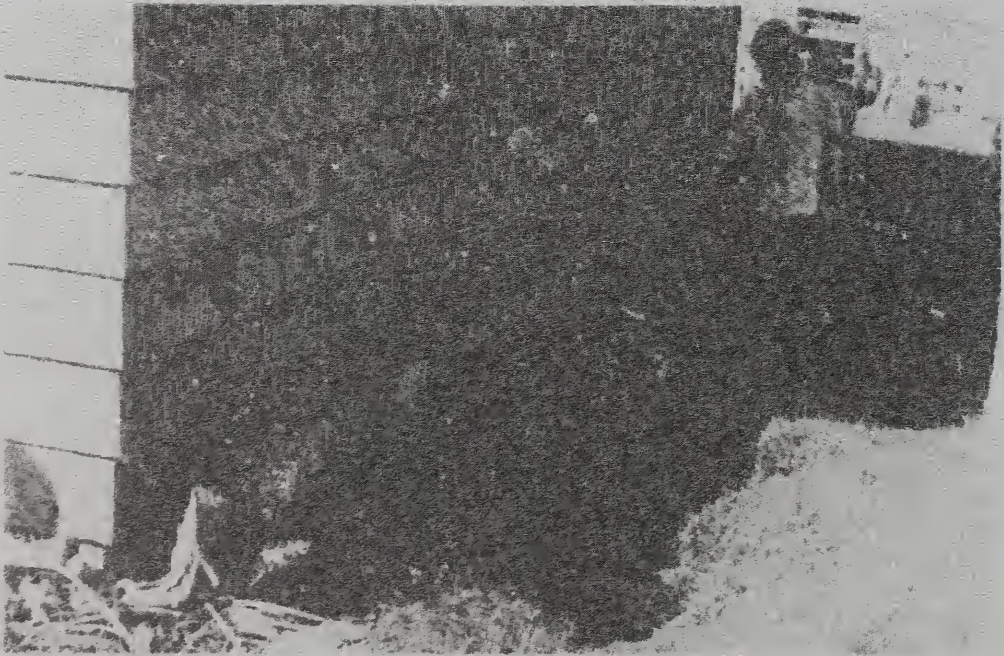
Figure 3. The compaction of backfill around foundation walls had a significant influence on performance during the flood.

influence on the stability of the particular system or the surrounding ground during the flood or after the recession of the flood waters. For example, observations were made of many residences where the back-fill was washed away from basement walls. Further the garage concrete floors as well as sidewalks and other traffic surfaces of many residences settled and consequently deteriorated to such an extent that replacement was indicated.

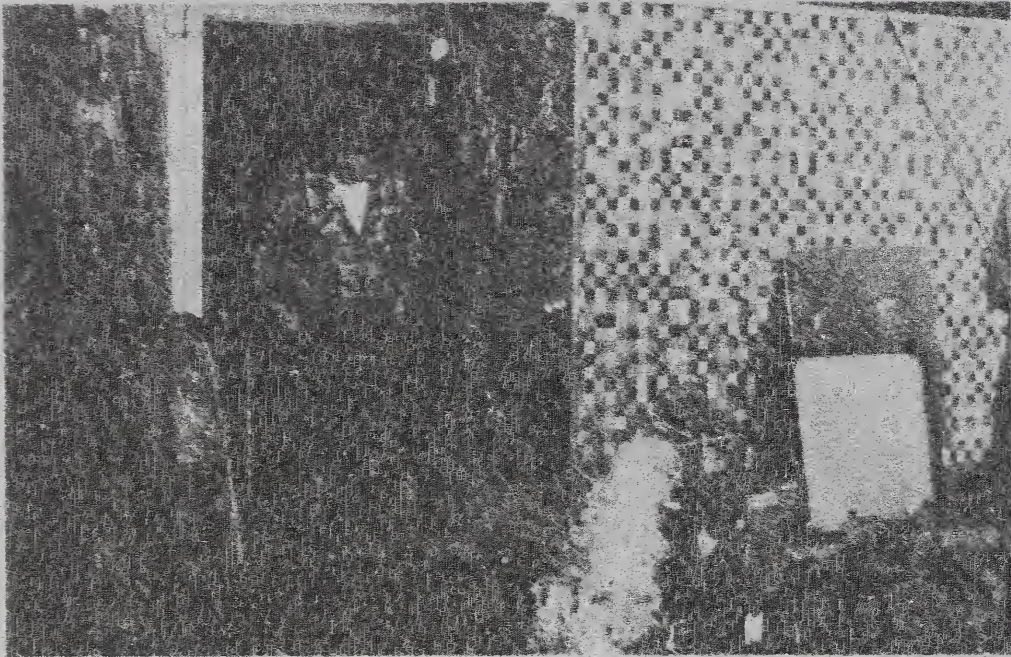
Figure 4 Removal of water should be delayed until the flood water has reached a safe level to prevent interior collapse.

The removal of water from a building as quickly as possible obviously appears to be the first step in the drying process. Experience during the Fairbanks flood has shown that in instances where this was accomplished when the exterior water-level was at ground level or above, serious and costly basement floor and wall problems were created by differential hydrostatic pressures between outside and inside. Therefore, removal of water should be delayed until such a time the water has reached a safe limit.

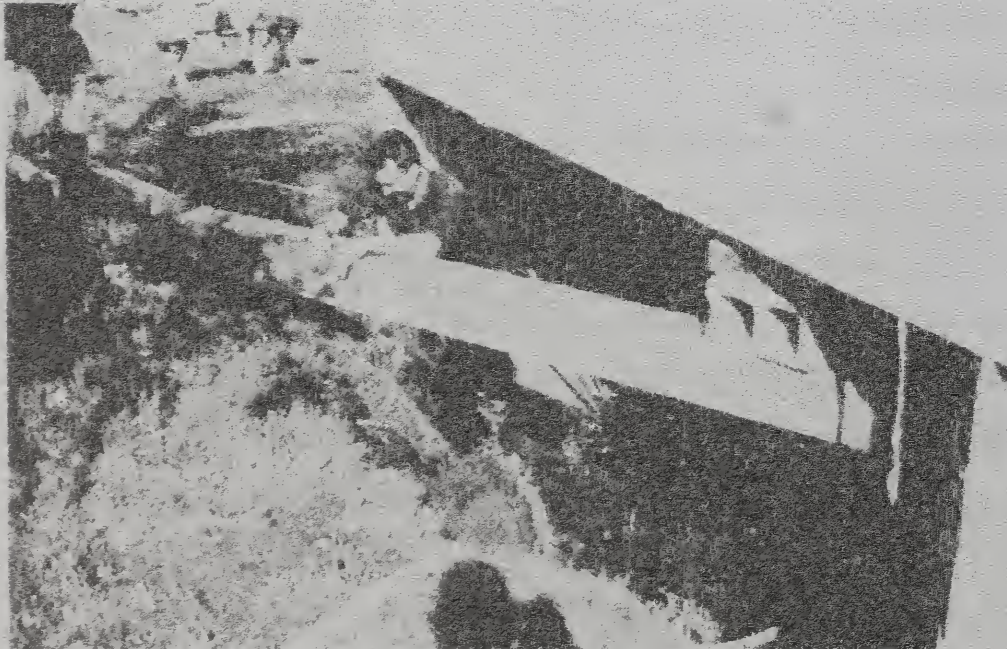
Ironically the immediate action implemented by the conscientious homeowner to keep his basement relatively free of water during the initial stages of the rising of the flood water, frequently resulted in the most serious and costly flood damage observed in residential houses. In some cases, the foundation walls actually imploded due to the hydrostatic pressure against the exterior walls. In others where the basement walls were sufficiently strong to resist the forces generated by the differential pressure, the basement floor actually heaved and cracked.

Figure 5 Collapse of basement wall due to hydrostatic pressure against exterior wall. August 1967.

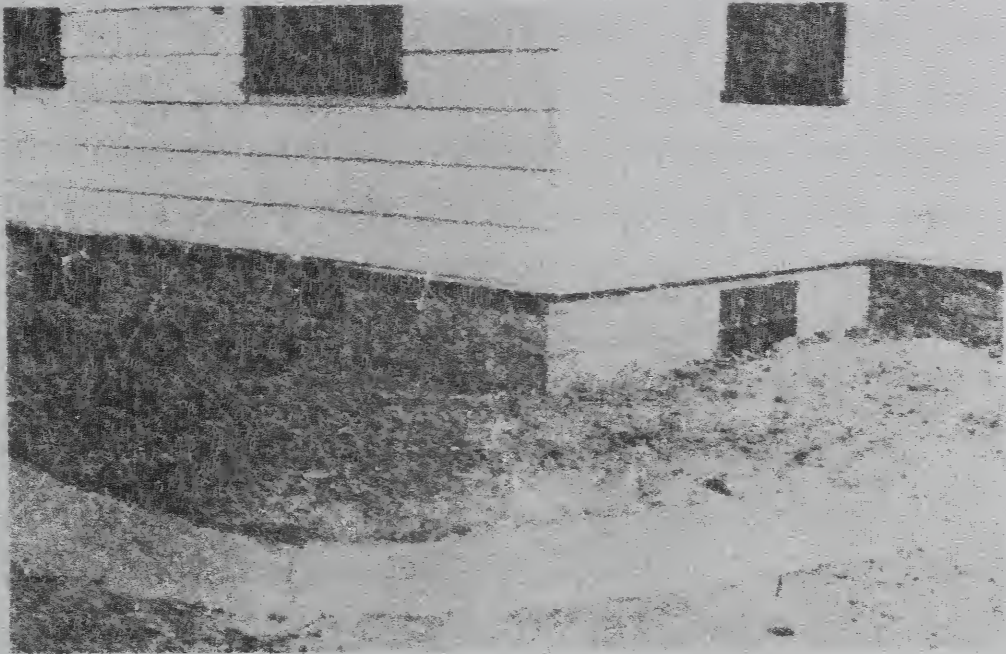
Figure 6 Restored basement wall shown in Figure 4.  
May 1968

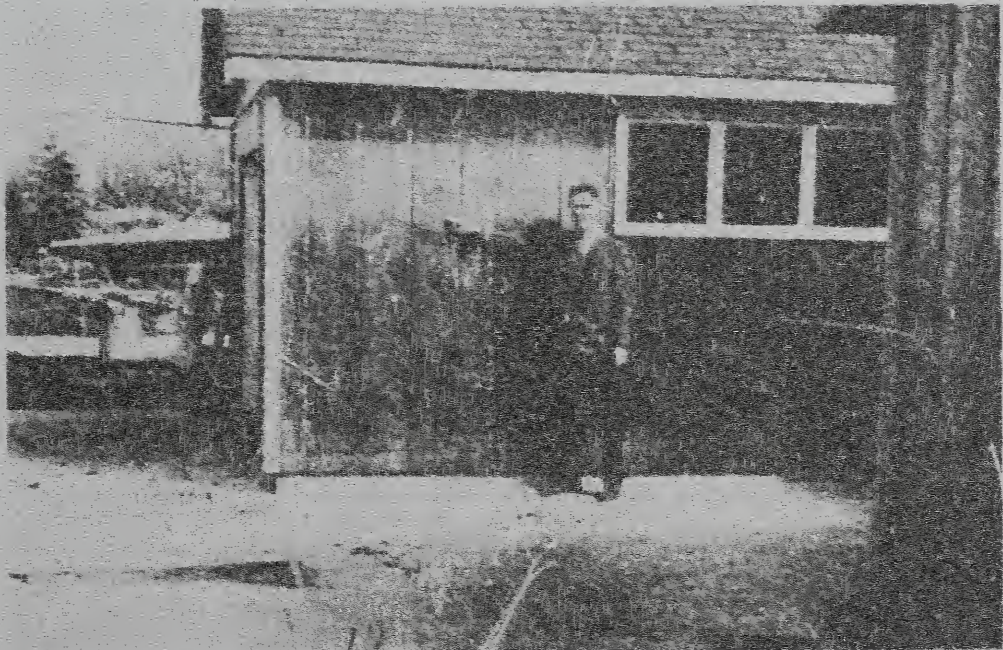
Figure 7 High-water mark exceeded five foot level  
in some cases.

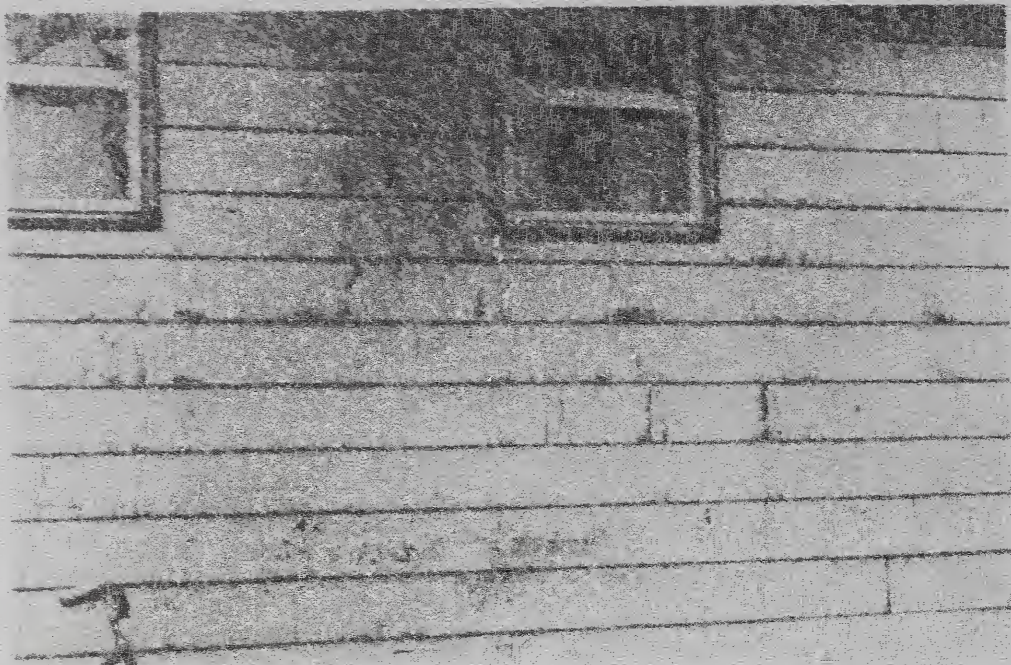
Figure 8 Staining of exterior siding due to forced drying procedure.

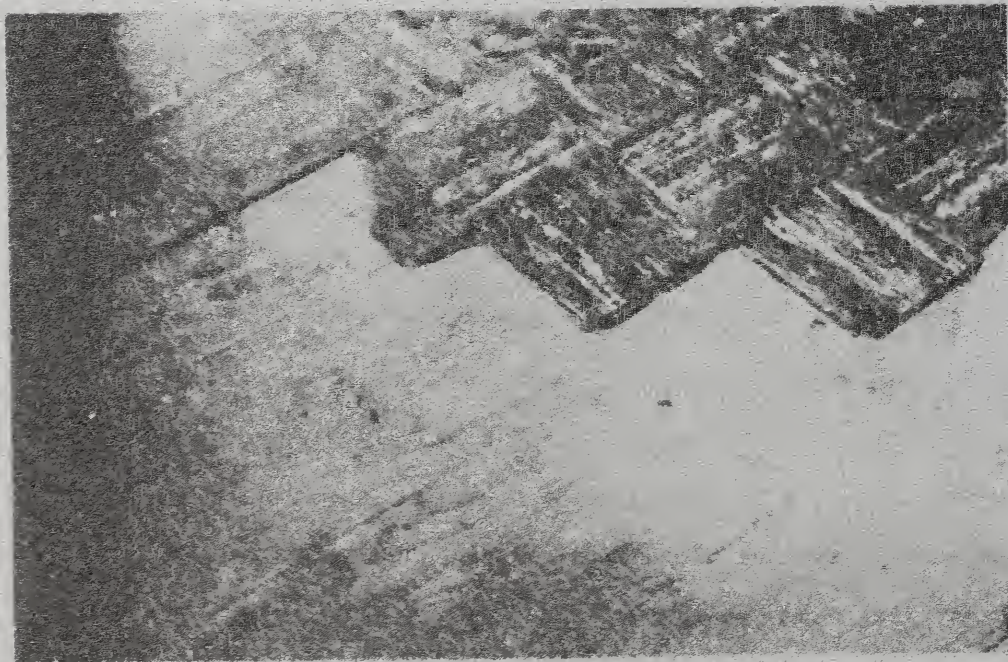
Floor coverings and subflooring were adversely affected by the flood water. In almost every instance the coverings including asphalt, vinyl and vinyl-asbestos tiles, sheet vinyls and textile type carpeting were soiled and damaged. The most common type of damage observed with the resilient type coverings was a failure of the adhesive used to bond the tiles to the substrate. The performance of the subflooring was certainly a factor in the performance of both the finished floor covering and the adhesive selected for its application. In cases where the substrate was concrete or exterior grade plywood and a water resistant adhesive was employed, it appeared that the flooring systems resisted major damage other than that due to soiling. However, where delamination or warpage of interior grade plywood occurred or where a water susceptible adhesive was employed, removal and replacement of the damaged flooring was indicated.

Figure 9 Failure of adhesive used to bond floor tile to substrate.

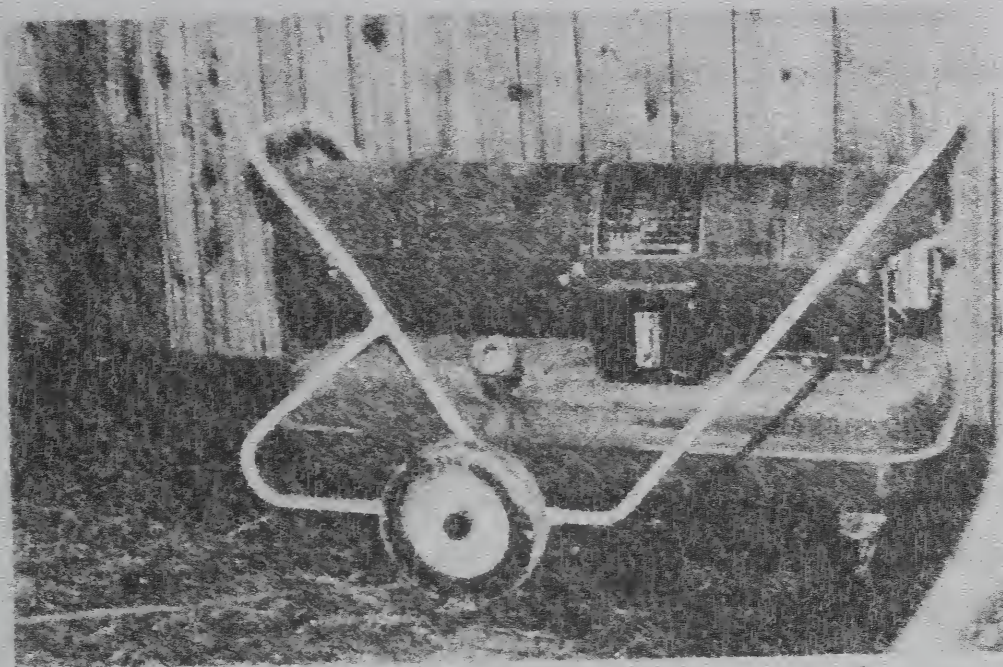
Figure 10 Supplementary heating in the form of portable units proved to be effective in the drying operation.

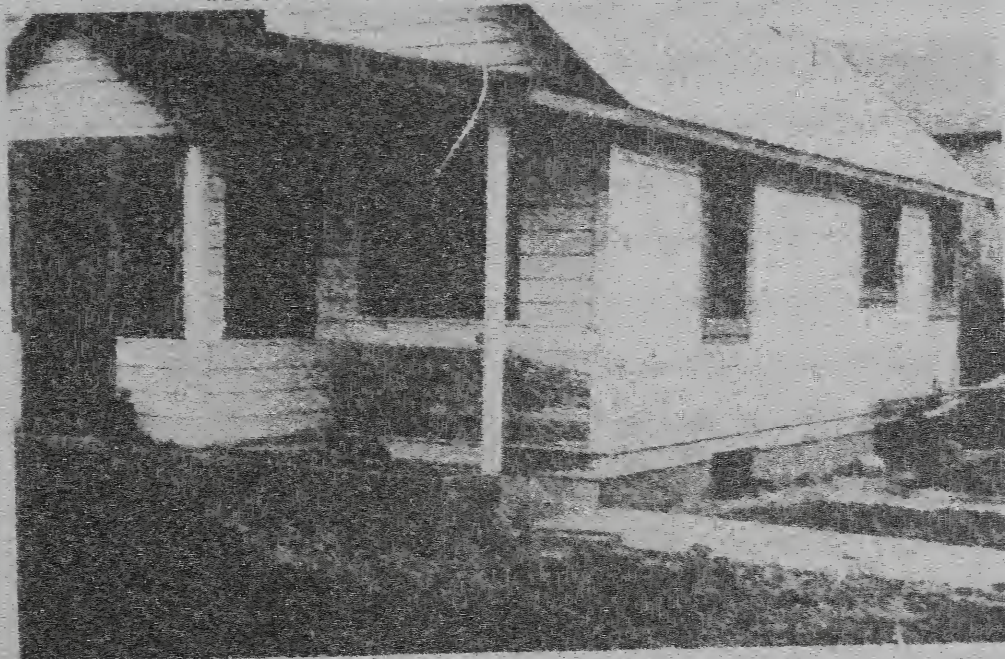
Figure 11 Paint failure clearly indicates level of flood waters. May 1968

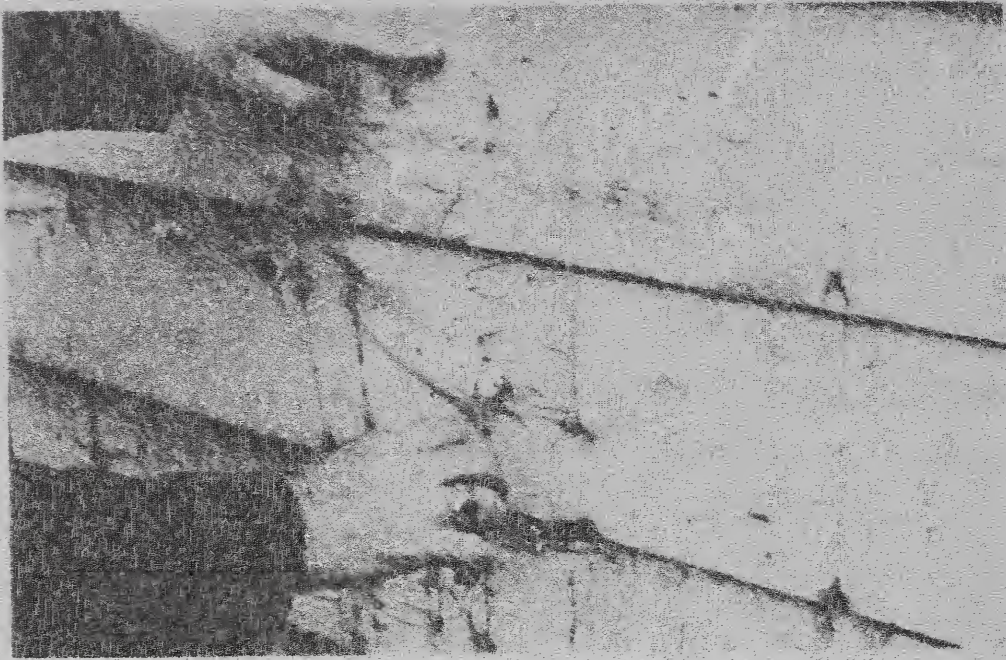
Figure 12 Blistering and flaking of paint coatings were predicted in August 1967 and observed in May 1968.

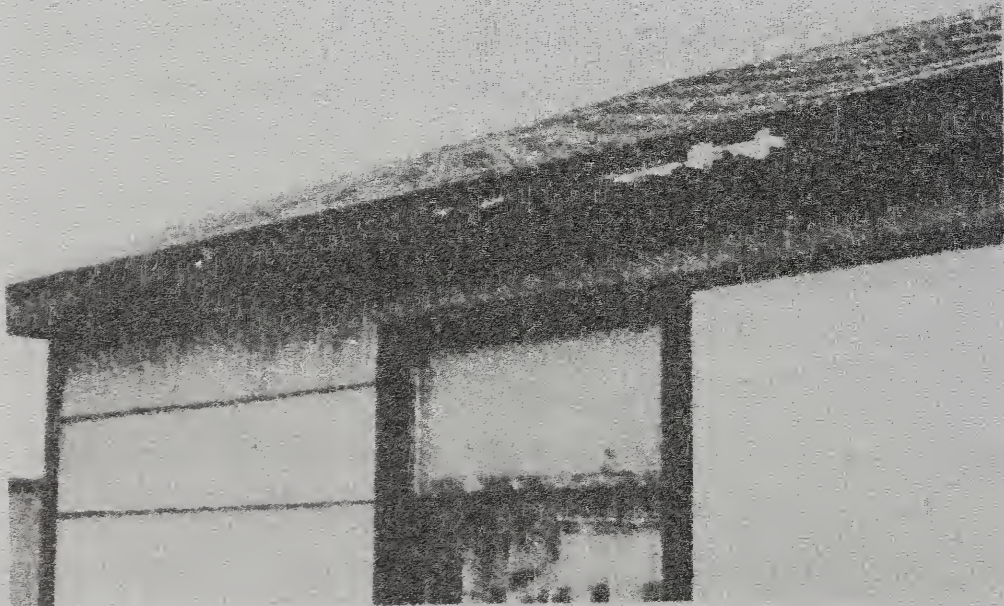
Figure 13 Paint failure due to drying operation. Ventilation of attic space will assist in reducing failures of this type.

The practice of providing adequate ventilation of the attic space during the heating season was required not only to facilitate the drying of the wet house but is a recommended and necessary practice for homes in all cold climates. The difference between houses with and without adequate attic ventilation was readily apparent by observing the condition of exterior paint coatings after exposure to the winter weather.

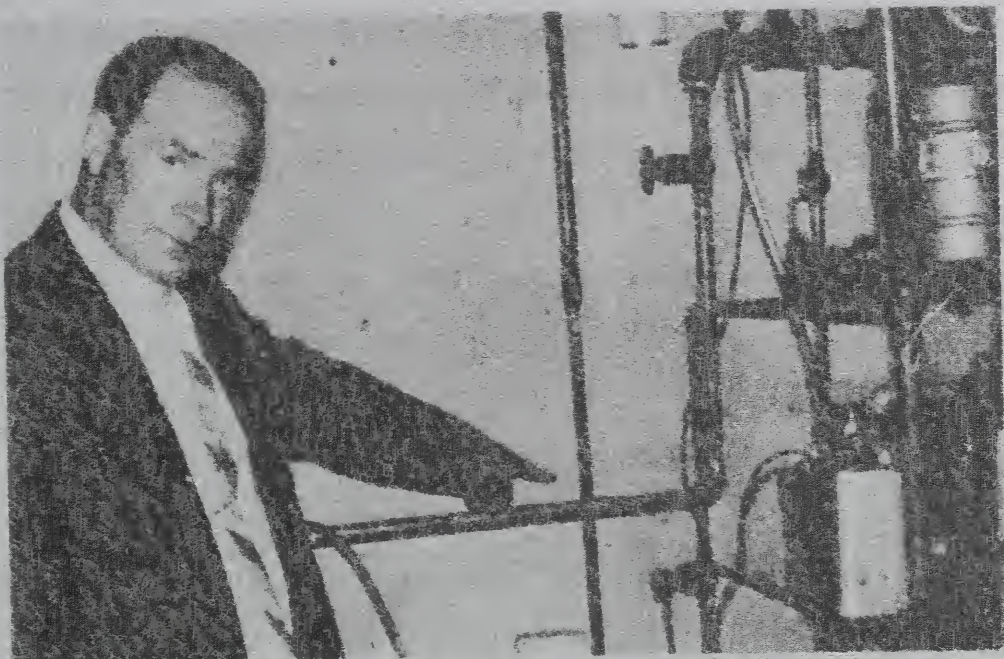
Heating systems which were completely submerged for a number of days functioned in a satisfactory manner after being cleaned and dried. The cleaning procedure for electric motors, burners and controls consisted of flushing with water, drying, treating with a water-displacement liquid and placing in service. As expected there was a high incidence of premature failure of various parts of the system such as bearings in motors, contacts in coils, etc. during the subsequent heating season. The failures were mainly attributed to abrasive silt and corrosion. The important fact remains that despite the severe exposure conditions, the systems upon drying, were able to function when the need for heat was most critical.

Figure 14 Furnace units which were completely submerged for a number of days functioned after cleaning and drying.

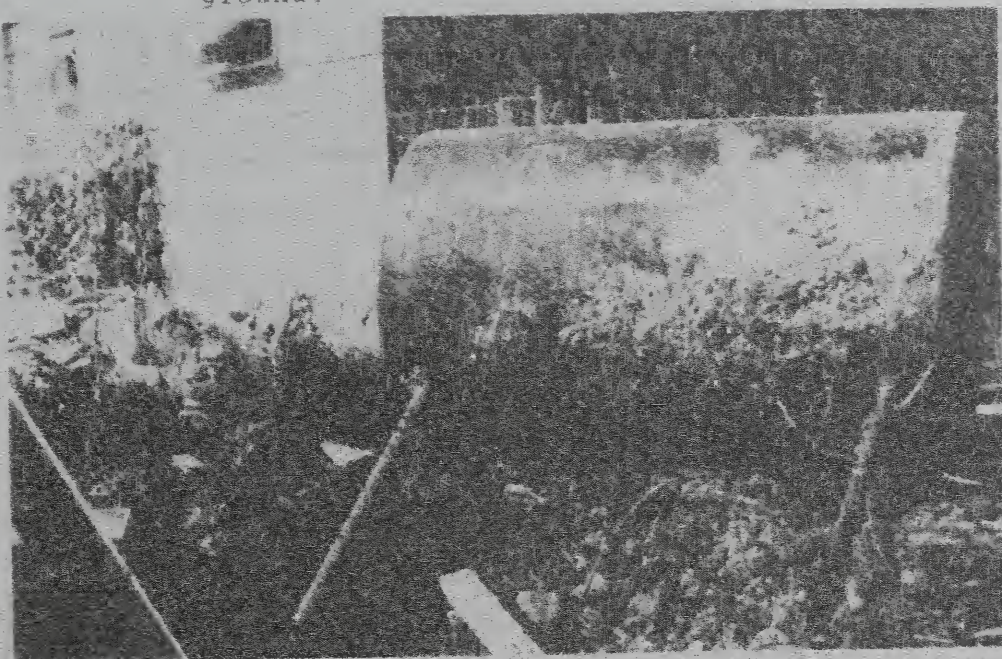
Figure 15 Buoyancy of partially empty oil tanks caused them literally to pop out of the ground.

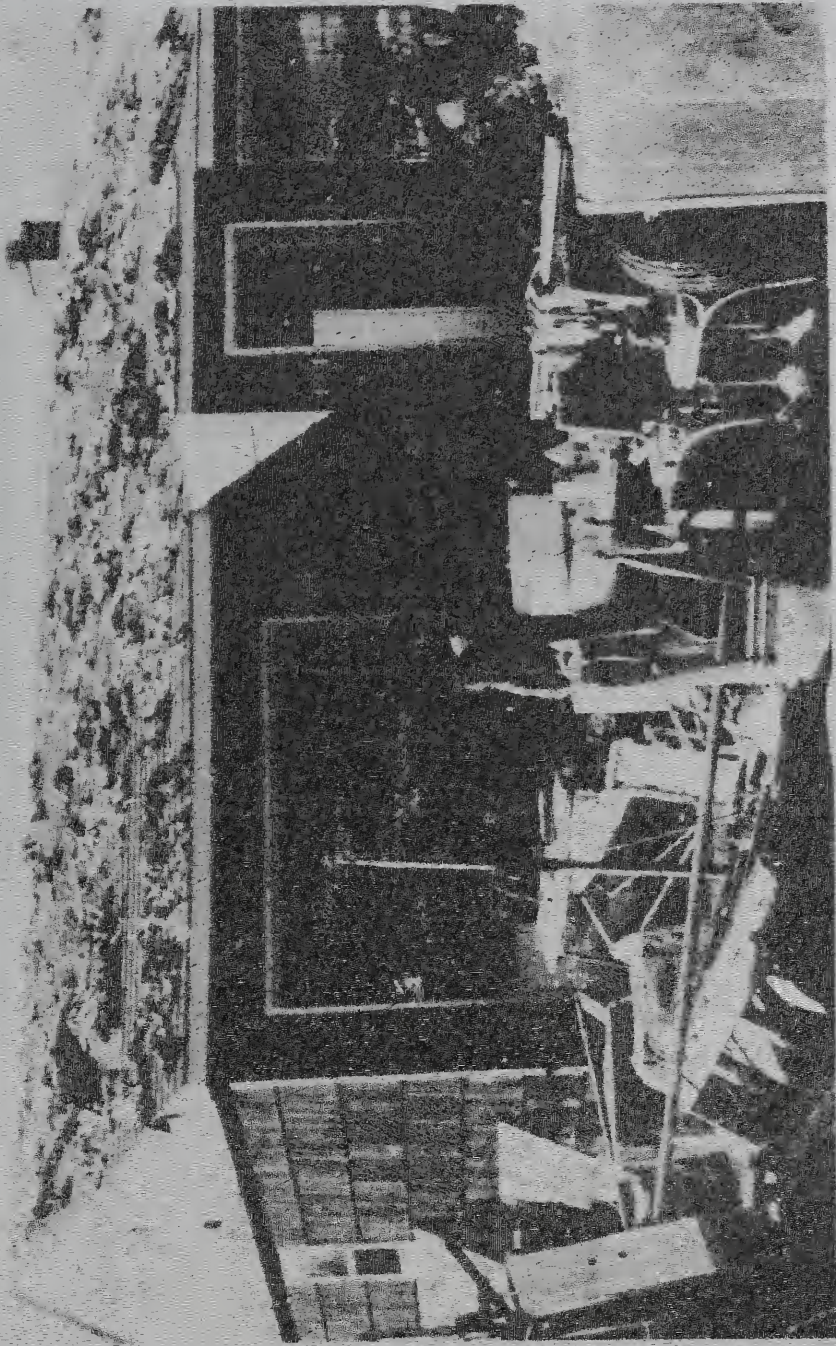
Figure 16 In addition to building damage, Flood victims suffered large losses in clothing and household effects.
