» Continental Europe Synchronous Area Separation on 24 July 2021

ICS Investigation Expert Panel » Final Report » 25 March 2022
Main Report

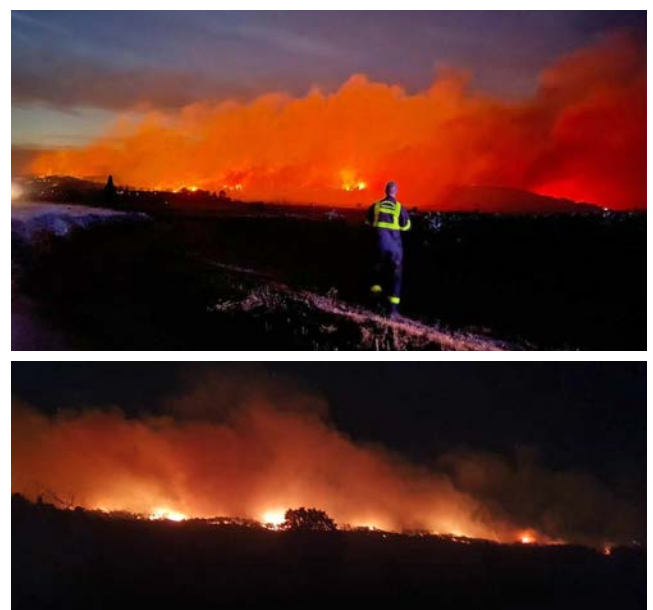
Figure 2 & 3: Picture taken during firefighting activities.

On 24 July 2021, at approximately 13:30, a severe fire broke out in the vicinity of the city of Moux, in the South of France. A massive mobilisation of firefighting services was activated, with more than 850 firefighters, one helicopter and nine firefighting planes. In total, 850 hectares of vegetation were consumed by flames during this two-day event; see Figure 1 through Figure 3.

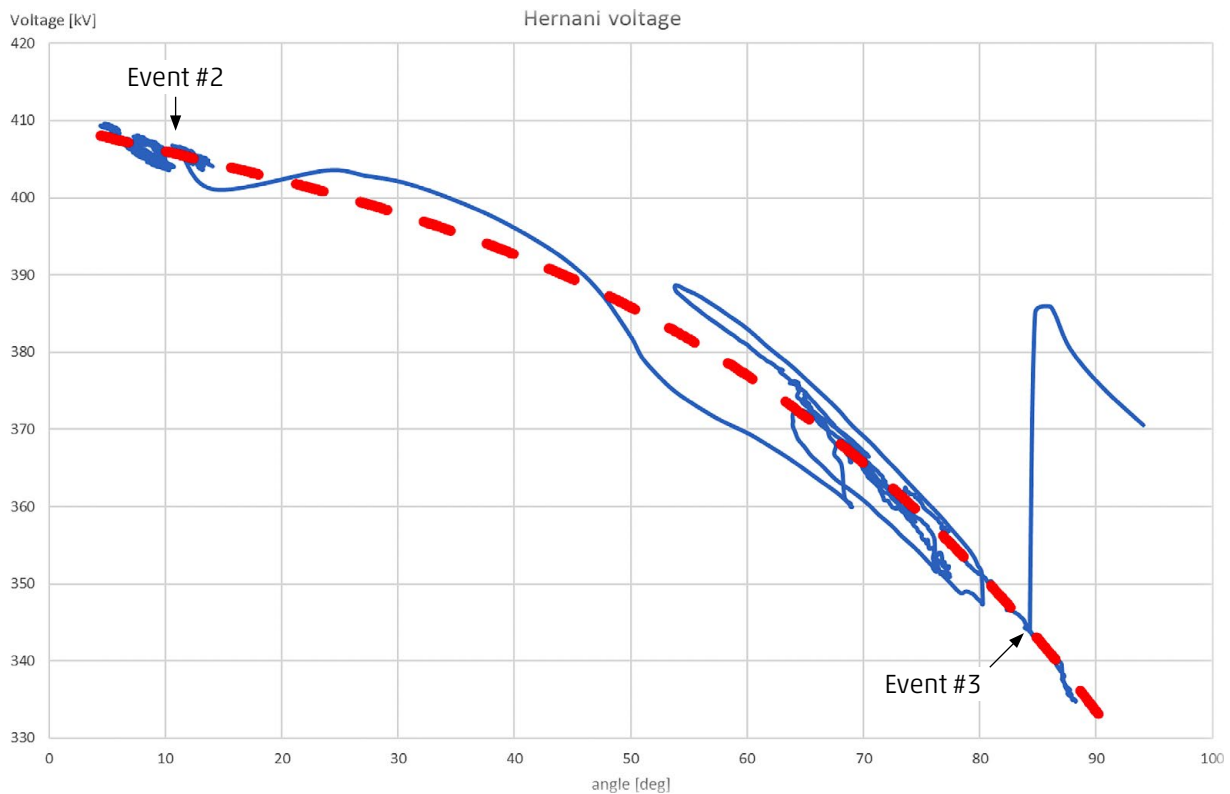
Figure 22: Voltage magnitude versus phase angle difference in Hernani substation - PMU recording (phase angle referred to Bassecourt (CH)).

In Figure 22, the voltage magnitude as recorded by a PMU in Hernani with respect to the angle difference of Spain against the centre of Europe is displayed. It can be assumed that the angle difference δ is proportional to the active power flow P between Spain and France, with the approximated relationship $P = (V^2 \div X) \times \sin(\delta)$, where V is the voltage phasor magnitude and X is the impedance of the corridor. Between Event #2 and #3 we, the classical "nose curve" can be clearly recognizeseen in the dotted red line (interpolant) the classical 'nose curve'), indicating a voltage collapse phenomenon caused by the high power flow increase on the physical section.

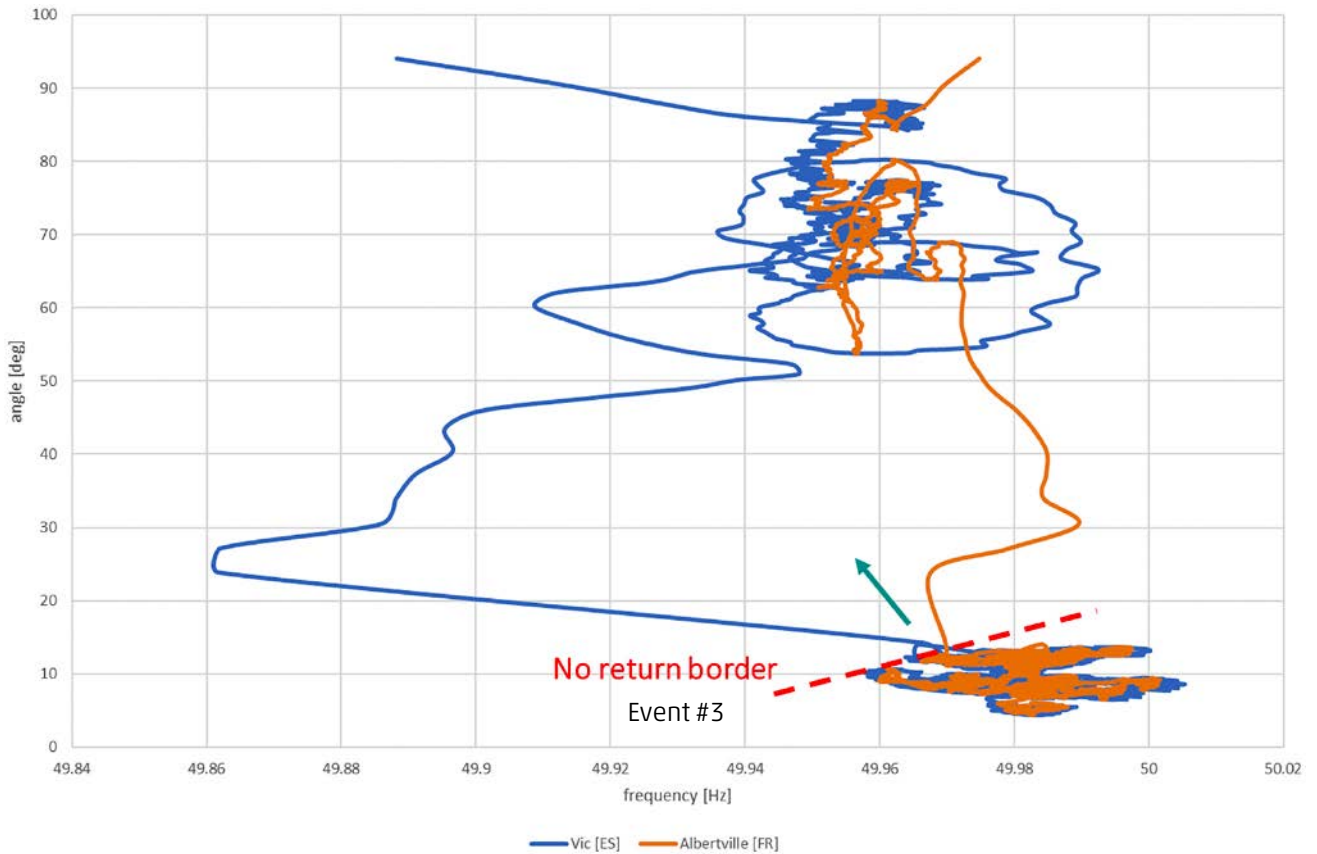
Figure 26: Phase plan (angle difference, frequencies) measured in France and Spain.

Event #3. Here, the phase angle difference was chosen between two substations from each area corresponding to their centre of inertia and, consequently, the illustrated voltage phase angle difference is representative for the transients before, during and after the system split.

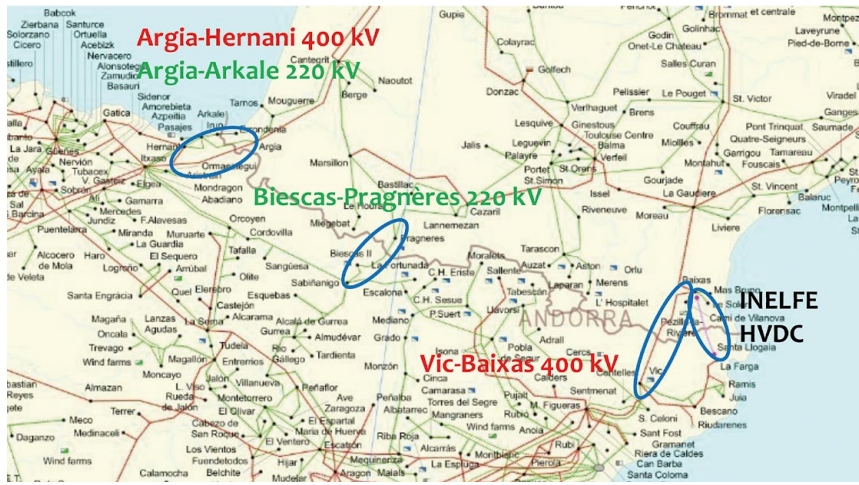
Figure 29: Transmission network in the French-Spanish border.

One of the interconnectors between Spain and France consists of a VSC HVDC of $2 \times 1,000$ MW of nominal power (INELFE HVDC), as seen in Figure 29 and Figure 30.

This HVDC connects the substations of Santa Llogaia 400 kV (in Spain) and Baixas 380 kV (in France). It runs almost in parallel with the AC interconnection line Vic–Baixas 400 kV, forming an AC–DC corridor.

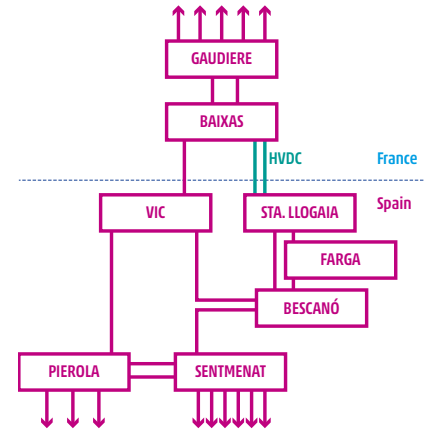
Figure 30: AC-DC corridor formed by the HVDC link and the Vic-Baixas line.

During the event, the HVDC and the AC line Vic–Baixas remained connected, supplying energy to the Eastern Pyrenees of France. In the following graph (Figure 31), the power flow during the system separation event at the AC–DC eastern corridor between Spain and France can be observed. The HVDC active power control mode is an angle difference control, which emulates the behaviour

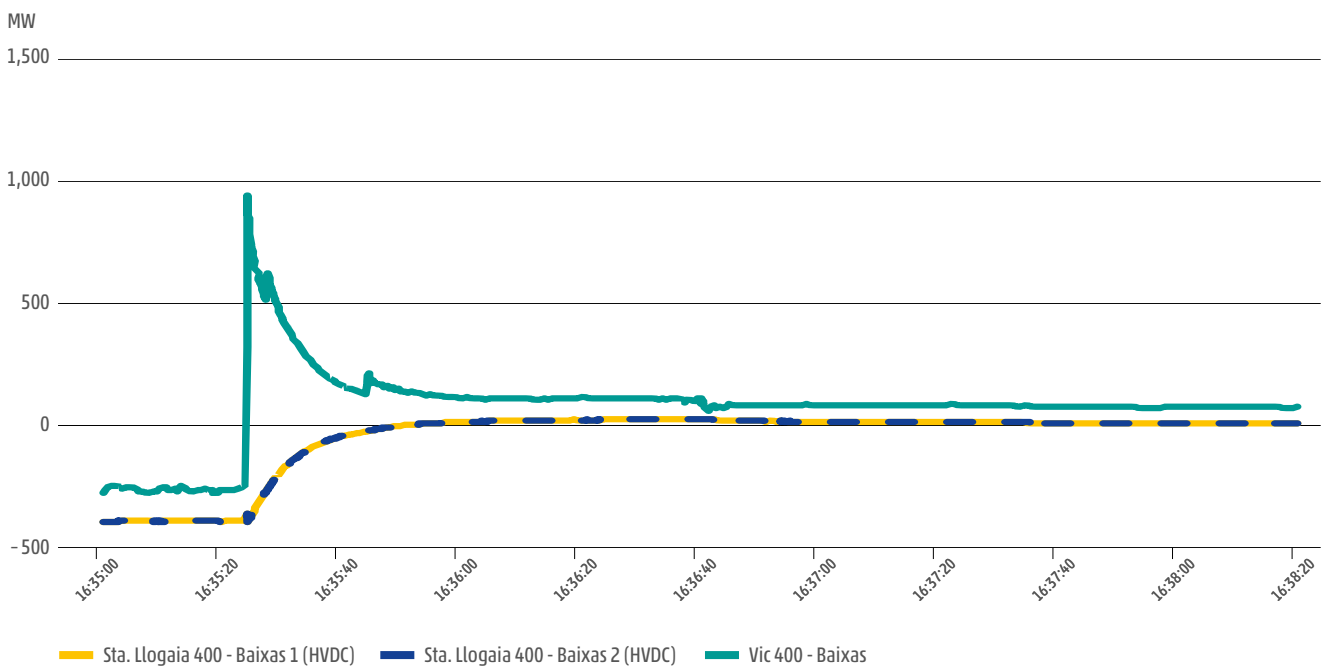
Figure 31: Active power of eastern France-Spain tie lines (positive means power transfer from Spain to France).

of the active power transfer of an AC line and adapts smoothly to the new topology and system conditions, as can be seen in Figure 31. In addition, each converter station kept performing a correct voltage control in its terminal substations, ensuring voltage stability in the French area that remained fed through the AC–DC eastern corridor and also in the Spanish side of the HVDC.
