**NIST NCSTAR 1-5A
Federal Building and Fire Safety Investigation of
the World Trade Center Disaster**

**Visual Evidence, Damage Estimates,
And Timeline Analysis**

(Chapter 9 - Appendix C)

FIRE BEHAVIOR IN WORLD TRADE CENTER 2

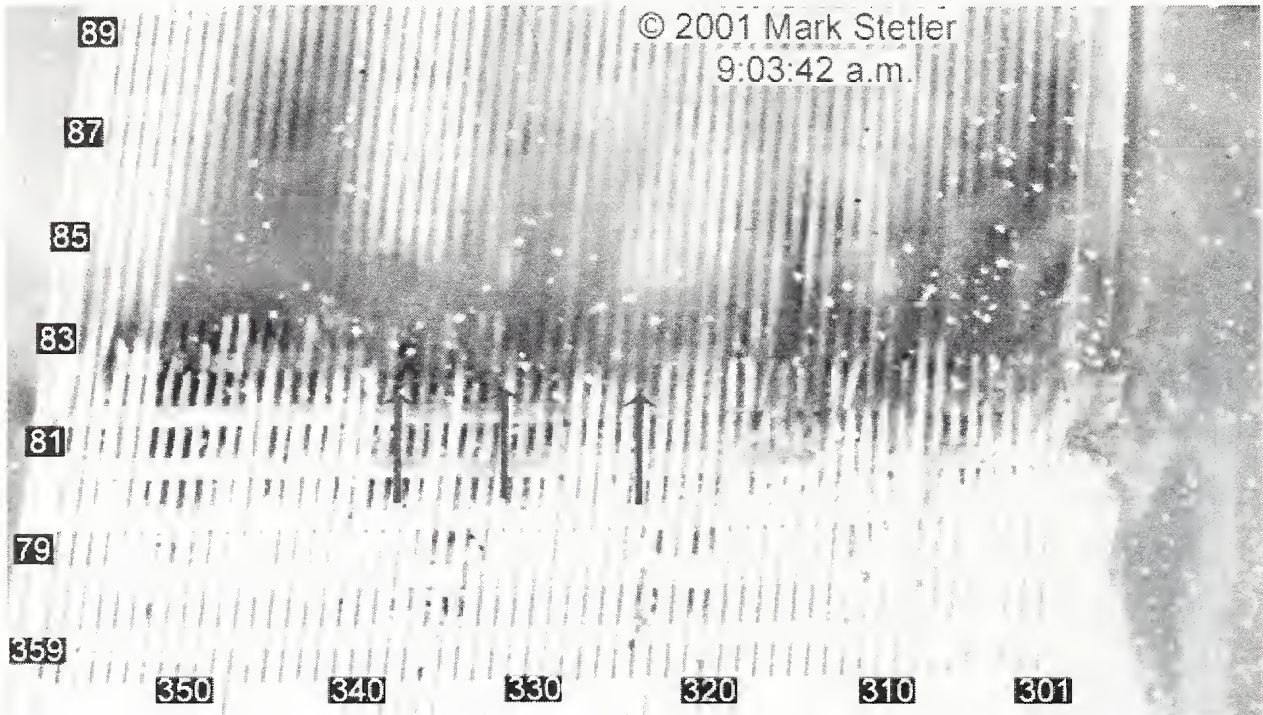
Figure 9–1 shows an image of the east face of WTC 2 recorded at 9:03:42 a.m., which was 43 s after the aircraft impact. The numerous white dots are pieces of paper that were expelled from the building due to the aircraft impact and subsequent fireballs. Extensive fires are visible on the 81st, 82nd, and 83rd floors. On the two lower floors, intense fires, which fill the windows with flame, appear to be nearly continuous from around windows 81-321 and 82-322 to the north edges of the floors. On the 83rd floor, the fires are intense, with considerable flaming outside of windows between windows 83-335 and 83-346. There is also a region with a lower intensity fire nearer the center of the face on the 81st floor, and there is an indication of a small fire near window 80-313 on the 80th floor. Despite the numerous fires present, the amount of smoke being released is relatively small, and it is possible to see most of the east face above the fires.

Figure 9-1. A view of the east face of WTC 2 recorded at 9:03:42 a.m. is shown. The original photograph has been rotated, cropped, and enhanced by adjusting intensity levels. Column and floor numbers have been added. The arrows highlight a hanging object observed through open windows on the 82nd floor.

Closer inspection of Figure 9–1 and Figure 9–2 shows that small flames are visible above the object at the tops of windows 82-335 to 82-337. While not as clear as in these windows, similar fires appear to be present elsewhere along the top of the line. Heavy flames are coming from windows on the 83rd floor immediately above this area. This suggests that the flames observed at the tops of windows on the 82nd floor are burning at the base of a fuel source located on top of the hanging object that is fueling the much larger flames visible on the 83rd floor. It is likely that this fuel is on top of the concrete floor slab that was originally attached to the spandrel above the 82nd floor.

The visual evidence supports a conclusion that a substantial length of the concrete floor slab for the 83rd floor along the east facade of the WTC 2 has been dislodged and has come to rest below the spandrel. The edge of the object appears to be continuous, suggesting that even though the floor slab has dropped down, it is essentially intact and is still acting as a single system.

In Chapter 7 it was also noted that a substantial flash fire lasting several seconds occurred on the 82nd floor due to the release of aviation fuel. The sudden appearance of this fire is believed to have generated an overpressure, that may have been on the order of several psi on the floor (see the discussion in Section 6.5). This overpressure was likely responsible for the removal of large sections of the curtain wall on the north and east faces, and it drove additional atomized fuel from the building, resulting in the formation of fireballs. It is possible that the separation of the 83rd floor slab from the spandrel was due the generation of sufficient overpressure on the 82nd floor to push the 83rd floor slab upward off of its seats, allowing it to then settle down below the spandrel.

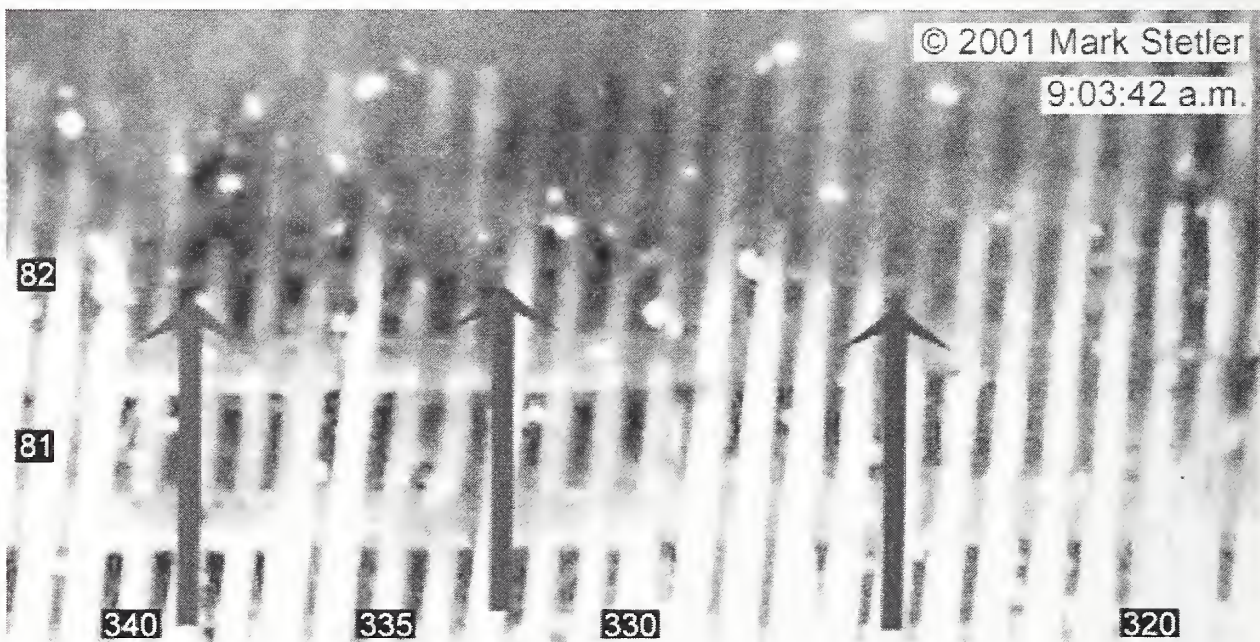
The intensity levels of the photograph in Figure 9–1 were adjusted to enhance the visibility of an object that is identified by the arrows added to the photograph. A blowup of the area of the photograph including the arrows is provided in Figure 9–2. The object appears as a narrow line that has been draped inside windows on the 82nd floor extending from at least window 82-321 to window 82-339. This hanging object will be observed numerous times in images to be shown below. While it is difficult to identify the object with certainty, the evidence will be strong that it is the end of a part of the 83rd floor concrete floor slab that has been dislodged from the spandrel located above the 82nd floor and has settled downward several feet to appear below the spandrel.

Figure 9-2. A section of the image shown in Figure 9-1 is blown up. The arrows point to the location of an object that is visible through open windows on the 82nd floor on the east side of WTC 2.

The hanging object on the 81st floor is now visible through windows 81-331 to 81-335 and windows 81-338 to 81-342. Windows further to the north remain obscured. Comparison of the location of the object with the image reproduced in Figure 9-1 and Figure 9-2, which was recorded at 9:03:42 a.m., shows that the object is at roughly the same height in the windows and has a similar shape.

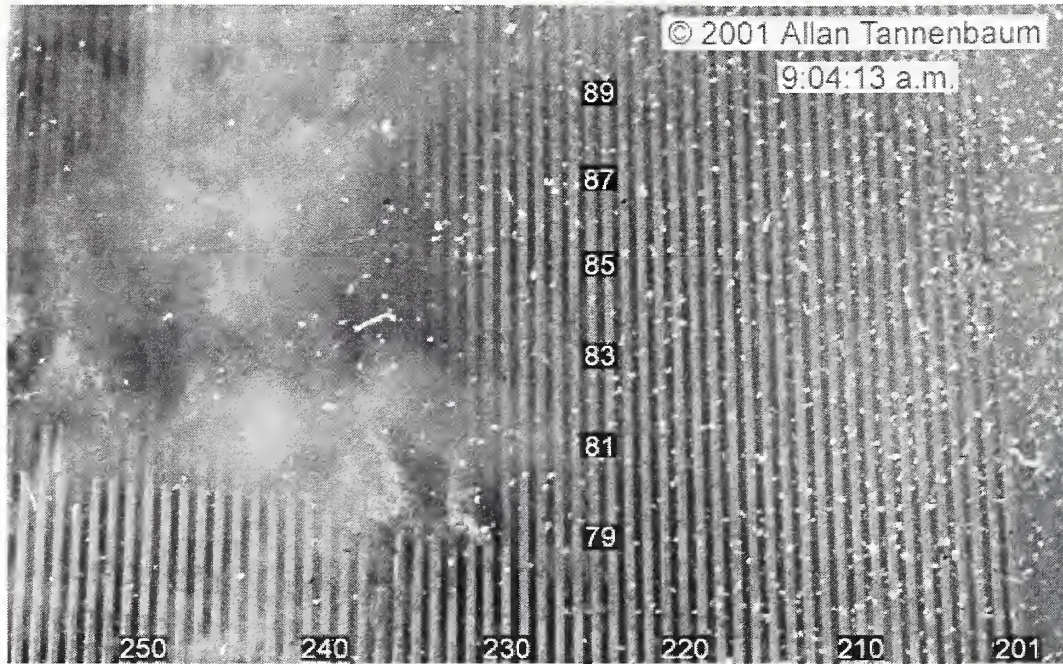
A view of the north face of WTC 2 recorded at 9:04:13 a.m. is shown in Figure 9–3. The large amount of paper expelled from the tower due to the aircraft impact and subsequent fires is apparent. Two areas of intense fire are seen. One of these is located near the east edge of the face on the 81st floor, and the second is on the 79th floor, extending from roughly windows 79-231 to 79-238. In Chapter 7 visual evidence was shown indicating that large piles of debris, presumably a mixture of aircraft and building debris, were present at these two locations. Evidently, these debris piles were ignited during the aircraft impact and subsequent fireballs and continued to burn intensely. Even though there is a large amount of dust evident, there does not appear to be a substantial fire in the region between the two burning areas.

Figure 9-3. This cropped photograph of the north face of WTC 2 was recorded at 9:04:13 a.m. The image intensity levels have been adjusted. Column and floor numbers have been added.

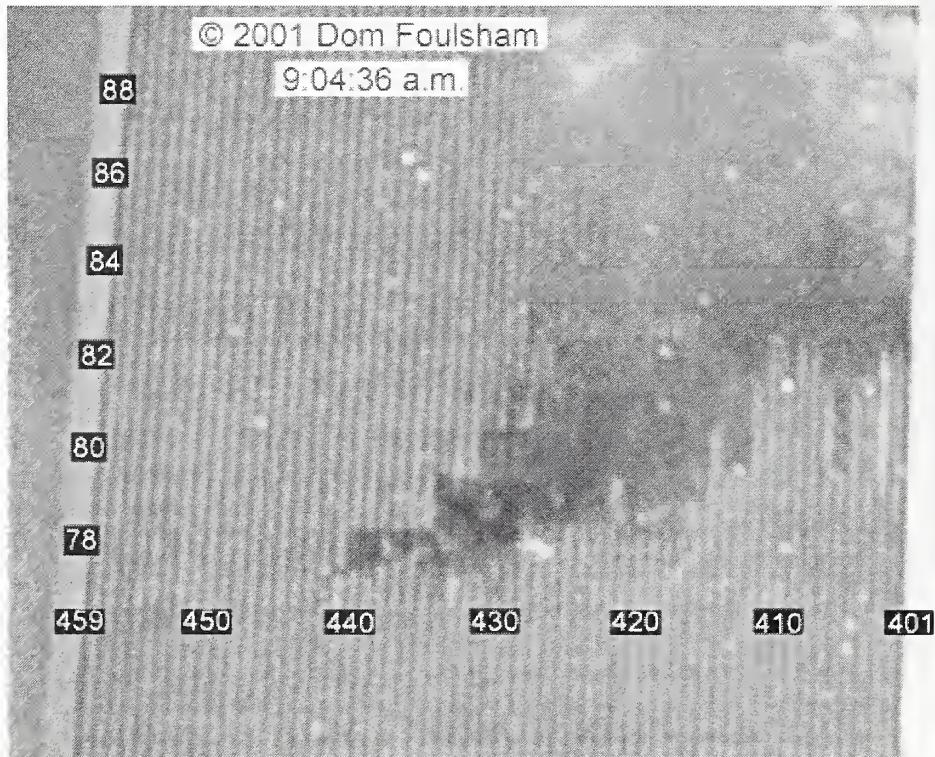
A view of the south face of WTC 2 recorded at 9:04:36 a.m. is shown in Figure 9–4. It was taken 97 s after the aircraft impact on this face. A number of sheets of paper are also visible on this side of the building. The most prominent feature is the damage caused by the aircraft impact. Two areas of bright flame are evident in the image on the 78th and 79th floors. On the 78th floor, the fire is located just to the right of the cavity generated by the aircraft impact, while on the 79th floor the fire appears to be burning within the cavity. On the 82nd floor there appears to be an orange glow from windows 82-420 to 82-425, suggesting that a fire is present in this area as well.

Figure 9-4. This cropped photograph shows the south face of WTC 2 at 9:04:36 a.m. Column and floor numbers have been added.

There is relatively little smoke coming from windows on the south face at this time. For later comparison purposes, note that the entire lengths of the 81st and 82nd floors can be seen and that very little smoke is evident coming from windows on these floors. The only significant plume of smoke is coming from the 83rd floor near the east edge of the face.

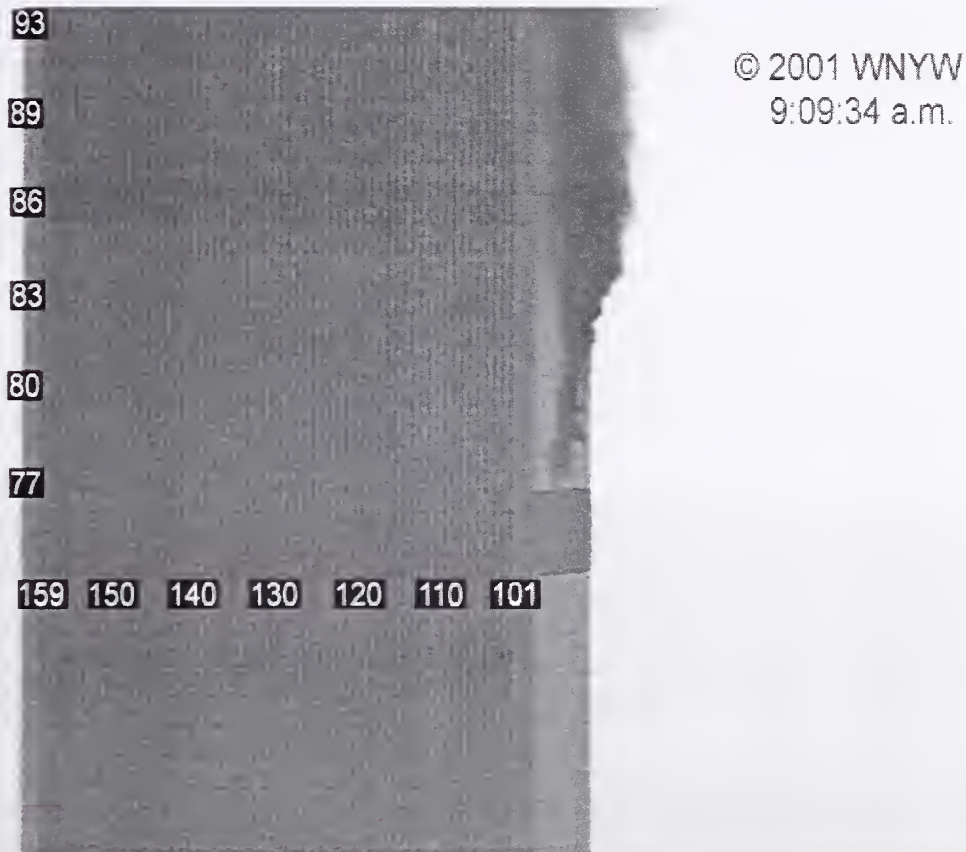
The database does not contain clear images of the west face of WTC 2 in the early period following the aircraft impact. Figure 9-5 shows an image of the face taken from a video recording made from a news helicopter at 9:09:34 a.m. At this time there was no visible smoke or fire on the face. This is consistent with the conclusion in Chapter 7 that the aircraft impact and subsequent fireballs caused no visible damage to the west face of WTC 2.

Figure 9-5. This image of the west face of WTC 2 was captured from a video shot from a news helicopter at 9:09:34 a.m. Column and floor numbers have been added.

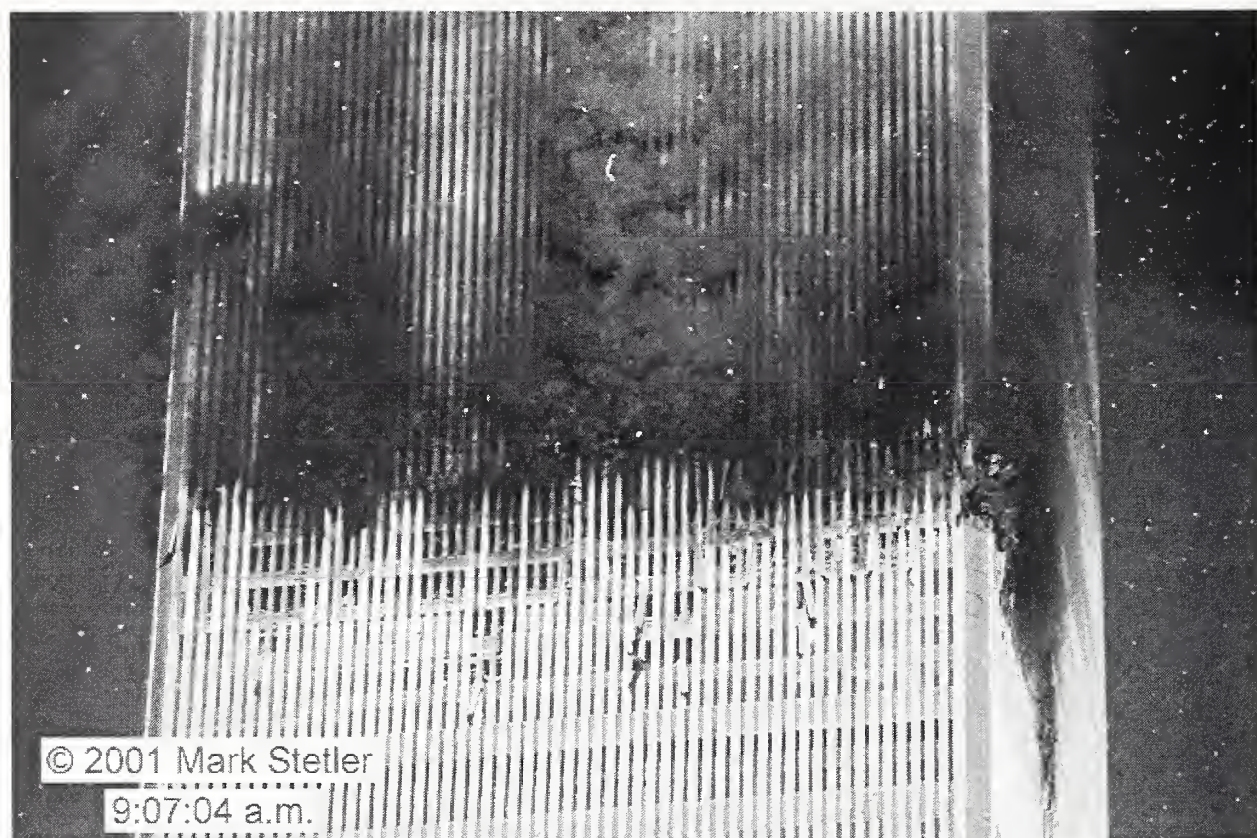
Figure 9-6. This photograph showing the east face of WTC 2 was recorded at 9:07:04 a.m.

A close-up view of the east face of WTC 2 recorded at 9:07:04 a.m. is shown in Figure 9–6. During the 3 min 20 s since Figure 9–1 was taken, the fire distribution on the face has changed. The large fires that were burning earlier on the 81st, 82nd, and 83rd floors appear to have died down somewhat. A new area of intense fire has appeared on the 82nd floor just to the south of where the large fire was visible on the 83rd at the earlier time.

A substantial increase in the amount of smoke coming from open windows is evident when the two photographs of the east face are compared. The smoke appears to be coming from two separate locations on the 82nd floor. Videos of the east face show that heavy smoke appeared first from the area on the south side of the face, increasing rapidly around 9:04:30 a.m. The smoke flow coming from windows just to the north of the center of the face increased markedly about 50 s later.

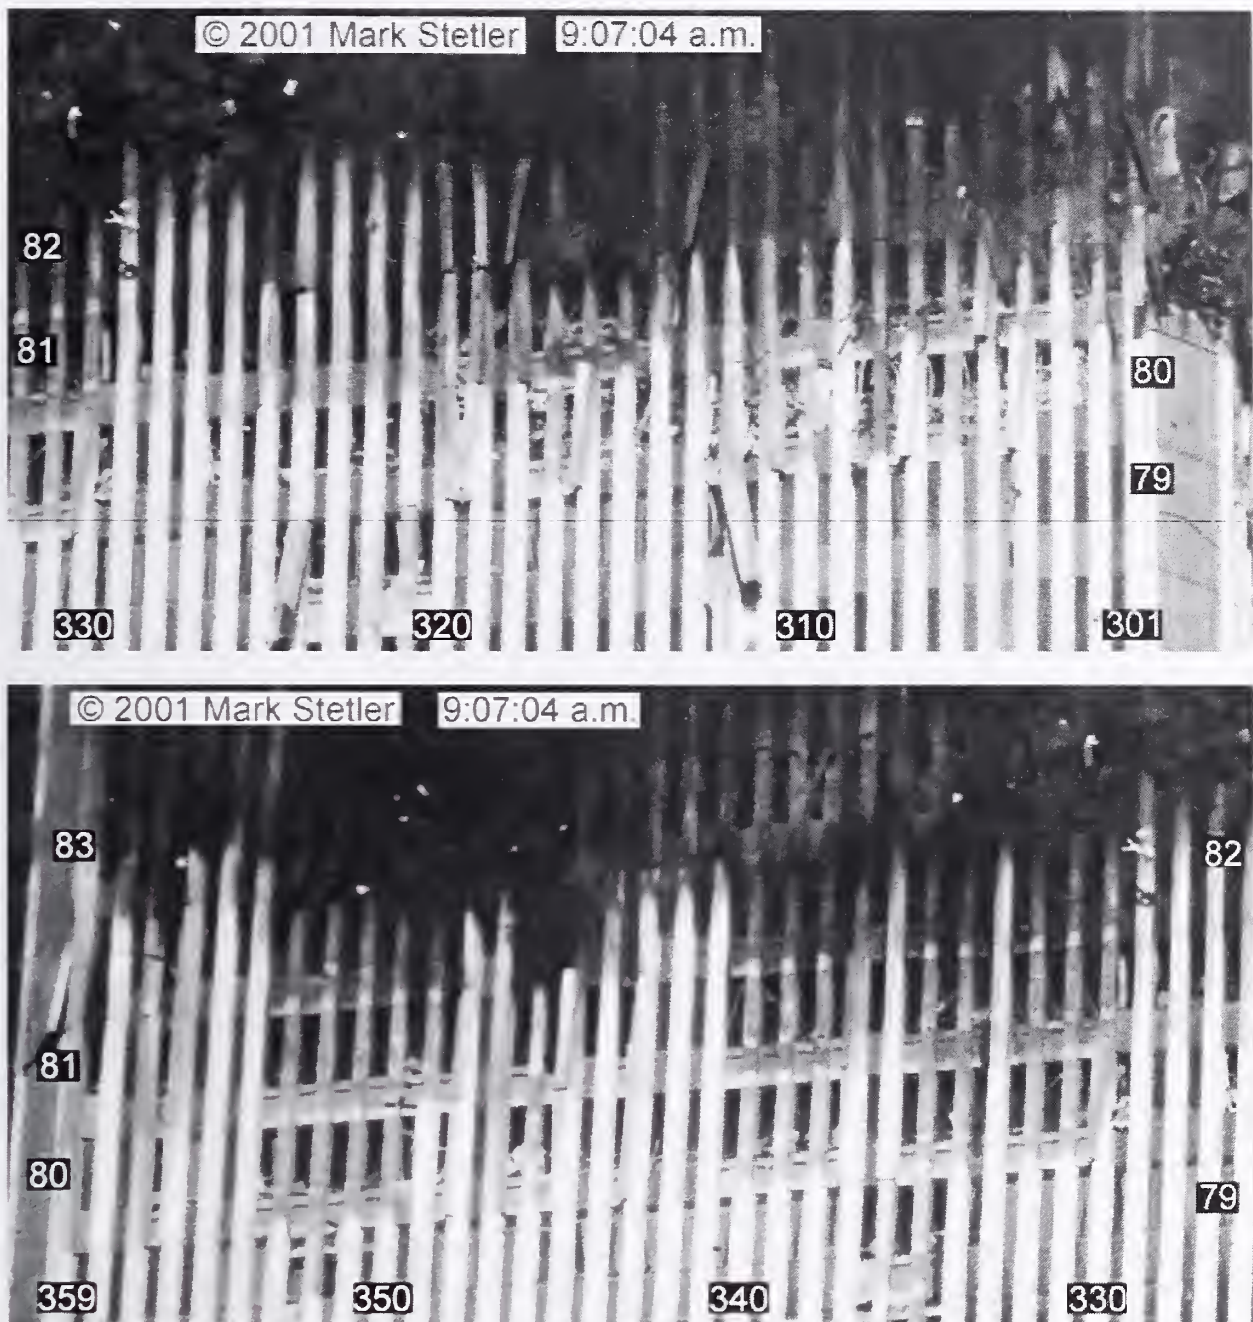
The image in Figure 9–6 provides a great deal more resolution than is evident from the way it has been sized. Figure 9–7 shows blowups taken from the photograph of the northern and southern halves of the east face for the floors where fires were present. The north side is at the top of the figure. In this image the damage to the aluminum façade is evident. The debris that has been piled along the east wall in the northeast corners on the 80th and 81st floor is visible. There is also a large amount of debris protruding from the opening created by removing the aluminum panel from the northeast corner of the 81st floor.

Figure 9-7. These two images show blowups of the north and south sides of the east face of WTC 2 taken from the photograph included in Figure 9-6, which was shot at 9:07:04 a.m. Column and floor numbers have been added.

Heavy fires are burning in the northeast corners of the 81st and 82nd floors. On the 81st floor flames are coming from windows 81-301 to 81-304 as well as from the northeast corner where the aluminum panel has been removed. Lower intensity flames are evident in many windows further to the south, extending at least as far as the last visible window, 81-332. It is likely that the fire is continuous across this entire length. On the 82nd floor flames are coming from windows 82-301 to 82-309. Flames further to the south do not appear to be as widespread as on the 81st floor, but there is much more smoke coming from open windows on this floor. The smoke flow is particularly heavy from windows 82-323 to 82-332. The

A blowup of the southern side of the fire floors is included at the bottom of Figure 9-7. Flames are visible on the 83rd floor over a length from near window 83-331 to window 83-338. The intensity of these flames has died down considerably from that observed at the earlier time in Figure 9-1. It can be seen that a considerable amount of the aluminum facing on this floor has been removed.

Unlike in the earlier photograph, intense flames are now visible in windows 82-341 to 82-349. Flames fill these windows and in many cases extend from the openings. Heavy black smoke is coming from the flame area as well as from windows immediately below on the 81st floor, particularly window 81-345 and window 81-346. Smoke is also coming from numerous windows to the north of the visible fire on the 82nd floor. This smoke has obscured the windows where the hanging object was identified in Figure 9-1 and Figure 9-2. Note that the aluminum panel on the southeast corner of this floor is pushed out, but is still attached.

On the 81st floor the last window to the south where a low-intensity fire is observed is window 81-333. It is interesting that despite the fact that there is a great deal of damage to the aluminum façade on this floor, there are several windows for which the glass is still in place. The small spot fire present in window 80-330 can be seen in the overlapping lower image as well. Several window panes are also still in place on this floor. No fire or smoke is visible on this half of the 79th floor.

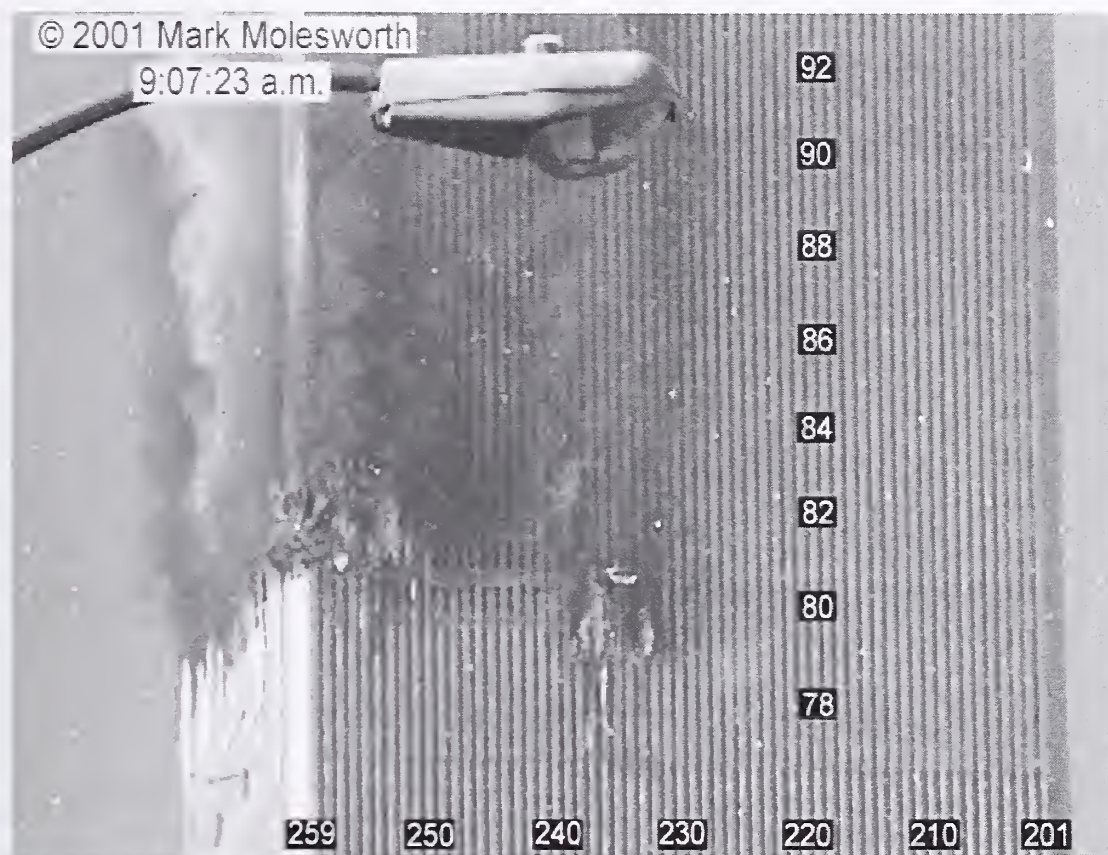
Figure 9-8 shows the north face of WTC 2 at 9:07:23 a.m. This is 3 min and 10 s later than the image of the north face included in Figure 9-3. The view of the fires in the current image is more complete due to the angle and distance from which it was shot. The two large fires that were observed on the 79th and 81st floors at the earlier time continue to burn vigorously. The fire on the 79th floor still consists of two large tongues of flame at the same locations however, flames are visible further to the west than at the earlier time, now reaching at least as far as window 79-228. In the earlier photograph, windows 79-228 and 79-229 appeared to have intact glass. The intense fire on the east edge of the 81st floor is in roughly the same location as earlier. In Figure 9-3 it was not possible to determine whether the 82nd floor was burning. It is clear in the later image that there is a fire on the 82nd floor, with flames coming from windows 82-252 to 82-258. It was difficult to see this area immediately following the aircraft impact because of the amount of debris released and the large flames present on the 81st floor. A review of images indicates that the 82nd floor was burning in this corner as early as 9:04:25 a.m.

Figure 9-8. This image captured from a video shows the north face of WTC 2 at 9:07:23 a.m. Column and floor numbers have been added.

Figure 9–8 provides a good view of much of the north face with sufficient resolution to resolve details on the face. For instance, the open windows on the 78th floor near window 78-225 can be discerned. There is no indication of fire or smoke at locations removed from the area that was originally damaged during the aircraft impact and subsequent fireballs.

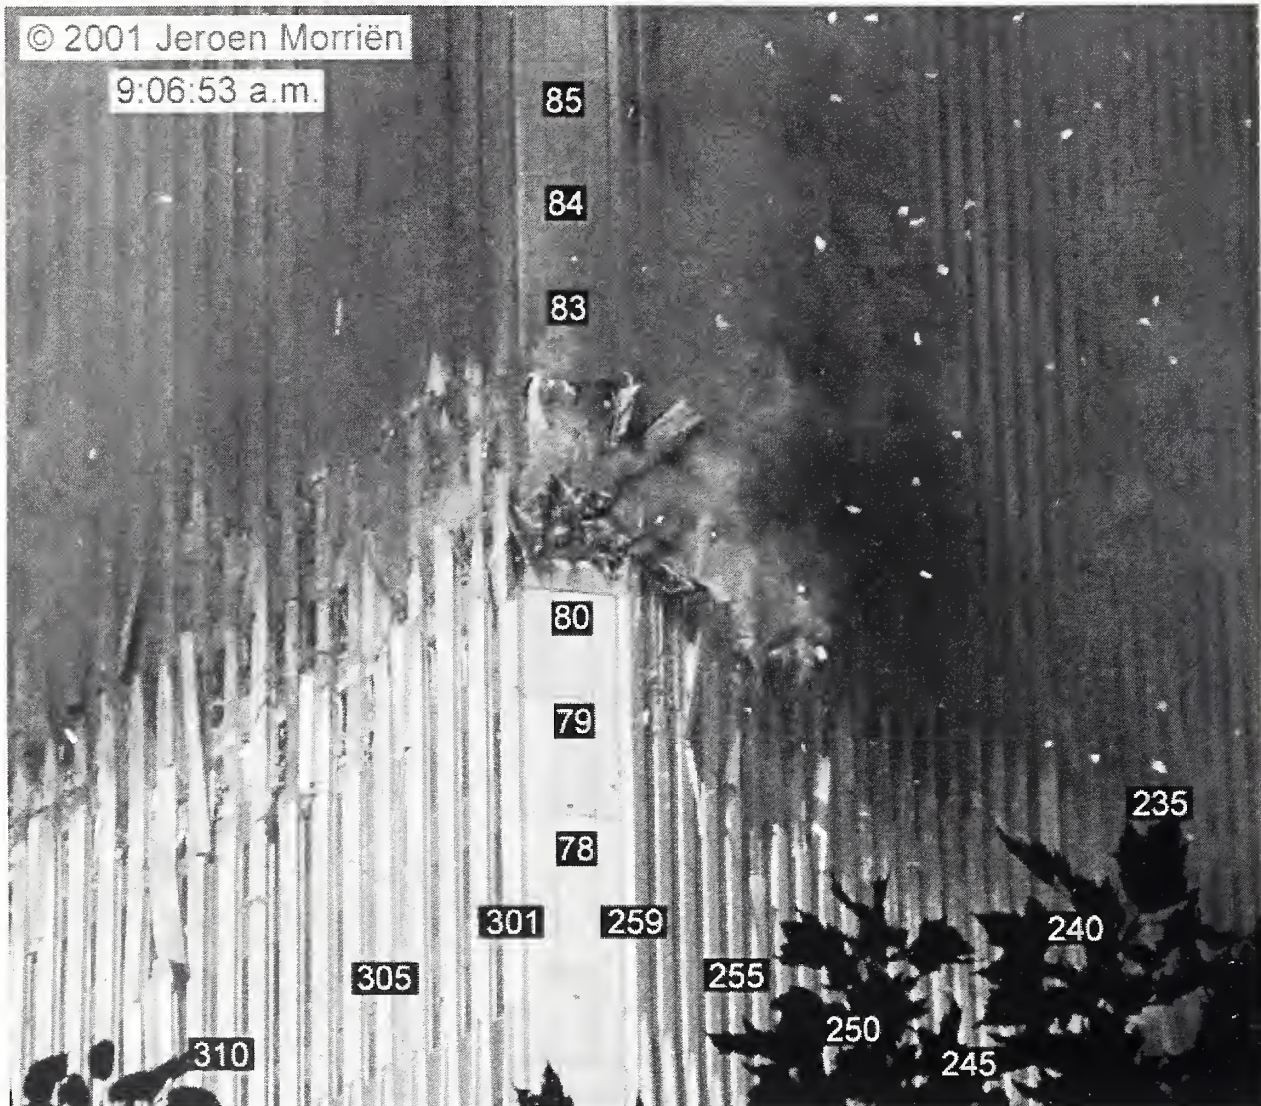
An image of the fires on north and east faces shot from the northeast at 9:06:53 a.m. is shown in Figure 9–9. It provides a good view of the debris that was protruding from the northeast corner of the 81st floor, as well as an indication of the actual extent and intensity of the fires burning in the northeast corners of the 81st and 82nd floors. The cold spot on the north face is easily identified from this angle.

Figure 9-9. This cropped photograph showing the northeast corner of WTC 2 was taken at 9:06:53 a.m. The image has been enhanced by adjusting the intensity levels. Column and floor numbers have been added.

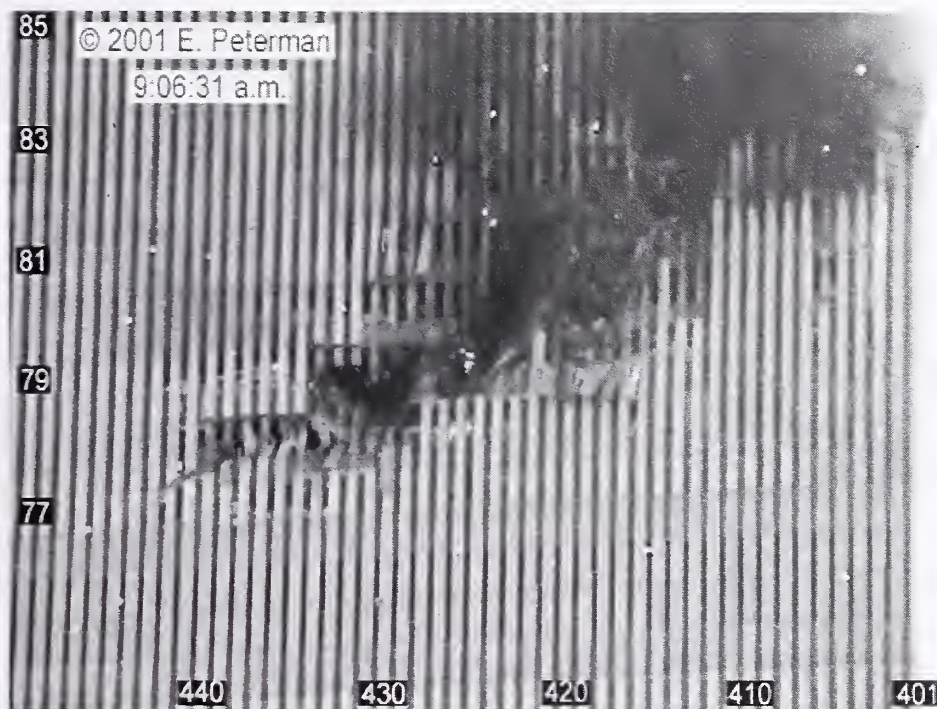
An image of the south face of WTC 2 taken from a video recorded at 9:06:31 a.m. is shown in Figure 9–10. This is slightly less than two minutes later than the image shown in Figure 9–4. Even though the latter image is clearer and shows more detail, it can still be seen that the appearance of the face has changed somewhat during this short period. A new fire has appeared on the 81st floor near window 81-430 that was not apparent earlier. The fire that was burning within the cavity created by the aircraft impact on the 79th floor seems to have moved toward the west and can now be seen on top of a pile of debris through open window 81-436, as well as at multiple locations on the debris within the impact cavity. In the later image there is no indication of a fire burning on the 82nd floor above the aircraft impact cavity.

In Figure 9-10, smoke is coming from open windows to the east of the aircraft impact cavity on the 81st floor, and there is an indication of flames in the area. In the earlier photograph, this area was clear of smoke, and some details on this floor as well as the one above could be identified. Apparently, a fire has grown quickly on the 81st floor in this area. Interestingly, a photograph of the east face taken around this time (see Figure 9-7) shows very little smoke and no visible flame near the south edge of the face. This suggests that the fire growing at this location was ignited near the aircraft impact location and is moving toward the east.

Figure 9-10. This image showing the south face of WTC 2 is a frame captured from a video recorded at 9:06:31 a.m. It has been enhanced by adjusting the intensity levels, and column and floor numbers have been added.

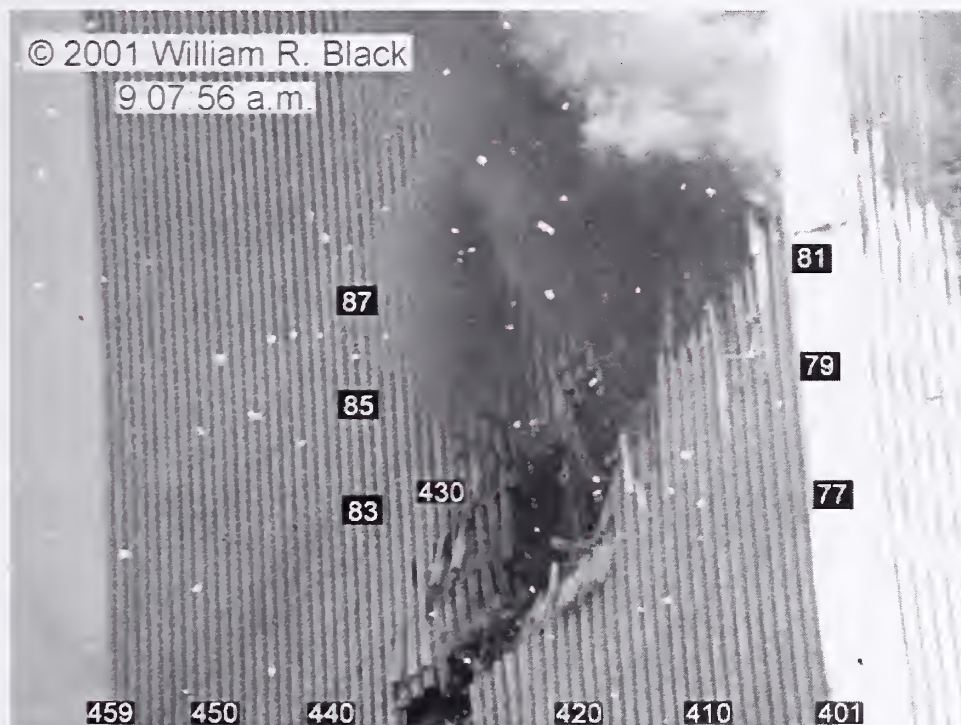
Another view of the south face at roughly the same time is shown in Figure 9-11. It was shot from further east than Figure 9-10. From this angle fires are visible at multiple spots inside the aircraft impact cavity, including locations corresponding to the 78th, 79th, and 80th floors. The smoke coming from the windows to the east of the aircraft impact cavity on the 81st floor is also visible. Apparently, the fires

Figure 9-11. This photograph of WTC 2 was taken at 9:07:56 a.m. from the southeast and shows the south face and a portion of the east face. The intensity levels have been adjusted, and column and floor numbers have been added.

growing on this floor are also venting through the aircraft impact cavity since a large amount of smoke is flowing from the opening just to the west. This photograph confirms that little smoke and no flames are visible coming from windows on the 81st floor of the east face that are adjacent to this area.

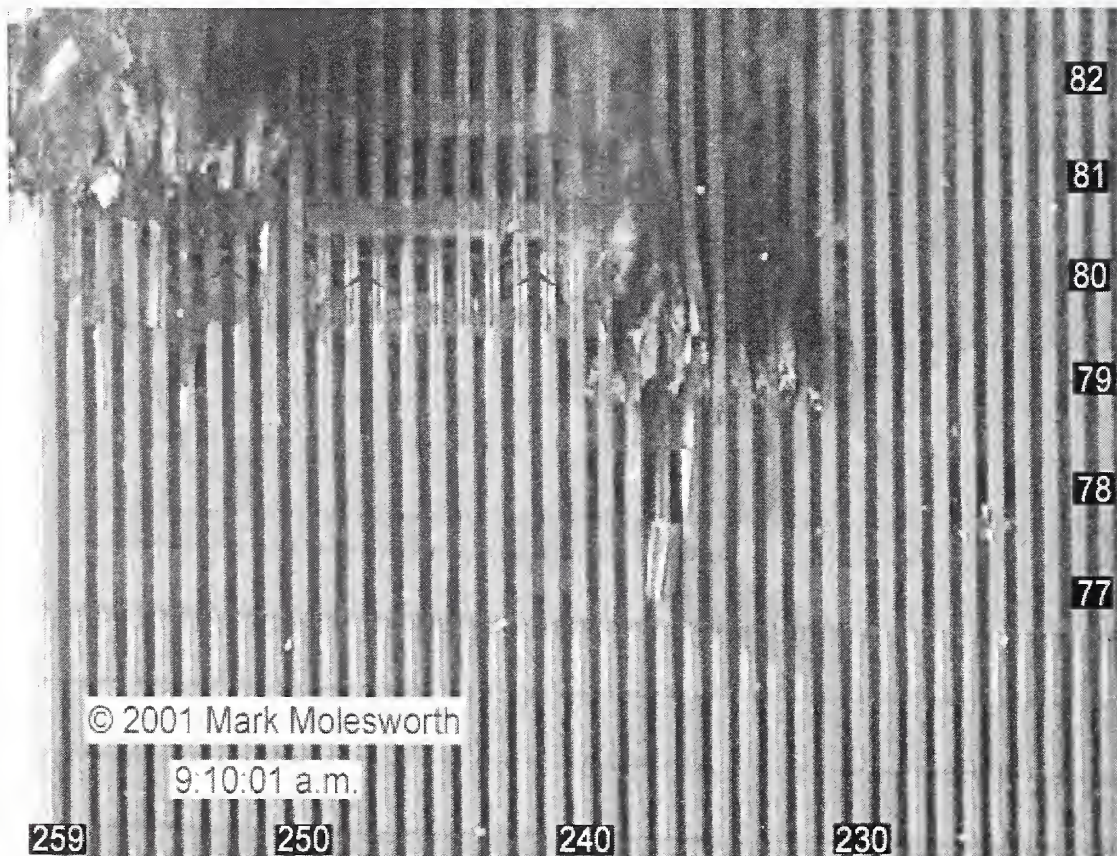
At 9:10:01 a.m. a videographer recorded a closer view of the north face of WTC 2 than those presented thus far. Figure 9-12 shows a frame captured from this video. The image shows that the fires burning on the 79th, 80th, and 81st floors have not changed markedly since 9:07:23 a.m. (see Figure 9-8). The cold spot is also distinct. The increased resolution of Figure 9-12 allows a detail to be resolved that was not easily identified in the earlier images. There appear to be two objects hanging across a length of open windows on the 80th floor. The arrows added to the image indicate these objects. One of the objects appears as a line running from at least window 80-255 to window 80-243. The second object also appears as a curved line. It is visible above the first object starting near the top of window 80-247 and extending west to at least window 80-241.

Figure 9-12. An image of the north face of WTC 2 captured from a video recording at 9:10:01 a.m. is shown. The intensity levels of the image have been adjusted, and column and floor numbers have been added. The arrows highlight hanging objects observed through open windows on the 80th floor.

Closer inspection of Figure 9–12 shows that flames are visible above the first object in windows 80-249, 80-252, and 80-253. These fires have similar locations and appearances to the numerous fires that were observed at the tops of windows in WTC 1 (see Chapter 8) and were attributed to burning thermal insulation located above the windows. In this case this explanation seems unlikely since the aluminum façade has been removed from the columns adjacent to these windows. Using Figure 9–12 as a guide, Figure 9–8 was reviewed more carefully to look for indications of these objects and fires. It is possible to barely discern the first of the objects, and the fires above the objects are clearly visible at the earlier time.

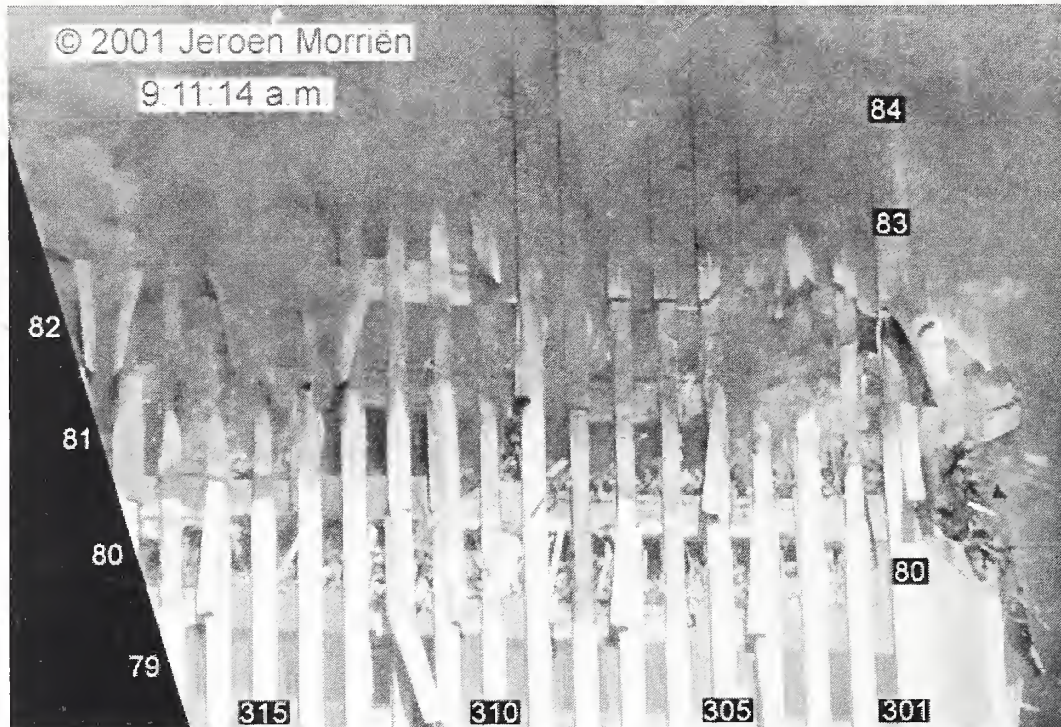
A close-up view of the northern portion of the east face of WTC 2 at 9:11:14 a.m. is shown in Figure 9–13. The debris piles on the 80th and 81st and in the opening on the northeast corner of the 81st floor are particularly clear. The fires on the 81st and 82nd floors continue to burn intensely. The only fire visible on the 80th floor is in window 80-317. Most of the glass is intact for windows on the 79th floor.

Figure 9-13. This photograph shows the northern portion of the east face of WTC 2 at 9:11:14 a.m. The image has been cropped and rotated, and the intensity levels have been adjusted. Column and floor number have been added.

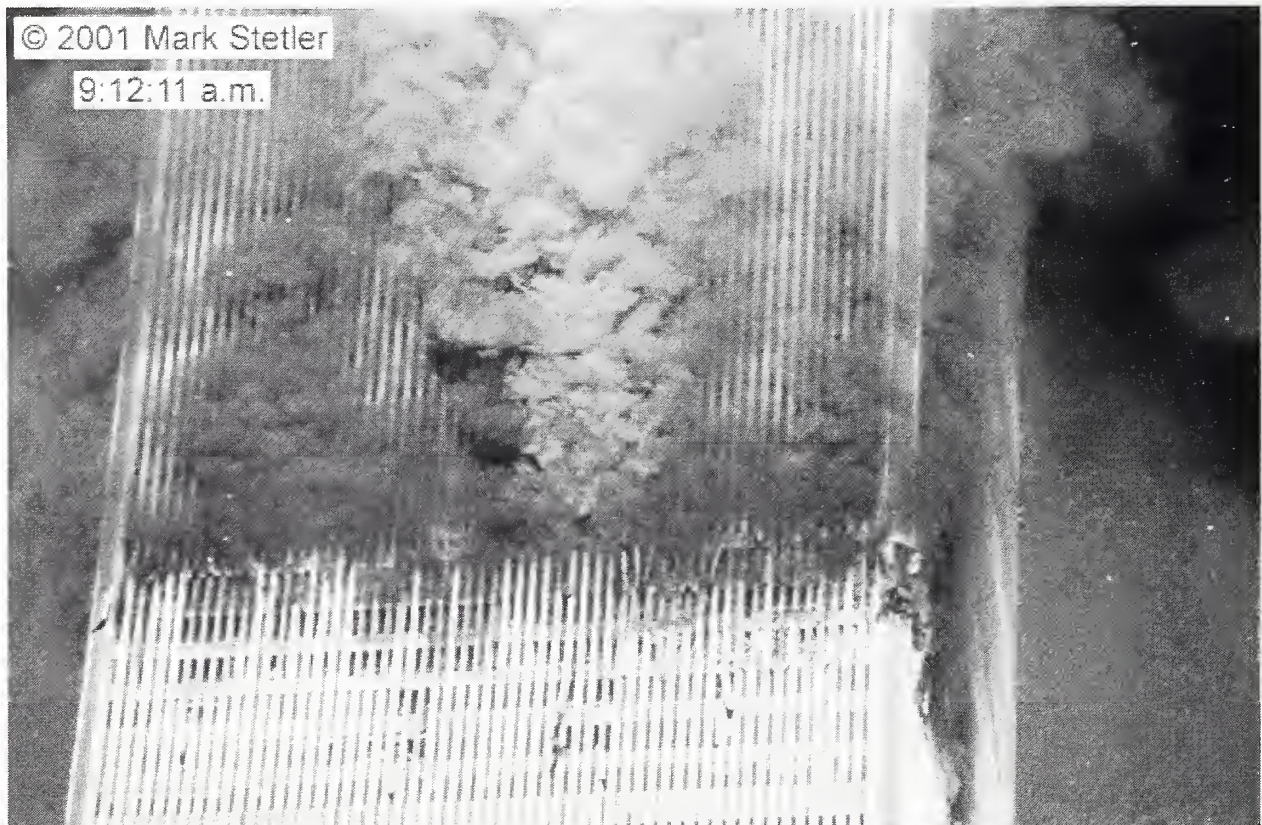
Another photograph of the east face of WTC 2 taken at 9:12:11 a.m. is shown in Figure 9–14. Figure 9–15 includes blowups of the north and south sides of the fire floors from this photograph. Comparison of Figure 9–14 with the similar photograph in Figure 9–6, which was taken just over 5 min earlier, shows that the heavy smoke flows from near the center and closer to the southern edge of the face have continued. In Figure 9–14, it appears as if a portion of the smoke flow near the center may be coming from the 83rd floor. It can also be seen that the fire burning on the southern half of the 81st floor has grown substantially.

Figure 9-14. This photograph showing the east face of WTC 2 was recorded at 9:12:11 a.m.

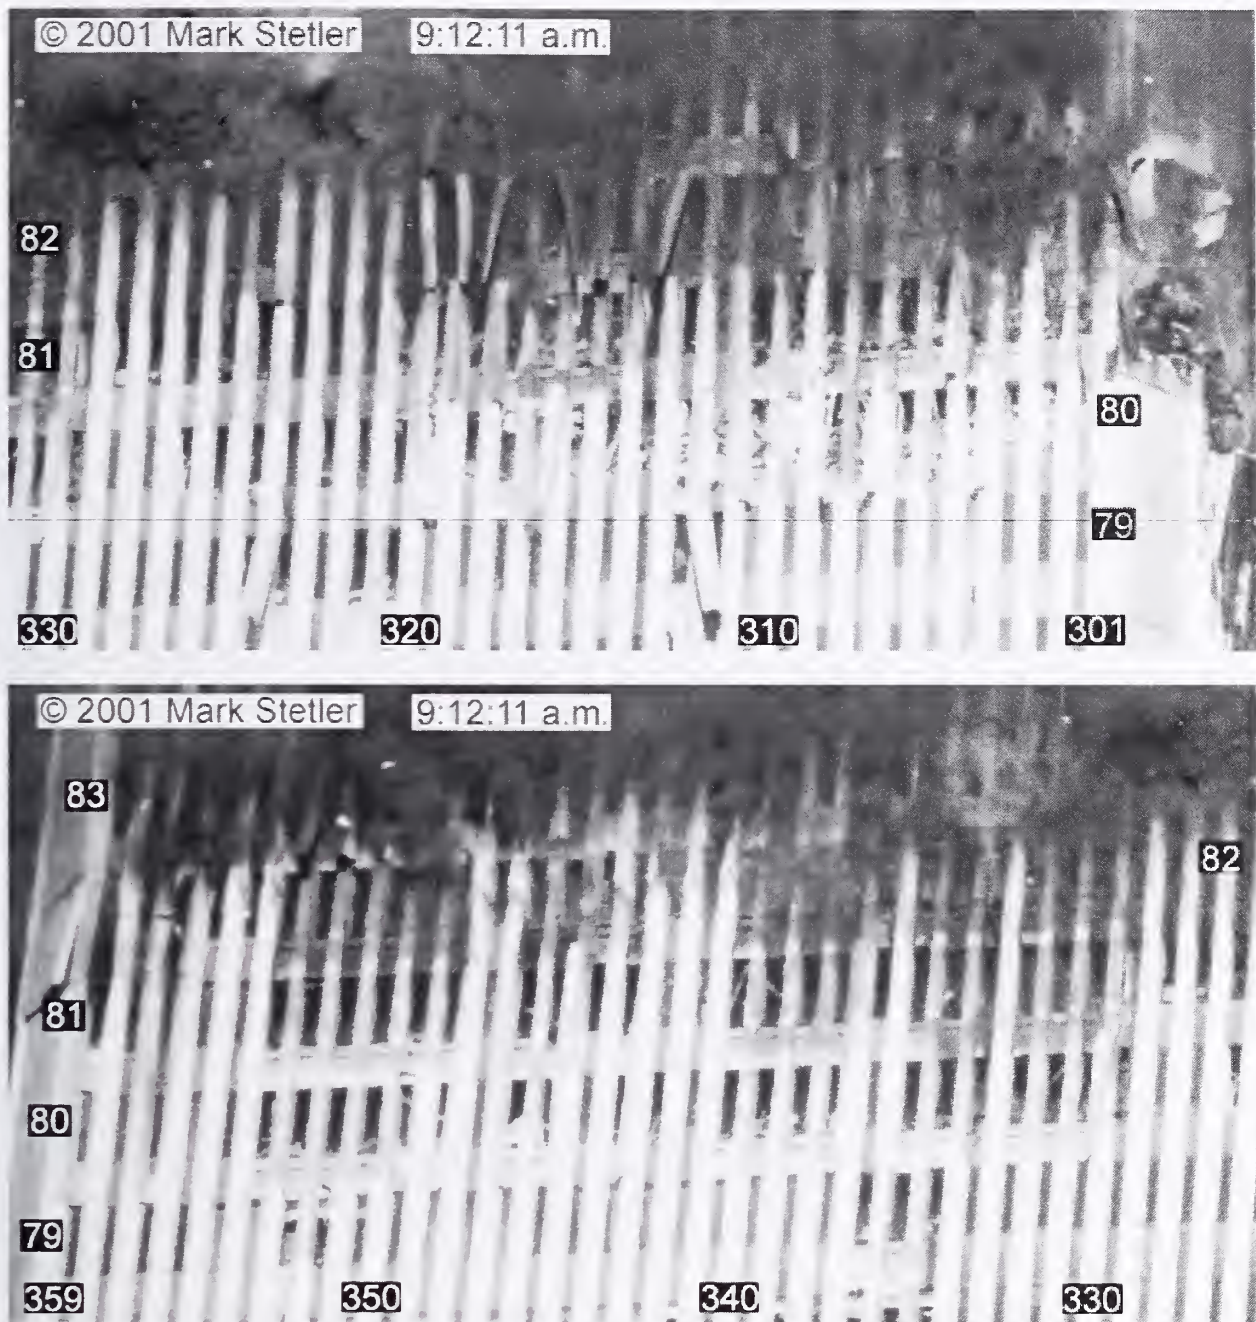
Figure 9-15. These two images show blowups of the north and south sides of the east face of WTC 2 taken from the photograph included in Figure 9–14, which was shot at 9:12:11 a.m. Column and floor numbers have been added.

The fire spread during the period is more easily characterized by comparing the blowups of the southern part of the face shown in Figure 9–7 and Figure 9–15. At the earlier time, flames were visible on the 82nd floor in windows 82-341 to 82-349. By 9:12:11 a.m., the flames had spread to cover a length of the floor, running from window 82-332 to window 82-350. At the earlier time, smoke was coming from some of the windows where fire has now appeared. This is likely an indication that growing fires were near these windows at 9:07:04 a.m. As the fires to the north have grown larger, the earlier fires in windows 82-341 to 82-349 have decreased in intensity, as reflected by their external flame lengths. This

The close up views of the north side of the east face shown at the tops of Figure 9-7 and Figure 9-15 look very similar. There appears to have been a slight decrease in the intensity of the fires burning in the northeast corners of the 81st and 82nd floors. Two small spot fires burning on the 80th floor also seem to have grown smaller.
