**NIST NCSTAR 1-5A
Federal Building and Fire Safety Investigation of
the World Trade Center Disaster**

**Visual Evidence, Damage Estimates,
And Timeline Analysis**

(Chapter 9 - Appendix C)

FIRE BEHAVIOR IN WORLD TRADE CENTER 2

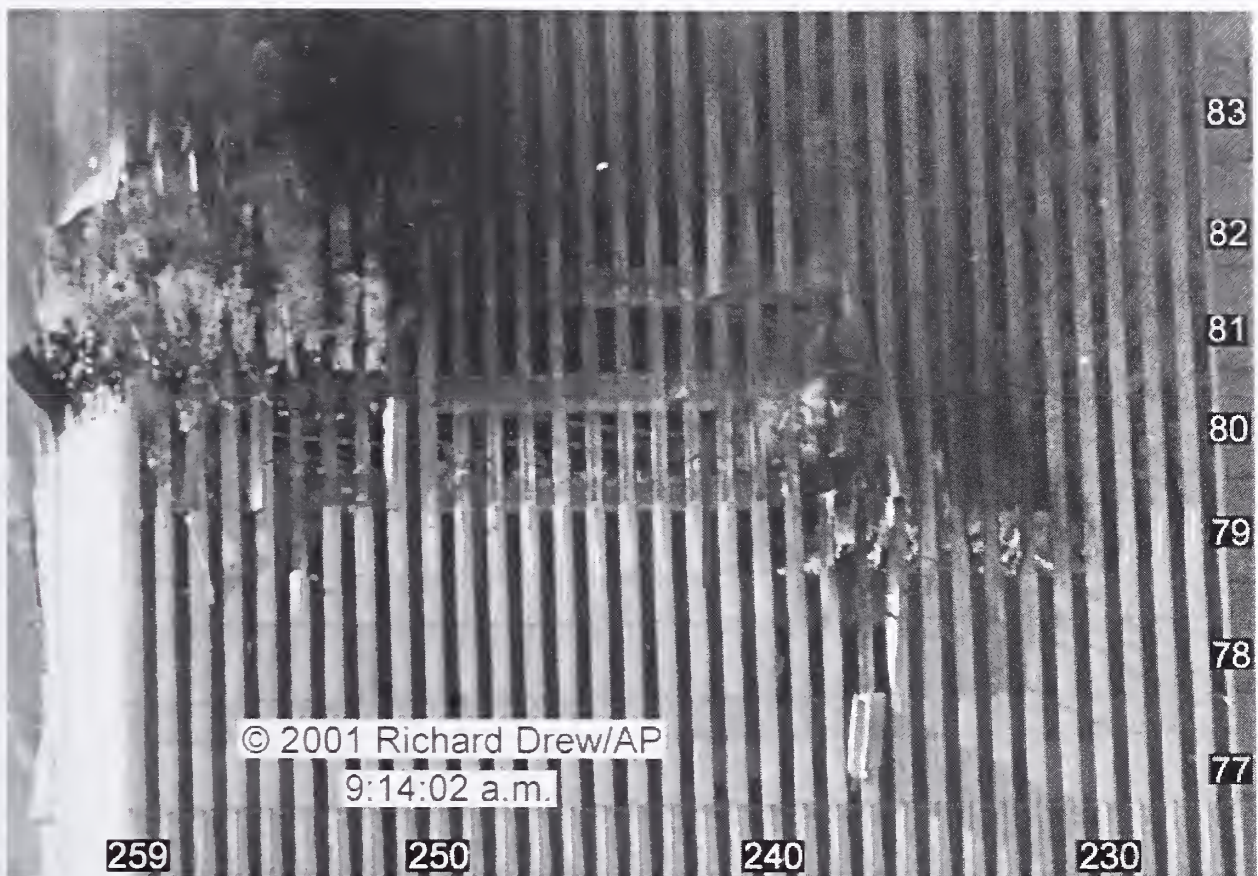
Figure 9-16 shows a close-up view of the north face of WTC 2 taken at 9:14:02 a.m. This is just over 4 min later than the image shown in Figure 9-12. This photograph provides somewhat higher resolution than the earlier image. The arrows point to objects that appear to be hanging across open windows on the 80th and 81st floors. The area of the image containing the arrows is blown up in Figure 9-17.

Even though the later image has higher resolution and shows more detail, a comparison of Figure 9-12 and Figure 9-16 indicates that the locations of the hanging objects identified in Figure 9-12 have not shifted appreciably during the 4 min period between the photographs. There are additional hanging objects resolved in the later photograph (seen most clearly in Figure 9-17) that are not easily identified in Figure 9-12. In addition to the two hanging objects on the 80th floor that were previously described, there is another similar object visible on the 81st floor near the tops of windows 81-239 to 81-242. This hanging object appears to consist of two closely spaced lines. There is yet another object in windows 80-251 to 80-254 that is below the much longer object that is visible hanging across window 80-242 to window 80-256.

In Figure 9-16 and Figure 9-17, small fires are visible above the longest hanging object seen through windows on the 80th floor at the tops of window 80-248 and windows 80-252 to 80-254, again suggesting that fuel located on top of the hanging objects is burning. The large fires nearest the eastern edge on the 81st and 82nd floors and in the opening on the northeast corner continue to burn intensely in the same windows as earlier. In Figure 9-16, it appears as if a fire is burning on the 83rd floor in window 83-257, but it is possible that these flames are an extension from the large fire on the 82nd floor. There is evidence in the photograph for strong heating of the façade at the base of the 83rd floor in this area. The lower portions of the aluminum covers on columns 83-256 to 83-259 are missing, and the bottom edges of the remaining aluminum have an inverted “v” shape. These observations indicate that these aluminum column covers have been melted by the intense heat coming from below.

Figure 9-16. This close-up image of the north face of WTC 2 was taken at 9:14:02 a.m. The original photograph has been cropped and rotated, and the intensity levels have been adjusted. Column and floor numbers have been added. The arrows highlight hanging objects observed through open windows on the 80th and 81st floors. The brown area to the right is the eastern edge of WTC 7.

Most of the cold spot continues to be smoke and fire free. In the lower right-hand corner of the area a small fire is now visible on the 80th floor in windows 80-238 to 80-240, burning on a debris pile. The image in Figure 9-16 has sufficient resolution to determine the condition of windows. All of the windows on the 83rd floor immediately above the cold spot have glass in place while windows 79-241 to 79-249 on the 79th floor below the spot were also closed at this time.

The debris pile on the 79th floor continues to burn vigorously. Comparison of Figure 9-12 and Figure 9-16 shows that flame lengths are decreasing slowly. This fire is visible in the same windows as earlier and does not appear to be spreading in either direction along the north side of the building.

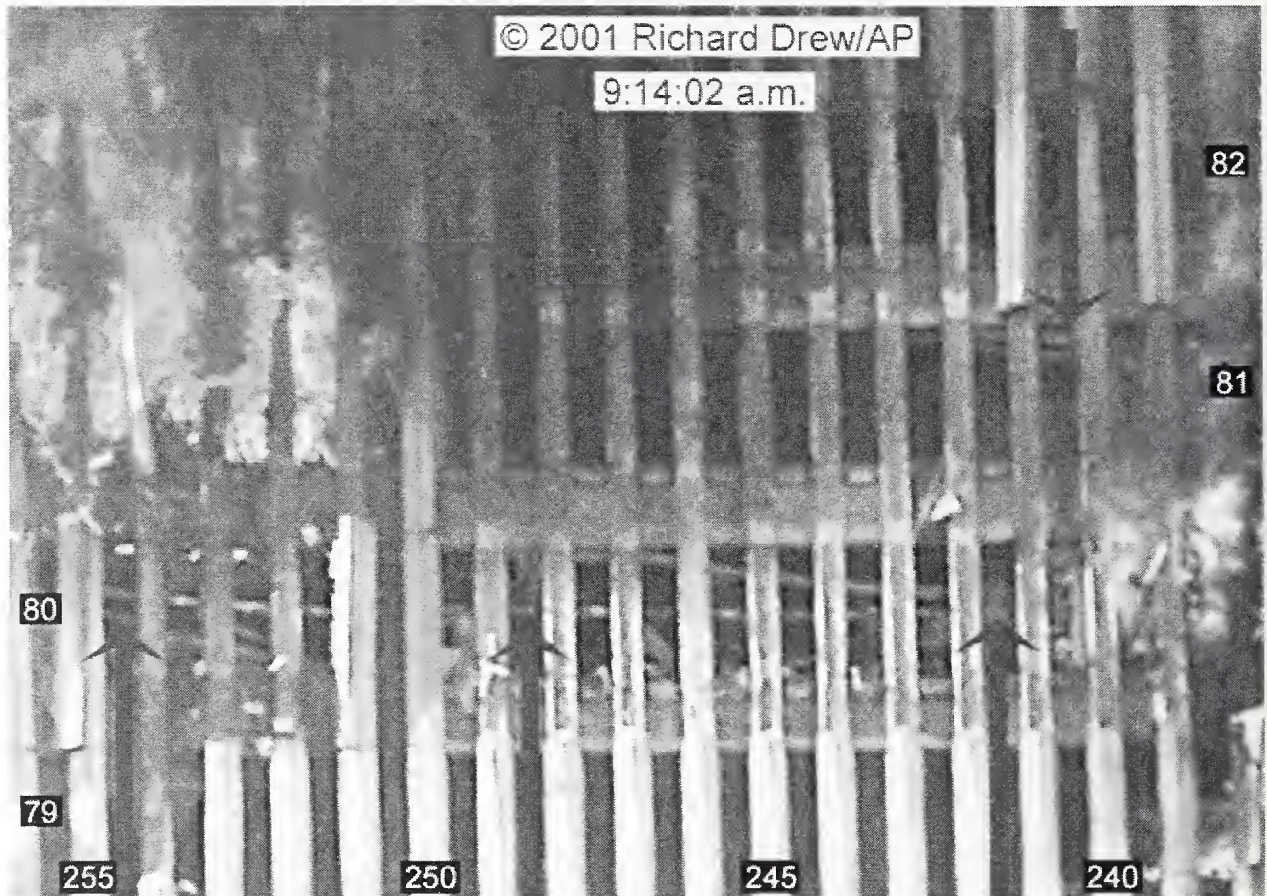
Figure 9-17. A section of the image shown in Figure 9-16 is blown up. The arrows point to the locations of hanging objects that are visible through open windows on the 80th and 81st floors on the north side of WTC 2.

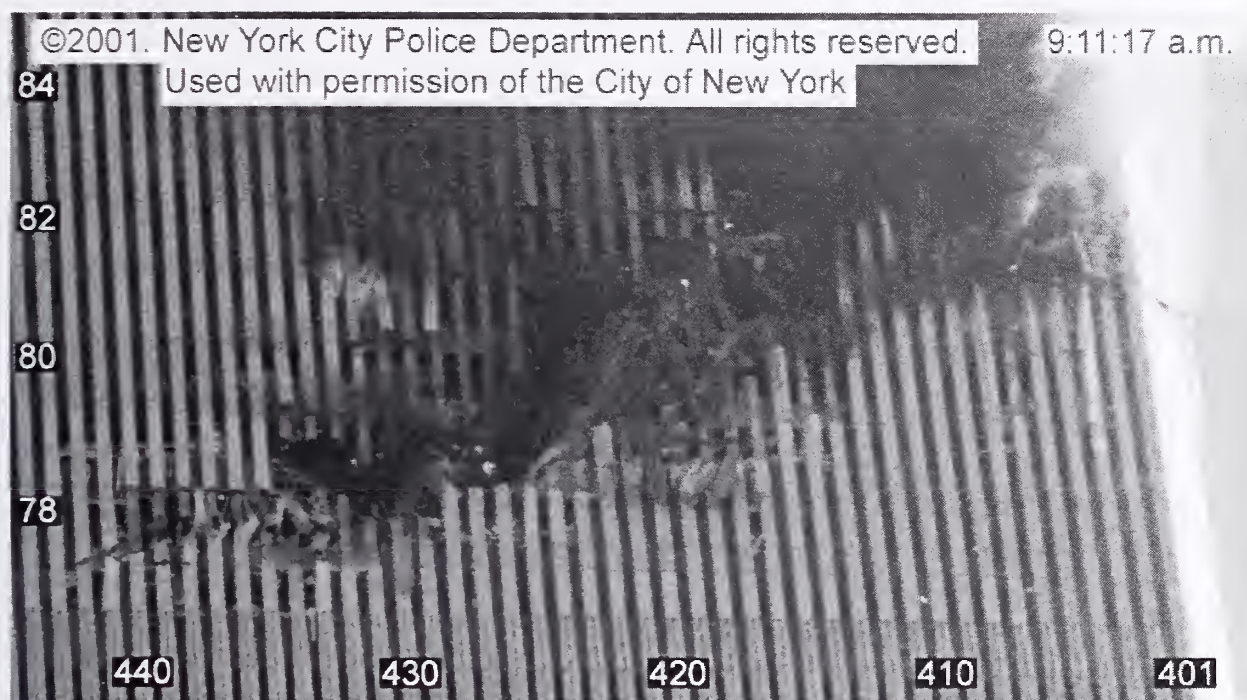
A view of the south face of WTC 2 at 9:11:17 a.m. is shown in Figure 9-18. It was taken approximately 4 min after the images shown in Figure 9-10 and Figure 9-11. During this time a large fire has appeared on the 81st floor to the east of the aircraft impact cavity. Flames are now visible on this floor in windows 81-401 to 81-409, and heavy smoke is coming from the area. Given the apparent intensity of this fire, it is noteworthy that there continues to be no indication of a fire, i.e., smoke and/or flame, from adjacent windows on the east face at this time. Figure 9-15, which was taken nearly a minute later, shows that this is the case.

Comparison of Figure 9-10 and Figure 9-18 indicates that the fires ignited at other locations within and immediately adjacent to the aircraft impact cavity have continued to grow and spread slowly. At the earlier time, the glass in window 81-431 appeared to be intact, while in Figure 9-18 flames are coming from this window and are visible in window 81-432 as well. The appearance of the fire burning on the debris pile located at the western edge of the aircraft impact cavity on the 79th floor is similar to that seen earlier, while the fire on the 78th floor seems to be slowly spreading across debris piled within the cavity.

Figure 9-18. This cropped photograph shows the south face of WTC 2 at 9:11:17 a.m. The image has been rotated and enhanced by adjusting the intensity levels. Column and floor numbers have been added.

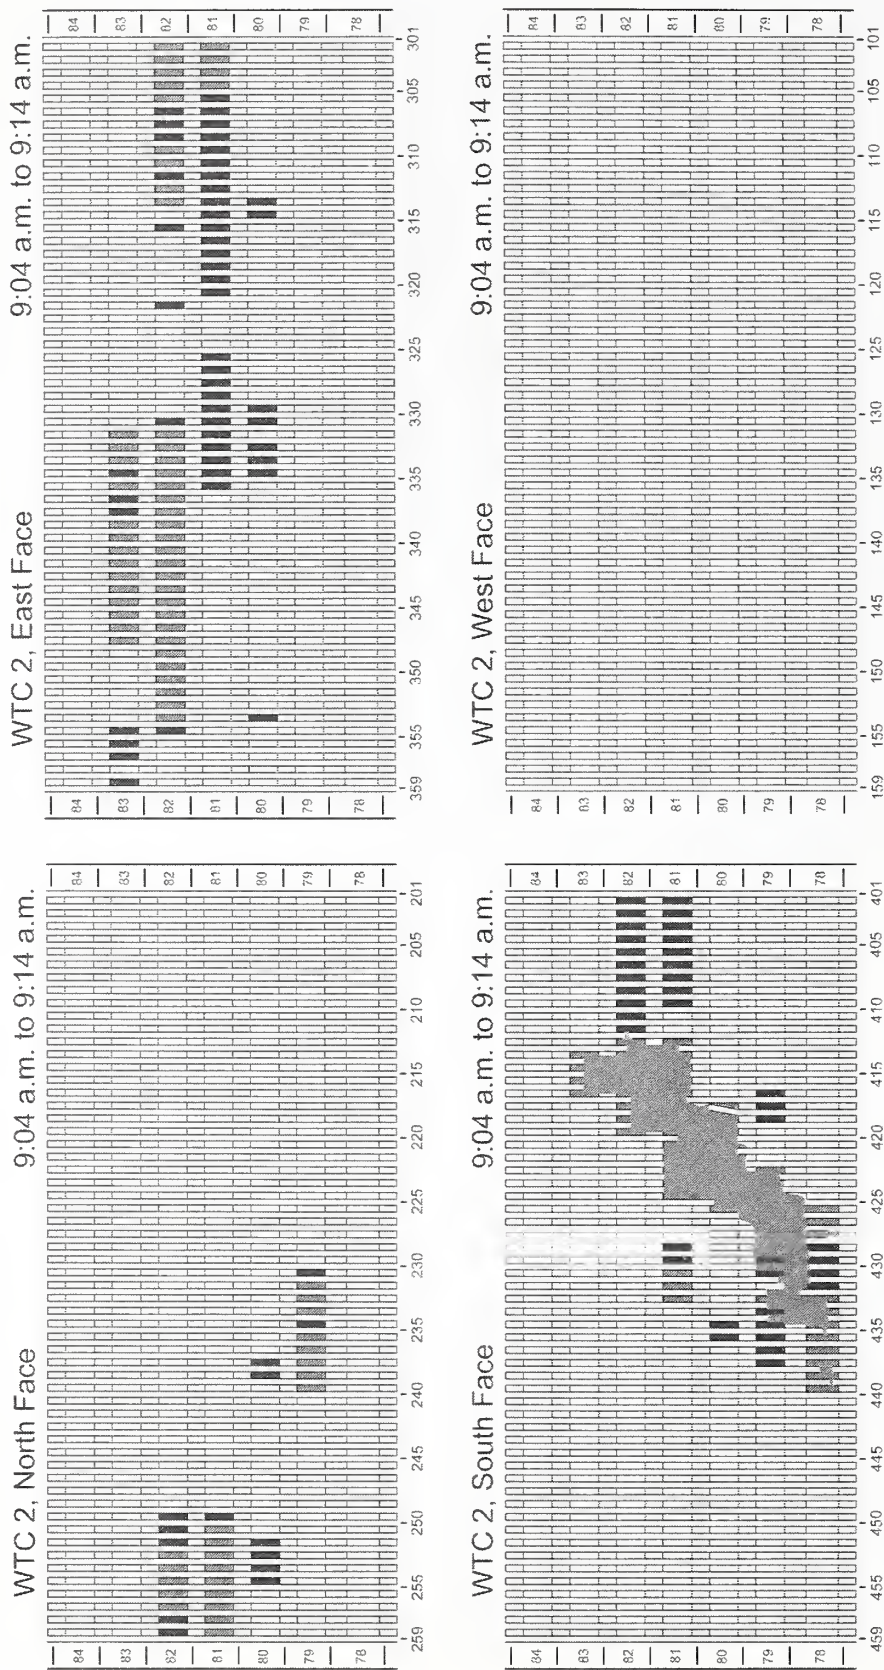
On the north face large fires were initially ignited on the eastern edges of the 81st and 82nd floors and at a location more toward the center on the 79th floor. On the 79th and 81st floors these fire were burning on large piles of debris located just inside the façade. These fires continued to burn intensely during the entire period. There was little indication of fire spread or additional growth. Little smoke and flame were observed in an area of the façade, covering the 80th, 81st, and 82nd floors and extending from column 238 to column 250, lying between the fires on the 81st and 82nd floors and the fire on the 79th floor. This area is referred to as the cold spot.

Immediately following the aircraft impact, extensive fires were visible on the east face over the northern halves of the 81st and 82nd floors and on the southern portion of the 83rd floor. An intense fire was also burning within the debris-filled opening created in the northeast corners of the 81st and 82nd floors by the aircraft impact. Smaller isolated fires were present on the 80th floor. The fire on the southern side of the 83rd floor died down rapidly, while a large fire appeared and rapidly grew on this side of the 82nd floor. The fires on the northern ends of the 81st and 82nd floors and in the northeast corner continued to burn vigorously during the entire period. Only small fires were visible on lower floors.

Figure 9-19. Maps of integrated fire observations between 9:04 a.m. and 9:14 a.m. are shown for the four faces of WTC 2. Colors represent the highest intensity fire observed in a window using the color scale defined in Figure 5-1.

Several small fires were visible on the south face shortly following the aircraft impact. These fires were located within the aircraft impact cavity and immediate adjacent areas. During the period considered here, these fires spread and grew relatively slowly. The only visible area of extensive fire spread was on the eastern side of the 81st floor, where a large fire grew between 9:07 a.m. and 9:11 a.m., and immediately above on the 82nd floor, where a fire was observed just prior to 9:15 a.m., after the fire on the 81st floor had died down.

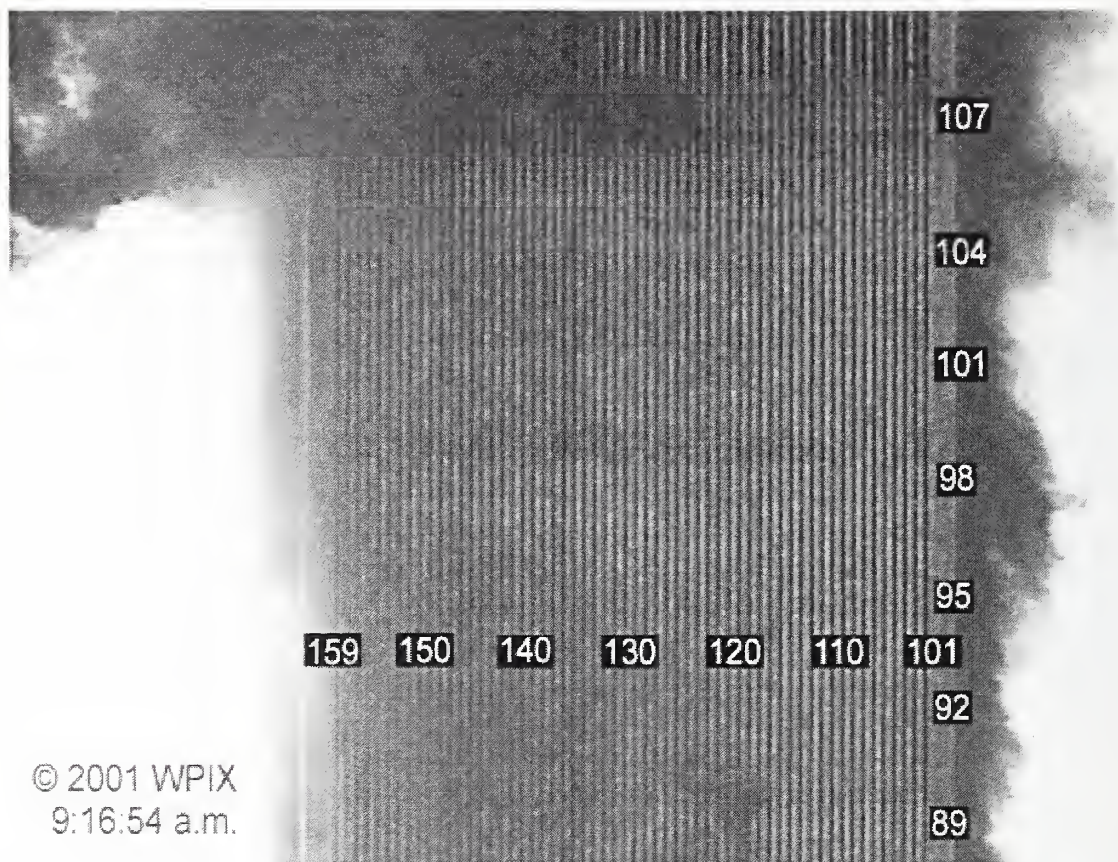
In the last section it was mentioned that smoke appeared from the 86th floor on the west face of WTC 2 at 9:10:29 a.m. An image of the west face captured from a news helicopter video at 9:16:54 a.m. is shown in Figure 9-20. Smoke is visible near the bottom of the photograph and coming from near the 107th floor. A view of the tower recorded just prior to that shown in Figure 9-20 in the same video indicates that the smoke in the lower part of the image is coming from a number of open windows on the 86th floor, which are just below the view of Figure 9-20. The windows emitting smoke spanned a length from roughly window 86-417 to window 86-423. The smoke flowing from the 107th floor was coming from windows centered near window 107-427.

The observations from the video indicate that several additional windows located on the 86th floor had broken out since 9:10:29 a.m. It also appears that heavy smoke had traveled to the top of the tower, and people on the 107th floor broke out windows.

Figure 9-20. This image of the west face of WTC 2 was captured from a video shot from a news helicopter at 9:16:54 a.m. It has been enhanced by adjusting the intensity levels, and bright areas to the right and left of the tower are saturated. Column and floor numbers have been added.

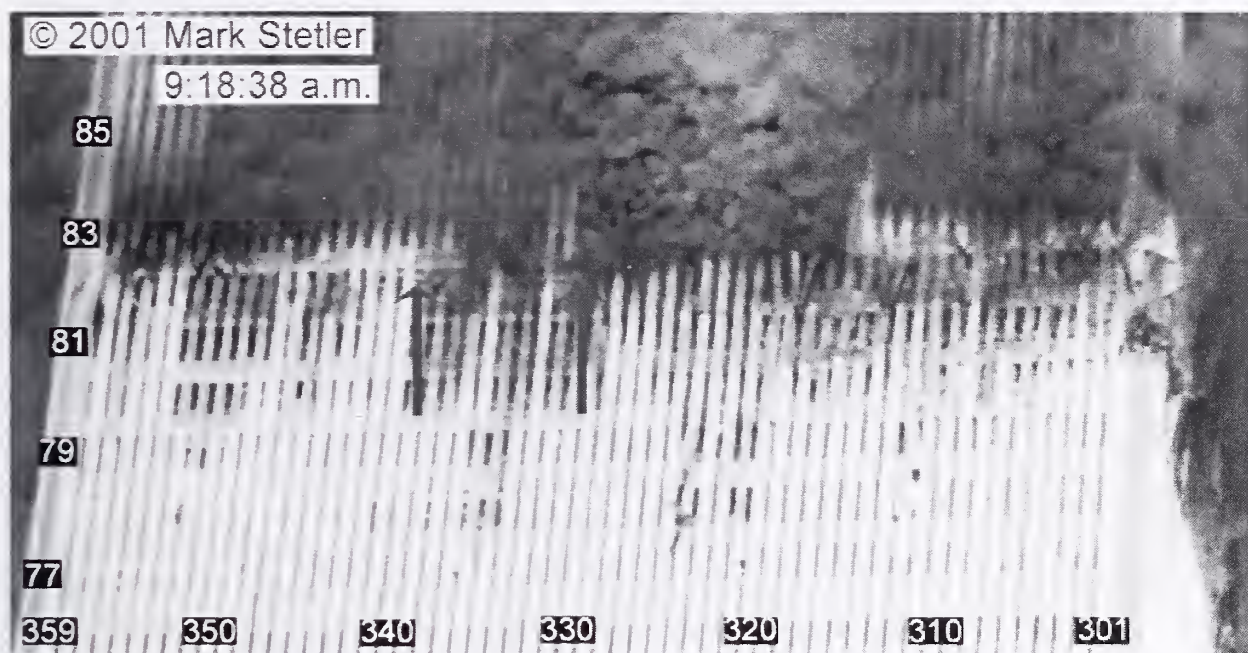
A photograph of the east face of WTC 2 at 9:18:38 a.m. is shown in Figure 9-21. It was taken almost 6½ min after the photograph reproduced in Figure 9-14 and Figure 9-15. Comparison with the earlier images indicates that the fire burning on the southern side of the 82nd floor has subsided during the intervening time. At the earlier time, intense flames completely filled windows 82-333 to 82-342 and hid the hanging object that had been visible in this area shortly after the aircraft impact. As indicated by the arrows added to Figure 9-21, the object was once again visible at 9:18:38 a.m. A review of photographs and videos recorded during the intervening period indicated that the view of this area had gradually

The hanging object on the 81st floor is now visible through windows 81-331 to 81-335 and windows 81-338 to 81-342. Windows further to the north remain obscured. Comparison of the location of the object with the image reproduced in Figure 9-1 and Figure 9-2, which was recorded at 9:03:42 a.m., shows that the object is at roughly the same height in the windows and has a similar shape.

The fires on the northern edges of the 81st and 82nd floors and in the opening on the northeast corner continue to burn intensely at a level comparable to that seen at 9:12:11 a.m. in Figure 9-14. There is still very little indication of a fire near the southern edge of the 81st floor. A small fire remains on the 80th floor near window 80-335. Heavy flows of smoke continue from the southern side of the 83rd floor and from near the center of the 82nd floor.

In the photograph taken at 9:18:38 a.m. there is no indication of significant smoke flow on the east face from windows lower than the 82nd floor. This was generally true around this time, but was not always the case. Starting around 9:12:45 a.m. a series of short-lived, apparently coordinated smoke releases were observed in which smoke was pushed out of multiple open windows on the 79th, 80th, and 81st floors.

Figure 9-21. View of the east face of WTC 2 recorded at 9:18:38 a.m. The original photograph has been cropped and enhanced by adjusting intensity levels. Column and floor numbers have been added. The arrows highlight a hanging object observed through open windows on the 82nd floor.

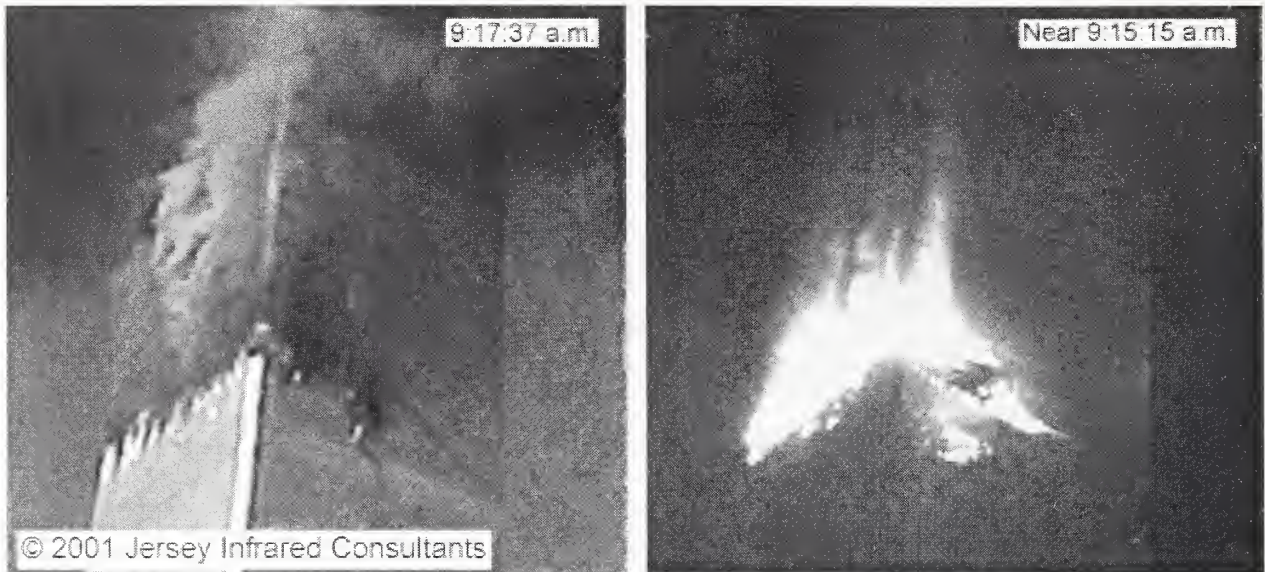
The most striking feature in the infrared image shown in Figure 9–22 is the dark region between the two bright areas on the north face. The low level of infrared emission coming from the dark region indicates that the temperature of this portion of the facade is close to the outside ambient temperature. By comparing the infrared image with normal images of the north face, such as that shown in Figure 9–16, it can be seen that the unheated region is located in the same area of the face that has been identified as the cold spot. It is clear that not only is the cold spot mostly free of smoke and fire, but that it is very nearly at room temperature, despite the presence of nearby fires on either side. The area is indeed a “cold spot” relative to its immediate surroundings.

Figure 9-22. This figure compares an infrared photograph (on the right) and an image of WTC 2 captured from a video that was shot from the same vantage point and scaled and oriented to match the infrared shot. The north and east faces of the tower are visible. The video frame was shot at 9:17:37 a.m., and the infrared image was taken around 9:15:15 a.m. (an uncertainty of 15 s has been assigned).

The cold spot does not appear to have a completely rectangular shape in Figure 9–22. There is a slightly heated area at the upper left corner that is most likely due to the flames on the 82nd floor that are visible in window 82-249 in Figure 9–16. Similarly, there is small heated region in the lower right corner on the 80th floor that is most likely associated with the small fire burning on the debris pile in window 80-241.

By using the heated areas within the cold spot as markers, it is possible to correlate other parts of the infrared image with Figure 9–16. The bright area below and to the west of the cold spot is the fire visible over many windows on the 79th floor. The narrow lighter line that extends westward from the brightest region indicates that heat is being transported across the floor, even though imagery indicates that these windows were still in place in the area. Similar heating is also apparent on this floor below the cold spot. A narrower bright region above the 79th floor reflects the fire burning on the pile of debris on the 80th floor that can be seen in Figure 9–16.

Individual open windows to the left of the cold spot on the 80th floor appear as points of light, indicating that some hot gases are likely flowing through the openings. The image is saturated immediately above these openings due to the intense fires burning on the 81st and 82nd floors. Interestingly, there also appears to be significant heating above the cold spot on the 83rd floor. In Figure 9–16 the windows on this part of the 83rd floor appear to have glass in place, suggesting that heat is being transported to this location from elsewhere on the floor. Finally, there is a bright region on the north face that is located well below those discussed thus far. Comparison with the video frame in Figure 9–22 indicates this heat source is located at the mechanical floors, i.e., the 75th and 76th floors. Apparently, this area was either heated earlier by the smoke and dust observed coming from these floors (see the discussion in Chapter 7), or heated gases are still being released from the mechanical floors.

The heated area on the mechanical equipment room floors is at a location where there is an exhaust spill louver for the ventilation system on the 76th floor between columns 242 and 258 (see the ventilation diagram in Figure A-6 in Appendix A). The heated area appears to cover roughly half of the length of the spill louver on the west side. Most of the heating seems to be on the 76th floor, but there is also evidence for heating at the 75th floor level. The amount of air allowed to pass through the spill louvers was varied depending on conditions. It is possible that a portion of the louvers were closed on September 11, 2001, which could explain the heat distribution. The presence of heating on the mechanical equipment room floors suggests that the exhaust ventilation system may possibly have continued to operate after the aircraft impacted WTC 2.

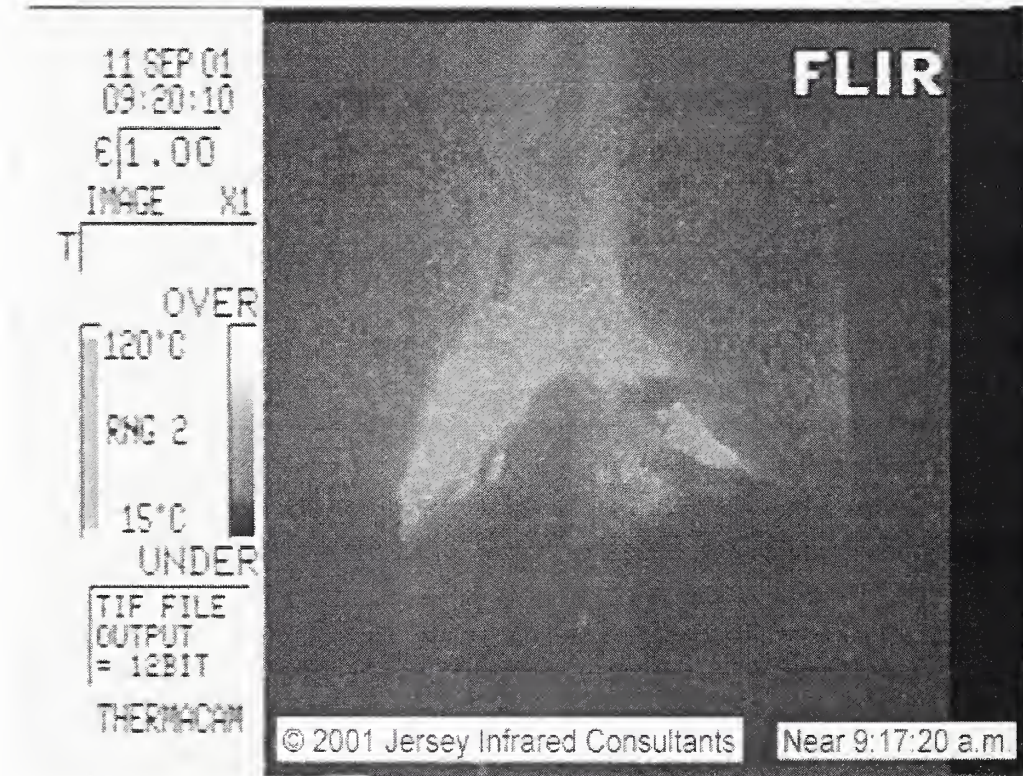
Figure 9-23. This image shows a frame from the false-color output of an infrared camera that was connected to a standard video camera. The time was around 9:17:20 a.m. (an uncertainty of 15 s is assigned). Blue represents the coolest temperatures and red the warmest temperatures.

Even though the exact times when Figure 9-22 and Figure 9-23 were taken are not available, it is known that the image in Figure 9-23 was taken 2 min and 4 s after Figure 9-22 was shot. The false-color image in Figure 9-23 is more saturated, but it is clear that the heat distributions on the north and east faces are similar to those described for Figure 9-22. This indicates that the thermal distributions on the north and east face of WTC 2 changed relatively slowly around this time.

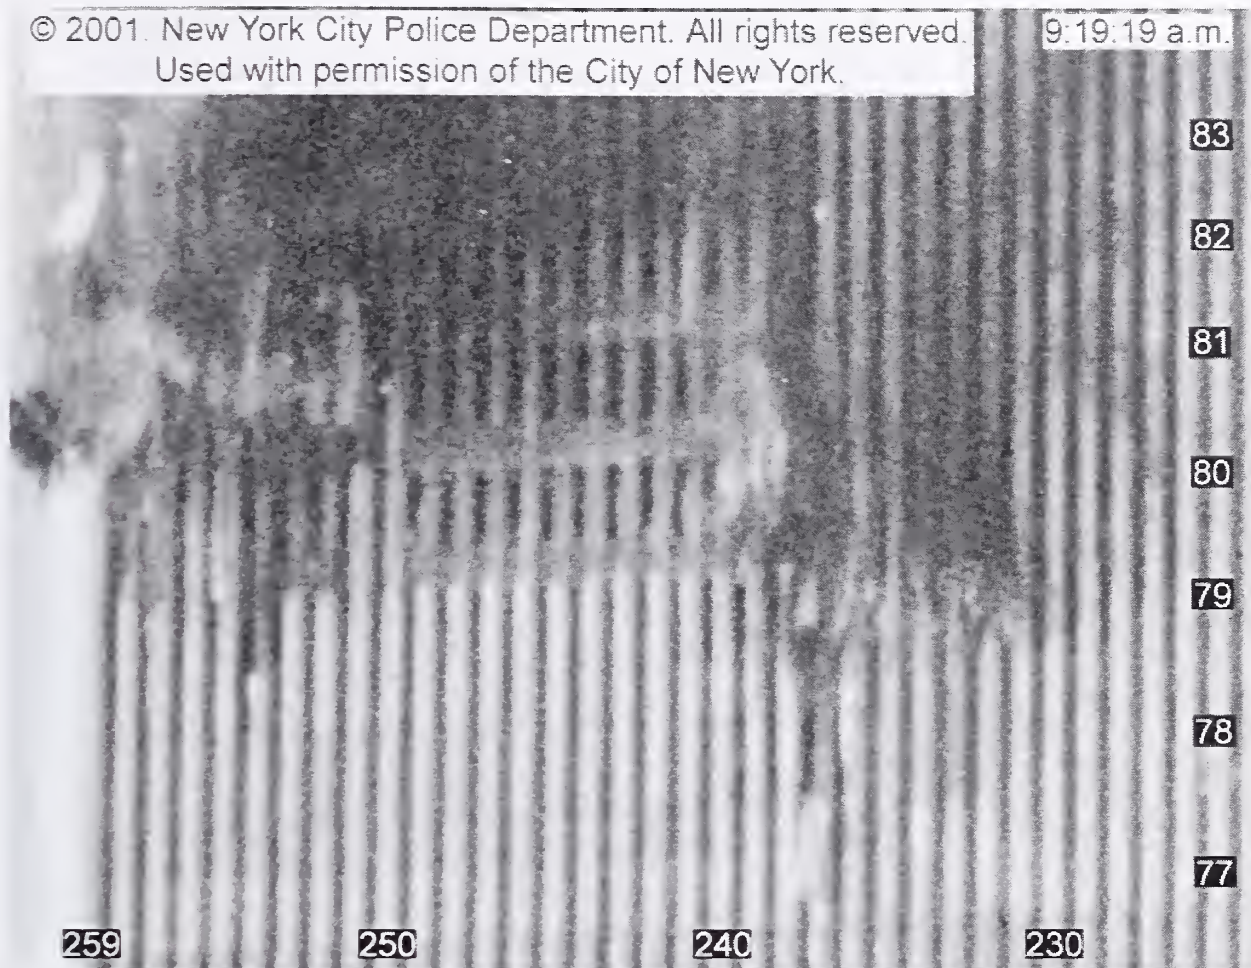
A photograph showing the fire areas on the north face of WTC 2 at 9:19:19 a.m. is reproduced in Figure 9-24. This image was taken just over five minutes later than that shown in Figure 9-16. Even though the later image is not as resolved, it is clear that the fire distribution and intensities have remained essentially unchanged during the intervening five minutes. The most prominent hanging objects, which are barely visible in Figure 9-24, also seem to be at the same locations. The similarity of Figure 9-16 and Figure 9-24 indicates that comparisons of the infrared images with Figure 9-16 are justified since they were most likely recorded during the period between the two photographs.

Figure 9-24. This cropped photograph shows the north face of WTC 2 at 9:19:19 a.m. The image has been enhanced by adjusting the intensity levels, and column and floor numbers have been added.

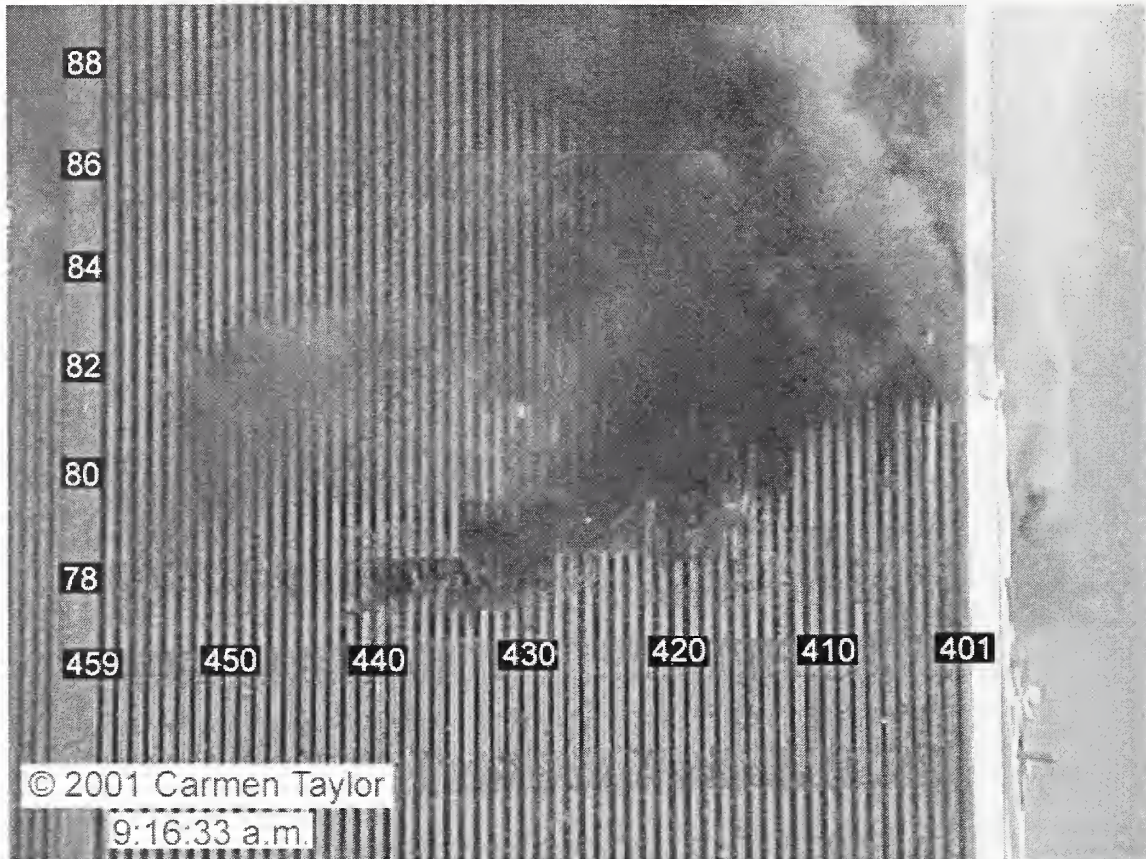
Figure 9-25 shows a view of the south face of WTC 2 recorded at 9:16:33 a.m. Comparison with Figure 9-18, which was recorded almost five minutes earlier, indicates that both the fire distributions and fire intensities have changed during this time. The most obvious change is the growth of a substantial fire on the 79th floor at windows 79-414 to 79-417. Consistent with earlier observations for fires on this face, it appeared at a location immediately adjacent to the aircraft impact cavity.

The fires on the east side of the face on the 81st and 82nd floors have also changed substantially. On the 81st floor, the fire intensity over most of the area has decreased noticeably, and the amount of smoke coming from the open windows has also decreased. The exception is window 81-401, where flames, which were not prominent at the earlier time, now fill the window. In the earlier photograph most of the windows on the 82nd floor were hidden by smoke coming from the 81st floor, and no flames were visible. It was noted in the last section that a distant video taken just prior to 9:15 a.m. showed that the fire on the 81st floor had died down and that a fire had become visible just above on the 82nd floor. At 9:16:33 a.m. these flames are visible in window 82-401 to window 82-408, and flames are extended from the windows in the center part of this length.

Two fires remain visible to the west of the aircraft impact cavity on the 79th and 81st floors. In both cases their intensity appears to have decreased during the five minute period. Meanwhile, the fire on the east side on the 79th floor next to the aircraft impact cavity seems to have grown larger.

Figure 9-25. This photograph shows the south face of WTC 2 at 9:16:33 a.m. The south face of WTC 1 is visible to the left of the western edge of WTC 2. Column and floor numbers have been added.

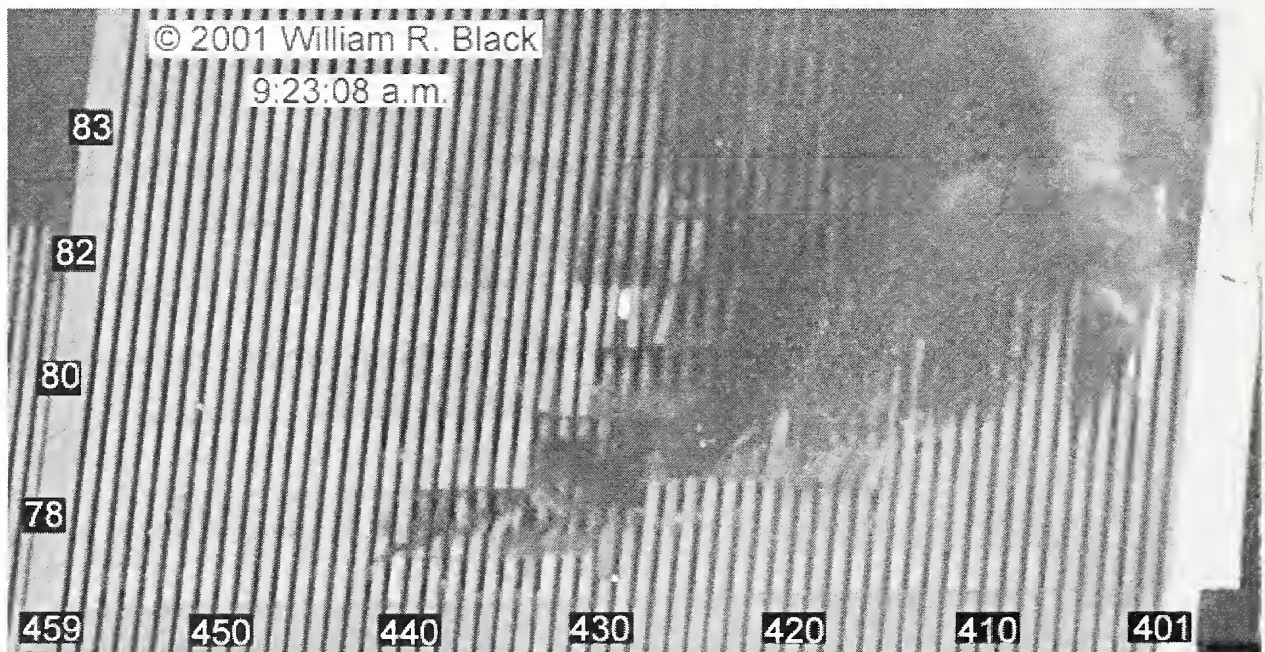
A later view of the south face taken at 9:23:08 a.m. is shown in Figure 9-26. During the nearly seven minutes since Figure 9-25 was shot, the fire that had appeared on the east side of the aircraft impact cavity on the 79th floor has grown and spread toward the east. The most intense flames are now observed in windows 79-413 to 79-415, and heavy smoke is coming from windows 79-411 and 79-412. At the earlier time flames were coming out of windows 79-415 to 79-417, and heavy smoke was coming from windows 79-412 to 79-414. A heavy smoke flow is also coming from window 79-406 at the later time.

The fires on the east sides of the 81st and 82nd floors have similar appearances in the two photographs. The same is true for the lower intensity fire burning on the 78th floor just to the east of aircraft impact cavity. The small fire to the west of the aircraft impact cavity on this floor is still, just barely, visible. The fire higher up on the 81st floor has grown brighter and now extends over windows 81-429 to 81-433. Comparison with Figure 9-10 and Figure 9-18, which were shot at 9:06:31 a.m. and 9:11:17 a.m., respectively, indicates that this fire has not spread significantly, but that its intensity seems to fluctuate with time.

Figure 9-26. This cropped photograph shows the south face of WTC 2 at 9:23:08 a.m. The image has been rotated and enhanced by adjusting the intensity levels. Column and floor numbers have been added.

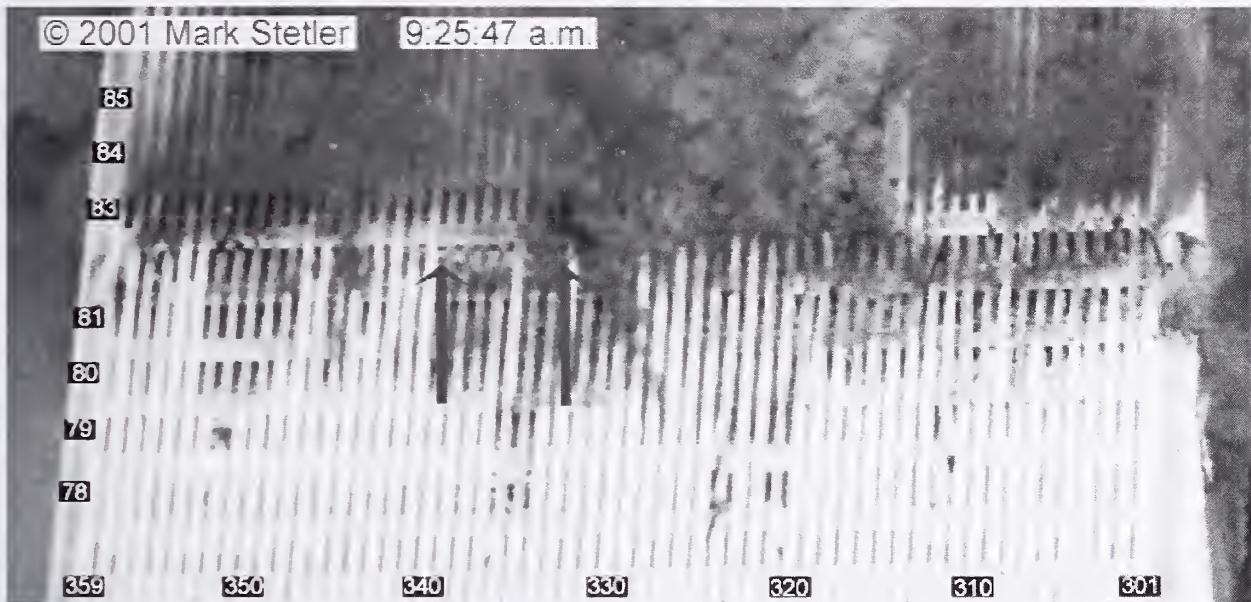
A photograph of the east face of WTC 2 at 9:25:47 a.m. is shown in Figure 9-27. This image was taken 7 min and 9 s later than the similar photograph reproduced in Figure 9-21. Arrows added to the figure indicate the hanging object observed earlier through windows on the 82nd floor. Its appearance has changed substantially from earlier times (compare with Figure 9-1, Figure 9-2, and Figure 9-21). In the vicinity of window 82-336, it is now visible lower down in the open windows. The hanging object no longer has the appearance of a thin line, but now looks like a curved sheet since the top of the object has been revealed. On either side of the dip the object remains high in the windows and still has the appearance of a line.

Figure 9-27. View of the east face of WTC 2 recorded at 9:25:47 a.m. The original photograph has been cropped and enhanced by adjusting intensity levels. Column and floor numbers have been added. The arrows highlight a hanging object (floor slab) observed through open windows on the 82nd floor.

By comparing Figure 9-6, Figure 9-14, and Figure 9-21 with Figure 9-27, it is apparent that the fire that grew on the south side of the east face on the 82nd floor shortly after the aircraft impact has continued spreading to the north. Intense flames are now coming from windows 82-321 to 82-329, while the fires have died down in windows further to the south. Heavy smoke is coming from windows as far north as window 82-316.

The fire distributions also changed at other locations on the east face between the times when Figure 9–21 and Figure 9–27 were taken. At the earlier time there was a large fire visible on the 82nd floor in windows 82-305 to 82-312 on the north side. By 9:25:47 a.m. this fire appears to have died down, and flames are no longer evident in this area. A flaming region is now present immediately above on the 83rd floor. Flames are visible on this floor in windows 83-302 to 83-312. In the earlier photograph heavy smoke was coming from these windows, but flames were not as evident. The fire burning in the northeast corner of the 81st floor appears to have decreased somewhat in intensity during the period. The heaviest flames are now coming primarily from the opening on the northeast corner of this floor. Even in this area, the flame lengths have decreased somewhat. It is now possible to barely discern the corner column 82-300, which is still in place, through the opening on the 82nd floor.

In Figure 9–27, the heaviest smoke is coming from windows on the 82nd and 83rd floors, and the lower floors are visible. A smoke plume is flowing from one of the windows, 79-227, on the 79th floor where there appears to be some flame visible, and light smoke can be seen exiting from a few other windows on the lower floors. Nevertheless, the general impression is that of little smoke flowing from floors lower than the 82nd. As mentioned above, this conclusion is somewhat misleading since brief periods of smoke release from lower floors had been observed starting before 9:13 a.m. Review of videos and photographs showed that these smoke releases increased in both frequency and the amount of smoke released as time progressed.

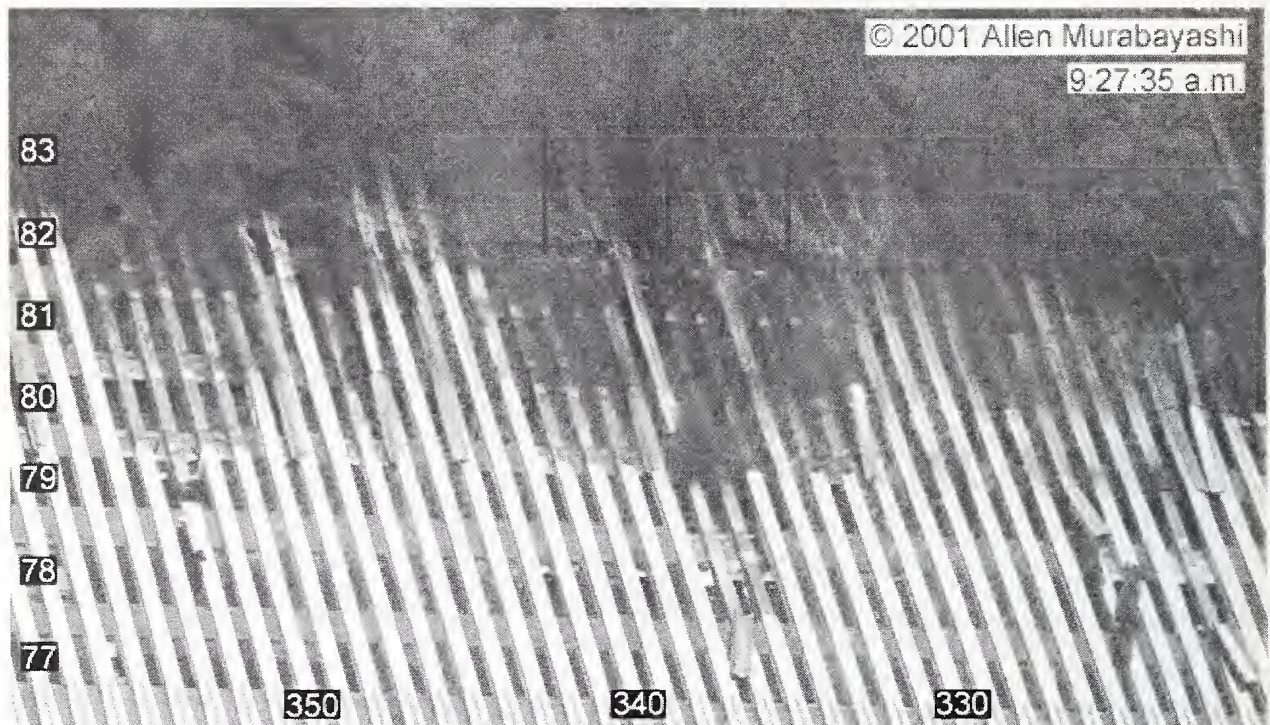
Another view of this object, shot from a different angle, is shown in Figure 9-28. This photograph was taken from a location on a nearby street to the southeast of the tower. As a result, the photograph is looking up at the hanging object from below. The arrows indicate the object. An enlarged view of the area with the object is shown in Figure 9-29. From this angle the object also has a sheet-like appearance, but, unlike in Figure 9-27, the underside of the object is in view. This is most easily seen in window 82-332. The sheet-like structure of the object is that which would be expected if the hanging object were a portion of the 83rd floor slab that, after having been dislodged from the east perimeter wall, had settled down further below the open windows on the 82nd floor. This closer view shows that the object was visible as far south as window 82-342 at this time. At earlier times the object was visible further to the north than in Figure 9-27, but these windows remain hidden by dark smoke.

Figure 9-28. This cropped photograph shows the east face of WTC 2 at 9:27:35 a.m. The original image has been rotated, and column and floor numbers have been added. The arrows highlight a hanging object observed through open windows on the 82nd floor.

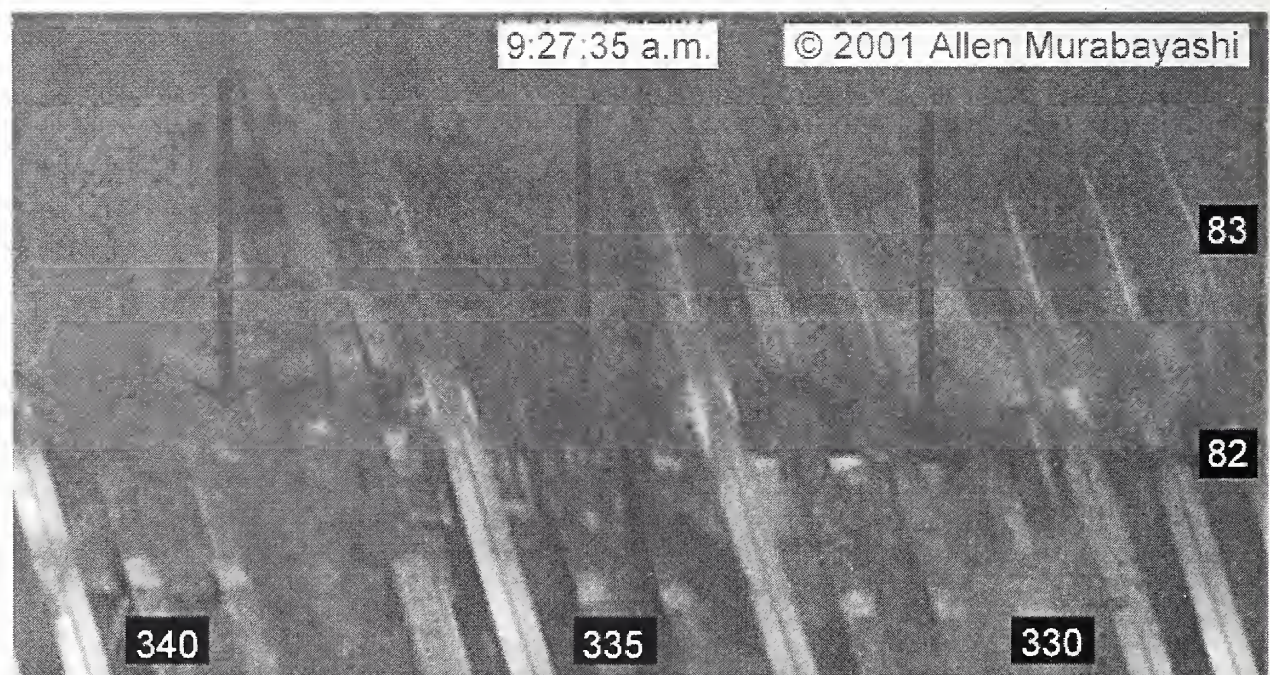
Figure 9-29. This image is an enlargement of a portion of Figure 9-28 showing the east face of WTC 2, where a hanging object is visible through open windows on the 82nd floor. Column numbers have been added.

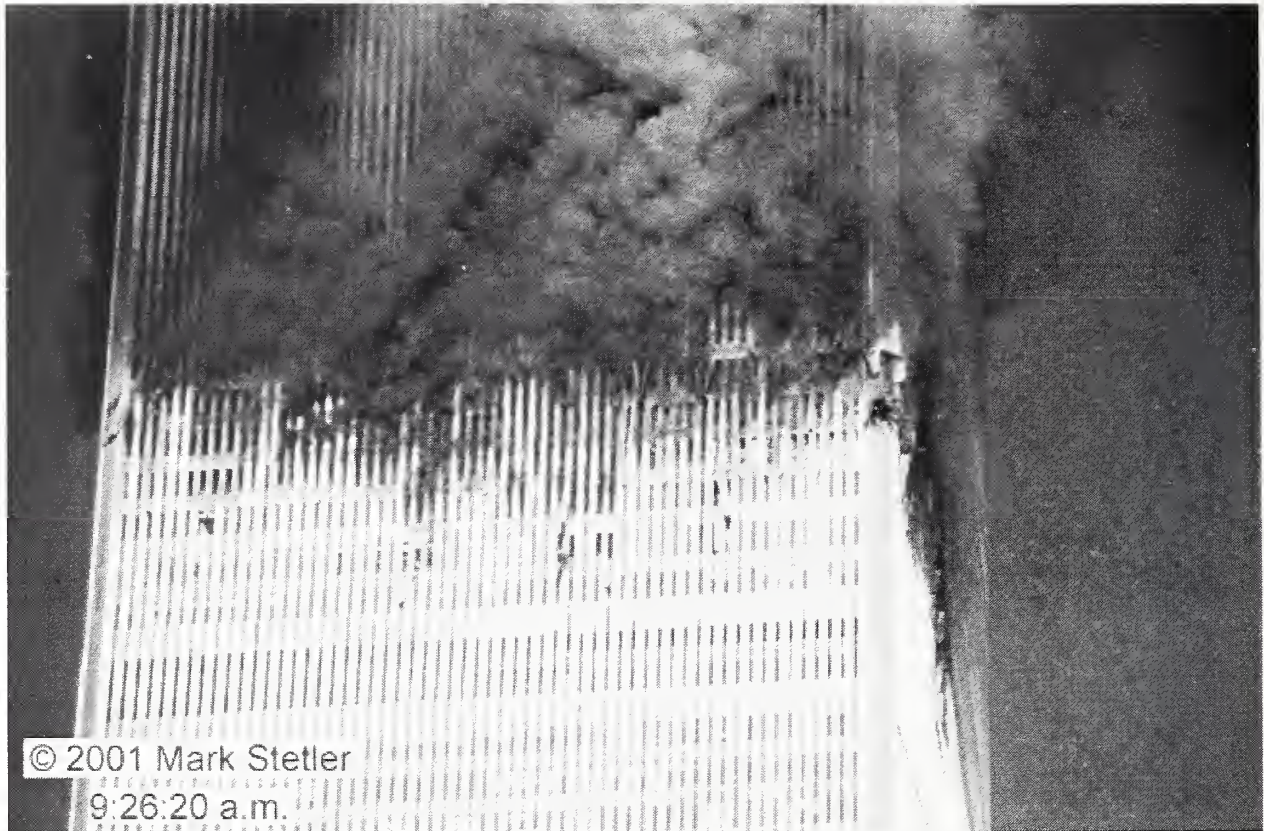
Comparison of Figure 9–27 with Figure 9–30 and Figure 9–31 provides an indication of how quickly the appearance of the east face could change during the smoke release events. In Figure 9–30 heavy smoke almost completely obscures the hanging object seen clearly less than a minute earlier through the 82nd floor windows. This smoke had been pushed out of open windows on the 79th through 82nd floors. In the blowup of the south side of the face in Figure 9–31, the hanging object is just visible at the tops of windows 82-329 through 82-333, as indicated by the arrow placed on the lower image in Figure 9–31. A small fire is visible at the top of window 82-229 above the object.

Figure 9-30. This photograph showing the east face of WTC 2 was taken at 9:26:20 a.m.
