**NIST NCSTAR 1-5A
Federal Building and Fire Safety Investigation of
the World Trade Center Disaster**

**Visual Evidence, Damage Estimates,
And Timeline Analysis**

(Chapter 9 - Appendix C)

FIRE BEHAVIOR IN WORLD TRADE CENTER 2

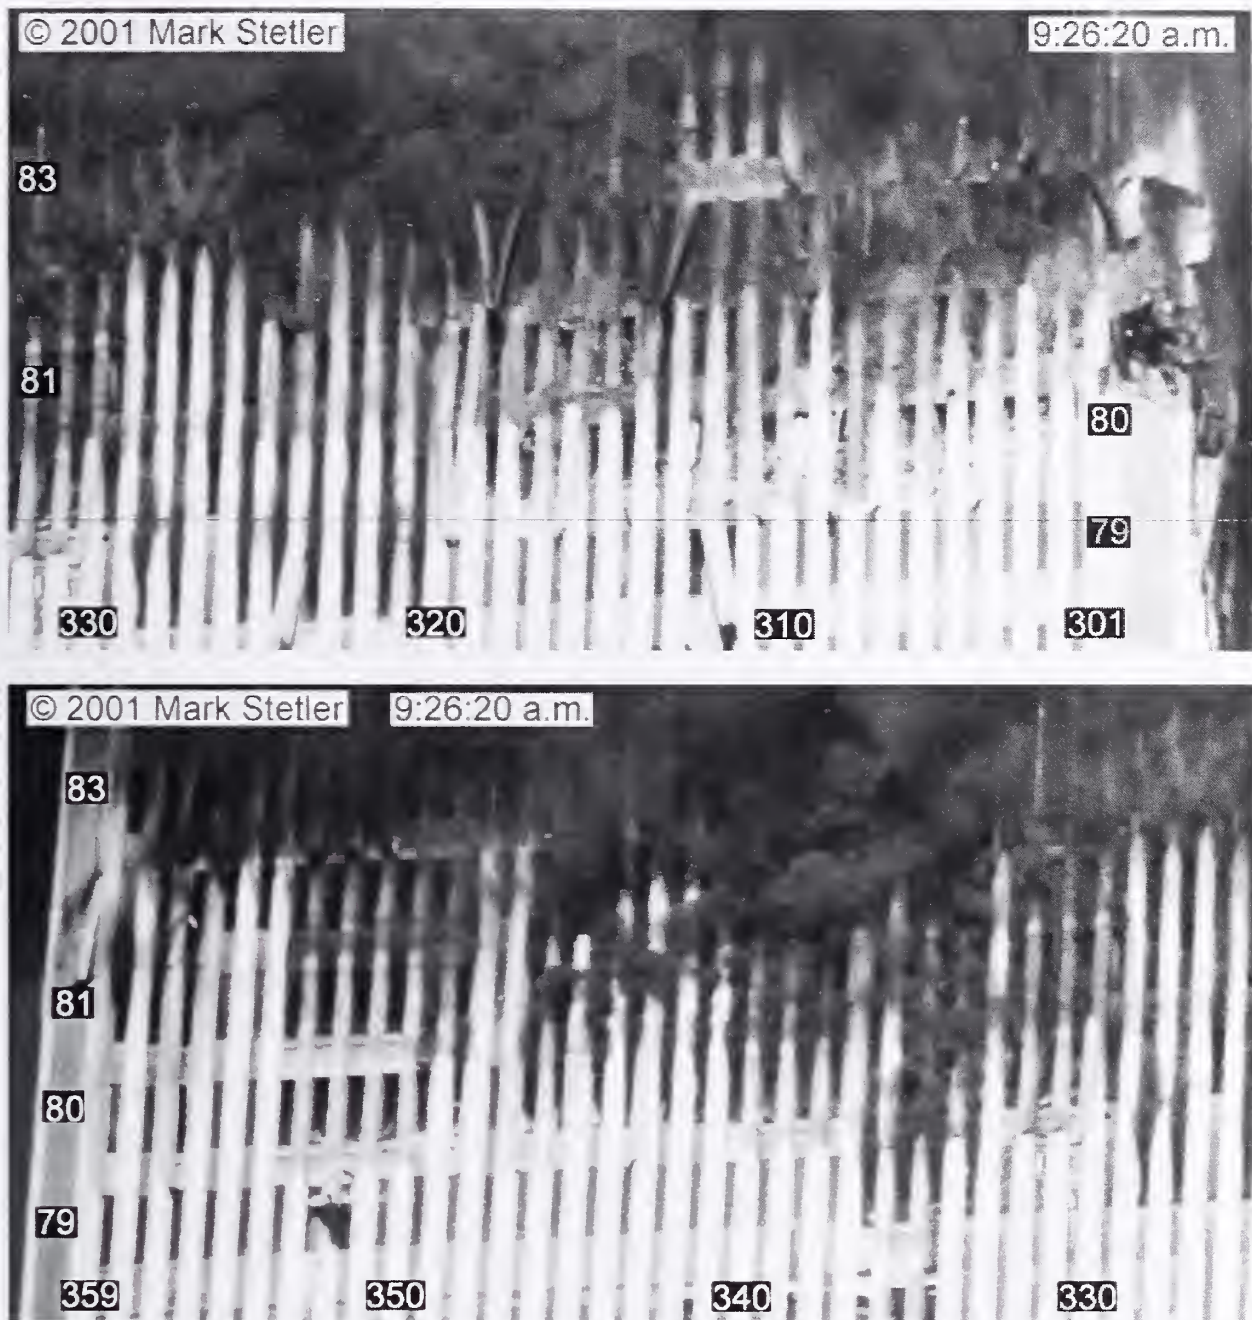
In this photograph (see lower image in Figure 9–31) the heaviest smoke flow on the 79th floor is from windows 79-333 to 79-336, but lighter smoke is also flowing from windows 79-320 to 79-325, 79-327, and 79-328. The glass is still in place for the intermediate windows where no smoke is observed, as well as on either side of windows 79-320 and 79-336. A long-distance video of the smoke release indicates that the relative density of smoke flowing from these windows varied rapidly with time and location and that heavy smoke was pushed from the other open windows during a portion of this release.

In Figure 9-31 smoke is also coming from open windows at the southern end of the east face on the 80th, 81st, and 82nd floors. Unlike on the 79th floor, flames as well as smoke are visible on the 80th floor in windows 80-333 to 80-340. Fire was present in this vicinity as early as 9:07:04 a.m. (see Figure 9-7). It has apparently grown slowly during the intervening 20 min. A small fire is also visible in window 81-335 on the 81st floor.

The heavy flames coming from windows 82-321 to 82-329 on the 82nd floor 33 s earlier in Figure 9-27 have retreated back into the windows. In Figure 9-31 extended flames are only visible in windows 82-326 and 82-327. The intense fire on the northern edge of the 83rd floor in Figure 9-27 has also died down. In particular, the flames that filled windows 83-310 to 82-312 earlier appear to have completely dissipated in Figure 9-31. The appearance of the fire burning on the northeast corner of the 81st floor has also changed. At the earlier time large flames were visible coming from the opening on the northeast corner. Thirty-three seconds later, the fire covered a much broader extent of the debris in the corner, while the flames in the northeast corner opening appeared to have died down. A long-distance video of this corner around this time shows that the intensity of the fire on the 81st floor was highly variable.

Figure 9-31. These two images show blowups of the north and south sides of the east face of WTC 2 taken from the photograph included in Figure 9-30, which was shot at 9:26:20 a.m. Column and floor numbers have been added. The arrow highlights a hanging object visible through open windows on the 82nd floor.

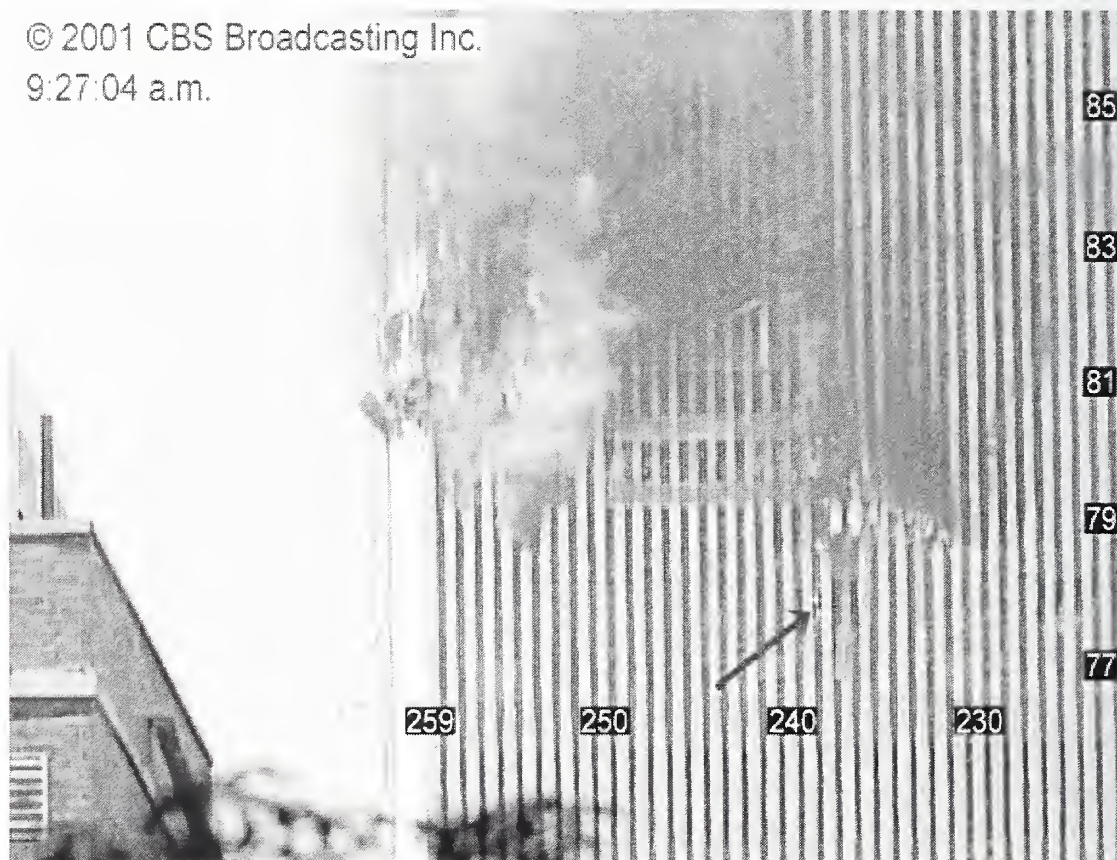
A view of the north face recorded at 9:27:04 a.m. is shown Figure 9–32. It was shot nearly 8 min after the image shown in Figure 9–24. The fire distribution on this face has changed very little during this period. The intense fires ignited immediately following the aircraft impact on the east edges of the 81st and 82nd floors continue to burn, even though the fire intensity on the 82nd floor has continued to decrease. The fire in the northeast corner opening on the 81st floor also decreased in size. The column in the corner of the 82nd floor, column 82-300, which was hidden by flames in Figure 9–24, is now fully visible.

The fire burning on the 79th floor to the west of the cold spot remains in the same location and is burning with a comparable intensity to the earlier time. Flames are visible in both of the lower corners of the cold spot on the 80th floor in Figure 9–32. Due to the lower image quality of Figure 9–24, it is difficult to determine whether these flames have grown more intense during the 8 min period.

Figure 9-32. This captured video frame showing the north face of WTC 2 was recorded at 9:27:04 a.m. The intensity levels have been adjusted, and column and floor numbers have been added. The arrow indicates a stream of liquid-like material that was observed on the 78th floor falling in window 78-238.

Closer inspection of Figure 9–32 shows what appears to be a shiny silver string (indicated by a red arrow) passing from the top to the bottom of one of the windows, 78-238, on the 78th floor. In the video from which this image was taken, the material actually appeared to be a liquid pouring intermittently from the top of the window and splashing at the window base. The liquid looked as if it was glowing. It was only observed during the six seconds that this video recorded this area of the tower. In Section 9.5, a flow of similar material from windows 80-255 and 80-256 on the 80th floor of the north face will be described. It will be hypothesized that the material was most likely aluminum from the aircraft that had melted and was pouring down through an opening from the floor above. This is also a plausible explanation for the current observation. If correct, it suggests that the pile of debris located on the 79th floor above this window may have contained aluminum from the aircraft. Recall that a pile of debris in this area of the 79th floor was present immediately following the aircraft impact. An intense fire had been burning on this debris since the impact that would have provided the heat necessary to melt the aluminum.

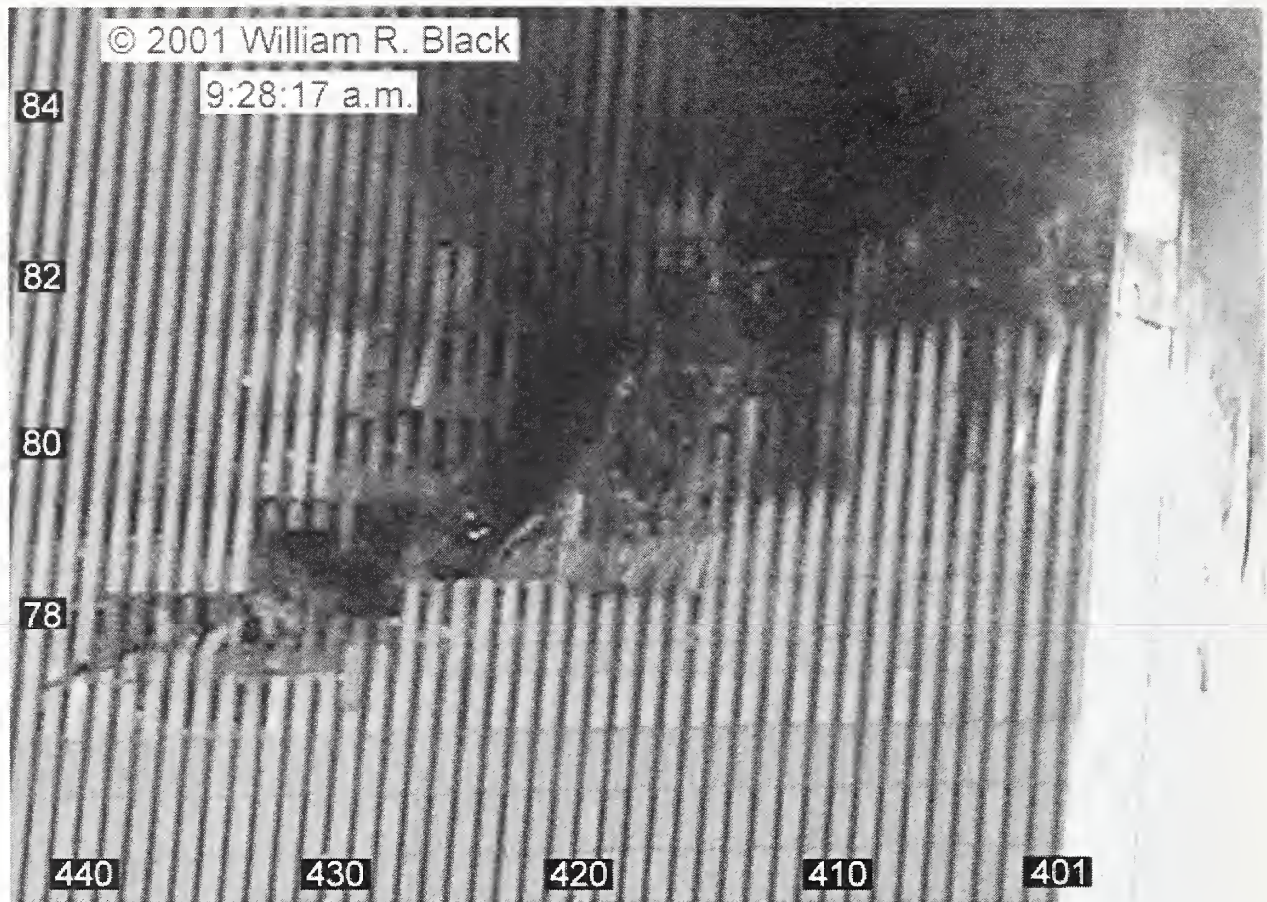
Figure 9-33. This cropped photograph showing the south face of WTC 2 was shot at 9:28:17 a.m. The image has been rotated, and the intensity levels have been adjusted. Column and floor numbers have been added.

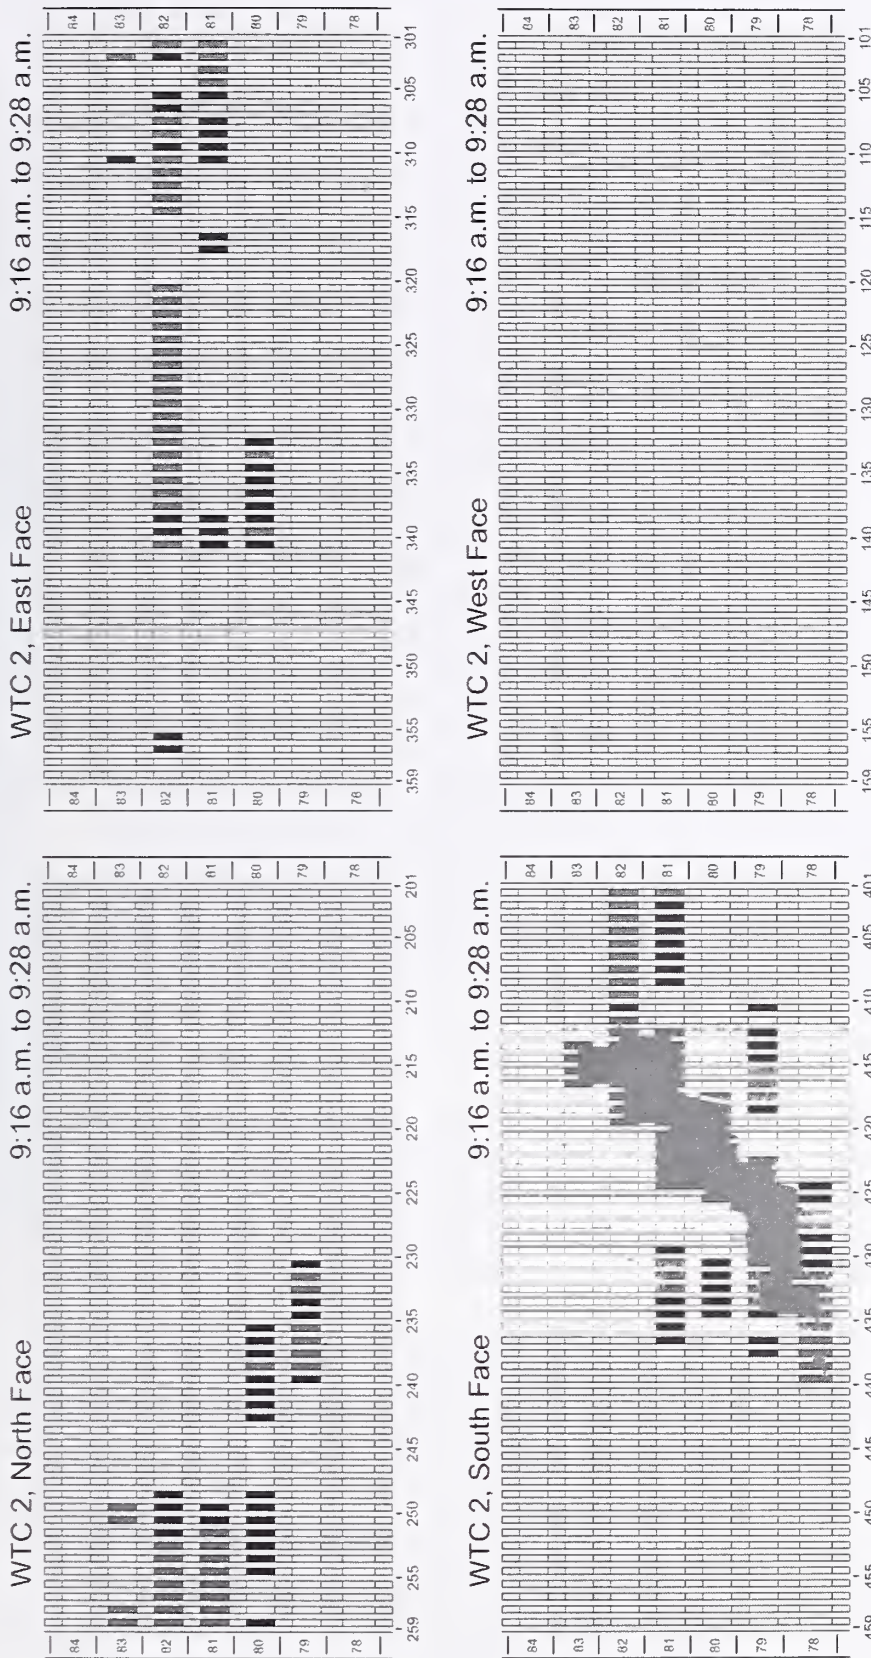
Major observations concerning WTC 2 between 9:15 a.m. and 9:29 a.m. are summarized here. Visual representations of integrated fire intensities over the period for the four faces are shown in Figure 9–34. Changes in fire distributions during the period can be tracked by comparing the results with Figure 9–19, which shows similar maps for the first time period. It should be kept in mind that the integrated fire maps for this period incorporate some very rapid changes in fire distribution.

Figure 9-34. Maps of integrated fire observations between 9:15 a.m. and 9:29 a.m. are shown for the four faces of WTC 2. Colors represent the highest intensity fire observed in a window using the color scale defined in Figure 5-1.

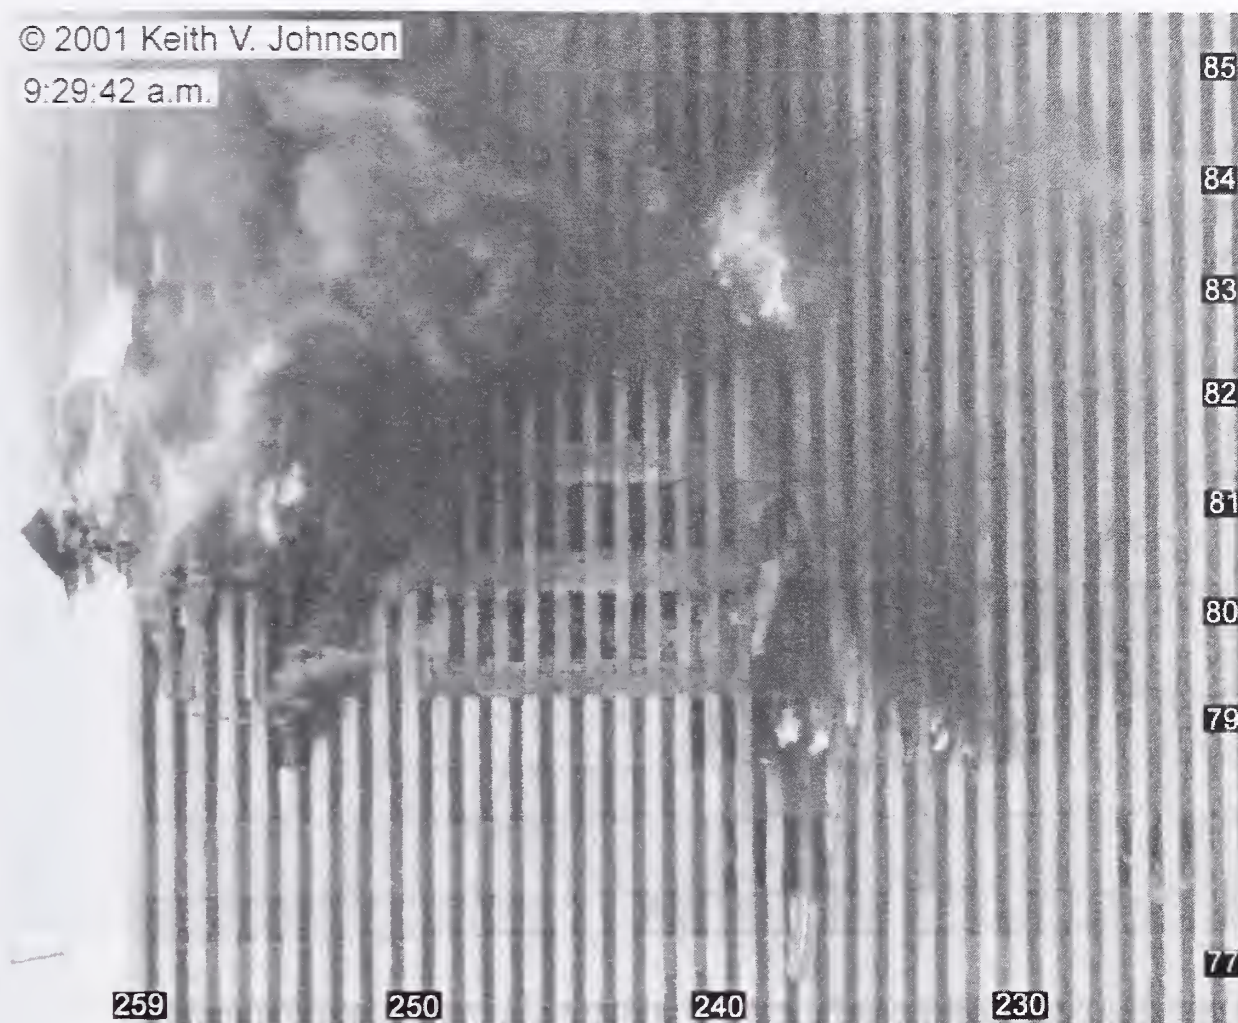
At first glance, it appears the new area of fire on the 83rd floor in Figure 9–35 is well separated from other flames on the floor. However, a dull red glow is barely visible in windows 83-240 to 83-245, suggesting there is a low intensity fire burning behind closed windows immediately above the cold spot. It seems this low intensity fire had spread further west, where it eventually broke out windows and then grew rapidly.

Figure 9-35. This cropped photograph shows the north face of WTC 2 at 9:29:42 a.m. The intensity levels have been adjusted, and column and floor numbers have been added

Elsewhere on the face, the appearance of the fires at 9:29:42 a.m. is much the same as at 9:27:04 a.m. The fires continued to burn on the debris piles at the eastern edges of the 81st and 82nd floors and closer to the center of the face on the 79th floor. The fires at the lower corners of the cold spot on the 80th floor are visible in both images. The hanging objects visible earlier in Figure 9-12 and Figure 9-16 are not immediately apparent in Figure 9-35. This is somewhat unexpected given the quality of the image.

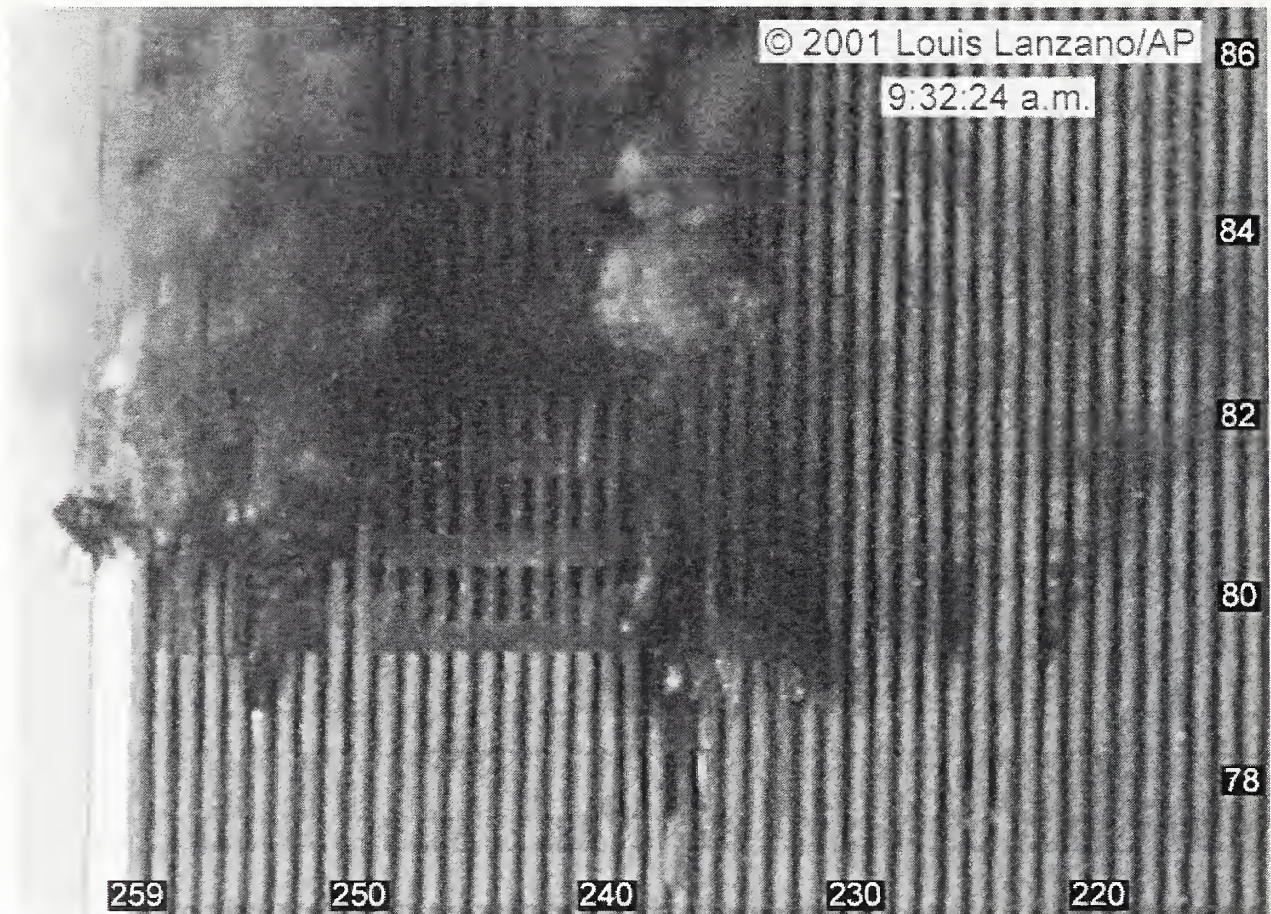
Another view of the north face taken at 9:32:24 a.m. is shown in Figure 9-36. Comparison with Figure 9-35 reveals that the intense area of fire on the 83rd floor to the west of the cold spot has spread during the 2 min and 42 s period between the times the images were taken. Long flames are now coming from a length of windows running from window 83-234 to window 83-239. Flames are also visible on this floor starting at window 93-249 and extending to the eastern edge. Flames are not visible on the floor in windows immediately above the cold spot.

Figure 9-36. This cropped photograph shows the north face of WTC 2 at 9:32:24 a.m. The image has been rotated and enhanced by adjusting the intensities. Column and floor numbers have been added.

Another difference between Figure 9-35 and Figure 9-36 is apparent on the 79th floor. At the later time a dull red glow is visible in windows 79-224 to 79-228, and smoke is coming from window 79-226 and window 79-222. This is evidence that the fire that has been burning on the 79th floor since the aircraft impact has begun to spread across the face toward the west.

Elsewhere on the face, the fires present in Figure 9-36 have not changed markedly for many minutes.

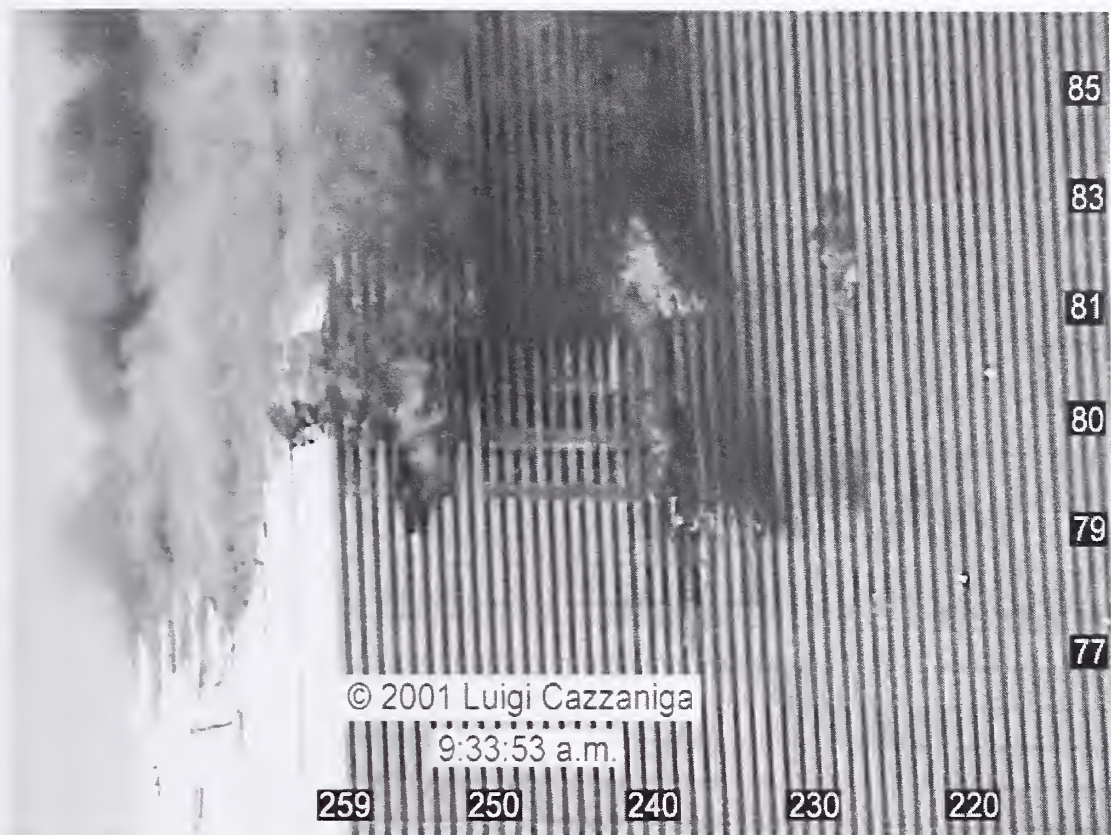
At 9:33:52 a.m. the fire burning on the 83rd floor of the north face seemed to jump several windows to the west when window 83-226 broke open, and a large flame exited. The resulting flare can be seen in Figure 9-37, which was recorded 0.9 s after the window opened. This large flame only lasted a few seconds, but after it died down heavy smoke and a shorter flame continued to come from the window.

Figure 9-37. This frame taken from a video shows the north face of WTC 2 at 9:33:53 a.m. The intensity levels of the image have been adjusted, and column and floor numbers have been added.

In Figure 9-37 small flames are visible in windows 83-240 to 83-244, which are located above the cold spot on the 83rd floor. This confirms that fires were present on this part of the floor. As an aside, since flames are not observed on the floor below, it also suggests that the 83rd floor slab is in place above the cold spot. The fires observed elsewhere on the face have similar distributions and intensities to those in Figure 9-32, Figure 9-35, and Figure 9-36.

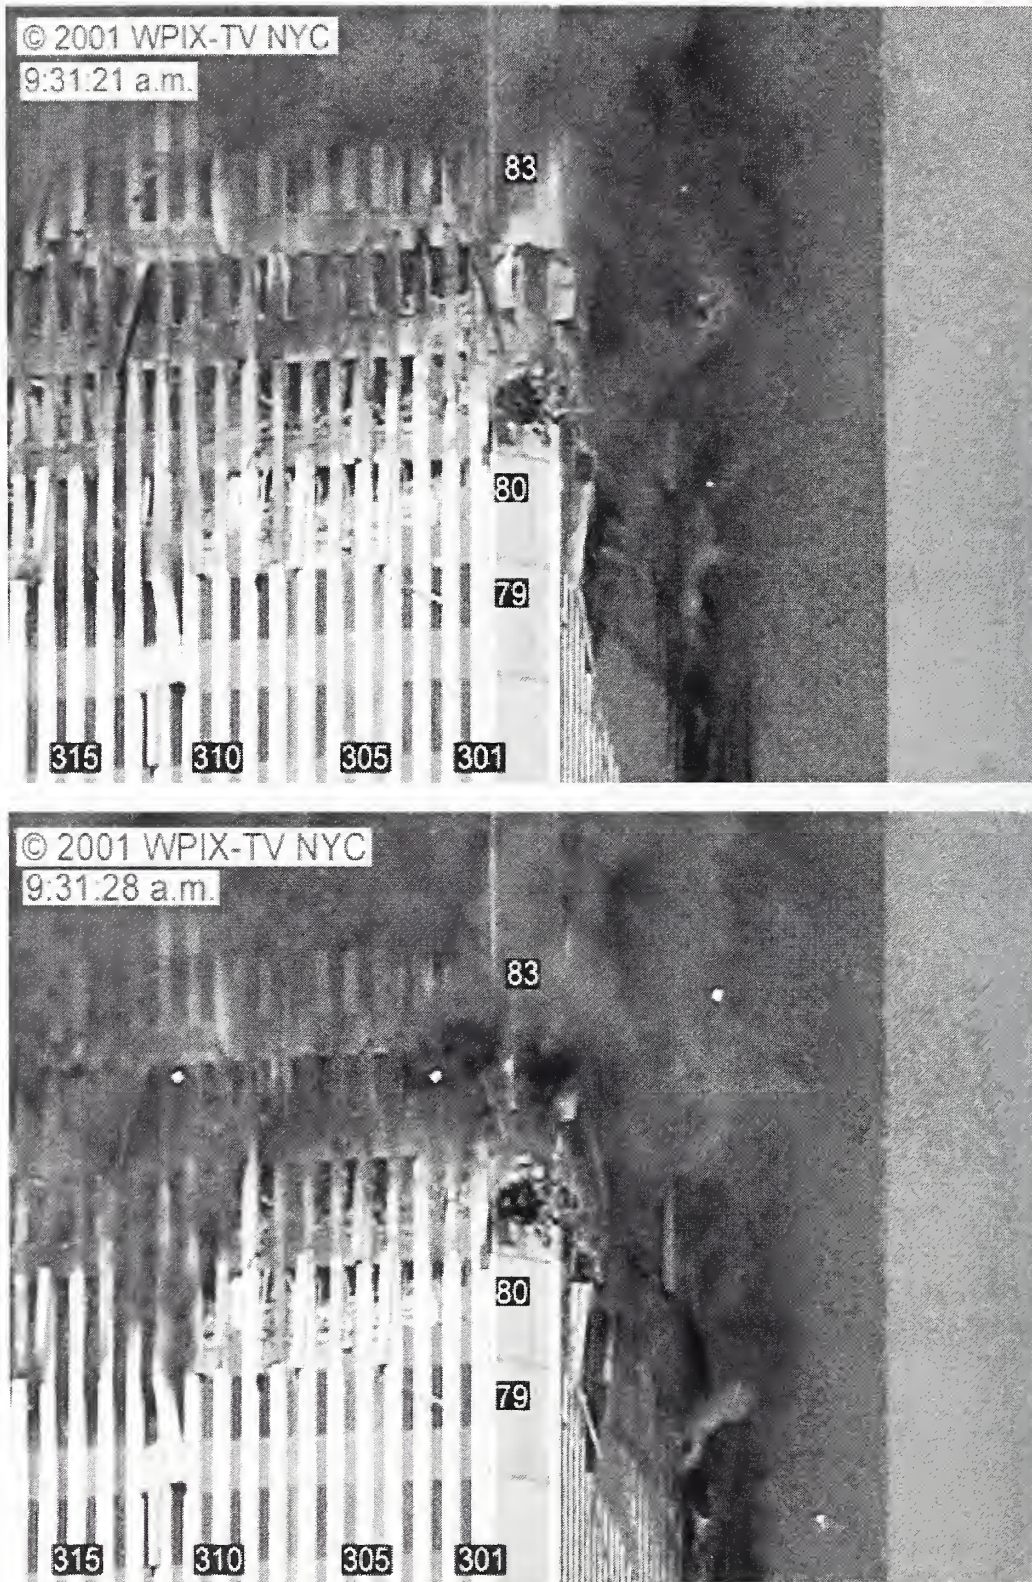
Two views of the northeast corner of WTC 2 are shown in Figure 9-38. The two images were captured from a video recording at 9:31:21 a.m. and 9:31:28 a.m. They were chosen to illustrate the appearance of the smoke puffs that had been observed periodically on the east face of WTC 2 for nearly twenty minutes. In the earlier image shown at the top of Figure 9-38, the visible portion of the east face is relatively clear of smoke. The only flame visible in windows on the east face at this time is the relatively small fire on the 81st floor in window 81-302, even though a fire continues to burn in the opening at the northeast corner of the 81st floor. Otherwise, the fires that were previously observed on this part of the east face seem to have died down. A video shot from a longer distance shows that shortly after the upper frame was recorded a smoke release occurred from multiple windows over multiple floors on the east face. This particular release was not as intense, i.e., less smoke was released, as others that were observed around this time.

Figure 9-38. Two frames captured from a video at 9:31:21 a.m. and 9:31:28 a.m. show the northeast corner of WTC 2. The intensity levels of the images have been adjusted, and column and floor numbers have been added.

The effects of the smoke release are evident in the lower image shown in Figure 9–38. Smoke has been pushed out of open windows on the 79th floor, i.e., windows 79-311 to 79-316, and can be seen rising above these windows. Comparison of the frames shows that the appearance of the smoke and fire in the vicinity of the burning corner on the 81st floor has also changed. Not only has smoke been pushed out of windows 81-301 and 81-302 and the opening on the northeast corner, but the fire intensity has also increased in the immediate area. Flames have been pushed out of windows 81-301 and 81-302. In the video it is clear that smoke was also pushed from windows on the 80th floor on the north side of the tower. In the lower image, this smoke appears as a white stream that has been pushed away from the building. In a video shot from a longer distance it was observed that smoke also appeared from windows on the 80th floor located on the south side of the east face. These observations suggest that the smoke puffs could be associated with pressure variations that were extensive enough to affect multiple floors and faces of the tower simultaneously. It should be noted that while the pressure variations that create the puffs may be the result of structural changes within the tower, the resulting pressure increases are likely to be much too small to have any impact on the structure.

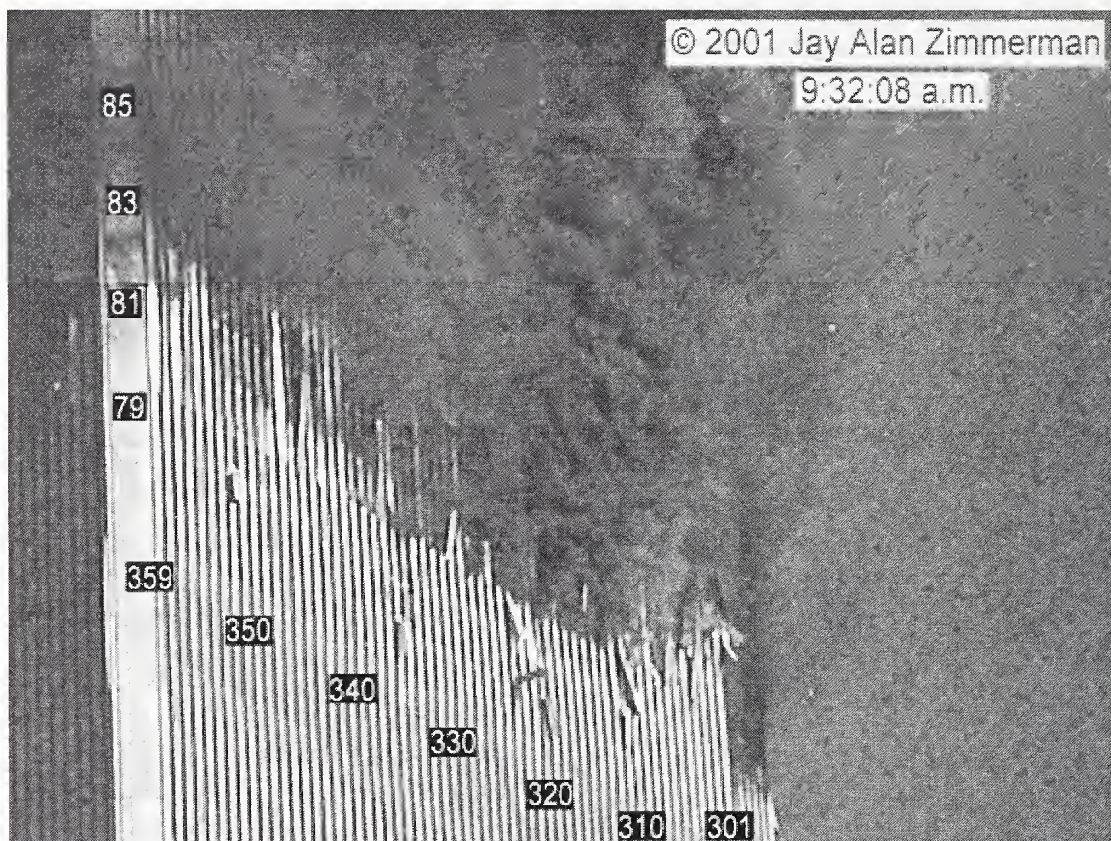
Figure 9-39. This view of the east face of WTC 2 is a frame from a video taken at 9:32:08 a.m. Column and floor numbers have been added. The northeast corner of WTC 1 is visible in the background.

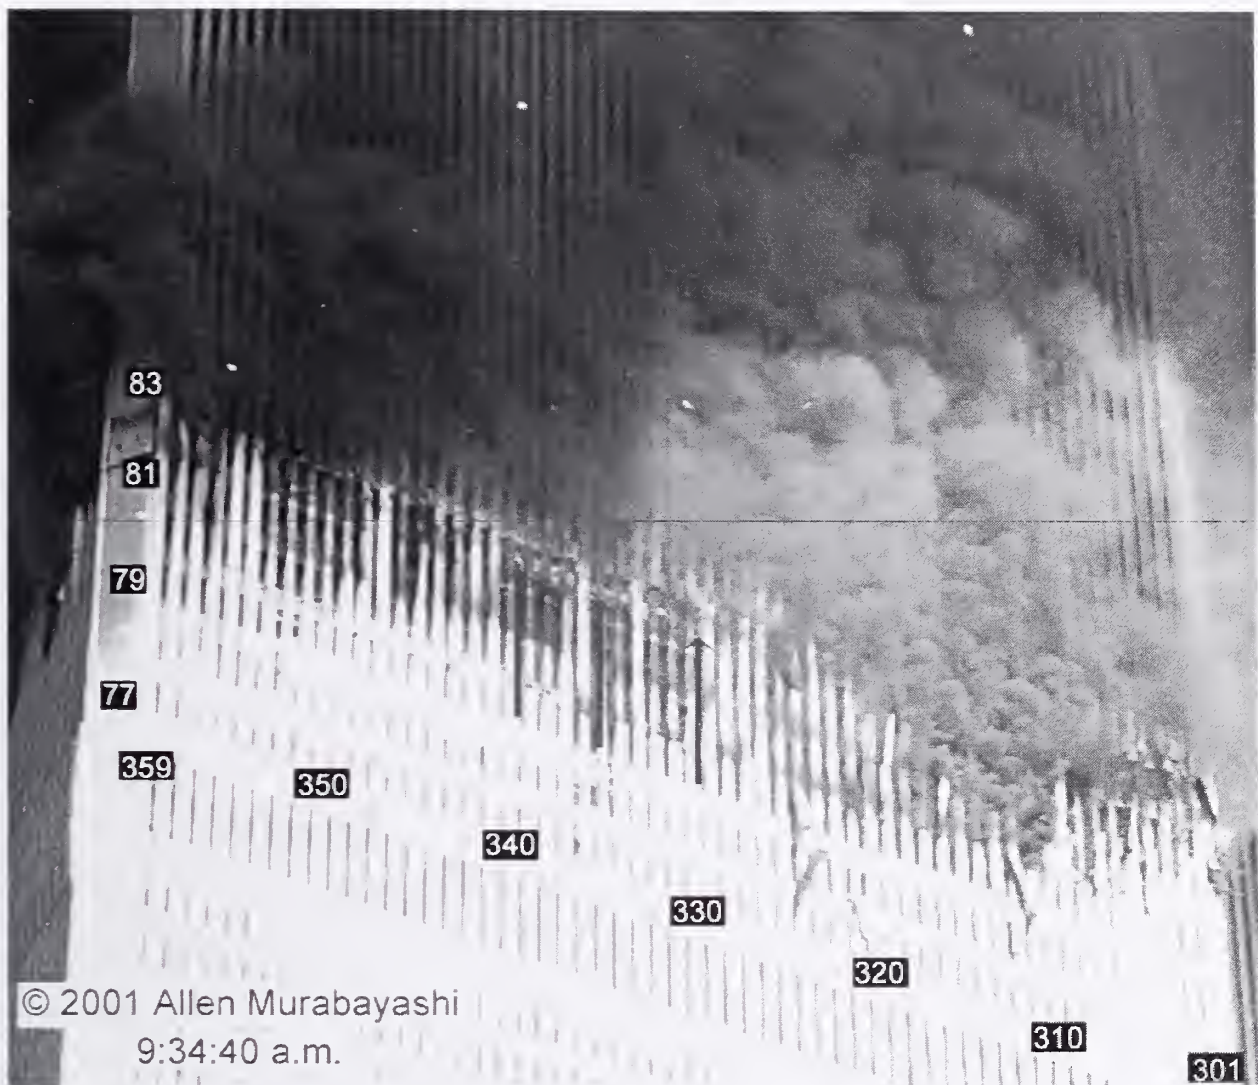
A relatively close view of the east face shot from southeast of WTC 2 at 9:34:40 a.m. is shown in Figure 9–40. This photograph was taken during a period when the flow of smoke coming from windows on the northern side of the 79th floor was fairly heavy, but when little smoke was coming from other windows below the 82nd floor. In Figure 9–27, taken at 9:25:47 a.m., windows 79-314 to 79-320 on the 79th floor had glass in place. These windows are open in Figure 9–40, suggesting that a fire must be burning nearby. The southern half of the face is visible to the tops of 83rd floor windows. Flames are

visible on the 82nd floor from window 82-322 to window 82-328. The fire on this floor has continued its spread toward the north since 9:27:35 a.m. (see Figure 9–28 and Figure 9–30 and related discussion). The fire burning in and near the northeast corner of the 81st floor is also visible in the photograph.

The arrows in Figure 9–40 indicate the hanging object that was described earlier. The appearance of the object is much the same as in Figure 9–28, which was shot from a similar angle at 9:27:35 a.m. This indicates that the portion of the object that is visible has not moved a great deal in the intervening period.

Figure 9-40. This cropped photograph, shot from the southeast at 9:34:40 a.m., shows the east face of WTC 2. The intensity levels have been adjusted, and column and floor numbers have been added. The arrows highlight a hanging object observed through open windows on the 82nd floor.

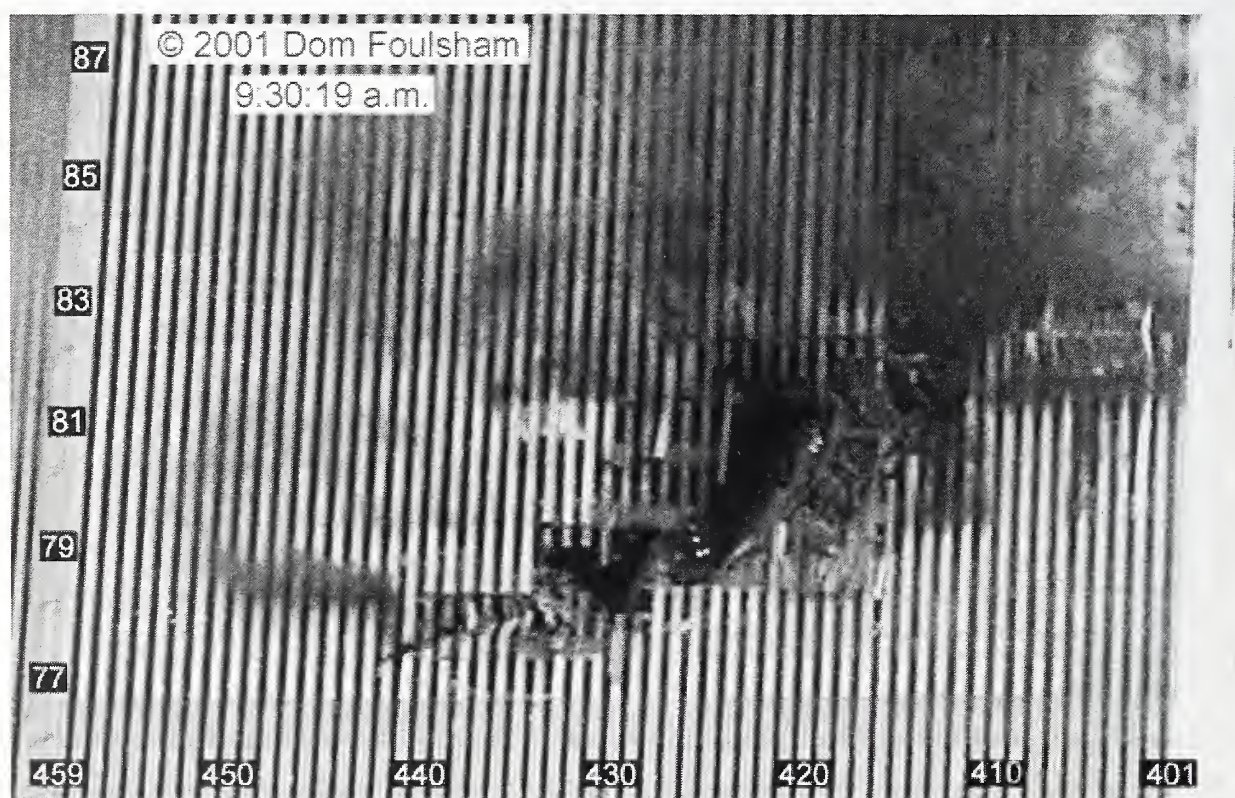
In Figure 9-41, flames are visible on the 83rd floor in window 83-424. This is the first visual evidence of a fire burning on the 83rd floor on the south face. The fire on the 82nd floor between the aircraft impact cavity and the east edge has decreased in intensity, and the smoke has cleared up since Figure 9-33 was taken. Part of the 83rd floor is now visible. It appears as if the spandrel covers at the base of this floor are missing below windows 83-401 to 83-407. There does not appear to be an active fire on this part of the 83rd floor. The small fires burning elsewhere around the aircraft impact cavity have similar appearances to those observed at the earlier time.

Figure 9-41. This cropped photograph shows the south face of WTC 2 at 9:30:19 a.m. The image has been rotated, and column and floor numbers have been added.

Comparison of Figure 9-55 with Figure 9-41, which was taken roughly 8½ min earlier, shows that changes in fire locations and intensities have taken place on the south face. In comparing the images it should be kept in mind that Figure 9-55 was shot from further east and, as a result, low intensity fires are likely to be hidden by columns. With this caveat in mind, it is clear that the large fire visible in windows 81-431 to 81-435 to the left of the aircraft impact cavity in Figure 9-41 has died down. In Figure 9-55

only a small spot fire is visible near the bottom of window 81-435. On the 79th floor, flames are no longer evident near window 79-426, but the fire has migrated to the east from this area, and burning is now visible in windows 79-408 to 79-410.

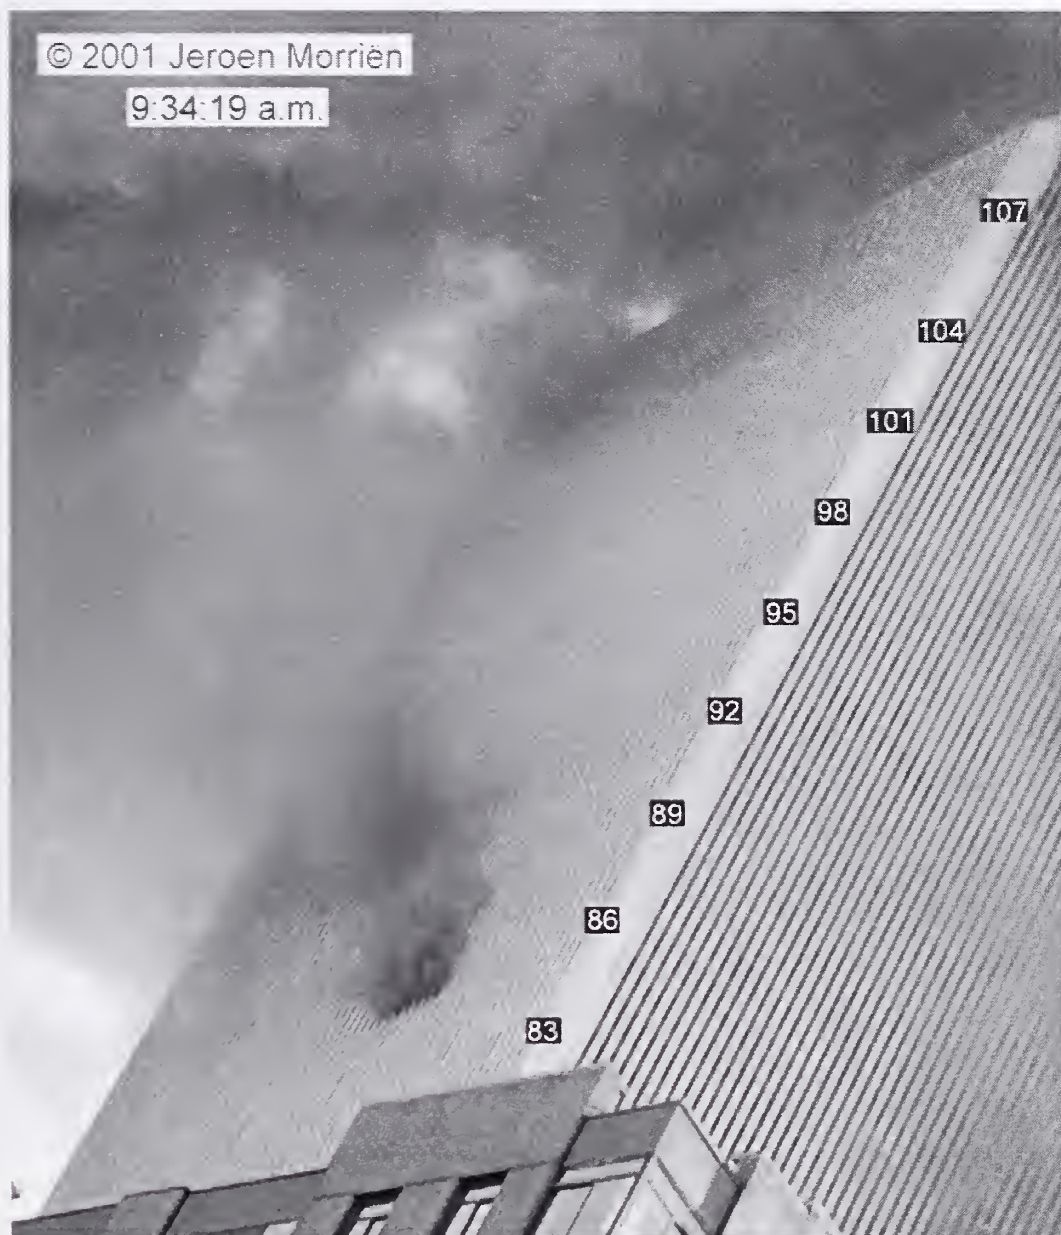
An oblique view of the west face of WTC 2 at 9:34:19 a.m. is shown in Figure 9-42. Smoke is visible at several locations on the west face. The densest smoke is flowing from windows 86-117 to 86-122 on the 86th floor. Lighter smoke is flowing from near window 88-142 and window 84-149 on the 88th and 84th floors, respectively. Smoke is also visible at two locations near the top of the tower; on the 107th floor,

where it was observed earlier, and at the top next to the southwest corner. The latter smoke flow is much lighter and is barely discernable in the photograph. In other images (not shown) it is more distinct. This smoke appears to be flowing from windows 108-101 and 108-102, which were located on the lower level of the mechanical equipment room that spanned the 108th and 109th floors. The nearest louvers to these windows are for a fresh air intake for the 107th floor observation area located opposite windows 108-101 to 108-109 (see Figure A-1 in Appendix A). This suggests that the smoke coming from the upper mechanical equipment room is back flowing through the fresh air intake for the 107th floor. Each of the locations with smoke flow on the west face is above the floors where fires have been observed, which is consistent with the possibility that people broke the glass out and released local build-ups of smoke.

Figure 9-42. This cropped photograph shot from the southwest shows an oblique view of the south and west faces of WTC 2 at 9:34:19 a.m. The intensity levels have been adjusted, and floor numbers have been added.

In Figure 9-42 smoke was also coming from a window, 84-149, on the 84th floor. Smoke is not visible at this location in Figure 9-57, but the image has sufficient resolution to confirm that this window was open. Windows 84-141 and 84-127 also appear to be open on this floor. It is interesting that no smoke seems to be flowing from the open windows that are located closest to the fire floors. No other open windows are apparent on lower floors (note that the image from which Figure 9-57 was cropped extended as far down as the mechanical equipment room on the 76th floor).

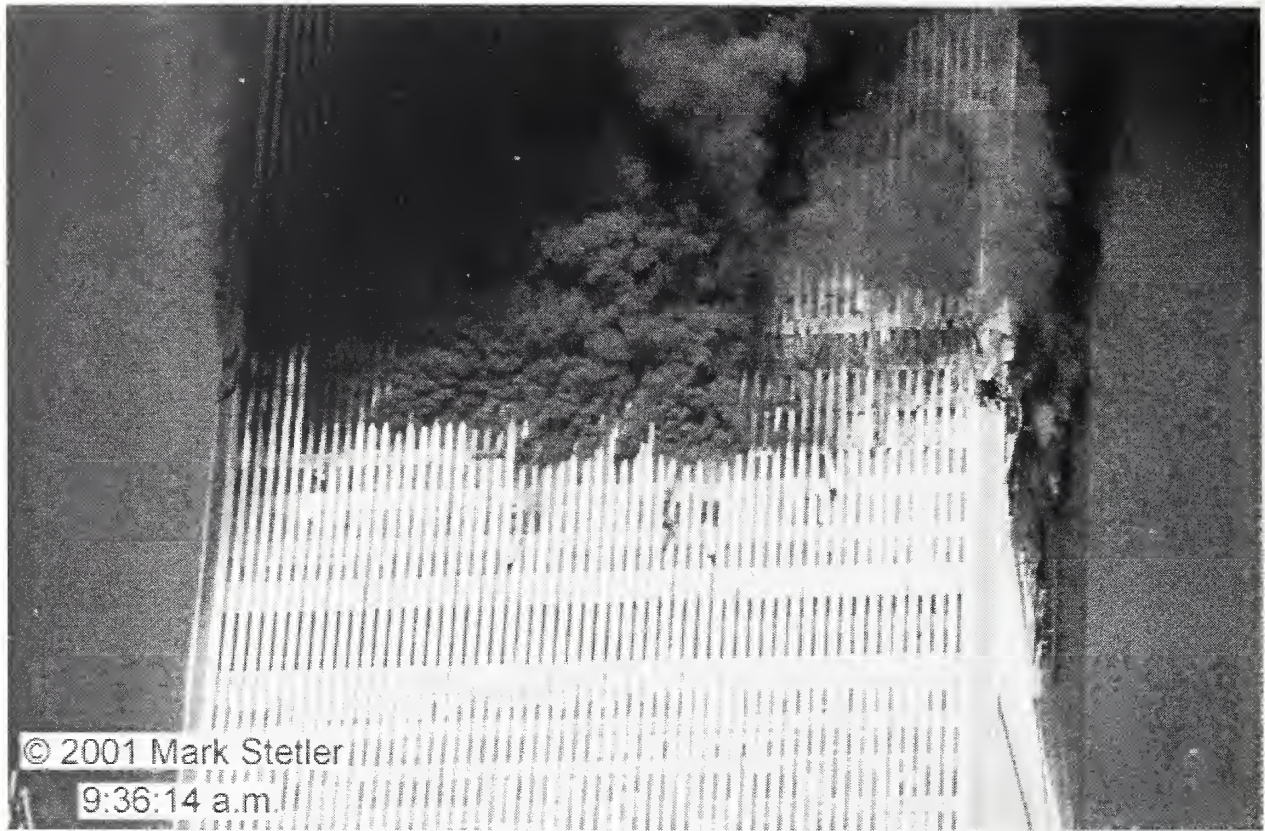
Figure 9-43 shows a photograph that was shot during this period of heavy smoke flow at 9:36:14 a.m. The northern and southern sides of the floors with smoke and fire are shown as blow-ups in Figure 9-44. The enormous increase in smoke is evident by comparing Figure 9-43 with Figure 9-40, which was shot only 1 min 34 s earlier. In the earlier photograph relatively light smoke was coming from open windows on the 79th floor roughly located between windows 79-311 and 79-317. In the later photograph smoke

flow from these windows has apparently completely halted, but now heavy smoke and fire are visible over a range of windows from window 79-318 to window 79-336. In Figure 9-44 it is apparent that smoke and, in many cases, fire are coming from every window that is open over this range. Windows 79-326, 79-329, 79-330, and 79-332 still have glass in place.

Figure 9-43. This photograph showing the east face of WTC 2 was taken at 9:36:14 a.m.

Heavy smoke and fire are also visible on the 80th floor from window 80-229 to window 80-249. Flames are particularly prominent in windows 80-336 to 80-343. These fires might extend over an even wider range, but many windows are hidden by smoke rising from the 79th floor. Flames are barely visible higher up on the face, which suggests that the fire on the 82nd floor continues to burn near column 330.
