**NIST NCSTAR 1-5A
Federal Building and Fire Safety Investigation of
the World Trade Center Disaster**

**Visual Evidence, Damage Estimates,
And Timeline Analysis**

(Chapter 9 - Appendix C)

FIRE BEHAVIOR IN WORLD TRADE CENTER 2

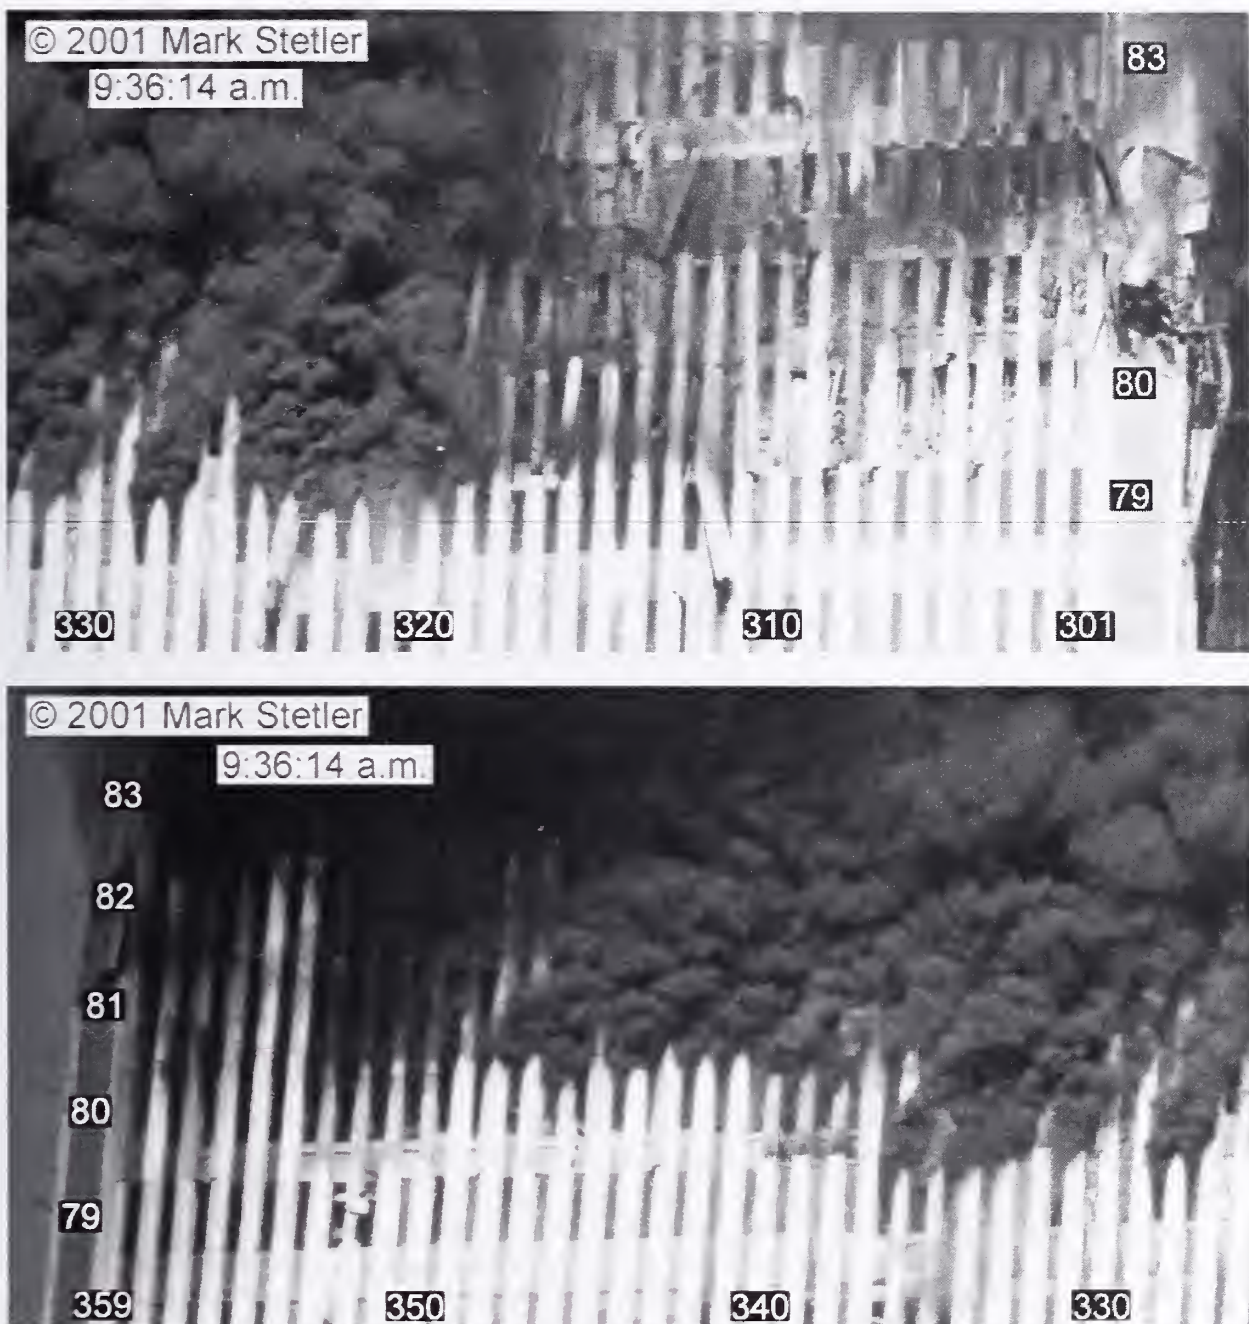
The intense fire in the northeast corner opening of the 81st floor is still present. An unusual flame is visible within this fire. In the upper photograph in Figure 9-44 a very bright white flame, as opposed to the typical yellow or orange surrounding flames, which is generating a plume of white smoke, stands out. The intensity of this flame is considerably brighter than normal flames. It was easily identified in numerous photographs and videos shot from long distances at which the surrounding “normal” flames were not visible. The brightness of the flame, along with the white smoke, suggests that some type of metal is burning. Metal combustion is known to generate much higher flame temperatures than hydrocarbon combustion, and, as a result, to burn much brighter. It is difficult to identify what type of metal is burning. Aluminum will burn, but in normal fires it usually melts instead because the metal surface is protected by an oxide layer that must be breached before ignition can take place. Aluminum oxide melts at high temperatures that are not typically reached in normal fires. There were limited quantities of other metals on the aircraft that might also burn. Whatever the metal, the ignition of a metal fire is an indication of the significant heating of the debris that took place in the northeast corner of the 81st floor due to the prolonged intense burning in this area following the aircraft impact.

Figure 9-44. These two images show blow-ups of the north and south sides of the east face of WTC 2 taken from the photograph included in Figure 9-43, which was shot at 9:36:14 a.m. Column and floor numbers have been added

Given the large amounts of smoke coming from the central regions of the 81st and 82nd floors on the east face, there is surprisingly little smoke at the north and south ends of these floors. With the exception of a light smoke flow from windows 78-334 and 78-335 on the 78th floor, no smoke is observed coming from below the 79th floor. Videos show that short bursts of smoke did come from other open windows on the 77th and 78th floors during the heavy smoke release.

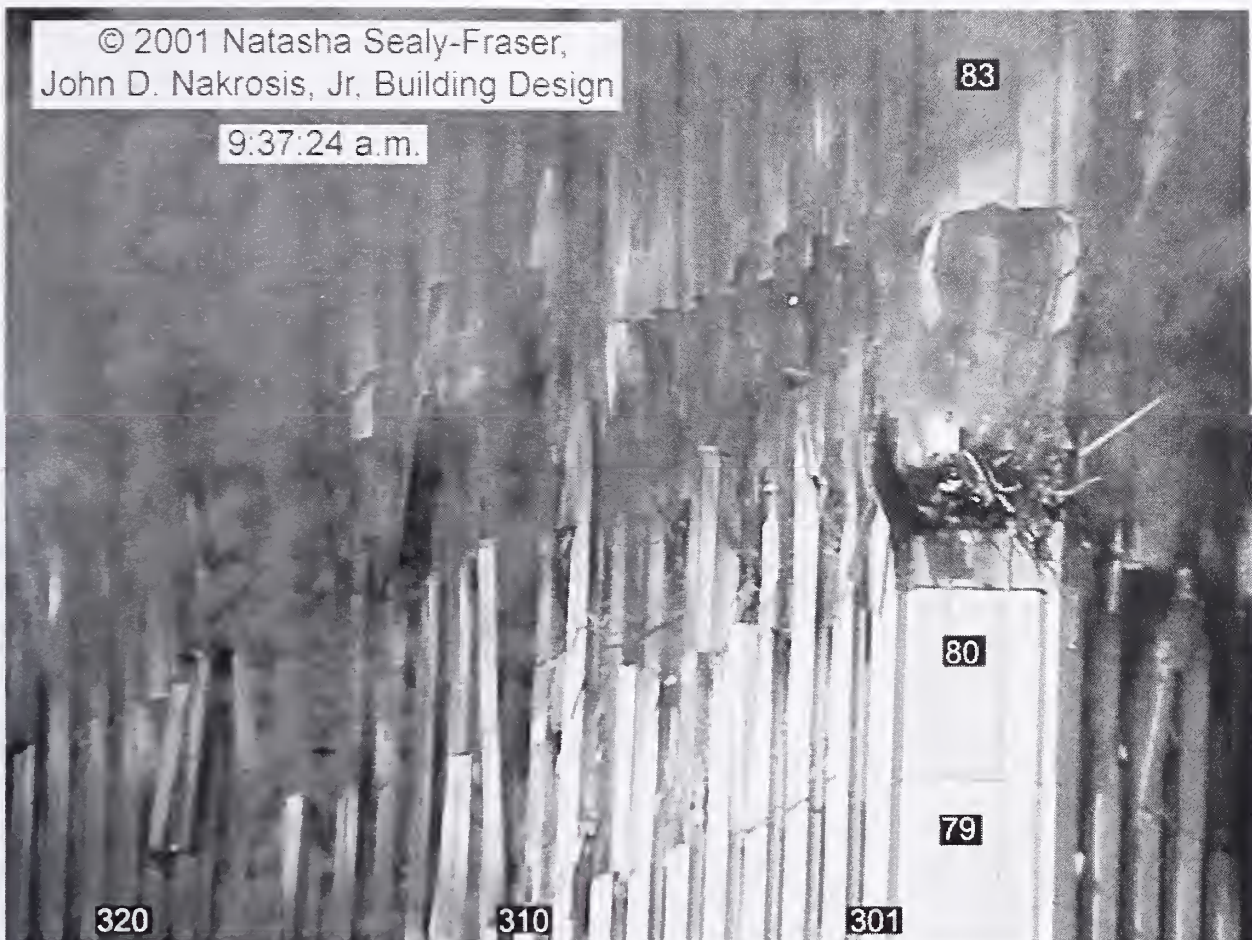
Figure 9-45 shows the northeast corner of the tower. The bright flame in the 81st floor corner opening, which has been attributed to metal combustion, stands out. A check of the original image shows that the pixels at this location are essentially saturated, providing an indication of how much brighter this flame was than the surrounding flames, which had intensities that were far from saturating the pixels. From this angle, flames are visible extending from the 82nd floor at windows 82-204 to 82-207. These windows appeared to be flame-free at 9:36:14 a.m.

Figure 9-45. This photograph was taken from the northeast at 9:37:24 a.m. and shows portions of the north and east faces of WTC 2. The intensity levels have been adjusted, and column and floor numbers have been added.

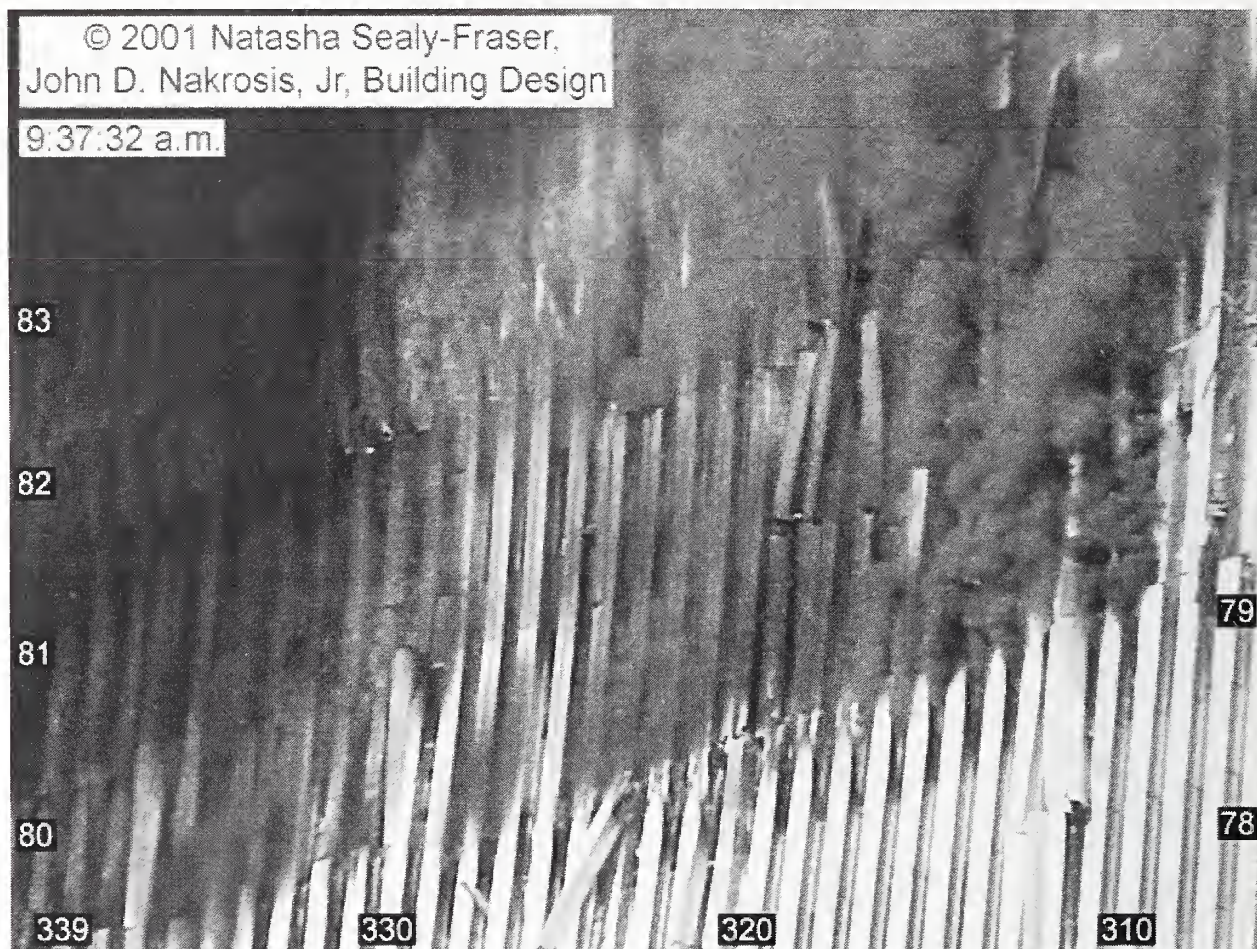
The largest changes in appearance occurred near the center of the east face. In Figure 9-46 the only heavy smoke and flames visible on lower floors is coming from windows 79-310 to 79-317 on the 79th floor. At 9:36:14 a.m. these windows appeared to be free of smoke and fire. On the other hand, the only evidence of the intense fires raging on the 79th floor seconds earlier in windows 79-318 to 79-325 are the carets visible at the tops of the adjacent column covers. Heavy smoke hid much of the upper floor façade in Figure 9-44. The only flames visible on the 82nd floor appeared to be just to the south of column 330. At the later time, large flames are coming from windows 82-320 to 82-333. Recall that intense flames became visible in this region around 9:37:18 a.m.

Closer inspection of Figure 9-46 reveals that the columns on the 80th and 81st floors on either side of column 330 appear to be bowed inward. This bowing could be identified in images taken as early as 9:21:29 a.m. Several additional photographs to be described below show a similar bowing. This indicates that columns on these floors were distorted at least 37 minutes prior to the collapse of the tower.

Figure 9-46. This photograph was taken from the northeast at 9:37:32 a.m. and shows the center portion of the east face of WTC 2. The intensity levels have been adjusted, and column and floor numbers have been added.

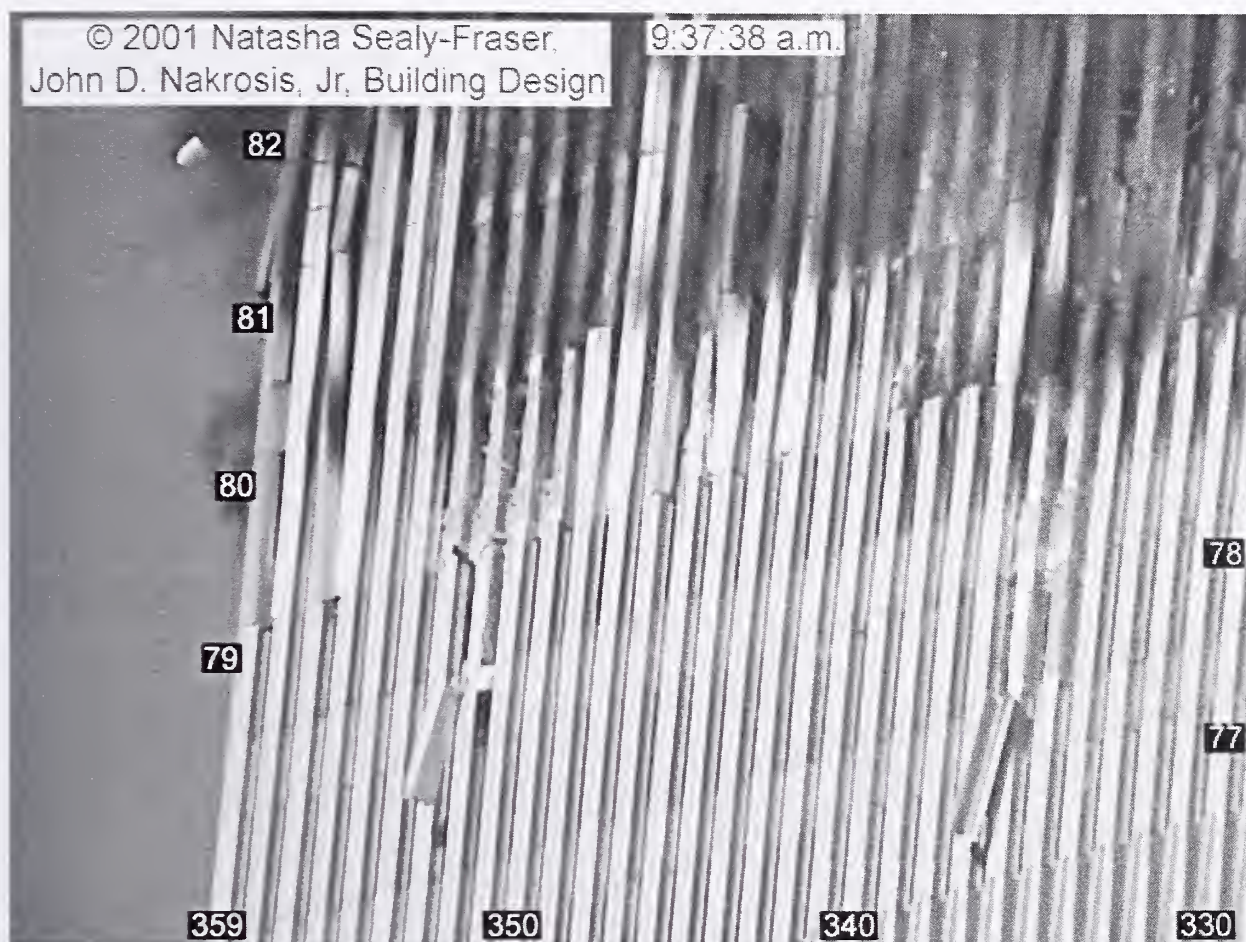
Figure 9-47 show the southern portion of the east face. There is very little smoke and no fire coming from windows in this area. This contrasts sharply with Figure 9-44, in which intense flames and large amounts of smoke were visible coming from numerous windows on the 79th and 80th floors.

Figure 9-47. This photograph was taken from the northeast at 9:37:32 a.m. and shows the western portion of WTC 2. The intensity levels have been adjusted, and column and floor numbers have been added.

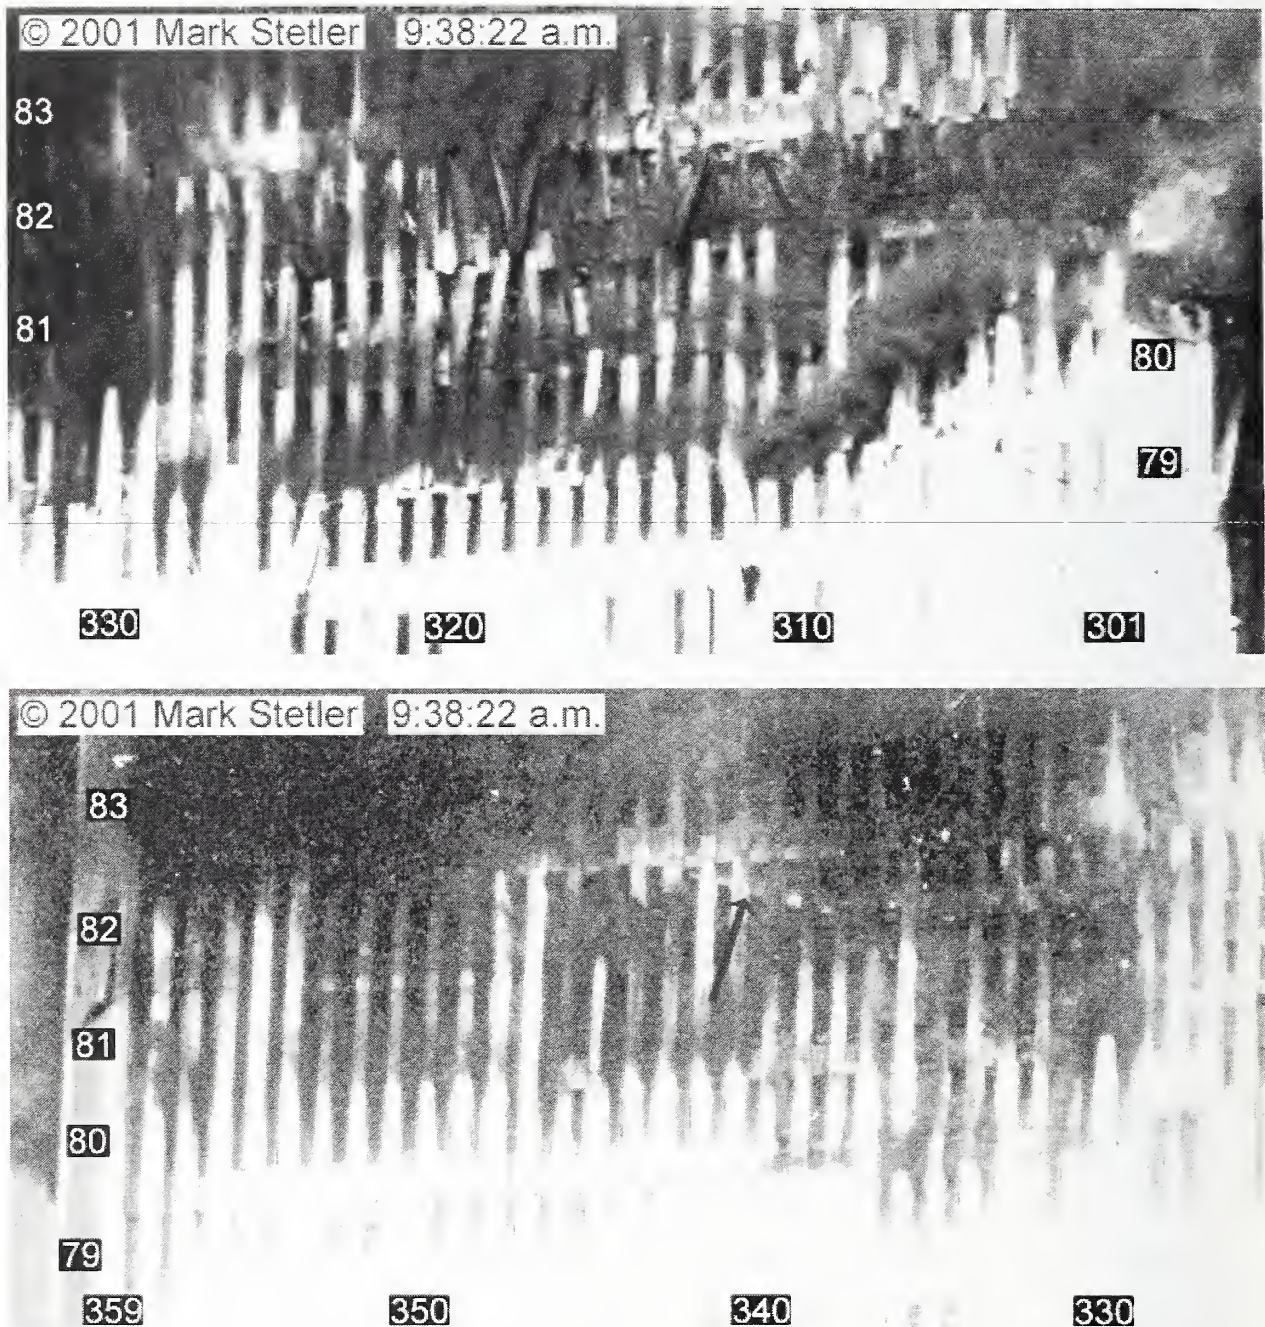
Views of the northern and southern sides of the east face enlarged from the same photograph taken at 9:38:22 a.m. from the east are shown in Figure 9-48. The intensities have been adjusted to overexpose much of the images in order to highlight the object marked with arrows. This is the same hanging object described earlier that has been tentatively identified as the 83rd floor slab. Its appearance has now changed from those seen in Figure 9-1 and Figure 9-2 (9:03:42 a.m.), Figure 9-21 (9:18:38 a.m.), Figure 9-28 (9:27:35 a.m.), Figure 9-31 (9:26:20 a.m.), and Figure 9-40 (9:34:40 a.m.). At these earlier times, the object was visible hanging near the tops of open windows 82-321 to 82-342, even though it did shift downward locally between 9:18:38 a.m. and 9:26:17 a.m. In the bottom image of Figure 9-48, it can still be seen at the top of window 82-342, but now it drops very rapidly and seems to disappear below the base of window 82-337. The object is no longer visible in windows at least as far to the right as window 82-330. Windows immediately to the north of window 82-330 are filled with fire that would hide the object even if it was above the window base.

In the top portion of Figure 9-48, the visible fire area near the center of the 82nd floor ends at window 82-318. Beyond this point, it is possible to see inside the windows again, and the hanging object (marked with arrows) is visible starting near the base of window 82-317 and rising toward the top of window 82-311. This location is 10 windows further north than where the object was seen earlier. These observations suggest that the object, which may have been the 83rd floor slab, that had been hanging near the tops of windows on the 82nd floor since shortly after the aircraft impact sank much lower sometime between 9:34:40 a.m. and 9:38:22 a.m. At some unknown time an additional length of the object became visible on the north side. The fire that had reappeared at the northern edge of the 82nd floor in Figure 9-45 continued to burn at 9:38:22 a.m.

In the top part of Figure 9-48, an extensive fire can be seen on the 79th floor between windows 79-310 and 79-320. There had been indications of a fire in this area prior to the sudden release of smoke and fire (see Figure 9-40). Isolated fires are also visible on the 81st floor at window 81-331 and on the 80th floor at windows 80-338 and 80-339, with flames extended from window 80-339. These latter fires are the only visible remnants of the large fires visible on these floors in Figure 9-43 and Figure 9-44.

Figure 9-48. These two images show blow-ups of the north and south sides of the east face of WTC 2 taken from a photograph that was shot at 9:38:22 a.m. The intensities have been adjusted to purposefully overexpose parts of the images. Column and floor numbers have been added

It is conceivable that the pressure pulse generated within WTC 2 at 9:37:04 a.m. could have resulted from the sudden collapse of the hanging object, presumed to be a portion of the 83rd floor slab, observed through open 82nd floor windows. While the rapid collapse of a large section of a floor slab would likely generate a substantial pressure pulse, evidence supporting such a conclusion is circumstantial, at best. The actual collapse of the object was not observed, and there is no evidence that it occurred rapidly or even at this time. The appearance of large fires on the 82nd floor shortly after the pressure pulse is an indication that something happened on this floor around this time. On the other hand, most of the direct effects of the pressure pulse were observed on lower floors, particularly floors 77 through 79. The available pathways for transporting the pressure pulse are unknown, but it might have been expected that its largest effects would have been apparent near the floor where it was generated. It must be concluded that, while it is possible that the pressure pulse resulted from a partial collapse of the hanging object seen on the east side of the tower, the evidence is far from conclusive.

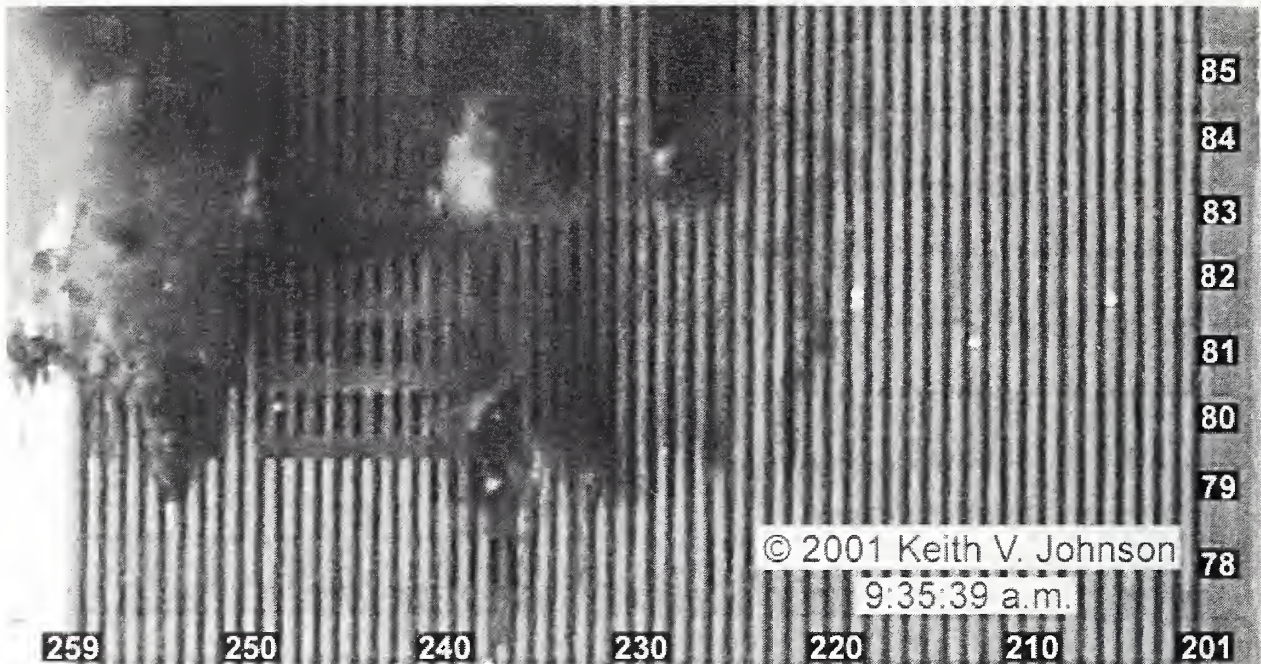
Twenty-one seconds after fire erupted from window 83-226 on the 83rd floor of the north face at 9:33:52 a.m. (see Figure 9-37), window 83-227 opened, and smoke and fire were released. By 9:34:14 a.m. windows 83-228 and 83-229 were also open, and flames were coming from all four windows. A photograph of the area taken at 9:35:39 a.m. is shown in Figure 9-49. The flames in windows 83-226 to 83-229 are visible. Flames are not visible in windows 83-230 to 83-232, but a continuous region of fire extends from window 83-233 to window 83-245. Comparison with Figure 9-36 and Figure 9-37, taken at 9:32:24 a.m. and 9:33:53 a.m., respectively, shows that this fire had died down somewhat from the earlier times and had apparently moved one window to the west. The absence of visible fire immediately adjacent to the new fire location, along with the rapid appearance of flames at multiple windows, observations that indicate flashover took place around this time, suggests that the fire seen in windows 83-226 to 83-229 was burning within an enclosed room. It is not possible to check whether a room was present at this location since floor plans are unavailable for this floor.

Figure 9-49. This cropped photograph shows the north face of WTC 2 at 9:35:39 a.m. The intensity levels have been adjusted, and column and floor numbers have been added.

The fire distributions elsewhere on the north face in Figure 9–49 are similar to those in Figure 9–36 and Figure 9–37. Fires were still burning at the east edge of the tower on the 81st, 82nd, and 83rd floors. The debris piles on the 78th floor and in the lower right-hand corner of the cold spot continued to burn, and fire was visible as far west as window 79-225 on the 79th floor. A plume of smoke is visible coming from window 79-222. There are no visible indicators of fire to the west of this window on any of the floors.

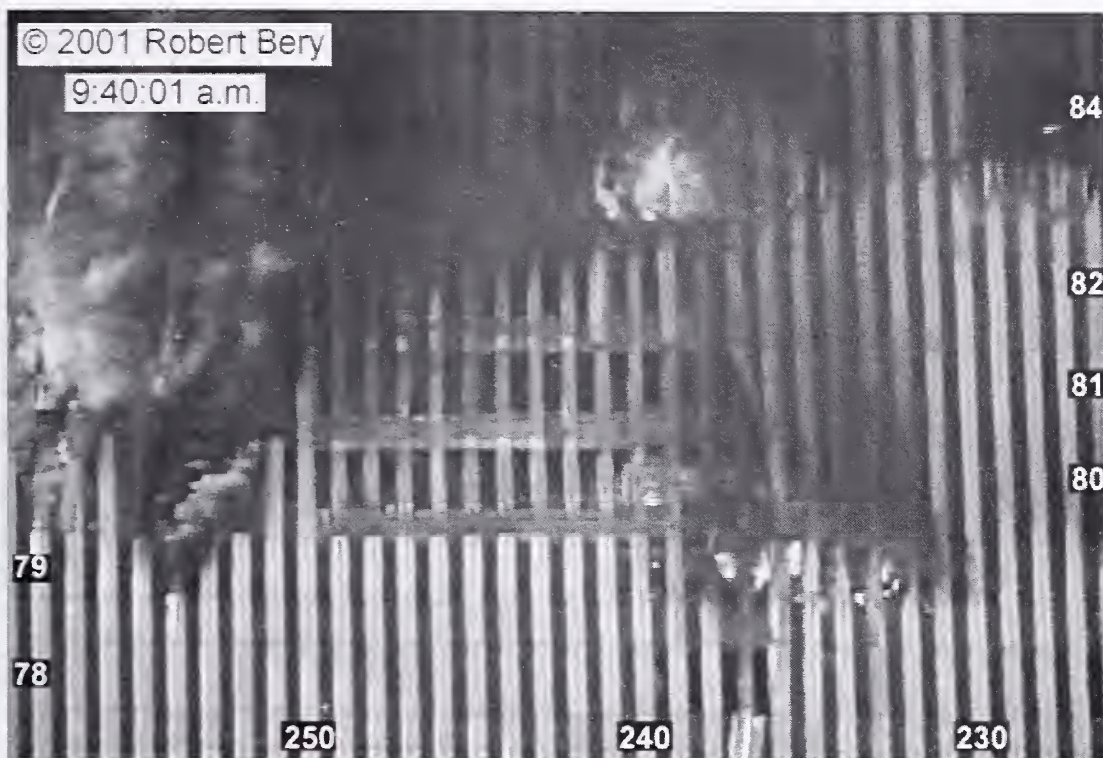
A somewhat closer view of the north face taken at 9:40:01 a.m. is shown in Figure 9–50. Even though the image contains some digital noise, it is sufficiently resolved that open and closed windows can be identified. By this time, the fire visible in windows 83-226 to 83-229 on the 83rd floor no longer had extended flames. The carets on the surrounding aluminum column covers reflect their earlier presence. The three windows immediately to the east, windows 83-230 to 83-232, appear to still have glass in place. Flames continue to extend from windows on this floor above the right-hand side of the cold spot, but flames in windows 83-234 to 83-236 have died down sufficiently that they are no longer visible. Carets around these windows indicate that extended flames were present earlier. The fire on the eastern edge of the 81st floor continues to burn vigorously, hiding the locations immediately above on the 82nd and 83rd floors. The fires burning on piles of debris on the 79th and 80th floors have comparable intensities to those seen in recent images.

Figure 9-50. This frame captured from a video shows the north face of WTC 2 at 9:40:01 a.m. The intensity levels have been adjusted, and column and floor numbers have been added.

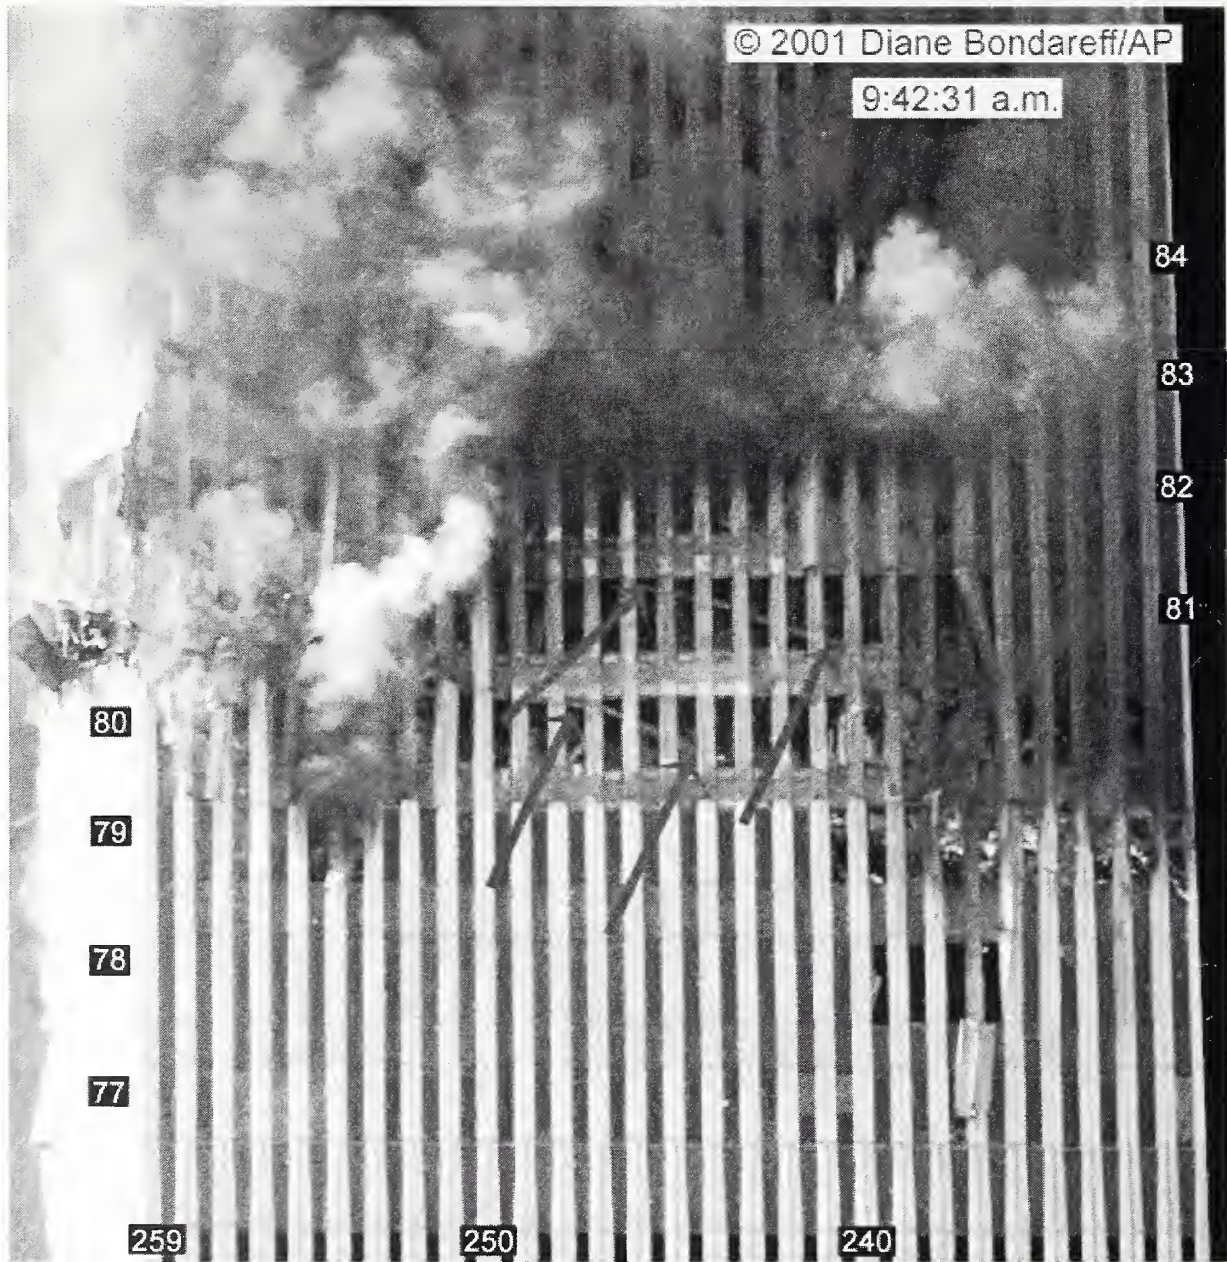
A high-resolution photograph of the area around the cold spot on the north face is reproduced in Figure 9–51. It was shot at 9:42:31 a.m. Arrows have been added to the image to indicate hanging objects that are visible through open windows on the 80th and 81st floors. The area containing the arrows is blown up further in Figure 9–52. It is instructive to compare this image with Figure 9–17, which shows a blowup of roughly the same area at 9:14:03 a.m., and Figure 9–12, which was recorded at 9:10:01 a.m.

Figure 9-51. This cropped photograph shows a portion of the north face of WTC 2 at 9:42:31 a.m. The image has been rotated and enhanced by adjusting the intensity levels, and column and floor numbers have been added. The arrows highlight hanging objects visible through open windows on the 80th and 81st floors.

Figure 9-51 provides good views of the fires that continued to burn on the east edge of the north face on the 81st and 82nd floors and on the piles of debris on the right side of the cold spot on the 79th and 80th floors. Flames are also visible on the 83rd floor in windows 83-238 to 83-244. All of these fires have similar appearances to those seen in recent earlier photographs.

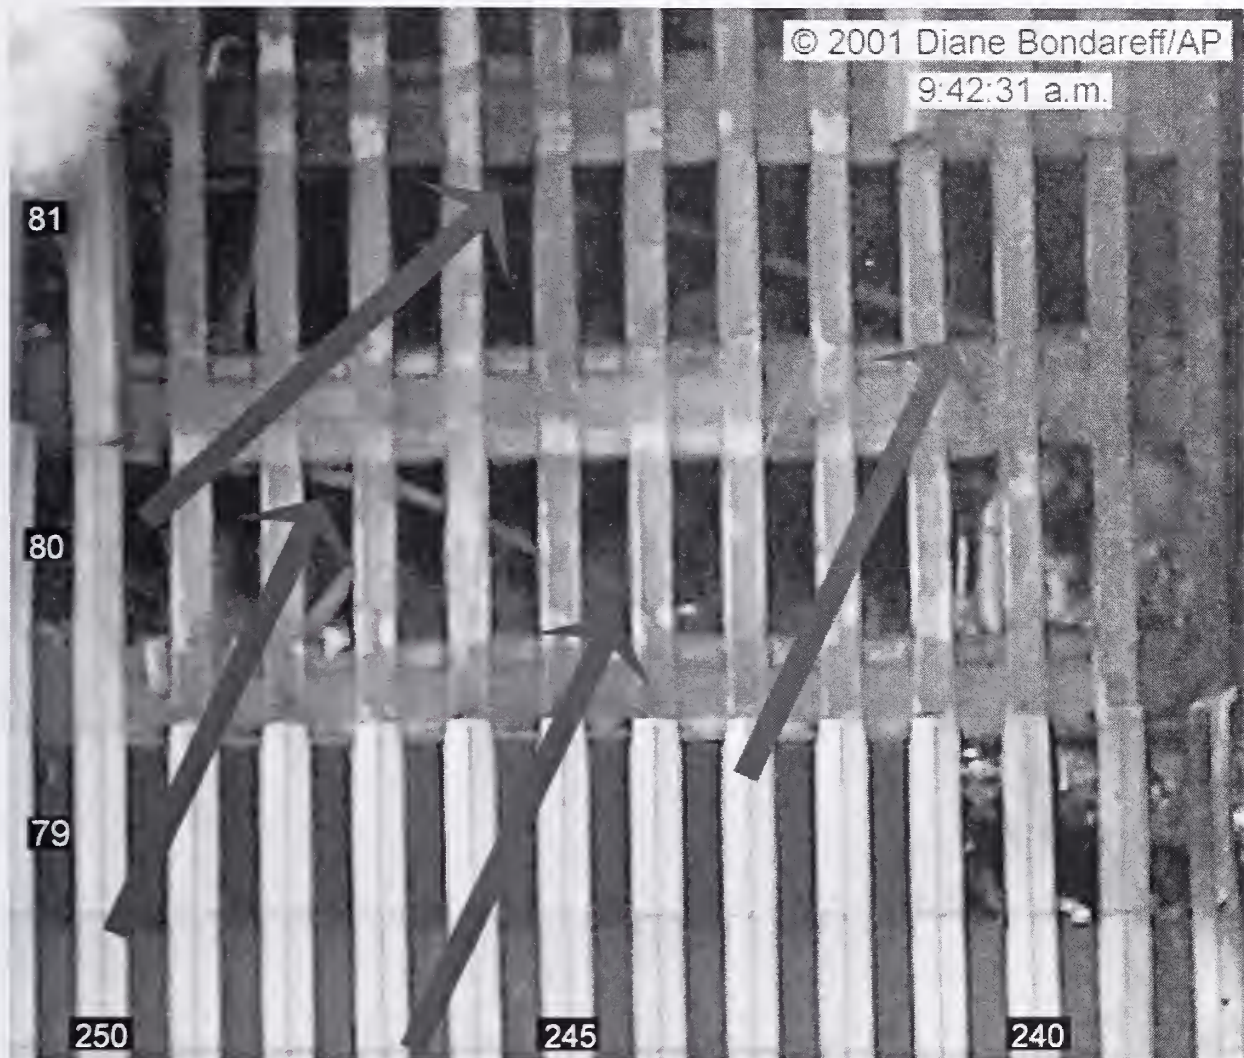
Hanging objects are visible in the two blow-ups shown in Figure 9-17 and Figure 9-52, but it is apparent that their locations and appearances have changed between the times when the two photographs were taken. At the earlier time, two objects were observed through open windows in the cold spot on the 80th floor. The first was located near the center of the windows and extended across the entire area, reaching as far east as window 80-255. The second was visible curving downward in window 80-247 and extending to near the center of window 80-242. In Figure 9-52 the lower object has apparently disappeared completely from view, and the object that was hanging higher up in the windows has dropped down. It now first appears in window 80-248 and curves rapidly downward, seeming to disappear below the spandrel at the base of window 80-243.

In the earlier blow-up there appeared to be two objects hanging in the cold spot on the 81st floor just below the tops of windows 81-239 to 81-242. In Figure 9-52 only a single object is visible through windows in this area of the 81st floor. It now first appears in window 81-245 and curves downward to the base of window 81-240. This object has also apparently shifted position.

Recognizing that the appearances of the hanging objects changed to such a large extent between 9:14 a.m. and 9:42 a.m., lower-resolution images, in which the objects were not well resolved, taken between these times were reviewed. In many of these images there are faint indications of the hanging objects, and it proved possible to narrow down the times when the changes occurred. In Figure 9-32 the objects are barely visible on the 80th and 81st floors at 9:27:04 a.m. Their locations are consistent with those seen in Figure 9-17 on both floors. This is no longer true in Figure 9-35. On the 80th floor the faint hanging object appears to have the same shape as in Figure 9-52, while on the 81st floor the hanging object seems

to be close to the top of the windows. These observations indicate that changes in the location of the hanging objects took place between 9:27:04 a.m. and 9:29:42 a.m. on the 80th floor and sometime between 9:29:42 a.m. and 9:42:31 a.m. on the 81st floor.

Figure 9-52. A section of the image shown in Figure 9-51 is blown up. The arrows point to the locations of hanging objects that are visible through open windows on the 80th and 81st floors on the north side of WTC 2. Column and floor numbers have been added.

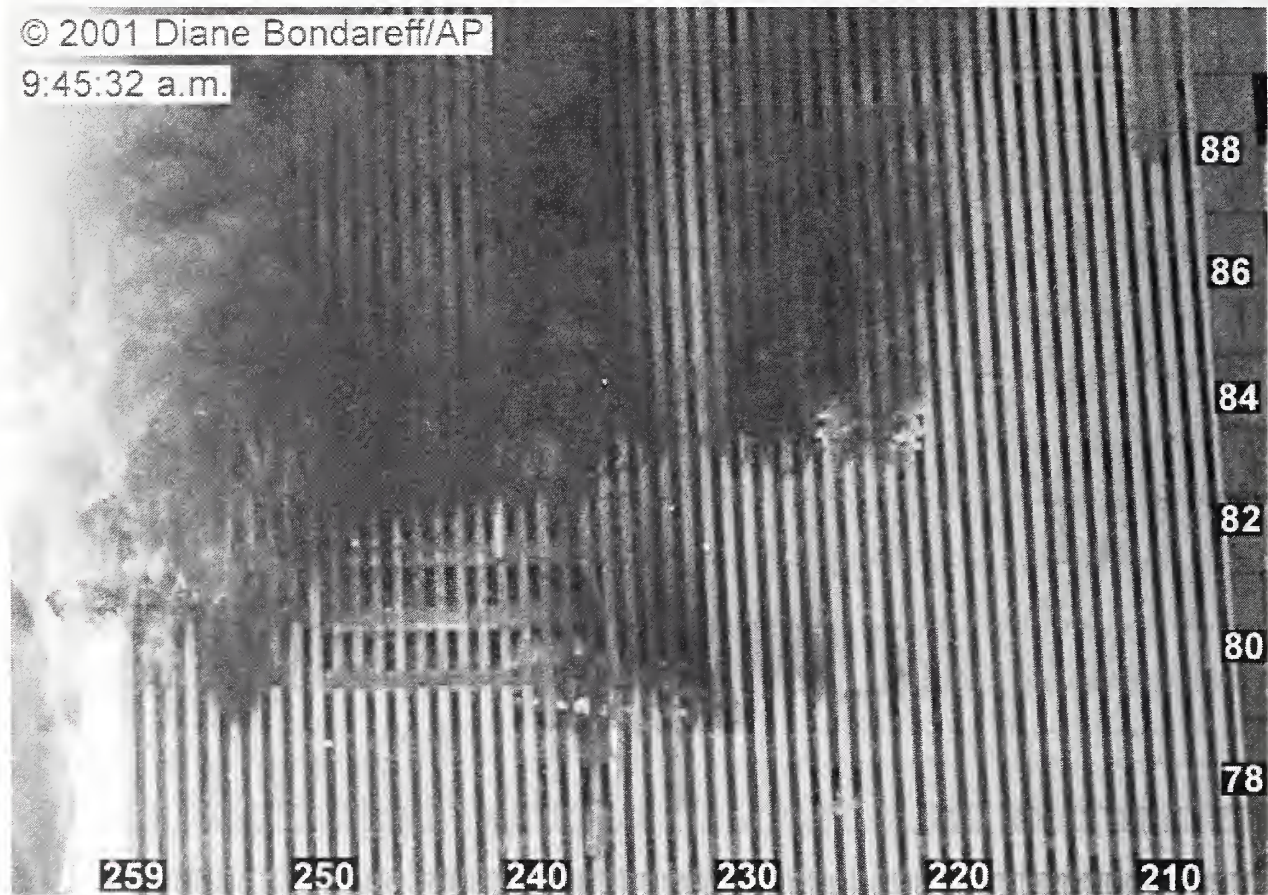
A video shows that a stream of smoke appeared from window 83-224 on the 83rd floor of the north face at 9:42:26 a.m., and a small object (window glass?) fell from the location at the same time. Twenty-seven seconds later, the smoke plume burst into flames. At 9:45:02 a.m. there was another burst of smoke and a falling object from window 83-222, followed by flames 5 s later. This flame spread to window 83-221 at 9:45:25 a.m. A photograph face taken 7 s later is shown in Figure 9-53. Two long tongues of flames are

coming from windows 83-221 and 83-224. Flames are no longer visible in windows 83-226 to 83-230, even though carets are visible on adjacent column covers. Windows 83-225, 83-231, and 83-232 appear to have glass in place. The sudden and isolated development of a fire on the 83rd floor in windows 83-221 to 83-224 suggests again that flashover within a room has occurred. The fire on this floor near the left edge of the cold spot has died down with internal flames only visible in windows 83-238 and 83-239.

Figure 9-53. This image of the north face of WTC 2 was taken at 9:45:32 a.m. The photograph has been cropped and rotated, and the intensity levels have been adjusted. Column and floor numbers have been added. The brown area to the right is the eastern edge of WTC 7.

The fire burning on the eastern edge of the north face on the 81st floor continues to burn vigorously, but flames are not visible in the 82nd floor windows at this time. A small fire is visible in window 83-259 on the 83rd floor. The fires on the 79th and 80th floors near the center of the north face continue to burn on the piles of debris. Fires are not evident on the 79th floor to the west of window 79-230, even though smoke marks and open windows at 79-220 and 79-222 are evidence of the earlier burning observed in this area.

In Figure 9-53 an isolated smoke plume is visible on the 88th floor coming from window 88-208. This is another location where it is possible that people have broken out a window. A photograph shot just before 9:45 a.m. showed that windows 88-201 to 88-203 were also open.

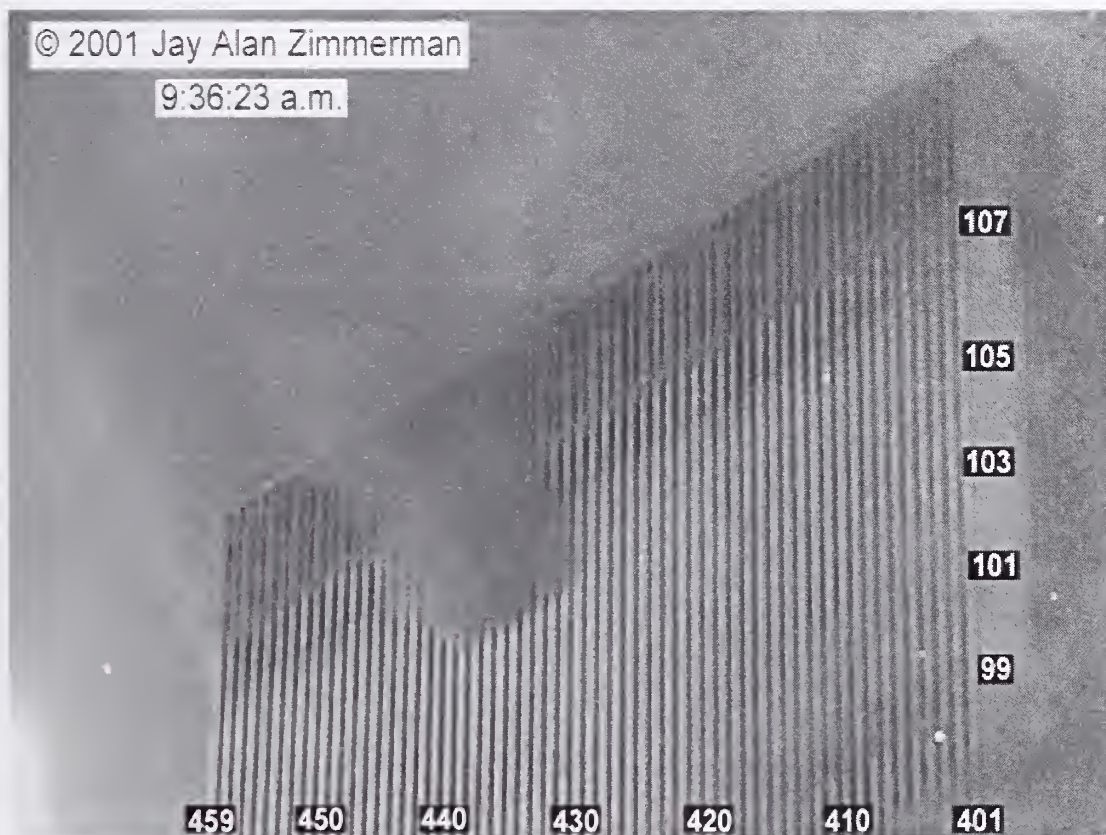
Clear close-up images of the fires on the south face of WTC 2 are limited between 9:30 a.m. and 9:38 a.m. Figure 9-54 shows a frame taken from a video of the upper portion of the south face at 9:36:23 a.m. It has been included because at this time the smoke on the face cleared sufficiently to observe that heavy smoke was coming from multiple windows, extending from roughly window 105-430 to window 105-438, on the 105th floor. This is another location where people may have broken open windows. This was the only location above the fire floors where smoke flow from open windows was evident on this face. In particular, no smoke was observed flowing from the upper mechanical equipment room floors.

Figure 9-54. This image is taken from a video shot from the southeast and shows the upper portion of the south face of WTC 2 at 9:36:23 a.m. The intensity levels have been adjusted, and column and floor numbers have been added.

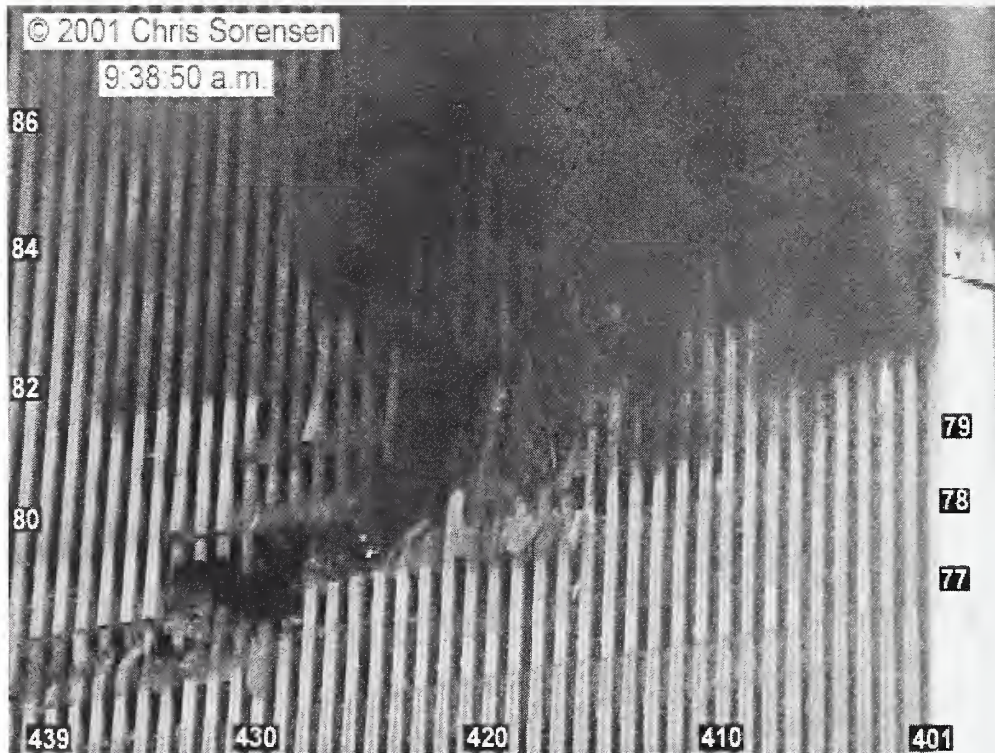
A video shows that heavy smoke began flowing from windows at the eastern edge of the south face on the 80th floor at 9:38:12 a.m. This smoke is visible coming from windows 80-401 to 80-408 in Figure 9-55, which shows a frame captured from a video recorded at 9:38:50 a.m. In the video, fire, which is visible inside windows 80-407 and 80-408, occasionally extended from these windows. The smoke coming from the 80th floor tended to hide the windows on the floors immediately above, but there were brief glimpses of a fire burning on the 83rd floor.

Comparison of Figure 9-55 with Figure 9-41, which was taken roughly 8½ min earlier, shows that changes in fire locations and intensities have taken place on the south face. In comparing the images it should be kept in mind that Figure 9-55 was shot from further east and, as a result, low intensity fires are likely to be hidden by columns. With this caveat in mind, it is clear that the large fire visible in windows 81-431 to 81-435 to the left of the aircraft impact cavity in Figure 9-41 has died down. In Figure 9-55

only a small spot fire is visible near the bottom of window 81-435. On the 79th floor, flames are no longer evident near window 79-426, but the fire has migrated to the east from this area, and burning is now visible in windows 79-408 to 79-410.

Figure 9-55. This image of the south face of WTC 2 was captured from a video recorded at 9:38:50 a.m. The intensity levels have been adjusted, and column and floor numbers have been added.

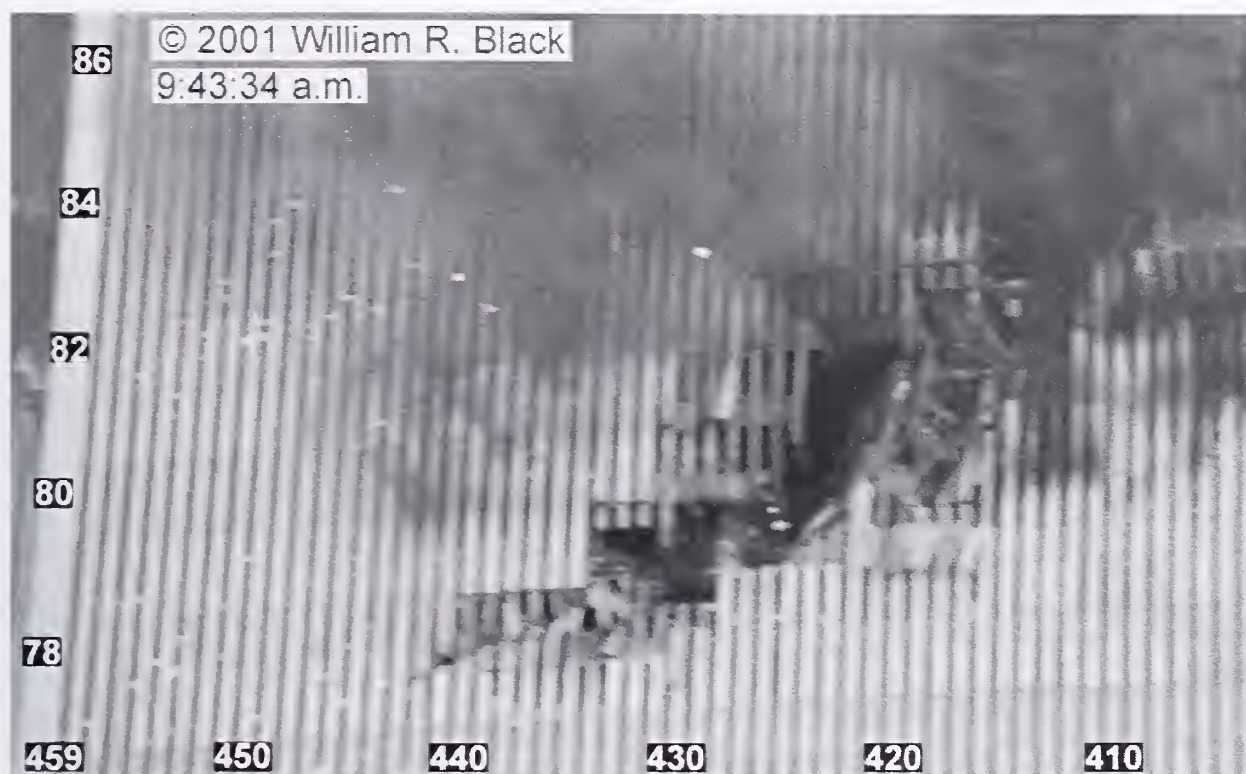
Another view of the south face taken at 9:43:34 a.m. is shown in Figure 9-56. More widespread flames are visible than in Figure 9-55 because it was shot from a location more directly to the south and further away. Low intensity fires are visible on the 80th and 81st floors to the west of the aircraft impact cavity. The fire on the 81st floor is a remnant of the intense fire seen in this area at 9:30:19 a.m. (see Figure 9-41), while the fire on the 80th floor has been burning at a low level since at least 9:23 a.m. (see Figure 9-26). A small fire, which has been burning on the 78th floor just to the east of the aircraft impact cavity since shortly after the impact, is also evident.

The fire on the east side of the 79th floor in windows 79-408 to 79-410 in Figure 9-55 was also present at 9:43:34 a.m., and there is now an indication of flame at window 79-406. The heavy smoke and fire present on the 80th floor at 9:38:50 a.m. seem to have dissipated, and it is possible to see the base of the 83rd floor on the eastern edge. Videos suggest that this change occurred around 9:40 a.m. There are now no flames visible east of the aircraft impact cavity on the 80th through 82nd floors as far east as column 404, which is the last column visible in the image.

Figure 9-56. This cropped, slightly out of focus photograph of the south face of WTC 2 was shot at 9:43:34 a.m. The intensity levels have been adjusted, and column and floor numbers have been added. The flames visible to the left of the western edge of WTC 2 are on the south side of WTC 1.
