**NIST NCSTAR 1-5A
Federal Building and Fire Safety Investigation of
the World Trade Center Disaster**

**Visual Evidence, Damage Estimates,
And Timeline Analysis**

(Chapter 9 - Appendix C)

FIRE BEHAVIOR IN WORLD TRADE CENTER 2

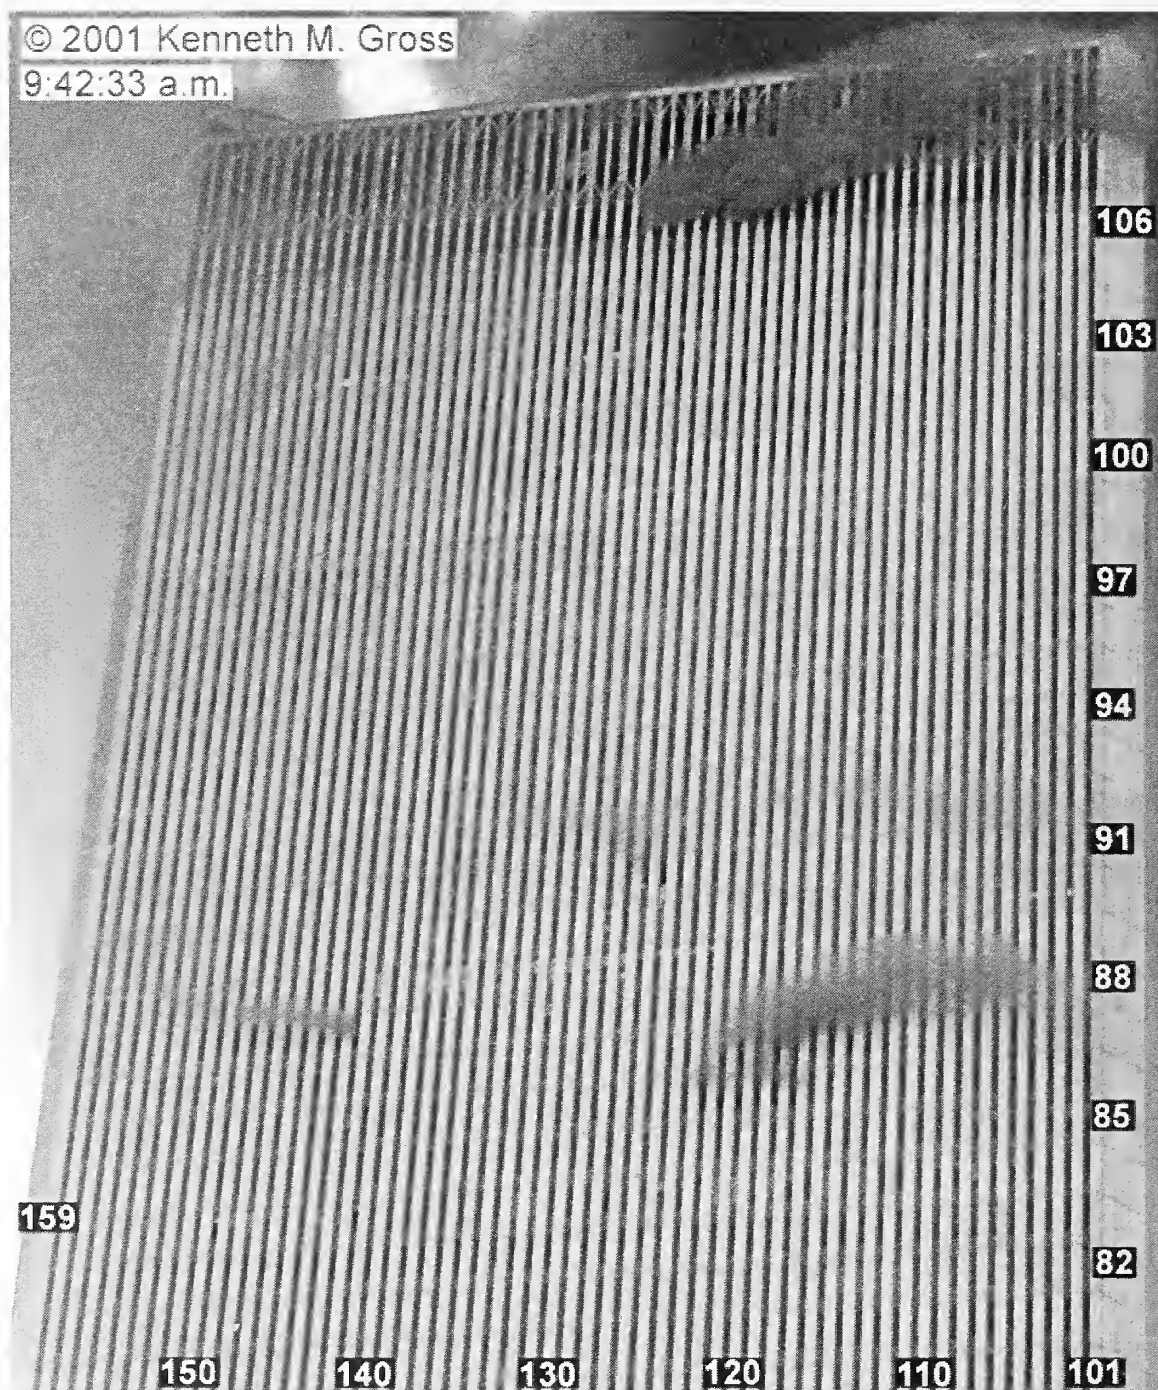
A clear view of the west face of WTC 2 at 9:42:33 a.m. is shown in Figure 9-57. Smoke is visible coming from several windows on the 86th, 88th, 91st, 105th, and 107th floors, as well as from the mechanical equipment room on the 108th and 109th floors. These locations include windows 86-117 to 86-122, 88-142, 91-125 and 91-126, 105-148, 107-123 to 107-129, and the two right-most windows on the 108th floor. Smoke was observed coming from these same locations at 9:34:19 a.m. (see Figure 9-42), with the exception of the windows on the 91st and 105th floors. These two locations had light smoke flows, and it is difficult to determine when the windows were opened.

In Figure 9-42 smoke was also coming from a window, 84-149, on the 84th floor. Smoke is not visible at this location in Figure 9-57, but the image has sufficient resolution to confirm that this window was open. Windows 84-141 and 84-127 also appear to be open on this floor. It is interesting that no smoke seems to be flowing from the open windows that are located closest to the fire floors. No other open windows are apparent on lower floors (note that the image from which Figure 9-57 was cropped extended as far down as the mechanical equipment room on the 76th floor).

On several floors electric lights are visible through windows on the west face in Figure 9-57. These include the 104th floor. The fact that lights remained on for floors well above the aircraft impact floors means that the aircraft did not cut all of the power lines running to the top of the tower as it passed through the core.

Figure 9-57. This cropped photograph shows the west face of WTC 2 at 9:42:33 a.m. It has been rotated and enhanced by adjusting the intensity levels. Column and floor numbers have been added.

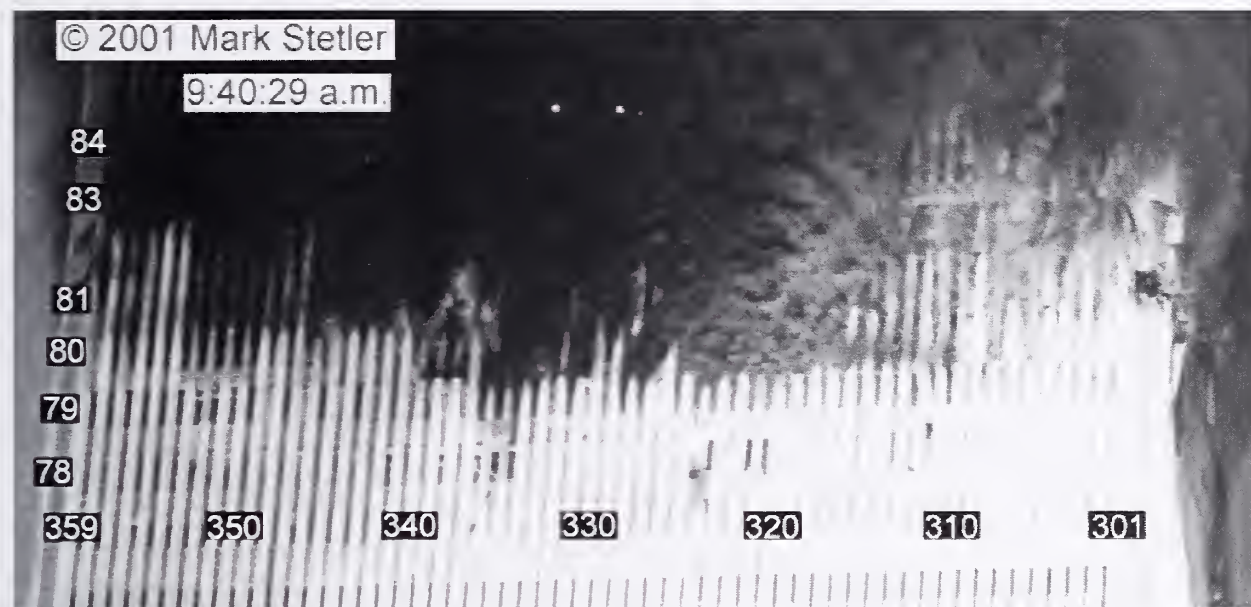
The relatively quiescent appearance of the east face at 9:38:22 a.m. is shown in Figure 9-48. Videos reveal that between 9:38 a.m. and 9:45 a.m. the fires on the east face of WTC 2 went through two additional periods, similar to that described above, in which heavy smoke and intense fires occurred for relatively short periods on the 79th and 80th floors. The first took place from roughly 9:39:53 a.m. to 9:40:41 a.m. Figure 9-58 shows a photograph of the east face taken at 9:40:29 a.m. during this time.

Fires are visible in Figure 9–58 on the 79th and 80th floors at roughly the same locations as in the photograph shown in Figure 9–43 and Figure 9–44, which was taken at 9:36:14 a.m. The fires are particularly heavy on the 80th floor near windows 80-331 to 80-339. The duration (roughly 50 s) of the heavy smoke flows and fires is comparable to that of the earlier event observed between 9:35:45 a.m. and 9:36:50 a.m. This suggests that the cause for the short-lived burning is the same. Therefore it is also tentatively attributed to the burning of a pool of aviation fuel somewhere inside the tower.

Figure 9-58. This cropped photograph showing the east face of WTC 2 was taken at 9:40:29 a.m. Column and floor numbers have been added.

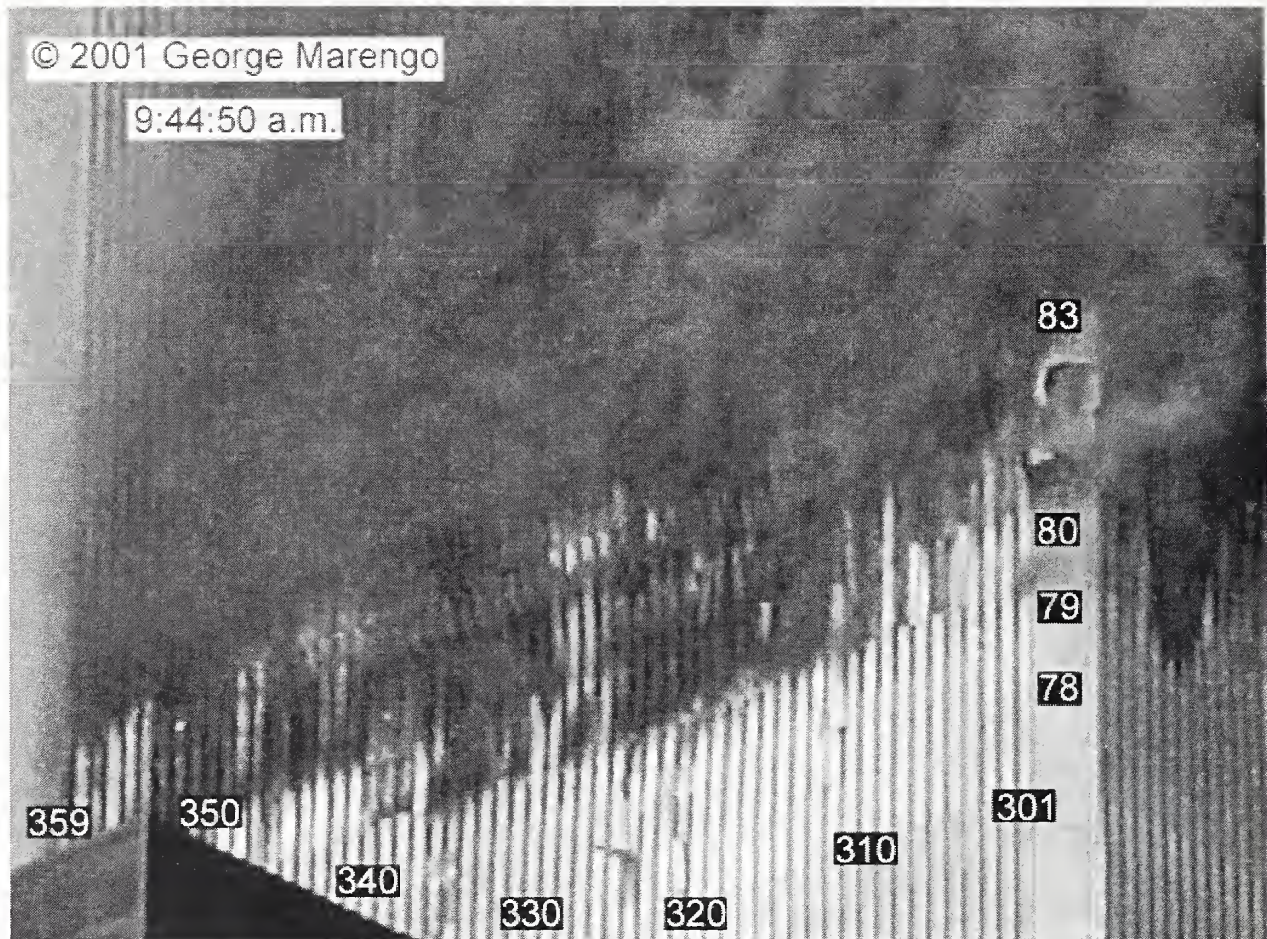
During the periods when the heavy smoke and fires were not present on the east face, its appearance was similar to that seen in Figure 9–48. Occasionally, coordinated puffs of smoke similar to those described earlier were observed coming from windows on the face. Figure 9–59 shows the east face at 9:44:50 a.m. in a photograph shot from the northeast. The amount of smoke coming from lower floors is light, and most of the face is visible. From this angle very little fire is evident, indicating that flames have receded back into the building or died down at many locations on the face. In particular, the heavy flames present near the center of the face in Figure 9–46 and Figure 9–48 seem to have died down by this time. There is evidence for a fire burning on the 82nd floor near the northern edge of the face. Fire had been observed here earlier. The fire in the northeast corner of the 81st floor continued to burn vigorously at 9:44:50 a.m. The bright flame attributed to metal combustion is still evident, but has markedly decreased in intensity.

In Figure 9–59 the columns near the center of the east face on the 80th and 81st floors appear to be bowing inward. A similar feature was identified earlier in Figure 9–46. This photograph provides additional visual evidence that the bowing was actually taking place and for its extent.

Figure 9-59. This cropped photograph was shot from the northeast and shows the east face of WTC 2 at 9:44:50 a.m. The original intensity levels have been adjusted, and column and floor numbers have been added.

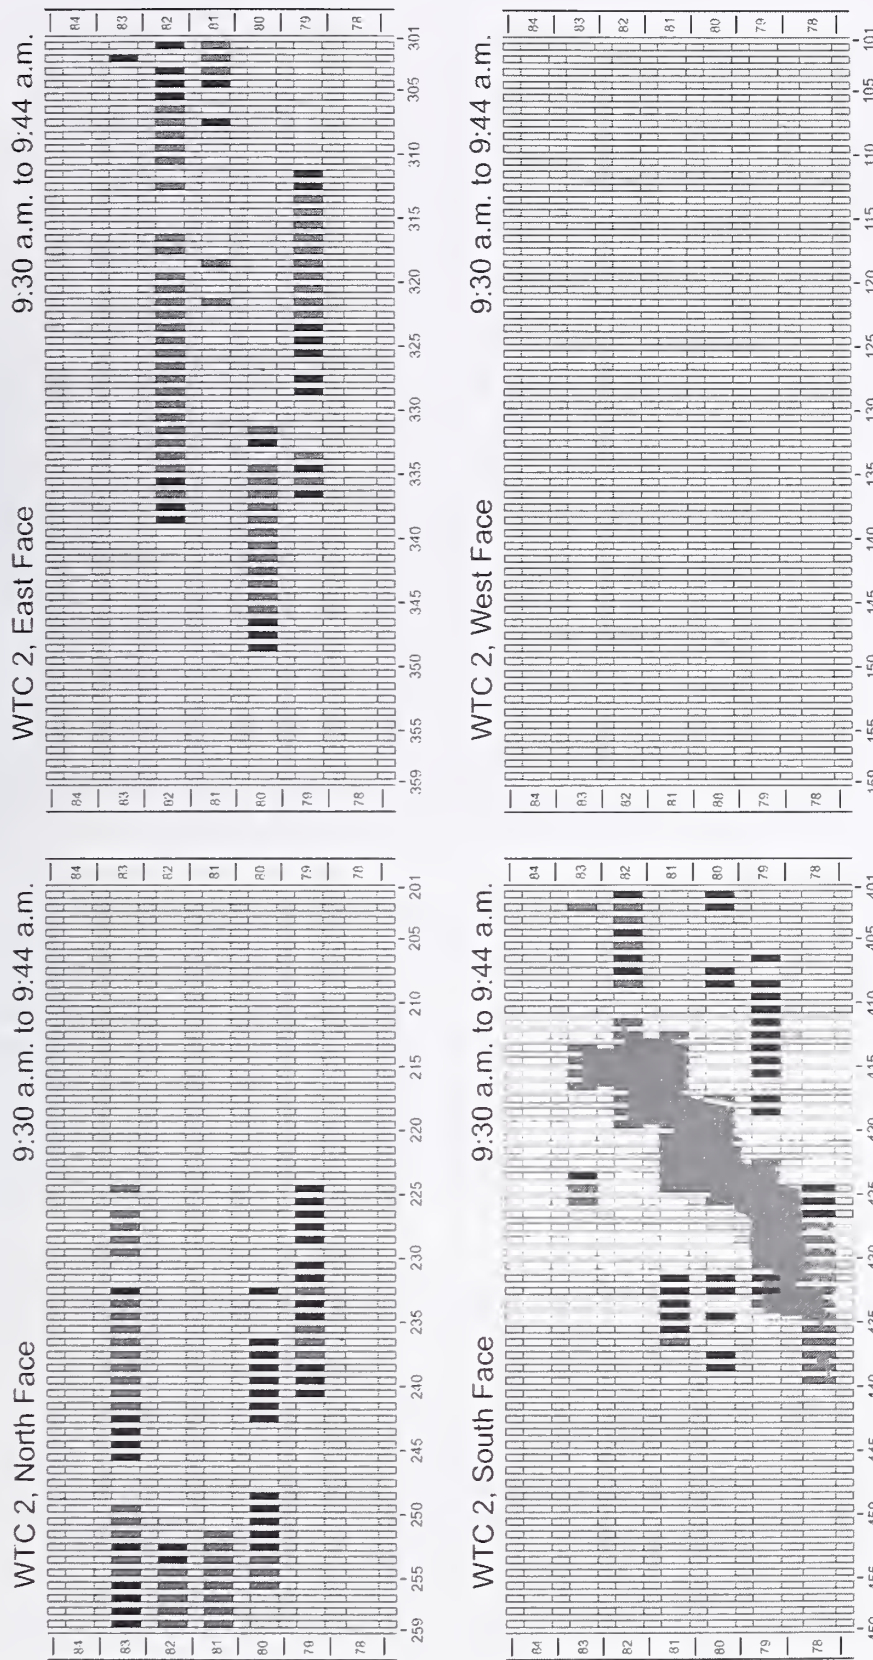
The fire behaviors and changes in distribution are more easily followed by comparing Figure 9-60, which shows integrated fire intensity maps for the four faces of WTC 2 during the period, with the corresponding maps for the period from 9:15 a.m. to 9:29 a.m. shown in Figure 9-34.

Figure 9-60. Maps of integrated fire observations between 9:30 a.m. and 9:45 a.m. are shown for the four faces of WTC 2. Colors represent the highest intensity fire observed in a window using the color scale defined in Figure 5-1.

Fires on the north face that were ignited on piles of debris on the 79th, 81st, and 82nd floors shortly after the aircraft impact, along with a fire that grew somewhat later on a debris pile on the 80th floor continued to burn throughout the period. At 9:29:15 a.m. a fire grew and spread rapidly on the 83rd floor just above the west side of the cold spot. During the period this fire spread to the west in two separate steps, reaching window 83-221 by 9:45:25 a.m. There was also evidence for westward fire spread on the 79th floor. Even though some small fires continued to burn at the periphery of the cold spot, the area continued to be mostly free of fire during the period. The fire behavior on the east face during this period was complex. In addition to the short periods of intense smoke release and burning on the 79th and 80th floors discussed above, a large fire with external flames burned for a short period on the 82nd floor near the center of the face. A fire on the northern edge of the 82nd floor, that had apparently died down earlier, reappeared. The 81st floor fire burning near and in the northeast corner continued to burn throughout the period. An unusually bright flame was observed in the corner that was attributed to metal combustion.

On the south face several fires on various floors around the aircraft impact cavity died down. A small fire was observed on the 83rd floor above the aircraft impact area. A new region of fire, as indicated by the presence of smoke and flame in windows 80-401 to 80-408, burned briefly on the eastern side of the 80th floor. A fire that had first appeared on the 79th floor to the east of the impact cavity around 9:15 a.m. continued to spread toward the east.

There were no indications of fire reaching the west face during the period. Smoke flow from additional open windows above the fire floors was observed and, as for earlier times, possibly caused by people breaking out the glass.

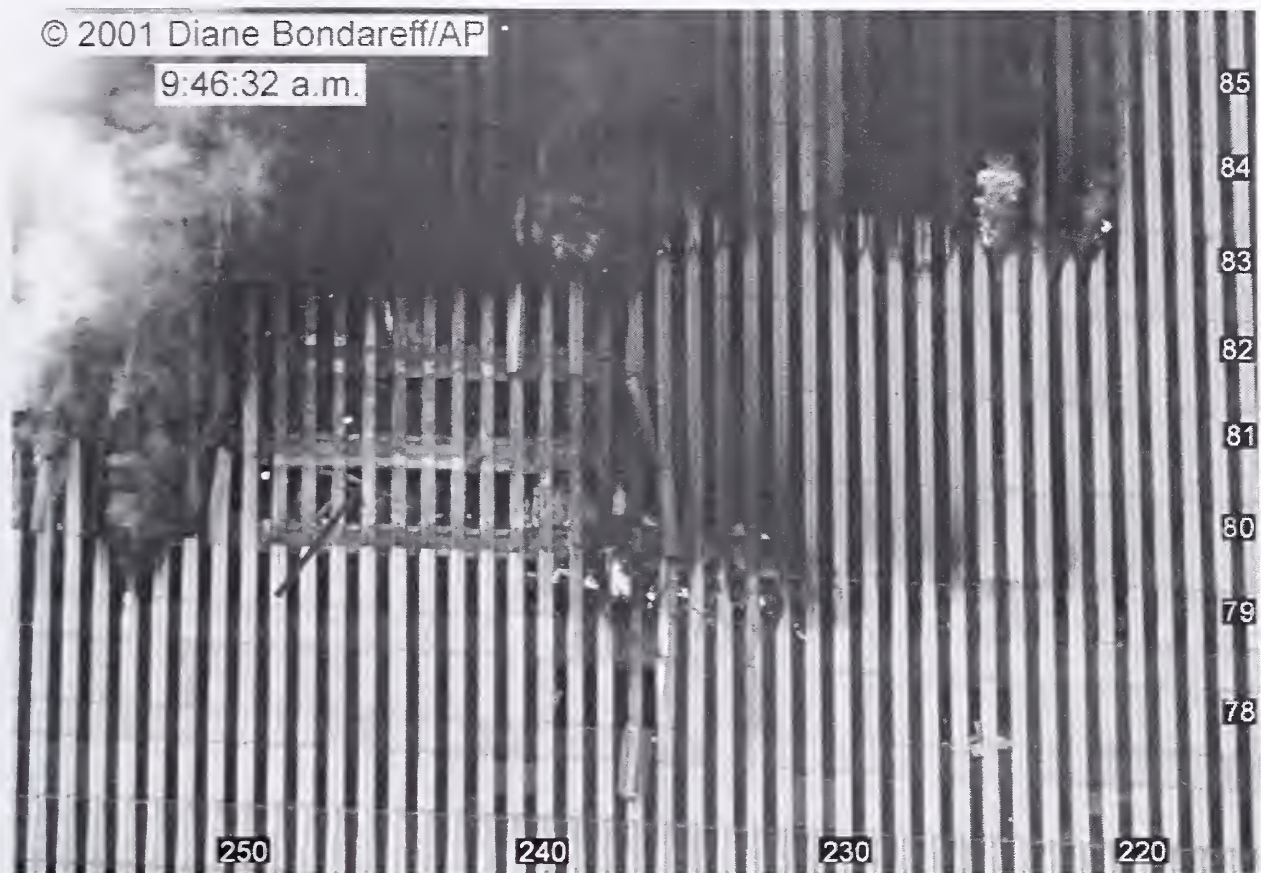
Figure 9-61 shows a photograph of the north face taken at 9:46:32 a.m. It was shot exactly 1 min after the image shown in Figure 9-53. While the fire distributions look similar in the two photographs, there has been a significant change. At 9:46:32 a.m. a substantial fire is visible near the center of the cold spot on the 82nd floor. Prior to this time, there had been no indication of a fire at this location. The photograph in Figure 9-61 was shot with high resolution and magnification. It is possible to enlarge it substantially. Two blow-ups of areas in the image are shown in Figure 9-62 and Figure 9-63. In the blow-ups the intensities have been adjusted to highlight darker regions.

Figure 9-61. This cropped photograph shows the north face of WTC 1 at 9:46:32 a.m. The intensity levels have been adjusted, and column and floor numbers have been added. The arrow indicates a hanging object visible through windows on the 80th floor.

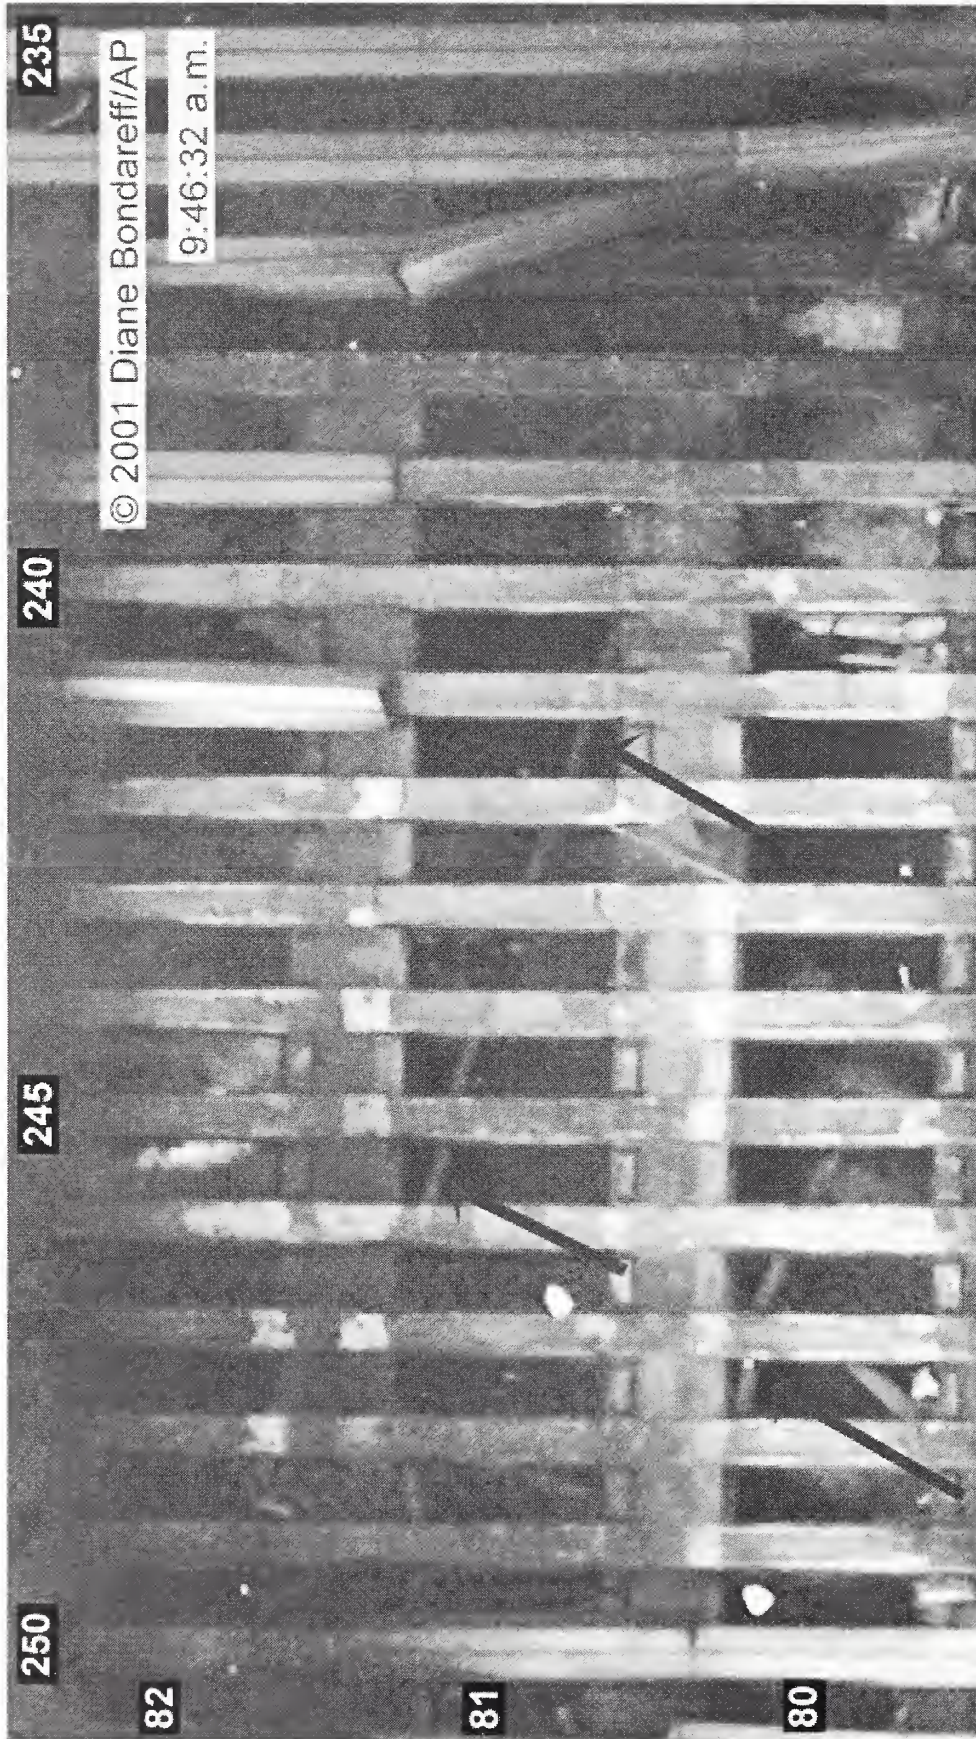
Figure 9-62 shows an enlargement of the area of the north face encompassing the cold spot. Here it can be seen that the fire that has grown on the 82nd floor consists of the bright flame visible through window 82-245 and duller flames that appear to be further back from windows 82-242 to 82-244 and 82-246. There is no indication of where this fire spread from. A hanging object, marked with arrows, is visible through the open windows on the floor immediately below the fire. This object was not immediately apparent in Figure 9-61, but became visible when the image intensities were further adjusted to highlight dark areas. This object was observed at the same location at 9:42:31 a.m. in the image shown in Figure 9-51 and Figure 9-52. Note that there is a section of the object visible near the tops of windows 81-248 to 81-250 that was not clear in Figure 9-52.

Closer inspection of Figure 9-62 shows that small dull-colored flames are visible on the 81st floor through windows 81-243 and 81-244 at the level of and above the hanging object. This suggests that a fire is burning on top of the object. It is possible that this fire is burning at the base of a debris pile that is also providing fuel for the fire visible immediately above on the 82nd floor. If true, this means that the hanging object is most likely a portion of the 82nd floor that has broken away from the spandrel at the base of the 82nd floor and settled to its current location from above.

The hanging object visible in Figure 9-62 on the 80th floor is also in the same position as observed at 9:42:31 a.m. In this closer view it has a very similar appearance to the hanging object on the 81st floor. Therefore, it appears to be a portion of the 81st floor slab that has separated from the spandrel and dropped down from above.

The fire that had been burning at the lower left-hand corner of the cold spot since before 9:15 a.m. is still burning vigorously in Figure 9-62. This long burning time suggests that the fuel is a large debris pile since typical office fuels should have burned out by this time. It may be that the 80th floor slab is missing in this area and that the fires visible on the 79th and 80th floors (see Figure 9-61) are actually burning on the same pile of debris. There is weak evidence to support such a conclusion. The arrows in Figure 9-63 have been added to highlight what may be a hanging object in windows 79-229 to 79-233 on the 79th

Figure 9-62. This image is enlarged from the photograph included in Figure 9-61 and shows the cold spot on the north face of WTC 2 at 9:46:32 a.m. The intensities have been adjusted to enhance dark areas, and column and floor numbers have been added. The arrows point to hanging objects visible on the 80th and 81st floors.

The contrast available in Figure 9–62 and Figure 9–63 is sufficient to identify whether or not glass has been broken out of windows. In Figure 9–62 the only window that is closed is window 81-235. In Figure 9–63 several windows are visible on the 79th floor in which glass has been partially removed, presumably due to heating from the nearby fire. The westernmost of these is window 79-220. A small spot fire is visible at the base of this window. On the 80th floor the westernmost open window is window 80-232. A small fire is also present in this window. The glass in the window to the immediate left, window 80-233, appears to be intact. Several open windows are visible on the 78th floor. These have been previously identified as having been broken during the aircraft impact and subsequent fireballs.

It is instructive to compare the image of the cold spot in Figure 9-73 with the close up shown in Figure 9-62, which was taken nearly 6 min and 20 s earlier. The first thing to note is that the hanging object on the 80th floor did not change position between 9:46:32 a.m. and 9:52:51 a.m. The fire burning on the west side of the cold spot on this floor has died down somewhat.

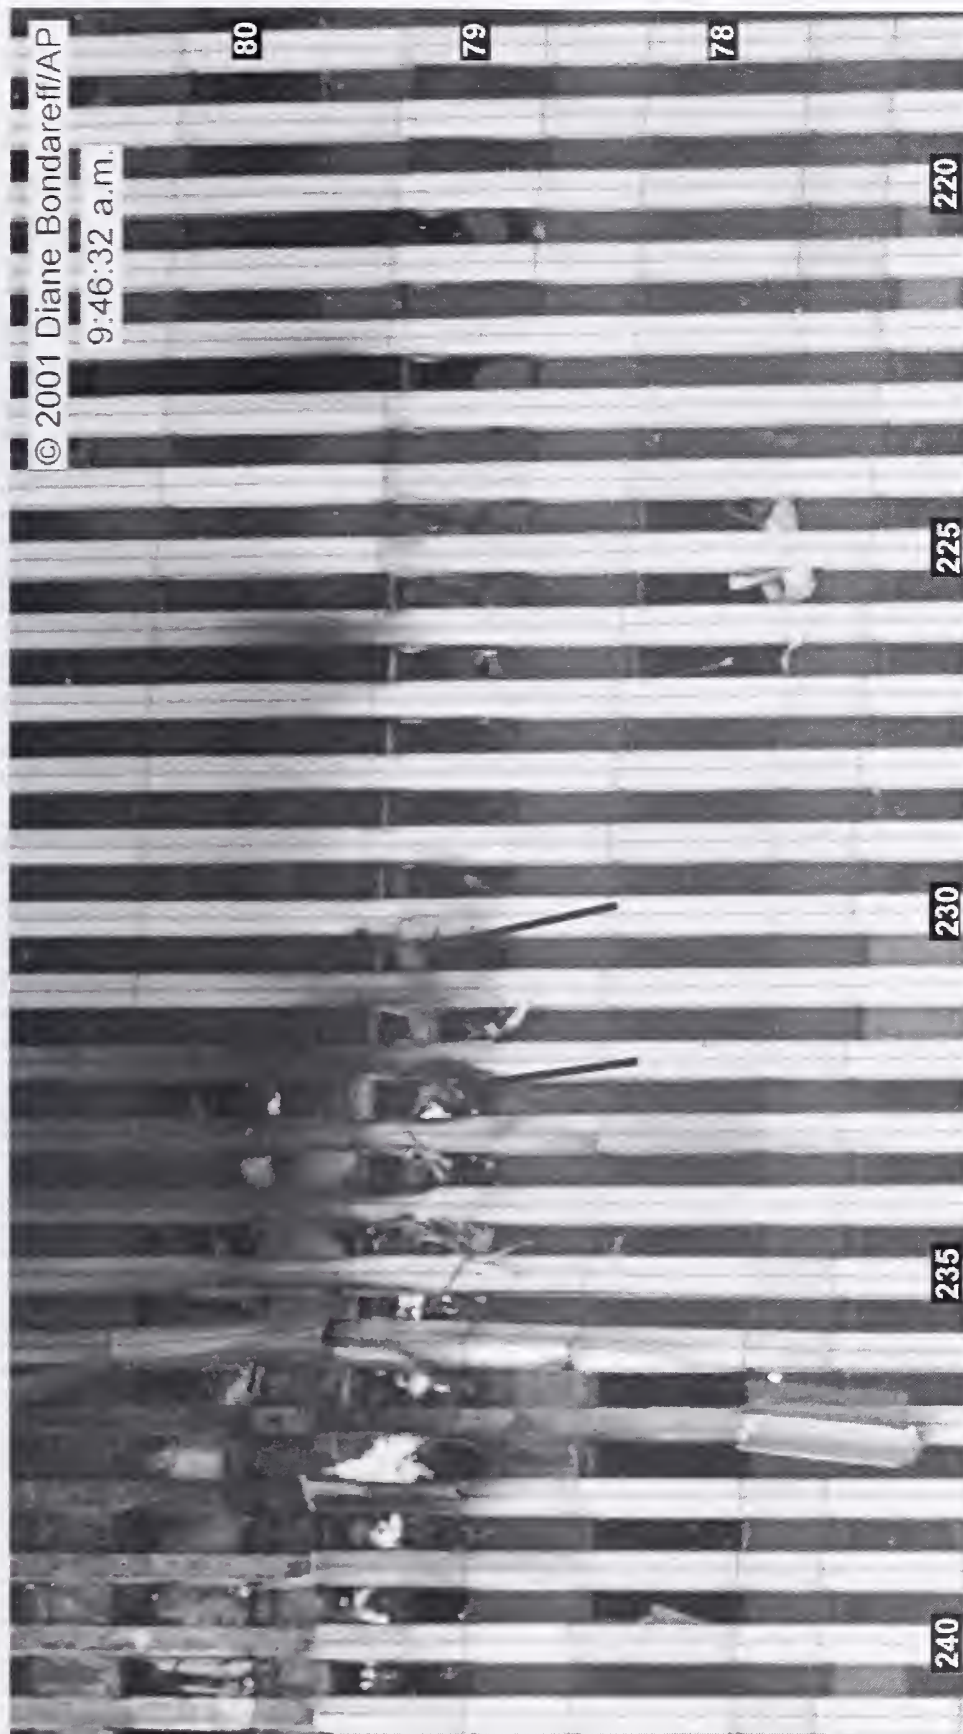
Figure 9-63. This image is enlarged from the photograph included in Figure 9-61 and shows fires near the center of the north face of WTC 2. The intensities have been adjusted to enhance dark areas, and column and floor numbers have been added. The arrows point to a hanging object visible on the 79th floor.

floor. The appearance of the object in these windows is somewhat different than those observed elsewhere on the north and east faces of WTC 2. This introduces some uncertainty into its identification as one of the hanging objects.

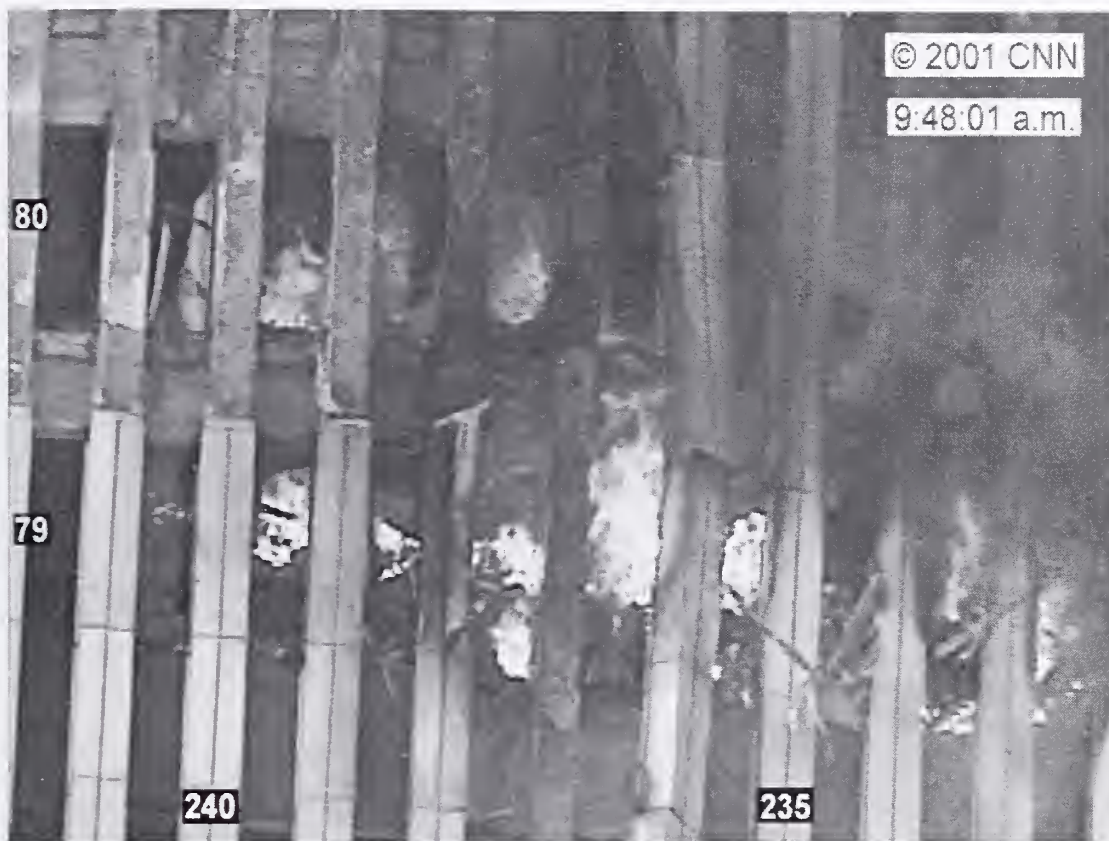
A close-up image of the burning debris pile on the 79th floor is shown in Figure 9–64. This image is a video frame that was captured at 9:48:01 a.m. The bulge in the spandrel at the base of the 80th floor is pronounced. Despite the degree of detail available in the image, it is not possible to determine whether the fires visible on the 79th and 80th floors are burning on a single large pile of debris, i.e., the intervening floor slab is missing, or there are two separate fires on the two floors.

Figure 9-64. This close-up image of the north face of WTC 2 was captured from a video recorded at 9:48:01 a.m. The intensity levels have been adjusted, and column and floor numbers have been added.

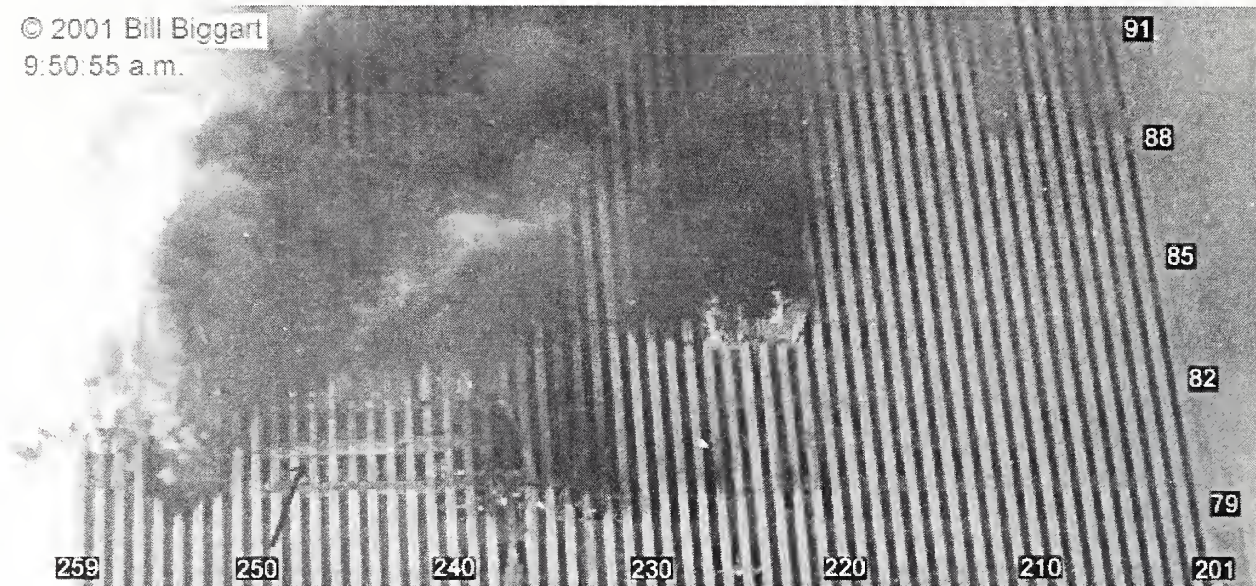
The fire on the eastern edge of the 81st floor seen in Figure 9-65 continues to burn on the debris pile in this area. The appearance of the fire that had earlier spread west on the 79th floor has not changed markedly. Earlier it was mentioned that windows on the 89th floor possibly had been broken open by people at windows 89-201 to 89-203 and window 89-208. Light smoke flows are visible coming from these windows in Figure 9-65.

Figure 9-65. This cropped photograph shows the north face of WTC 2 at 9:50:55 a.m. The original has been rotated and enhanced by adjusting the intensity levels. Column and floor numbers have been added. The arrow points to a ganging object visible through open windows on the 80th floor.

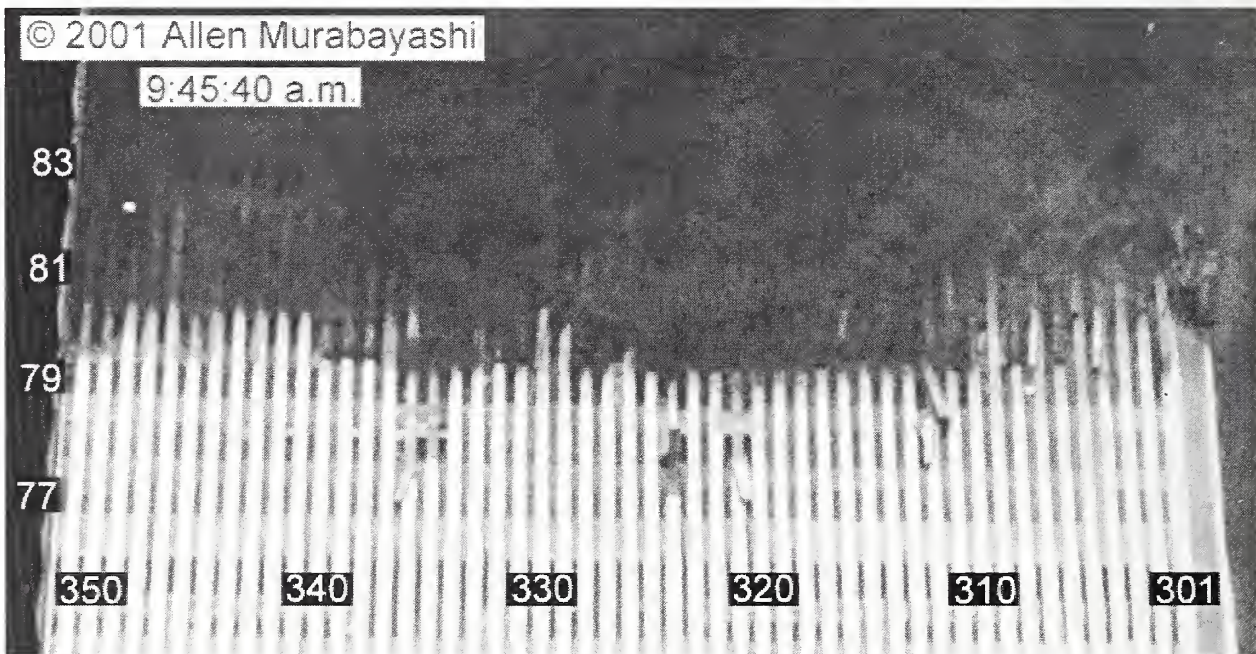
Starting around 9:44:58 a.m. there was another period during which heavy smoke flows came from numerous open windows on the 79th and 80th floors of the east face. This release lasted until approximately 9:46:05 a.m. Figure 9-66 shows an image recorded during this smoke release at 9:45:40 a.m. Comparison with Figure 9-43 and Figure 9-58 indicates that the amount of smoke flow and visible flame are much less than observed during the three similar earlier events. Nonetheless, the smoke flow obscured much of the face, and videos show that intermittent flames appeared outside of some windows. Near the end of this smoke release episode, there were two large pressure pulses at 9:45:57 a.m. and 9:46:01 a.m. that pushed large amounts of smoke out of windows on the 79th and 80th floors.

In Fig. 9-66 flames are visible on the 79th floor between windows 79-313 and 79-319 and are coming from window 82-306 to window 82-308 on the 82nd floor. At 9:38:22 a.m. (see Fig. 9-48) fires were observed at the same locations. The earlier photograph was shot in between the periods of heavy smoke flow and external flaming. This shows that these fires are well established and are not associated with the periods of heavy smoke flows and external burning. The fire in the 81st floor northeast corner continued to burn at 9:45:40 a.m.

Figure 9-66. This cropped photograph shows the east face of WTC 2 at 9:45:40 a.m. The image has been rotated, and the intensity range has been adjusted. Column and floor numbers have been added.

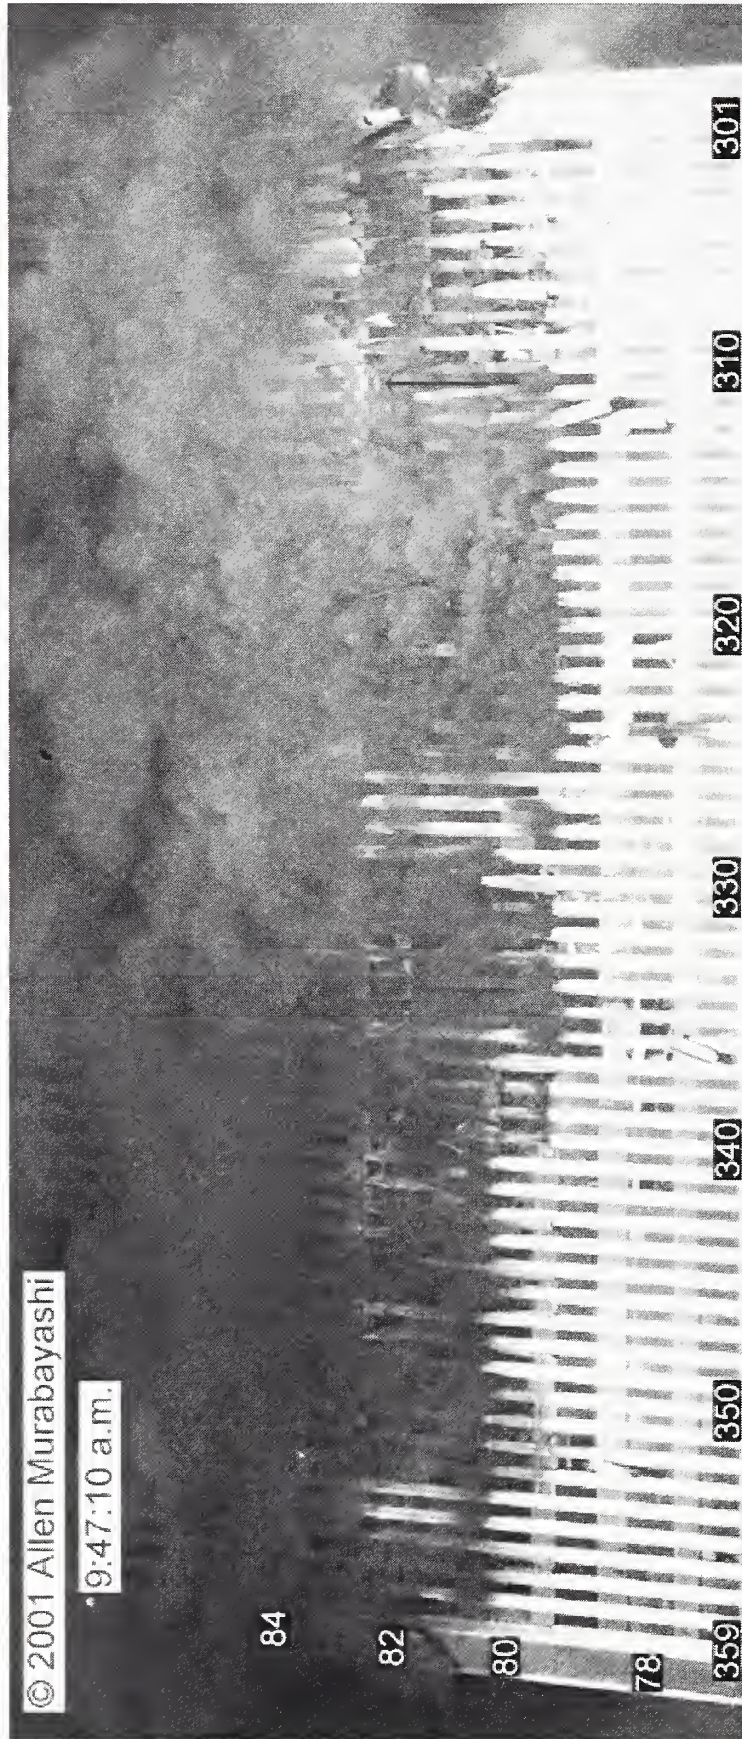
Figure 9–67 shows a higher resolution photograph of the east face taken 1½ min after Figure 9–66 at 9:47:10 a.m. The smoke has cleared up, and it is now possible to see many more windows at the south side of the face on the 80th and 81st floors, as well as higher up on the face. A substantial fire, visible in windows 79-313 to 79-320, continues to burn on the 79th floor. Flames are also present in windows 82-303 to 82-307. The fire on the 81st floor is isolated to the first couple of windows along the northern edge of the east face and the pile of debris in the northeast corner. At this time flames were not visible elsewhere on the east face.

Figure 9-67. This cropped photograph of the east face of WTC 2 was taken at 9:47:10 a.m. The original has been rotated slightly, and the intensity levels have been adjusted. Column and floor numbers have been added. The arrows highlight a hanging object that is visible through open windows on the 82nd floor.

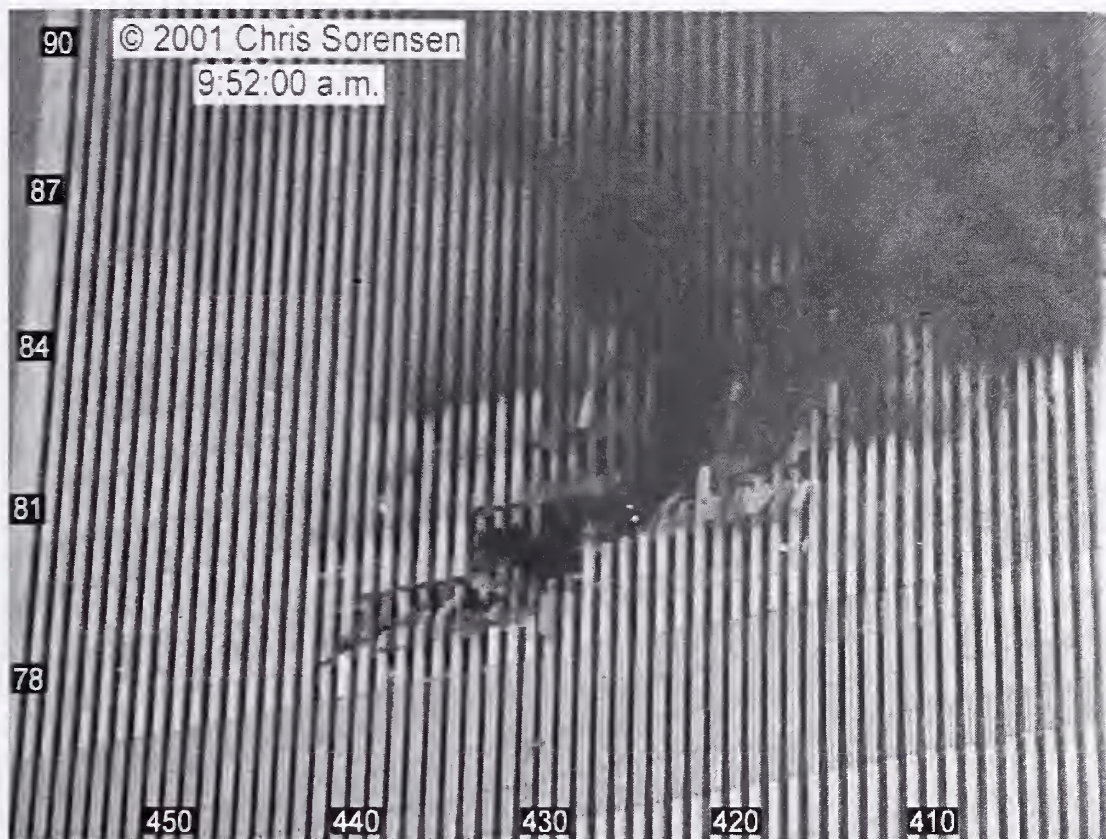
Figure 9–68 shows a view of the south face recorded at 9:52:00 a.m. It is taken from a video shot from a location to the southeast of the tower. Several small fires are visible on the 78th (window 78-418), 79th (window 79-408), 80th (windows 80-438 and 80-439), and 81st (window 81-436) floors. Heavy smoke is flowing from windows near the eastern edge of the 80th floor. There is a stream of smoke coming from the 81st floor in the same area. At this time the smoke flow from other areas of the face was relatively light. Markings on column covers near the tops of windows indicate that smoke had earlier come from windows on the 79th, 80th, and 81st floors just to the west of the aircraft impact cavity. The smoke band on the 81st floor, which extends from window 81-431 to 81-439, is the darkest. The presence of this smoke band is consistent with the recent smoke releases observed from this floor.

Figure 9-68. This view of the south face of WTC 2 was taken from a video recorded at 9:52:00 a.m. The intensity levels have been adjusted, and column and floor numbers have been added.

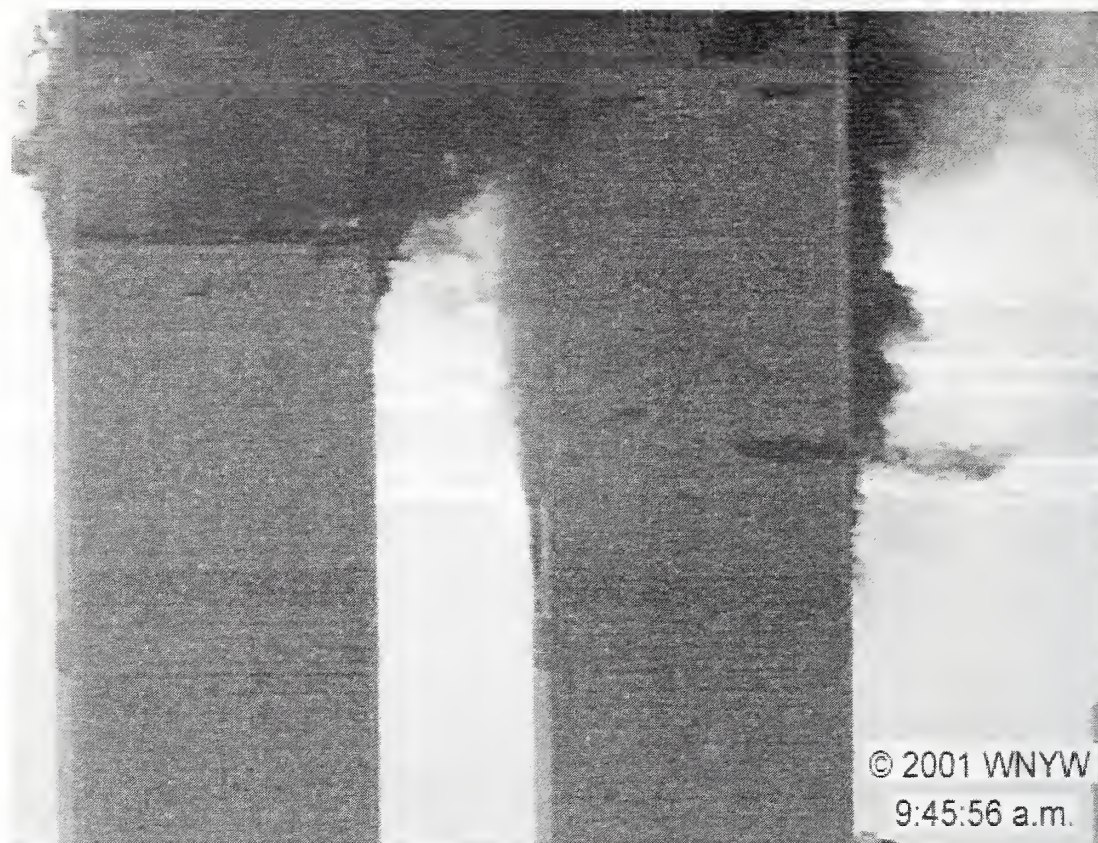
Figure 9-69 shows a long-distance view of the west face of WTC 2 at 9:45:56 a.m. Smoke streams are coming from open windows on several floors, many at the same locations observed in earlier images. The discussion associated with Figure 9-57 refers to open windows on the 84th, 86th, 88th, 91st, 105th, and 107th floors. The three lower smoke trails visible in Figure 9-69 are coming from the windows previously identified on the 86th, 88th, and 91st floor. Closer to the top of the face, three separate smoke trails are visible on the 95th floor. Slightly closer views of the area show that the northern most stream is coming from window 105-148, which is the location visible in Figure 9-57. The other two streams are from near windows 105-116 and 105-140. These two smoke flows were observed to be intermittent in videos of the west face. They were detected briefly as early as 9:43:45 a.m. The heavy smoke flow from the 107th floor observed earlier is prominent in Figure 9-69. The light smoke coming from the southern edge of the mechanical equipment room on the 108th floor is also visible.

Figure 9-69. This west view of WTC 1 and WTC 2 is a frame captured from a news helicopter video at 9:45:56 a.m. The intensity range has been adjusted.

Figure 9-69 provides an indication of the complexity of the wind patterns present on the west face of WTC 2 on September 11, 2001. The smoke trails on the lower floors are flowing in opposite directions. Around this time, the heavy smoke coming from windows on the 86th floor was observed streaming across the south face of the tower. A similar flow pattern is evident in Figure 9-57. Videos show that at other times the smoke from these windows would reverse direction and actually flow toward the north. Figure 9-42 shows an example of this flow at 9:34:19 a.m. As discussed in Section 4.1, these complex wind patterns developed because WTC 2 was on the leeward side of WTC 1, which shielded it from the direct impact of the ambient wind and created complex flow patterns that interacted with WTC 2.

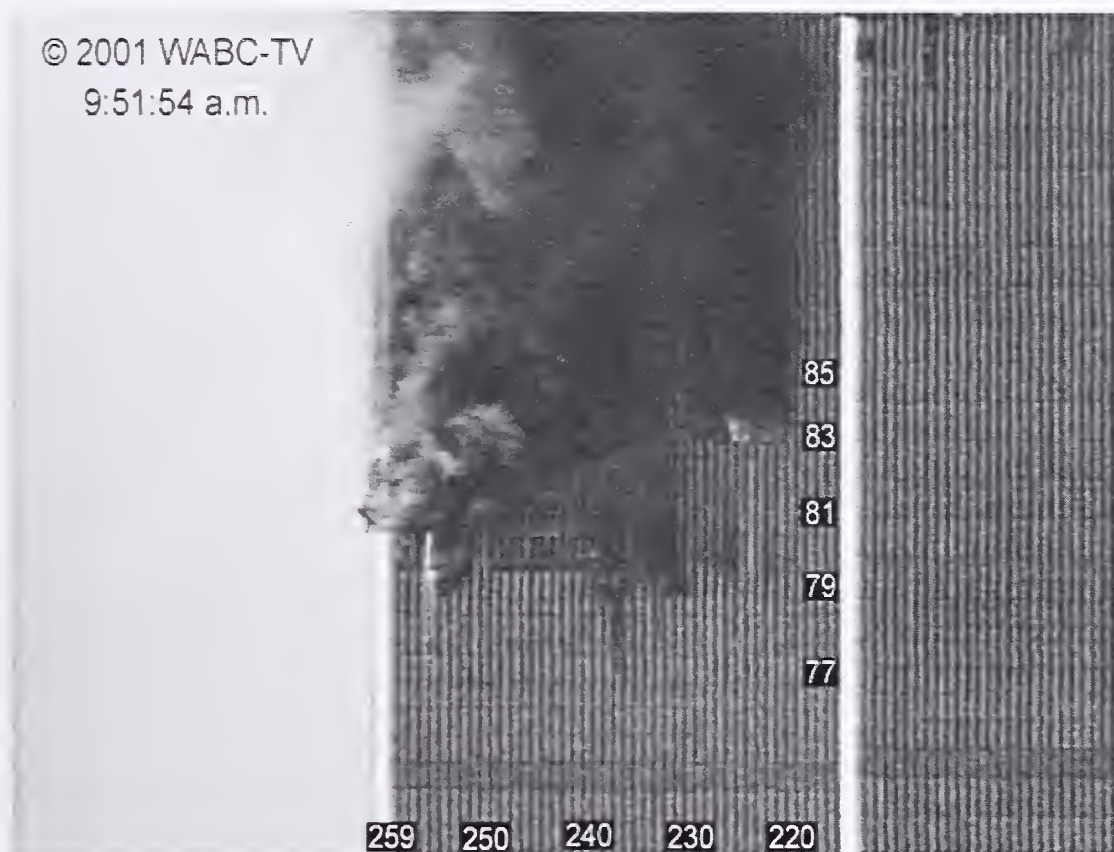
At 9:51:51 a.m. puffs of smoke and/or dust were expelled from open windows on the 79th, 80th, and 81st floors on the north face of WTC 2 near the east edge. These included windows 79-253 and 79-254, 80-257 and 80-258, and 81-254. Almost simultaneously, smoke was pushed from windows on the 79th and 80th floors of the east face. Just over a second later, a bright spot appeared at the top of one window, 80-255, on the 80th floor, and a glowing liquid began to pour from this location. As it fell, the glowing liquid struck the base of window 80-255 and splashed before falling further. Figure 9-70 shows a frame captured from a video at 9:51:54 a.m. in which the falling liquid and the splashing can be seen. This liquid flow lasted approximately 4 s before subsiding. After the flow stopped, the glowing spot was still visible at the top of window 80-255.

Figure 9-70. This image of the north faces of WTC 1 and WTC 2 was captured from a video recorded at 9:51:54 a.m. The intensity levels have been adjusted, and column and floor numbers have been added to WTC 2.
