**NIST NCSTAR 1-5A
Federal Building and Fire Safety Investigation of
the World Trade Center Disaster**

**Visual Evidence, Damage Estimates,
And Timeline Analysis**

(Chapter 9 - Appendix C)

FIRE BEHAVIOR IN WORLD TRADE CENTER 2

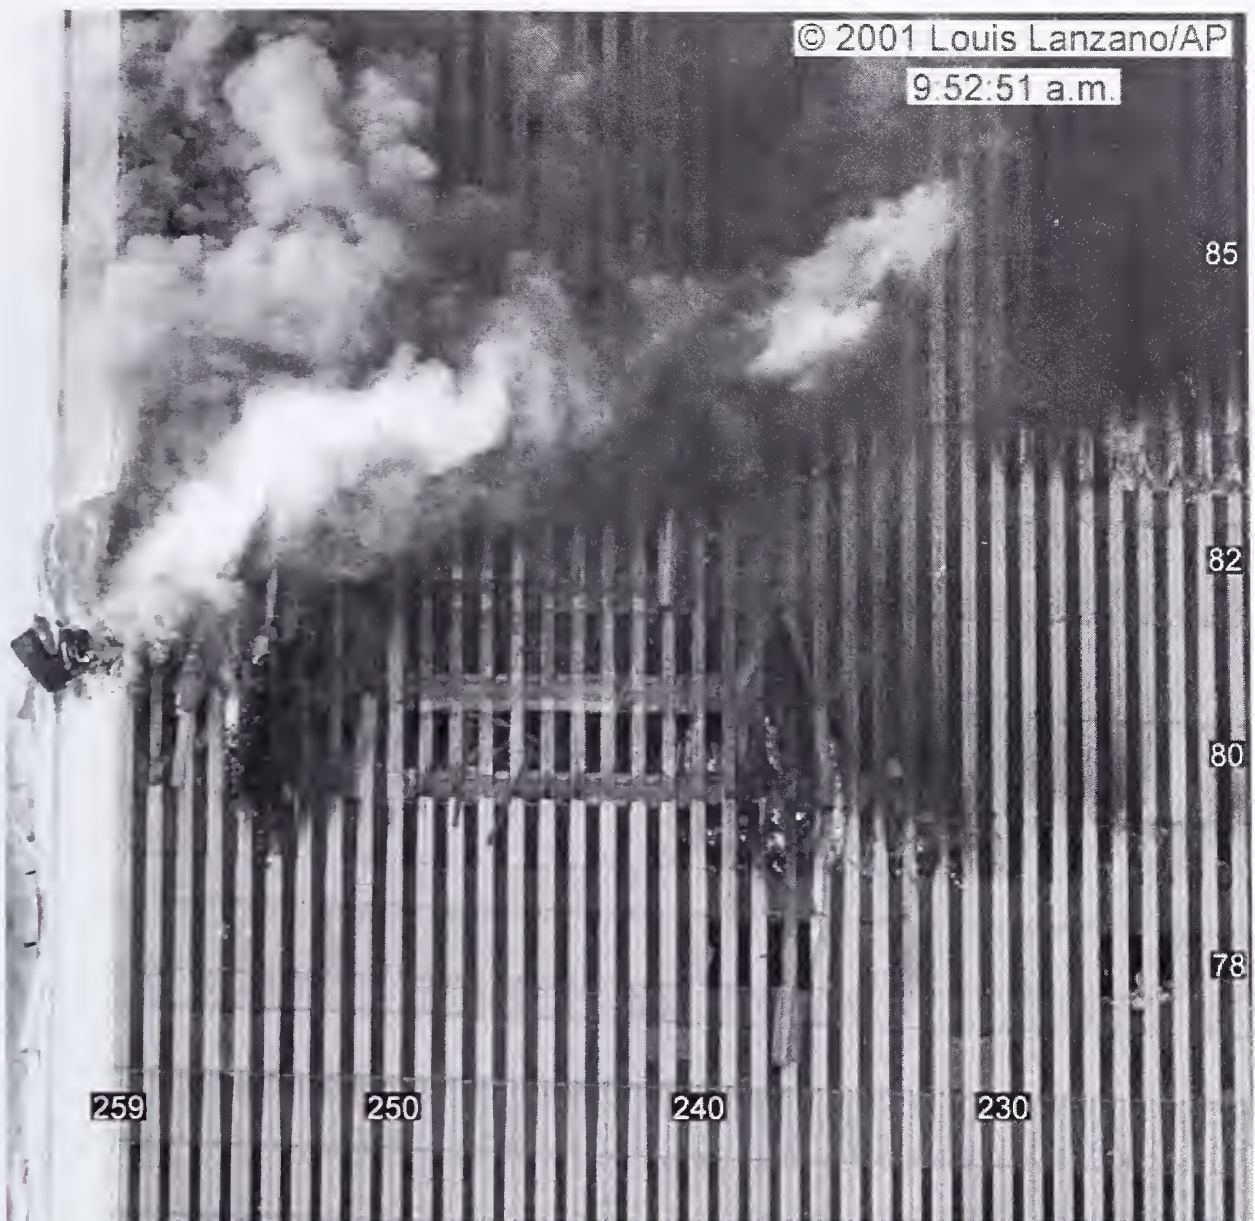
A high-resolution photograph of the north face shot at 9:52:51 a.m., i.e., just 4 s after the start of the first of the three pressure pulses, is shown in Figure 9-71. The white cloud in the photograph is the rising dust and/or smoke that was pushed from windows on multiple floors during the pressure pulse. Blow-ups of the area around window 80-255, which is the location on the 80th floor where the molten material poured from, and the cold spot are shown in Figure 9-72 and Figure 9-73, respectively.

Figure 9-71. This cropped photograph shows the north face of WTC 2 at 9:52:51 a.m. The image has been enhanced by adjusting the intensity levels, and column and floor numbers have been added. The arrows highlight a hanging object visible through open windows on the 80th floor.

As seen in Figure 9-71, the fire located on the 83rd floor in windows 83-221 to 83-225 continued to burn vigorously at 9:52:51 a.m. Recall that flames first appeared in this area at 9:42:53 a.m. Other images available around this time show no apparent additional spread of this fire towards the west. Carets are visible on many of the aluminum column covers between columns 83-222 and 83-236. Many of these carets are near the base of the windows, providing an indication for the intensity of the flames that were present at these locations earlier.

There appears to be a small fire burning on the 84th floor in window 84-223. This is an interesting observation because it is likely that this fire was ignited by flames coming from below, possibly through a window opened by the heat coming from the 83rd floor. If so, this would represent the clearest example of upward flame spread by an external pathway observed on September 11, 2001. On the 79th floor the fire burning on the debris pile is still visible in windows 79-232 to 79-239. The fire on this floor that had earlier spread to the west has died down and is no longer visible.

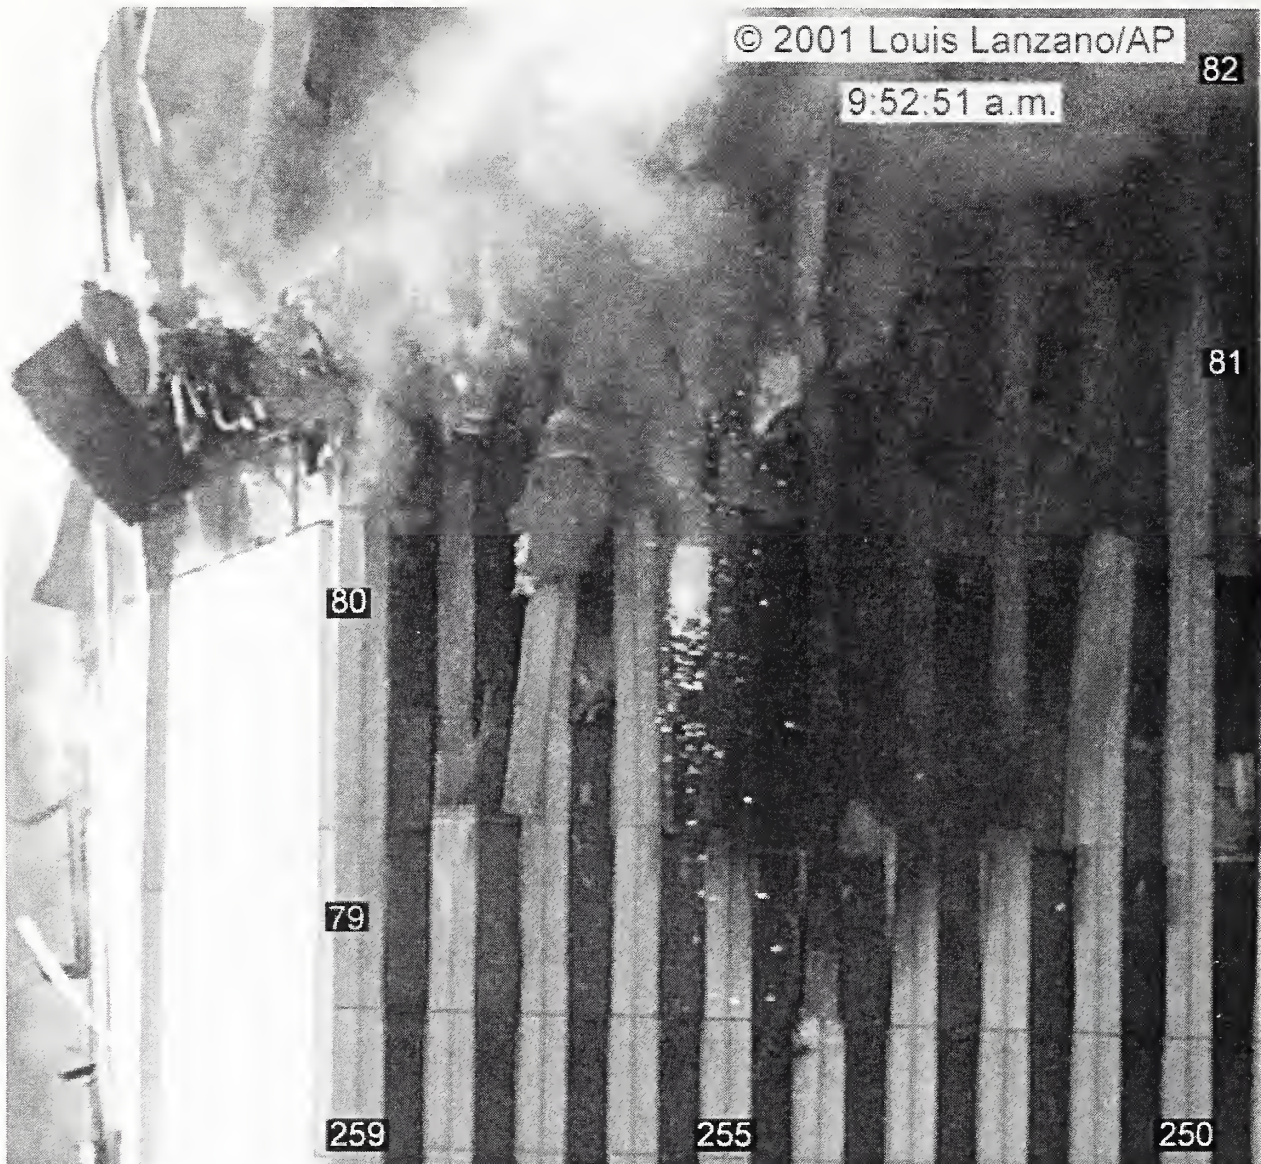
First, consider Figure 9-72. Videos show that a small amount of molten material poured from window 80-255 within a second or two after this photograph was taken. In the photograph the bright material is visible inside this window at the top. The area seems to be surrounded by a large number of glowing drops, which are likely associated with the liquid that will pour out shortly. Dull, deep-red glowing areas are just visible at the tops of windows 80-252 and 80-254. These might be an indication that the 81st floor slab has sunken below the spandrel at the base of this floor.

Figure 9-72. This image is a blow-up of a portion of Figure 9-71 showing the north face of WTC 2 around window 80-255 at 9:52:51 a.m. Column and floor numbers have been added.

This image provides a good view of the fire that continues to burn in the northeast corner on the 81st floor. It can be seen that column 81-254 on this floor is severely distorted. This damage may be a result of the landing gear that was identified as passing through the area during the aircraft impact (see the discussion in Section 7.4.3). Flames are also visible on the 79th floor through open windows 79-252 to 79-254. The orange color visible through the glass that remains in place in window 79-251 and windows 79-255 to 79-258 shows that fire is present behind these closed windows as well. This is one of a limited number of cases in which flames were seen through windows with glass still in place. In Figure 9-61, which was shot at 9:46:32 a.m., small flames could be seen in window 79-254. At this time the glass for window 79-252 was still intact.

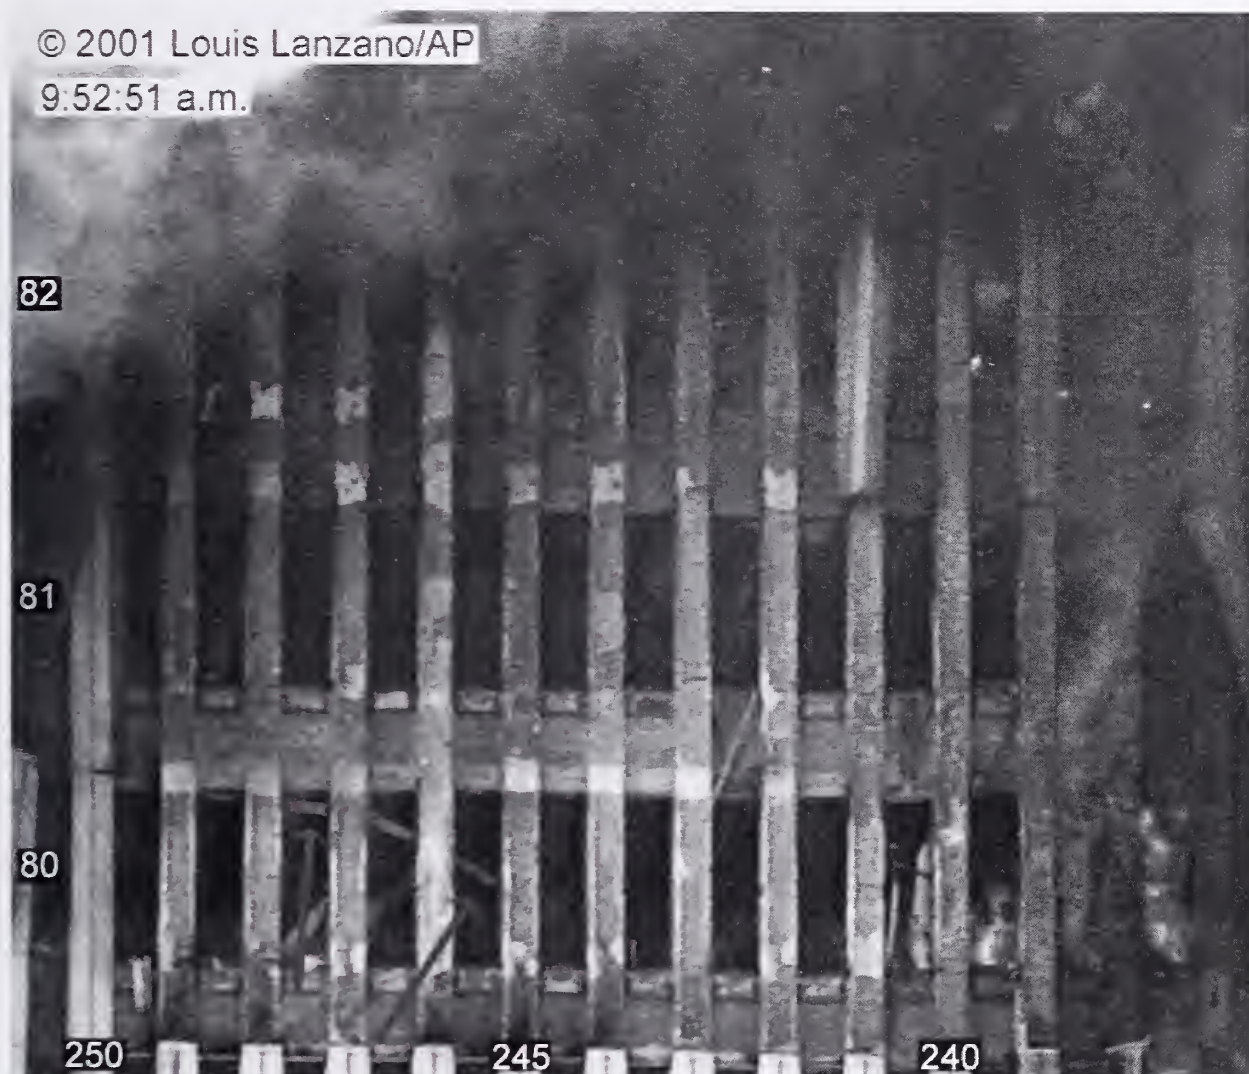
It is instructive to compare the image of the cold spot in Figure 9-73 with the close up shown in Figure 9-62, which was taken nearly 6 min and 20 s earlier. The first thing to note is that the hanging object on the 80th floor did not change position between 9:46:32 a.m. and 9:52:51 a.m. The fire burning on the west side of the cold spot on this floor has died down somewhat.

Figure 9-73. This image is a blowup of a portion of Figure 9-71 showing the cold spot on the north face of WTC 2 at 9:52:51 a.m. Column and floor numbers have been added. The arrows highlight a hanging object visible through open windows on the 80th floor.

The hanging object visible on the 81st floor at the earlier time is not apparent in Figure 9-73. This could simply be due to lighting, since the later photograph is somewhat darker, even though the intensities have been adjusted. In Figure 9-62 small flames were visible through window 81-243. In the later image these flames are not evident, but there is a curved region of dull red flames running from the top of window 81-242 to the middle of window 81-239. It is unclear why these flames are raised, i.e., what is holding them up in the window. One possibility is that the fuel for the fire is on top of a section of the 82nd floor slab (not visible) that became dislodged and settled below the spandrel at the base of the floor.

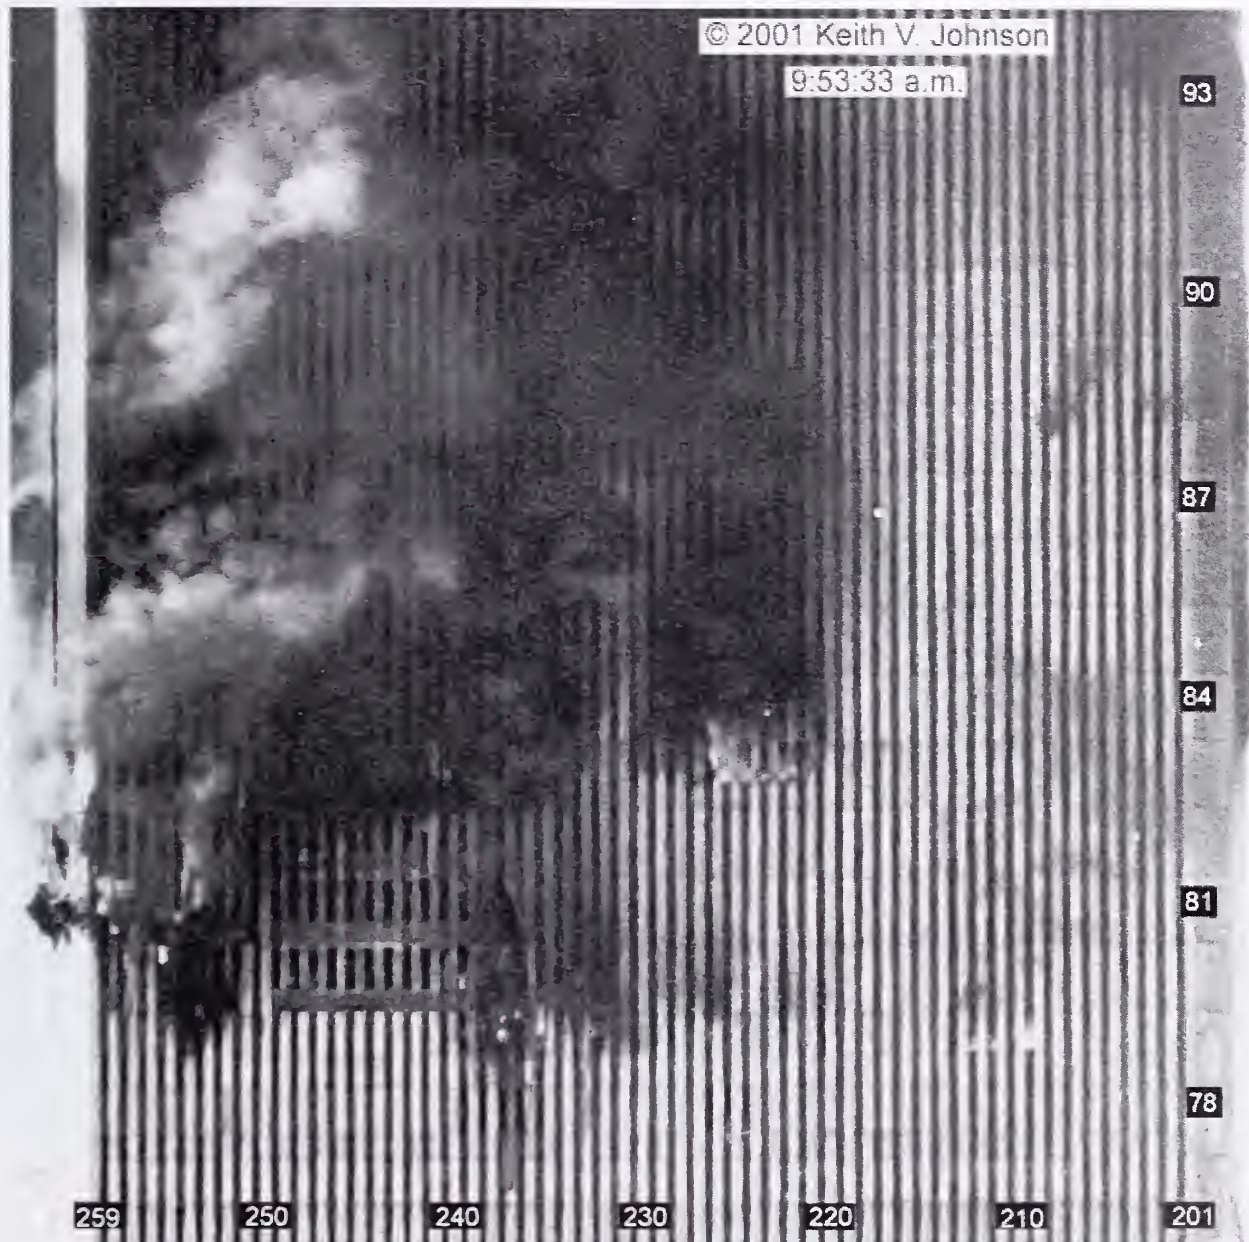
A photograph of the full width of the north face of WTC 2 at 9:53:33 a.m. is shown in Figure 9-74. Flames are visible on the 79th floor in windows 79-209, 79-211, and 79-212, and smoke is coming from window 79-213. It appears as if window 79-210 still has glass in place. The fires visible elsewhere on the face are very similar to those present in Figure 9-71, which was taken 42 s earlier. Of particular relevance is the bright emission from the top of window 80-255, which was the source of the molten flow on the 80th floor and the small fire visible on the 84th floor in window 84-223.

Smoke is visible coming from multiple windows near the western edge of the face on the 88th and 93rd floors. These windows have previously been identified as possibly having been broken open by people. Clearly, smoke is continuing to pass up through the core of the tower to these floors.

Figure 9-74. This cropped photograph shows the north face of WTC 2 at 9:53:33 a.m. The intensity range has been adjusted, and column and floor numbers have been added.

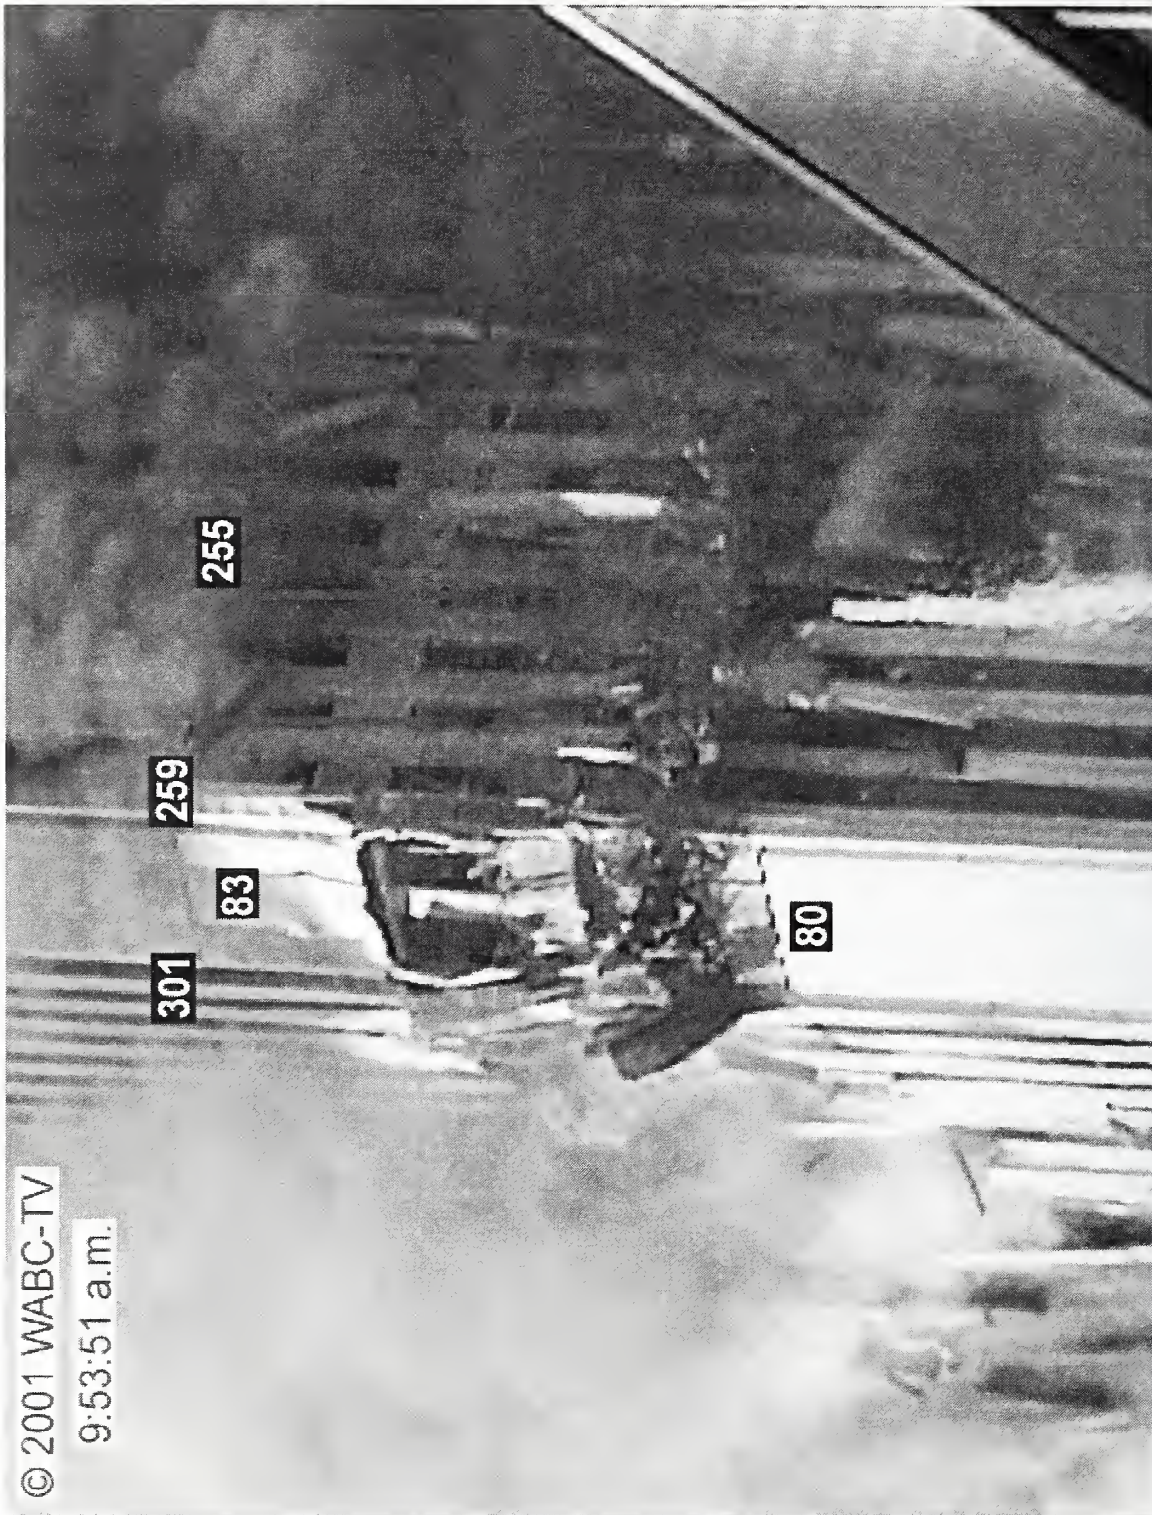
The arrows in Figure 9-75 highlight a hanging object that is visible through the open windows on the 82nd floor. In the windows nearest the east edge of the face, the object appears to have a flat surface that is being viewed from below and is drooping downward, away from the windows. The object also seems to be separated into two sections. Further to the west, the hanging object looks as if the edge of a flat object has dropped down below the top of the window from above. Its appearance is similar to the hanging objects seen elsewhere on the north and east faces of WTC 2.

Figure 9-75. This view of the northeast corner of WTC 2 is a frame captured from a video at 9:53:51 a.m. The intensity levels have been adjusted, and column and floor numbers have been added. The arrows highlight a hanging object that is visible through windows on the 82nd floor.

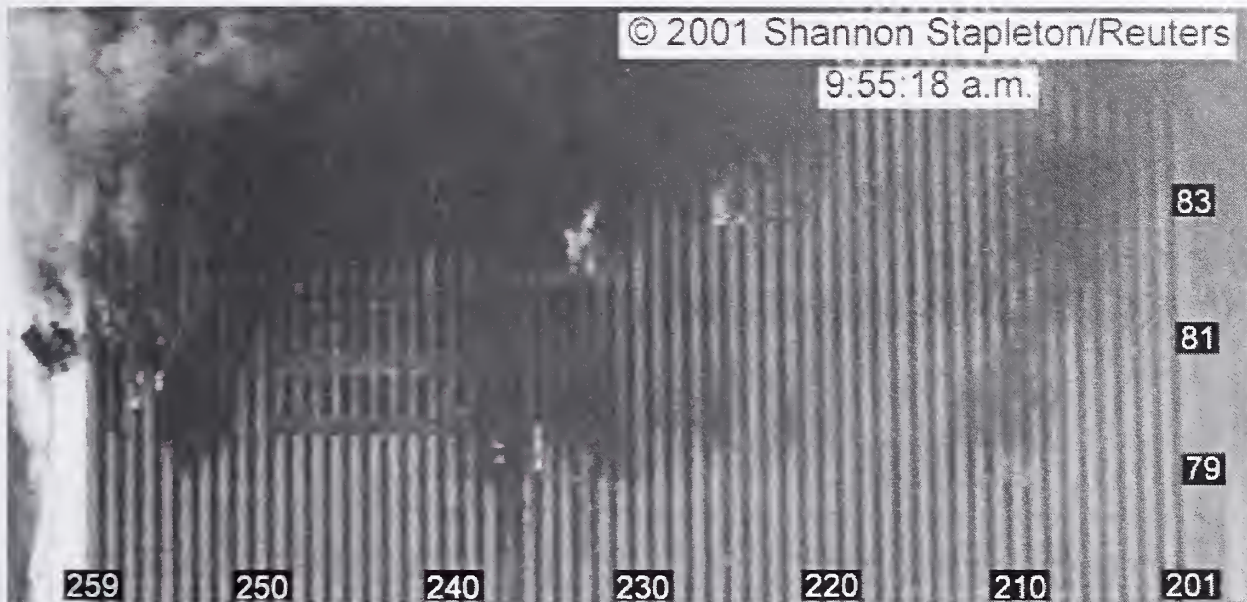
An image of the north face taken at 9:55:18 a.m. is shown in Figure 9-76. This image was shot 1 min 45 s after the one shown in Figure 9-74. The fire distributions are very similar in the two photographs, with the exception of the fire on the 82nd floor to the right of the cold spot in Figure 9-76. As discussed above, this fire was first observed at 9:53:47 a.m. burning in windows 82-234 to 82-337. At 9:55:18 a.m. flames were visible in windows 82-231 to 82-236, and flames were coming out of window 82-233. The bright spot at the top of window 80-255 is visible on the 80th floor, but there is no obvious molten liquid flow at this time. Unlike in the earlier photograph, fire is now visible in the adjacent window, 80-256.

Figure 9-76. This cropped photograph shows the north face of WTC 2 at 9:55:18 a.m. The image has been rotated, and the intensity levels have been adjusted. Column and floor numbers have been added.

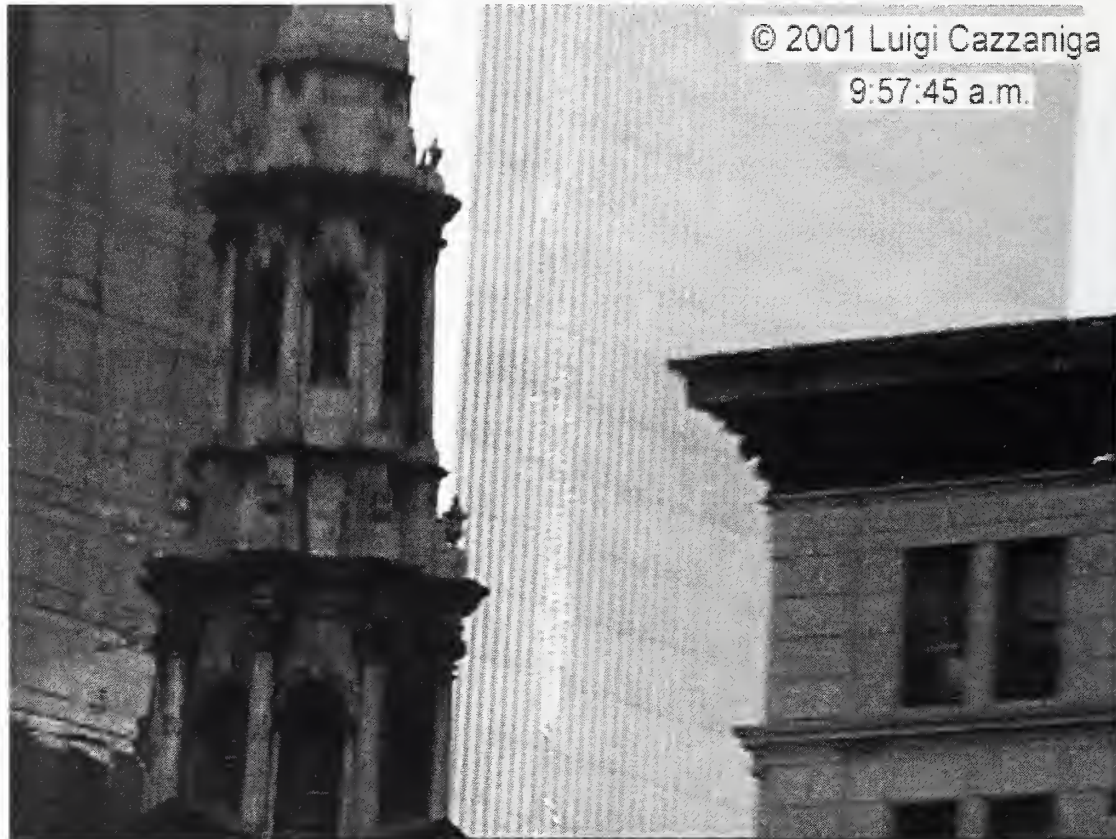
Figure 9–77 is a frame from a video that was shot at 9:57:45 a.m. It shows the falling molten metal as it was approaching the ground. The large amount of falling material is evident. Most of the molten metal seems to have broken up into small “droplets,” but there are a couple of large pieces falling as well. Apparently, the material flowing out of window 80-256 also included pieces of debris that had not fully melted. There was another very heavy flow of molten metal at 9:58:35 a.m.

Figure 9-77. This frame showing the lower portion the north face of WTC 2 was captured from a video shot from the northeast at 9:57:45 a.m. The intensity levels have been adjusted.

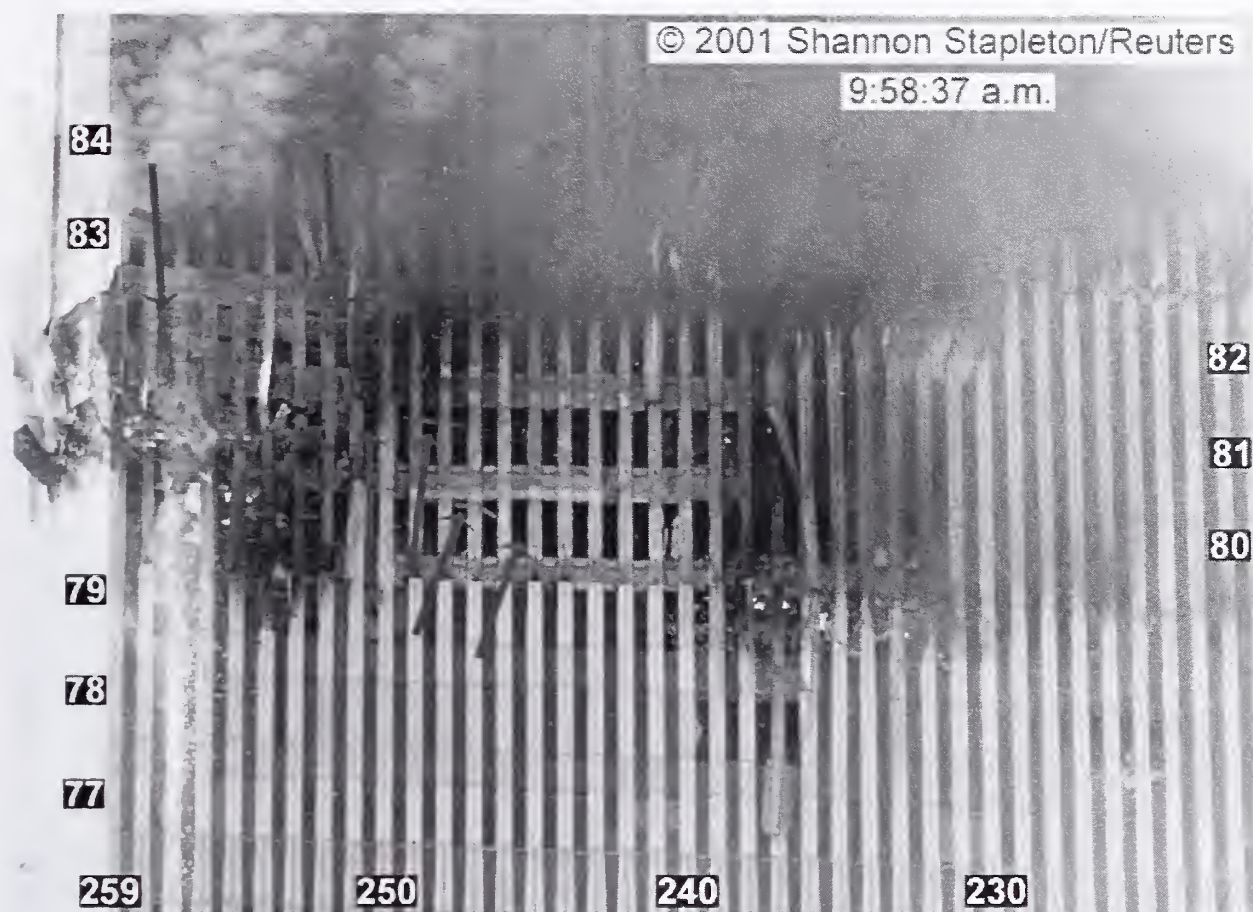
Figure 9–78 shows a photograph of the north face of WTC 2 taken at 9:58:37 a.m. The bright source of the recent molten metal flows stands out at the top of window 80-256 on the 80th floor. Some metal is visible flowing from the window at this time. An area, including this window and a portion of the cold spot, is blown up in Figure 9–79.

It is useful to compare Figure 9–78 with Figure 9–71, which was taken 5 min and 46 s earlier. Starting on the 83rd floor, it can be seen that the fire in windows 83-231 to 83-235 has died down considerably over the period between the photographs. In both cases the most intense flames are in window 83-225. Photographs and videos taken just prior to the collapse provide no indication of westward fire spread on this floor beyond window 83-220. The fire in this area grew rapidly just after 9:45 a.m. Apparently, it did not spread further after this time. The carets visible at the top of the adjacent columns show how intense the burning was in the area. The incipient fire on the floor above in window 84-223 is barely visible.

Figure 9-78. This cropped photograph shows the north face of WTC 2 at 9:58:37 a.m. The intensity levels have been adjusted, and column and floor numbers have been added. Arrows highlight hanging objects visible through open windows on the 79th, 80th, 81st, and 82nd floors.

The fire on the 82nd floor to the west of the cold spot, which grew rapidly just before 9:54 a.m., has continued to spread and grow. In Figure 9-71 there was no indication of this fire. At 9:58:37 a.m. flames are coming from windows 82-230 to 82-232. There are carets on the aluminum column covers around these windows, as well as on the covers next to windows 82-233 to 82-236. This fire seems to not only be spreading rapidly, but also to be going through a rapid cycle of growth and decline. Windows to the west of window 82-230 appear to have intact glass. No flames are visible in or to the east of the cold spot on this floor. At the earlier time the area was hidden by smoke.

During the period between when Figure 9-71 and Figure 9-78 were taken, the fires on the eastern edge and the northeast corner of the 81st floor have died down considerably. Prior to 9:53 a.m. intense fires had burned in these areas continuously following the aircraft impact. After this time it was observed that these fires suddenly died down and then reappeared several times. These cycles seemed to be associated with pressure pulses that pushed smoke and/or dust out of open windows on multiple floors of the north and east faces. This may be an indication that these fires died down due to changes in their local environment, e.g., a partial collapse of a floor, as opposed to simply burning out the available fuel. A low-level fire continued to burn at the western edge of the cold spot on the 81st floor. There had been no

The fires burning on the 79th and 80th floors between columns 230 and 241 have also died down. As a result, the large amount of debris piled up in windows 79-234 to 79-240 is more apparent than in earlier images. It is still not possible to identify whether the fires on these two floors were burning on a single pile of debris, i.e., the intervening floor had collapsed, or as two independent fires.

The only indication in Figure 9–78 of a fire burning on the 79th floor to the immediate west of window 79-229 is a small flame visible through a partially broken window 79-224. The fires that had been burning in this area earlier have nearly died out. Windows 79-221 and 79-223 to 79-225 still have glass. Half of the window pane is in place in window 79-222. These observations suggest that the fire that burned in this area was not too intense. Videos show that the fire that grew further west in windows 79-109 to 79-113 (see Figure 9–76) continued to burn at a comparable intensity until the tower collapsed. In Figure 9–78 it can be seen that window glass remains in place on the 80th floor in window 80-231 and windows to the west. Videos show occasional smoke coming from window 80-204 starting after 9:55 a.m. There is no indication of fire at this location. This window may have been broken earlier by a person.

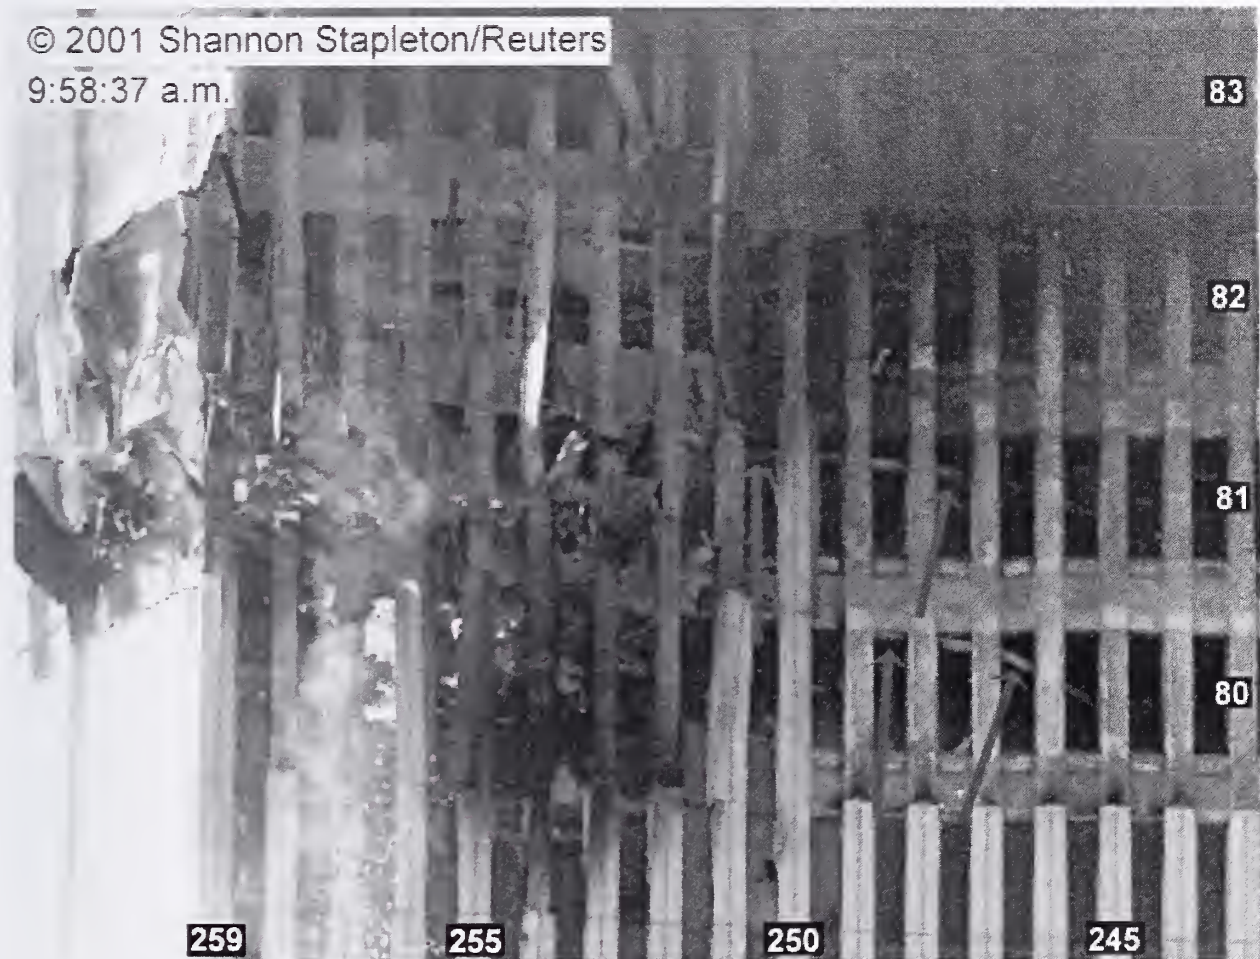
The blow-up of a section of Figure 9–78 shown in Figure 9–79 provides a closer view of the area around the 80th-floor window 80-256 and a portion of the cold spot. Since smoke is no longer obscuring the east side of the 81st floor, it is possible to see additional details concerning the damage in this area. The distortion of column 254 on the 81st floor, which was described earlier, is apparent. The column just to the west, 253, has been cut through near the top of the window. The spandrel at the base of the 82nd floor between column 251 and column 252 appears to be torn. It is not possible to say with certainty, but it is likely that this steel damage resulted from the large object observed exiting near this location during the aircraft impact (see the discussion in Section 7.4.3) and that it is not due to subsequent events.

On the 81st floor a hanging object is apparent in Figure 9–79 at the tops of windows 81-247 to 81-250. A faint trace of the object in the two windows to the west indicates the object is sloping sharply downward in windows 81-246 and 81-245. This object was not visible in the close-up of the area shown in

Figure 9-73, which was taken at 9:52:51 a.m. This was true even when the intensity levels for the photograph in Figure 9-73 were adjusted to emphasize the darkest levels. Interestingly, a hanging object is visible in this same vicinity in Figure 9-62, which was taken at 9:46:32 a.m., but it was located further west and had a different shape. A detailed comparison shows that the objects in the two photographs are at roughly the same height in window 81-250, but while the object curved upwards in windows 81-249 and 81-248 and disappeared above the spandrel in window 81-247 in Figure 9-62, in the later image it slopes downward in windows 81-249 to 81-247. At the earlier time the object reappeared in window 81-245 and then sloped gradually downward toward the west. In Figure 9-79 the object nearly disappears in window 81-246 and seems to be curving strongly downward to the west.

Figure 9-79. This photograph is a blow-up of a portion of the photograph shown in Figure 9-78. It shows the north face of WTC 2 and includes window 80-256 and part of the cold spot. The intensity levels of the original have been adjusted, and column and floor numbers have been added. Arrows highlight hanging objects visible through open windows on the 79th, 80th, 81st, and 82nd floors.

It is difficult to understand why the object is not visible in Figure 9-73 at 9:52:51 a.m. Either it is hidden by some unanticipated optical effect or the object moved between 9:46:32 a.m. and 9:52:51 a.m. If the former is the case, it means that the object visible at 9:46:32 was obscured sometime between 9:46:32 a.m. and 9:58:37 a.m. On the other hand, if the latter is the case, it suggests that the object visible at 9:46:32 a.m. sank down out of sight between 9:46:32 a.m. and 9:52:51 a.m. and that a second object

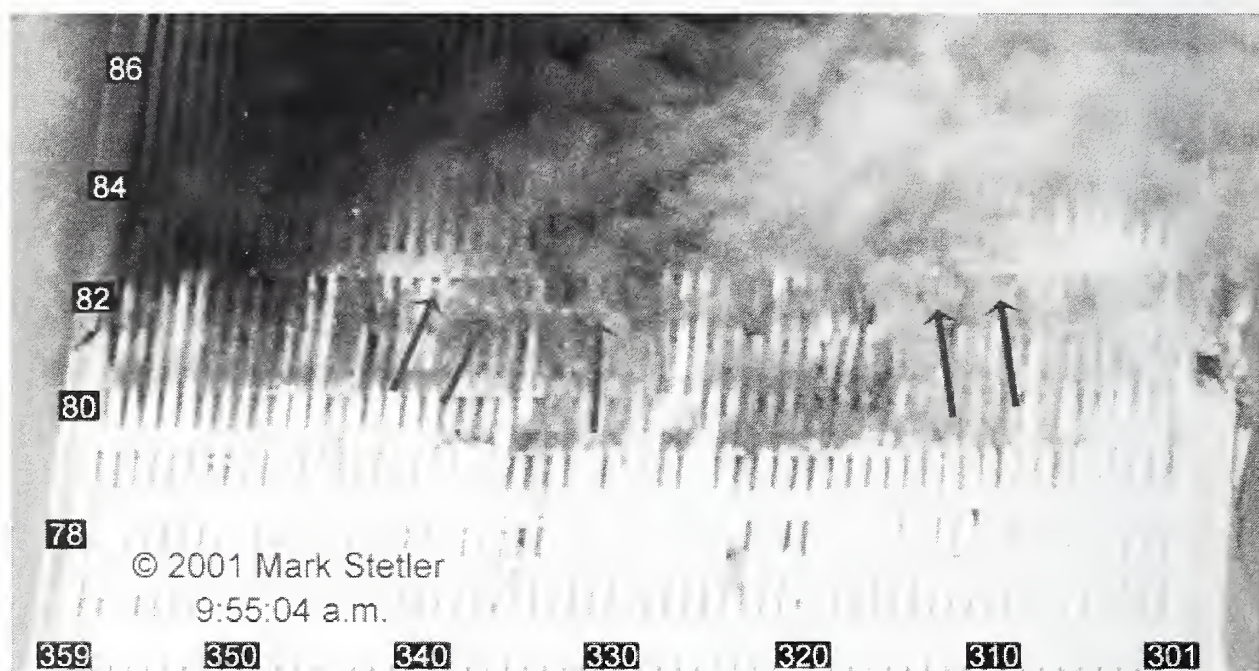
Figure 9–81 is a photograph of the east face that was taken at 9:55:04 a.m. This image was shot from a longer distance and from a higher position than Figure 9–80. In this image it is apparent that flames are present inside windows on the 79th floor over a length running from window 79-311 to window 79-319. This is roughly the same location as seen in Figure 9–67 at 9:47:10 a.m. Consistent with Figure 9–80, there is little smoke and no flame coming from the windows where fire is visible in Figure 9–81.

Figure 9-81. This cropped photograph of the east face of WTC 2 was shot at 9:55:04 a.m. The image has been rotated, and the intensities have been adjusted. Column and floor numbers have been added. Arrows indicate a hanging object visible through open windows on the 82nd floor.

There is also an area of flame visible on the 80th floor in Figure 9–81 extending from window 80-316 to window 80-326. Windows to the north of this length are hidden by smoke, while windows 80-327 and 80-328 on the other end still have glass in place. It is difficult to identify when this fire developed. These windows are visible in the east face view shown in Figure 9–48, which was taken at 9:38:22 a.m. At this time there was no indication of a significant fire in this area of the 80th floor, even though the fire on the 79th floor was already well developed. In similar views of the face shown in Figure 9–58 (9:40:29 a.m.), Figure 9–66 (9:45:40 a.m.), and Figure 9–67 (9:47:10 a.m.), smoke from the 79th floor hides these windows. Since the flames appear to be well inside and there is no smoke coming from the windows, it is not surprising that this fire can not be seen in Figure 9–80.

The arrows in Figure 9–81 highlight the hanging object visible through open windows on the 82nd floor. This object has been observed in a number of images, including Figure 9–67 at 9:47:10 a.m. On the southern end around window 82-340 the apparent position of the object has not changed during the almost seven minutes between the times when these photographs were taken. This is not the case at the northern end. At the earlier time the object was visible near the tops of windows 82-310 and 82-311. At 9:55:04 a.m. the object is visible at the top of window 82-309 and can be seen sloping downward across several open windows toward the left, approaching the base of window 82-315. This is another example of hanging objects, which may be dislocated floor slabs, changing position during the event.

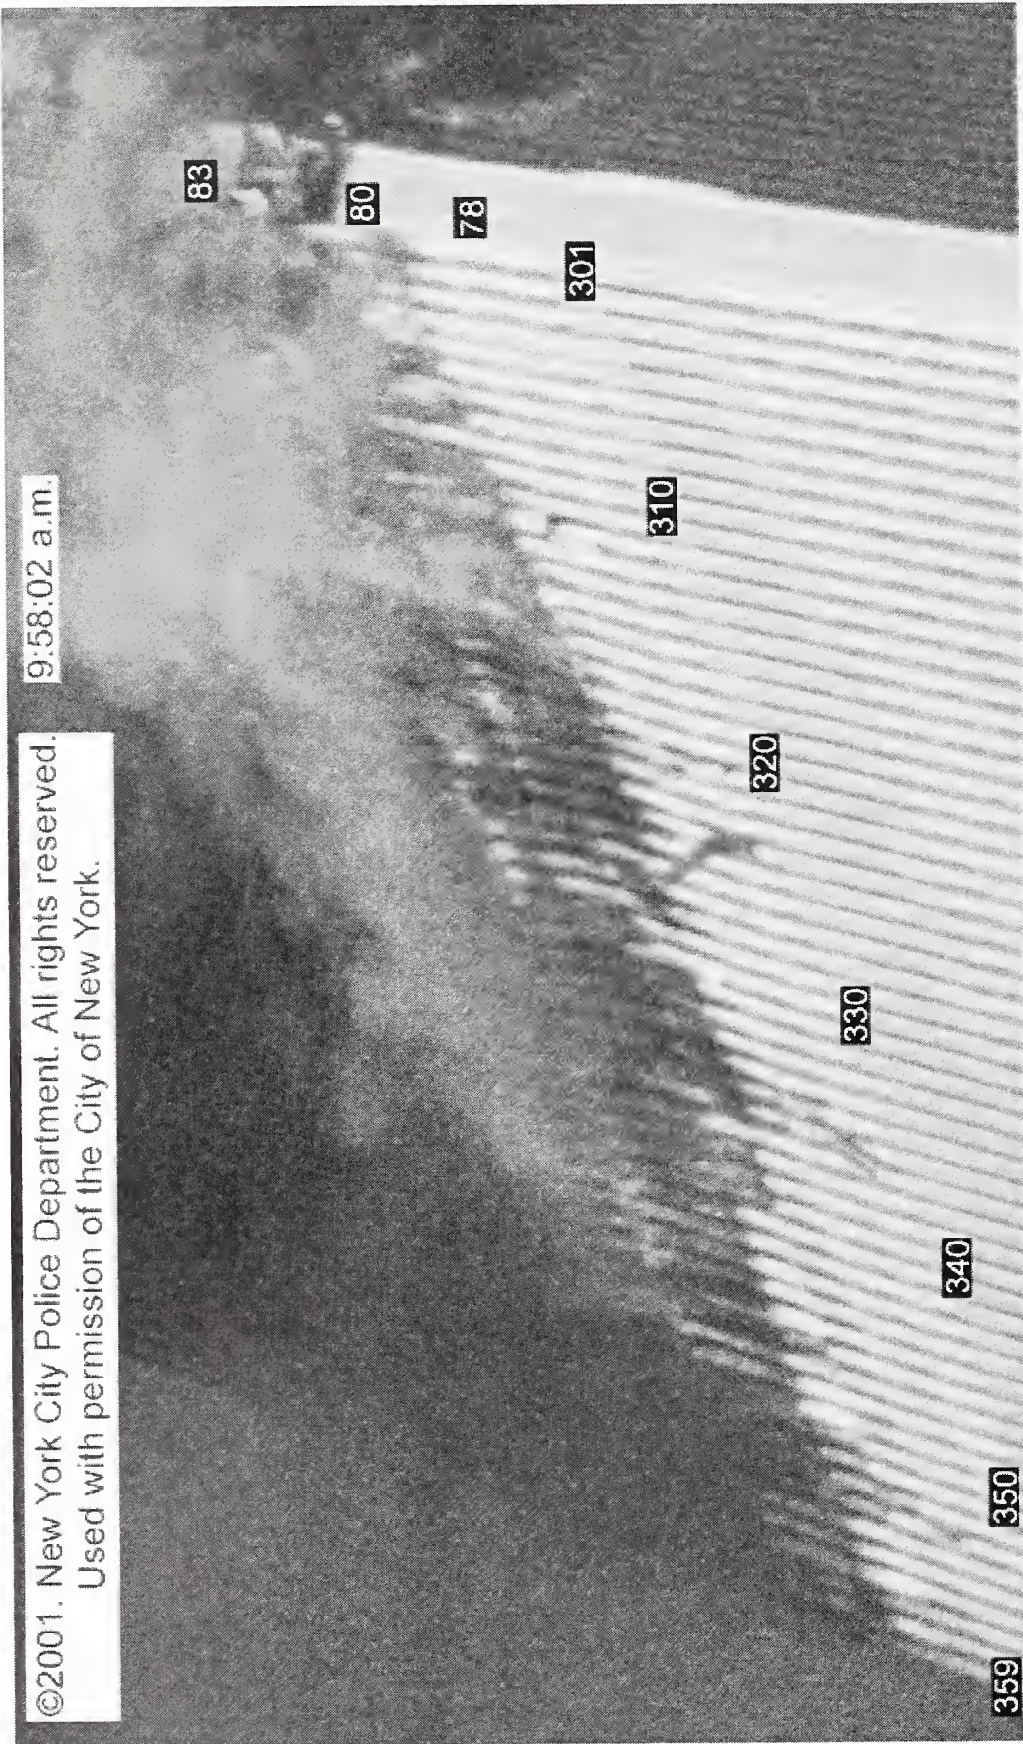
An even larger number of pieces of debris started falling from the same area around 9:58:49 a.m. This shower of debris lasted until the tower collapsed 10 s later. Figure 9–83 shows a photograph taken at 9:58:56 a.m., i.e., 3 s prior to the start of the collapse of WTC 2, from roughly the same location as Figure 9–82. A number of pieces of falling debris are visible on the north side of the east face.

The bowing of the columns near the center of the face stands out in Figure 9–83. Quantitative comparisons are difficult, but the bowing appears greater than in Figure 9–82. The fire visible at the northeast corner has a similar appearance to that seen earlier.

Figure 9-82. This cropped image shows the east face of WTC 2 at 9:58:02 a.m. The intensity levels have been adjusted, and column and floor numbers have been added.

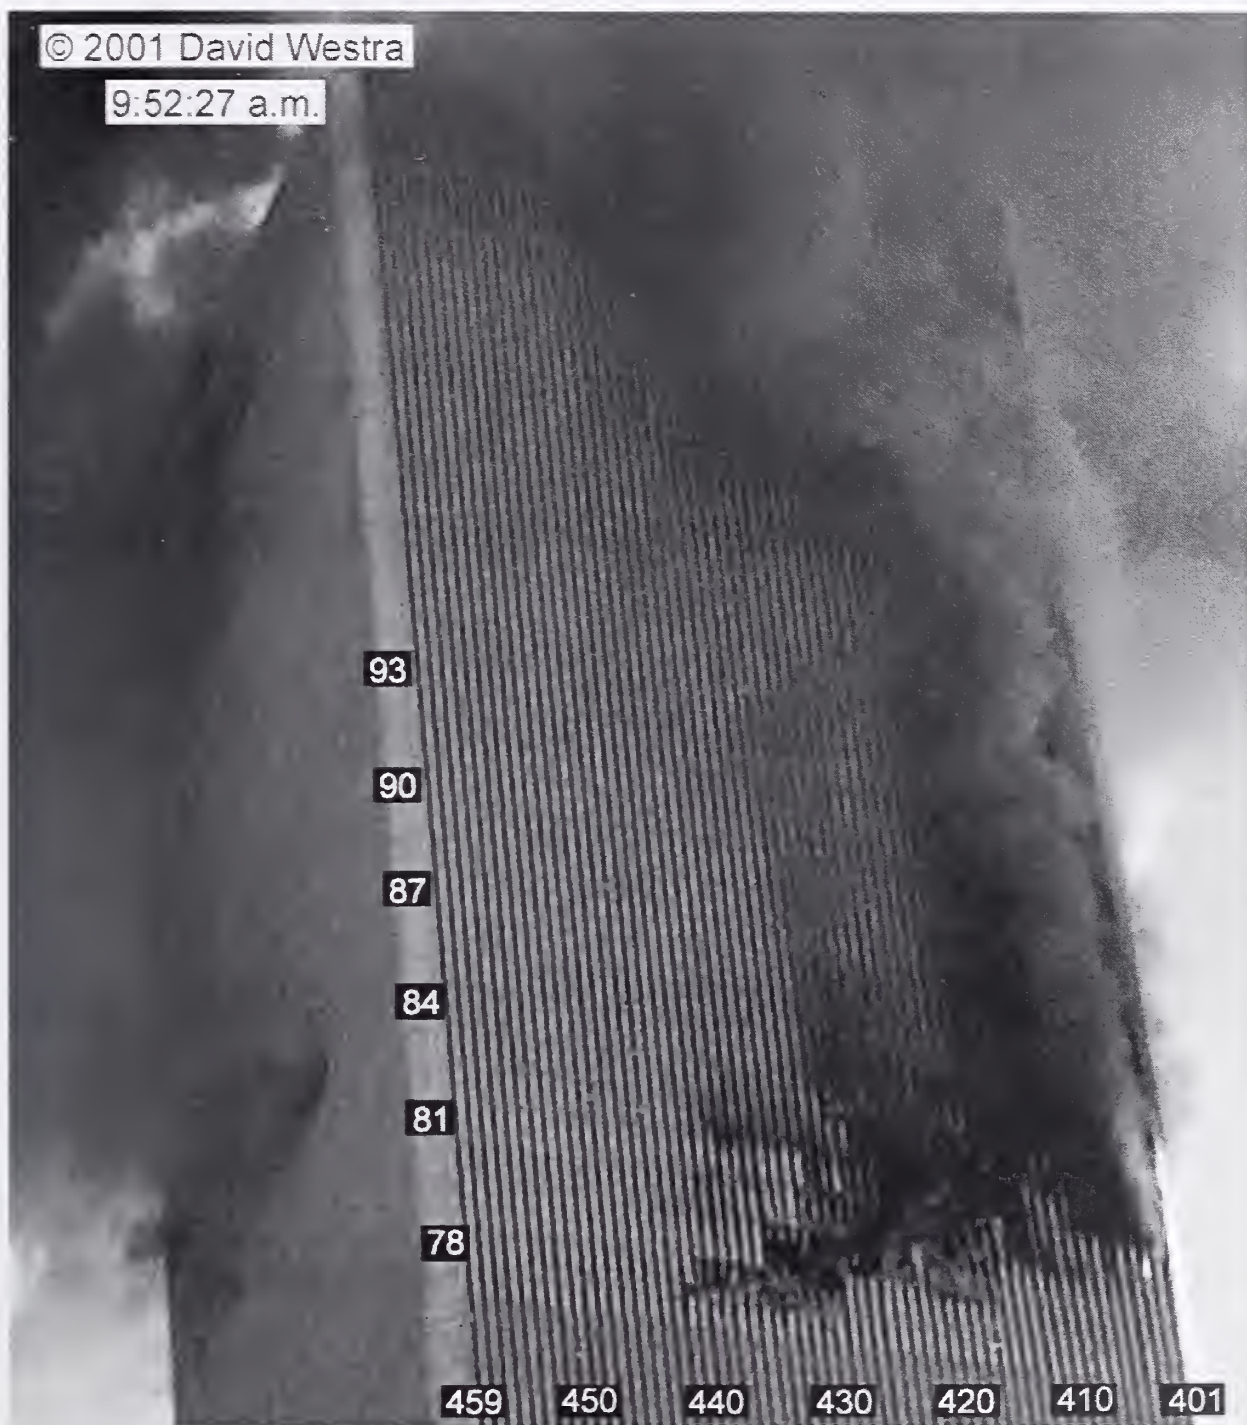
Figure 9-84. This cropped photograph shows the south and west faces of WTC 2 at 9:52:27 a.m. The intensity levels have been adjusted, and floor numbers have been added.

Views of the west face of WTC 2 at 9:52:27 a.m. and 9:57:49 a.m. are provided in Figure 9–84 and Figure 9–86, respectively. Smoke is coming from many of the open windows previously identified earlier as possibly having been broken by people. There are no indications of additional windows having opened, and no flames are visible. The visual evidence indicates that fires capable of breaking out window glass had not reached the west face of WTC 2 prior to the collapse.

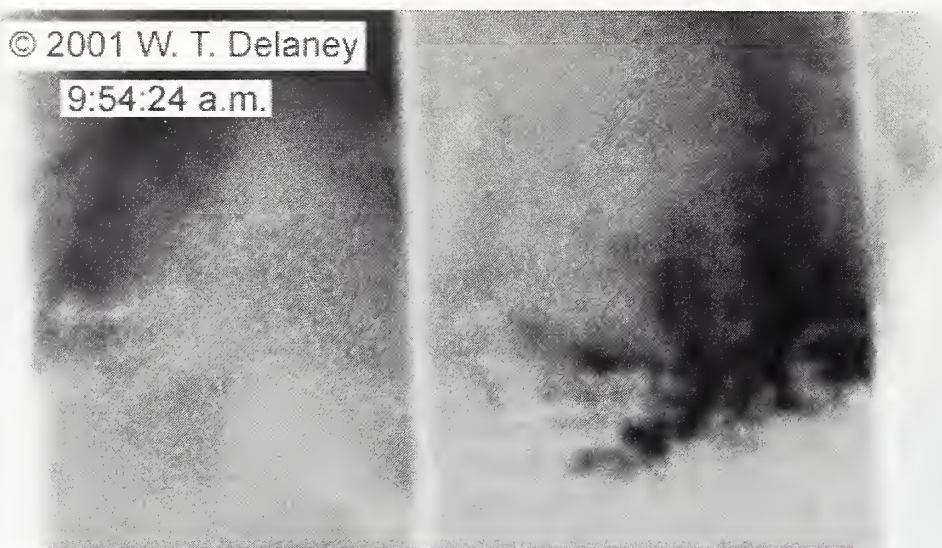
The video shot from the news helicopter shows that over the next few minutes the line of fire on the 80th floor had a steady appearance similar to that in Figure 9–85. Smoke flow from the fire area was generally light, even though there were occasionally streams of smoke released from various windows along the observed fire length. This situation changed at 9:56:44 a.m., when a heavy release of smoke lasting over 20 s took place from windows along the entire length of the fire. At this time the smoke appeared to be coming from as far west as window 80-454. Within 5 s of the start of the heavy smoke flow, large flames erupted from several windows centered near window 80-442. There was also a short flame flare from near window 80-450.

Figure 9-85. This cropped image shows the south faces of WTC 1 and WTC 2 at 9:54:24 a.m. The intensity levels have been adjusted.
