**NIST NCSTAR 1-5A
Federal Building and Fire Safety Investigation of
the World Trade Center Disaster**

**Visual Evidence, Damage Estimates,
And Timeline Analysis**

(Chapter 9 - Appendix C)

FIRE BEHAVIOR IN WORLD TRADE CENTER 2

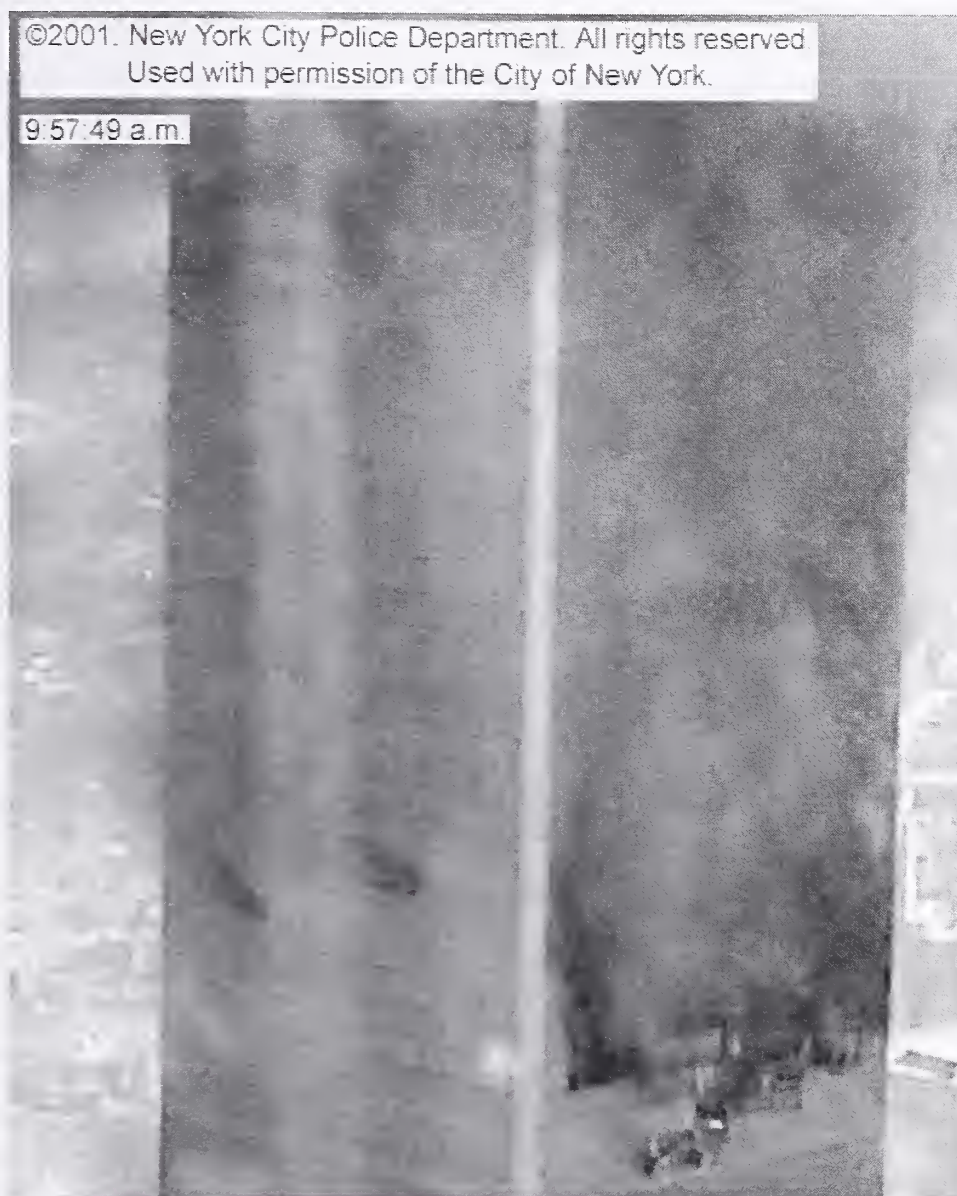
By 9:57:49 a.m. the smoke and flames on the 80th floor of the south face had subsided somewhat. The view of the south and west faces of WTC 2 at 9:57:49 a.m. shown in Figure 9–86 was taken from a NYPD helicopter looking down on the tower from the southwest. The line of smoke and flame to the west of the aircraft impact cavity on the south face is visible extending nearly to the west edge. Heavy smoke also appears to be coming from the 81st floor. There is a bright flame region visible near the 79th floor inside the aircraft impact cavity. Flames were observed in this general vicinity in several ground-based images including those in Figure 9–26 (9:23:08 a.m.) and Figure 9–41 (9:30:19 a.m.), even though such a large fire was not evident.

Views of the west face of WTC 2 at 9:52:27 a.m. and 9:57:49 a.m. are provided in Figure 9–84 and Figure 9–86, respectively. Smoke is coming from many of the open windows previously identified earlier as possibly having been broken by people. There are no indications of additional windows having opened, and no flames are visible. The visual evidence indicates that fires capable of breaking out window glass had not reached the west face of WTC 2 prior to the collapse.

Figure 9-86. This cropped photograph showing the west and south faces of WTC 2 was shot from a helicopter at 9:57:49 a.m. The intensity levels have been adjusted.

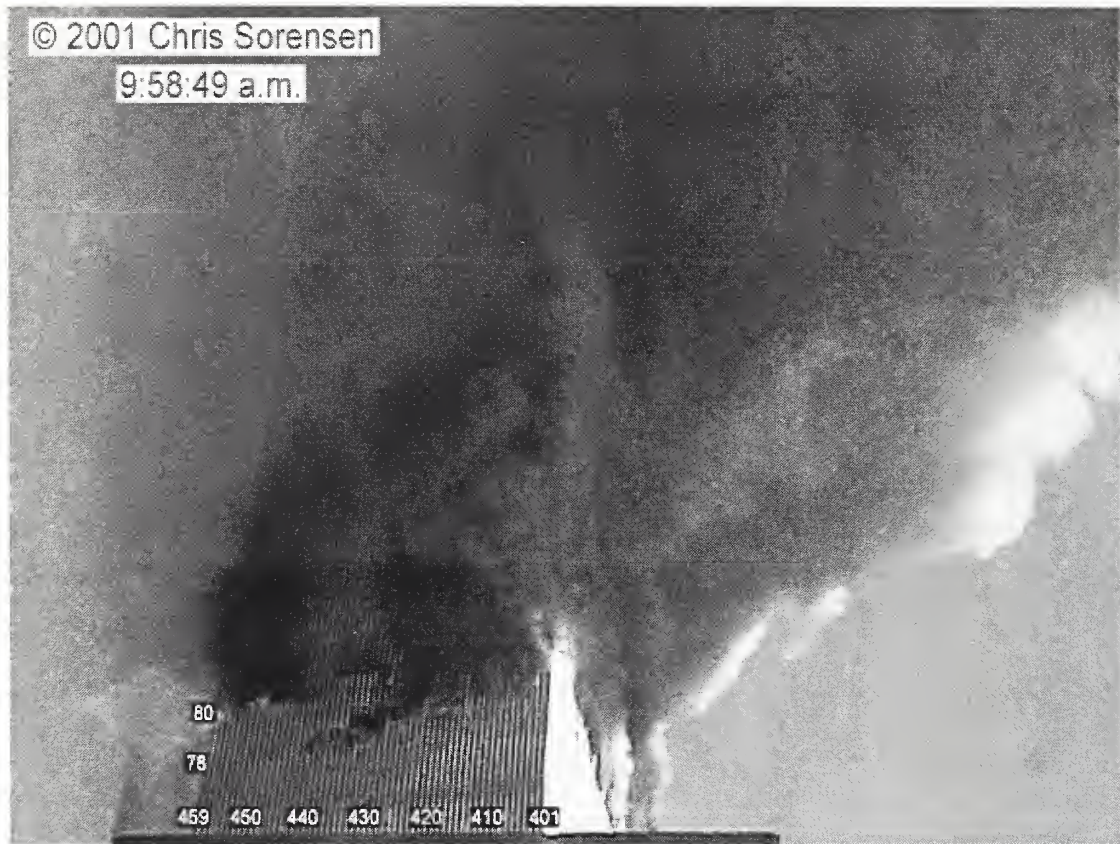
A view of the south face of WTC 2 captured from a video at 9:58:49 a.m. is shown in Figure 9–87. It was taken just 10 s before the start of the collapse of the tower. Flames are visible on the 80th floor from windows 80-440 to 80-452, and smoke is flowing from open windows 80-438 to 80-455. The aerial video shows that the bright region of flame near window 80-450 flared up briefly for several seconds around this time. There are no distinct flames visible at other locations on the face. In particular, the flames visible inside the aircraft impact cavity in Figure 9–86 are not seen from this angle.

Figure 9-87. This image of the south face of WTC 2 is a frame captured from a video recorded at 9:58:49 a.m. The intensity levels have been adjusted, and column and floor numbers have been added.

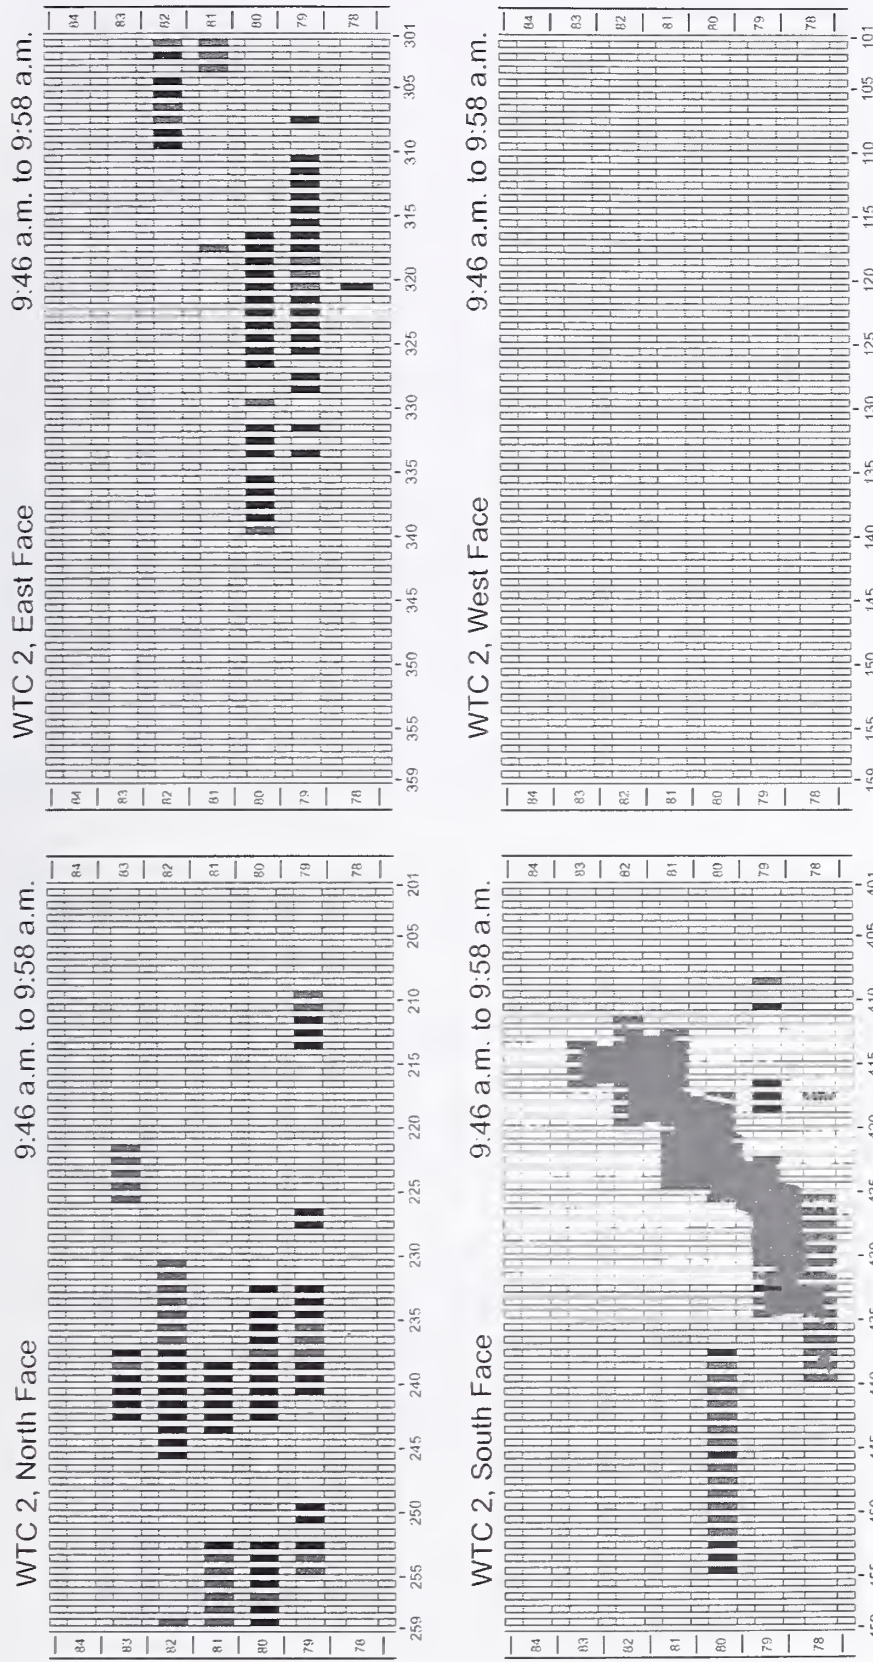
Façade maps of integrated fire intensities for the period from 9:45 a.m. to 9:59 a.m. are shown in Figure 9-88. Comparison with the corresponding maps for the 9:29 a.m. to 9:45 a.m. period shown in Figure 9-60 is helpful for tracking the changes in fire distributions during the current period.

Many of the fires observed during earlier periods were either no longer visible or were dying down during the final interval prior to the tower collapse. Fires dying down included those burning on debris piles located in the northeast corner of the tower and near the center of the north face on the 79th floor, a fire that had earlier burned from south to north across the 82nd floor on the east face, and numerous small fires ignited around the aircraft impact cavity on the south face.

Figure 9-88. Maps of integrated fire observations between 9:45 a.m. and 9:59 a.m. are shown for the four faces of WTC 2. Colors represent the highest intensity fire observed in a window using the color scale defined in Figure 5-1.

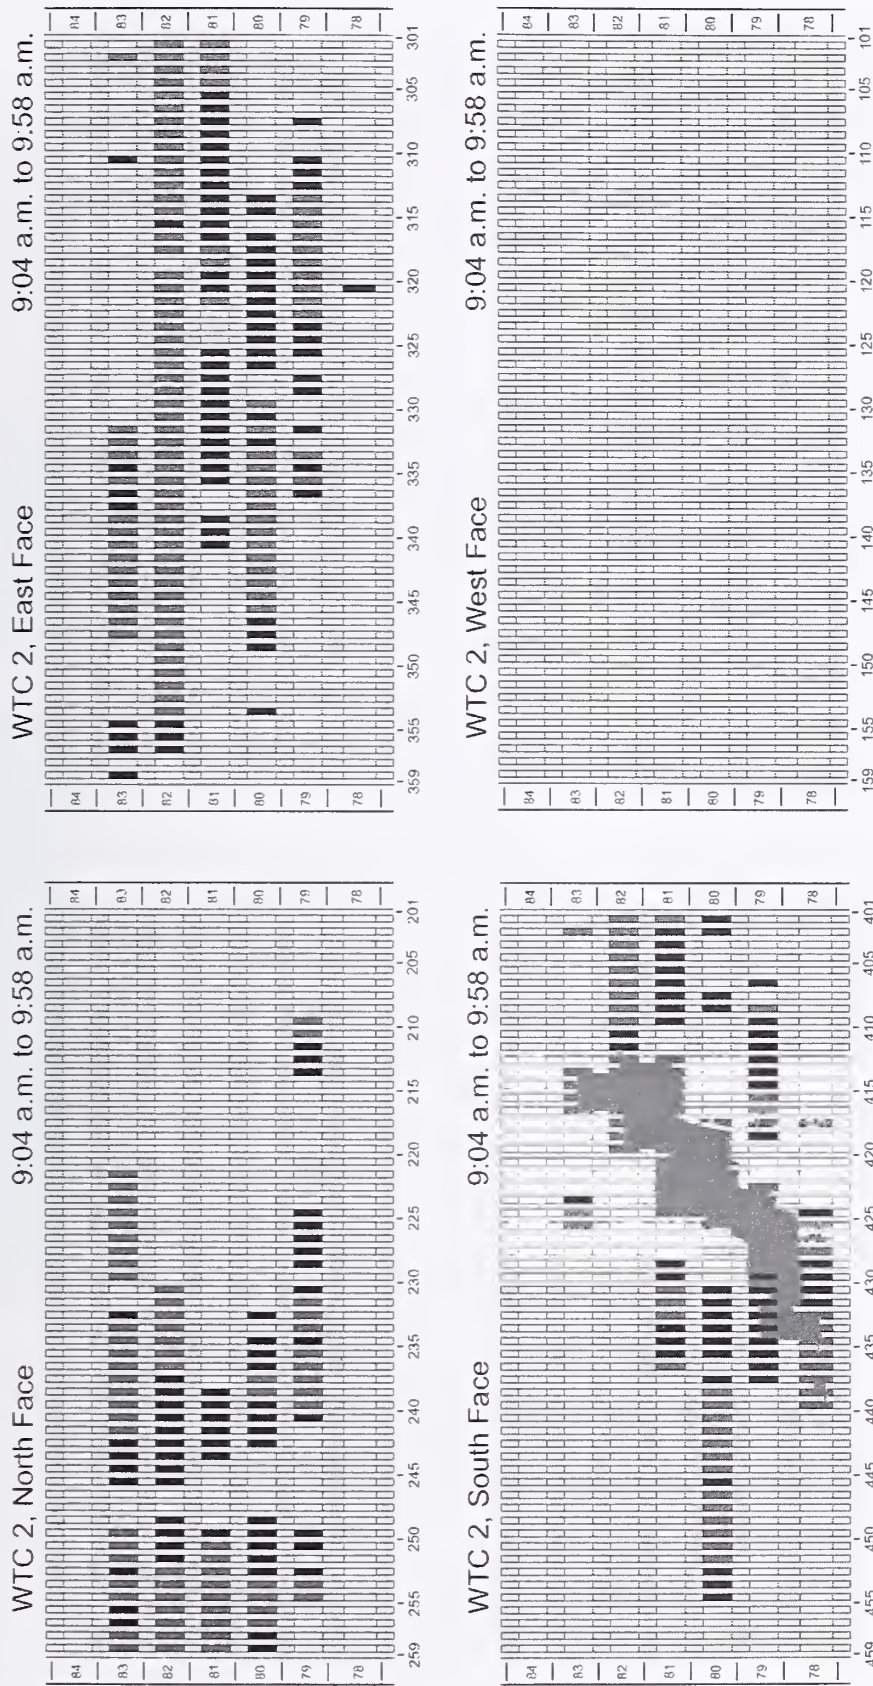
Compared to WTC 1, the amount of fire spread in WTC 2 was less extensive during the 56 min between the impact of United Airlines Flight 175 and the collapse of the tower. One approach for characterizing the fire spread in WTC 2 is to compare integrated façade maps for the entire period from 9:03 a.m. to 9:59 a.m. with the initial fire distributions shortly after the aircraft impact. Figure 9–89 shows fire maps for the four faces obtained by integrating the fire datasheets over the entire period. These maps are compared with the corresponding fire distributions around 9:04 a.m. in Figure 9–90.

Figure 9-89. Maps of integrated fire observations between 9:03 a.m. and 9:59 a.m. are shown for the four faces of WTC 2. Colors represent the highest intensity fire observed in a window using the color scale defined in Figure 5-1.

The effects of the fire behaviors discussed above are reflected in the integrated fire intensities for each face, shown in Figure 9-89 and Figure 9-90.

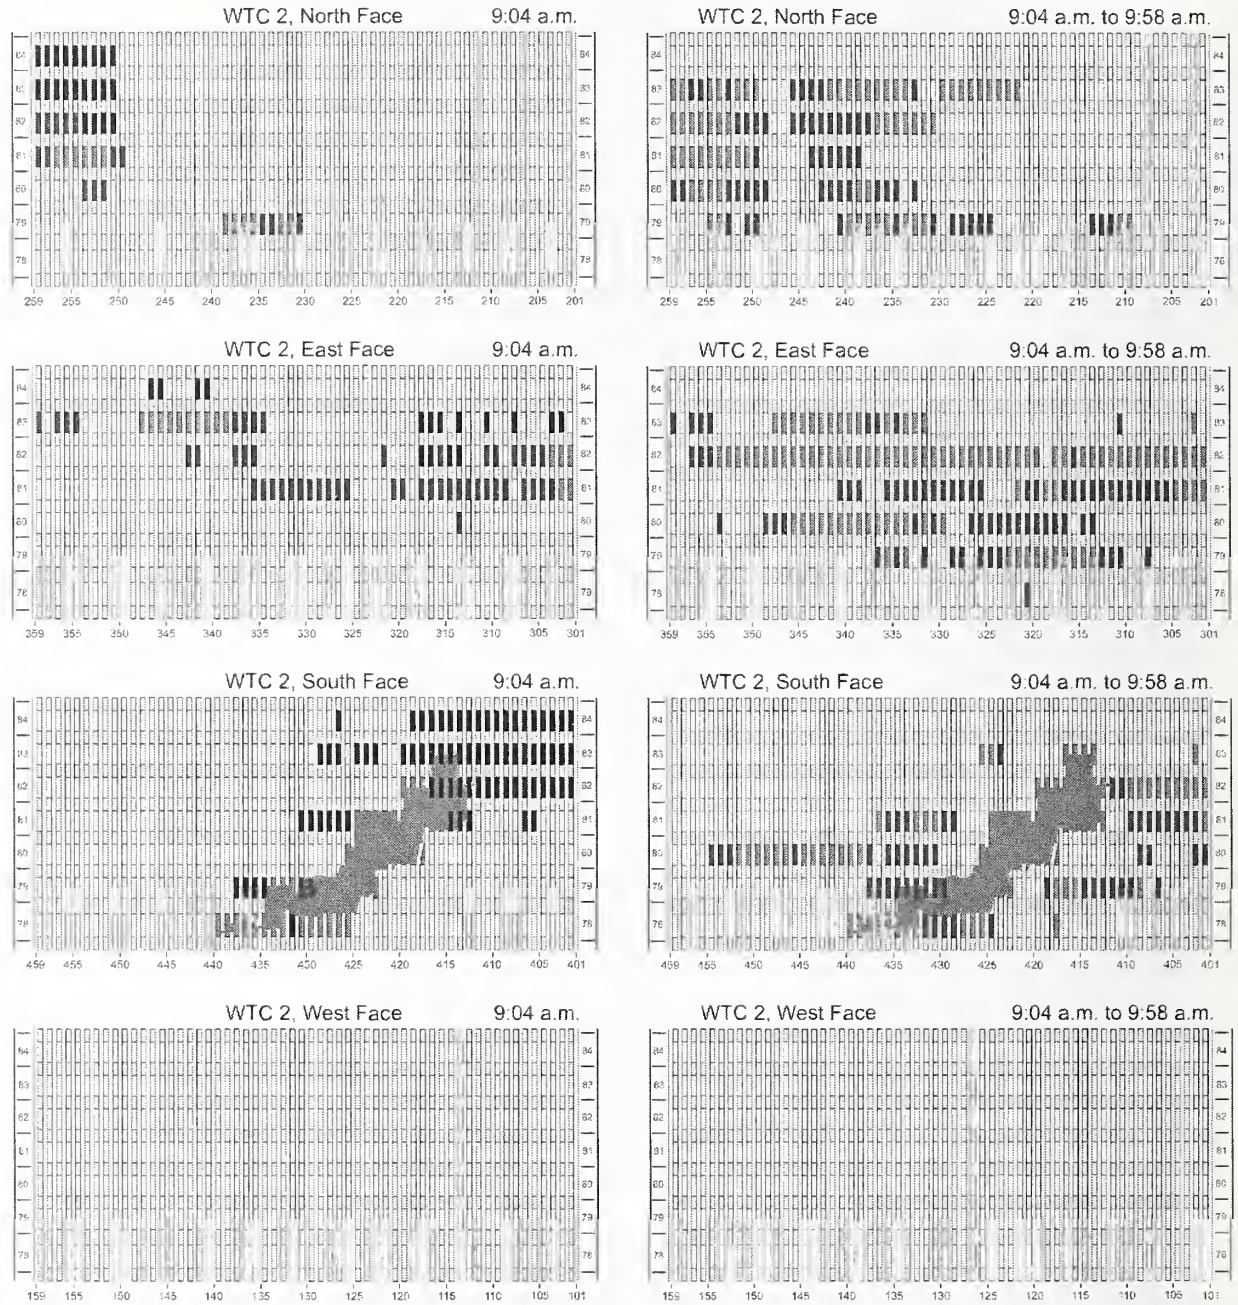
Figure 9-90. Maps of observed fire distributions on the four faces of WTC 2 shortly after the aircraft impact (near 9:04 a.m.) are compared with the corresponding integrated fire observations for the entire period between 9:03 a.m. and 9:59 a.m. The data for 9:04 a.m. are represented using the color scale in Figure 5-1. For the integrated results, the same color scale is used to represent the highest intensity fire observed in a given window during the period.

On the north face significant fire spread took place on the 79th, 82nd, and 83rd floors. The effects of this fire spread are revealed by areas of fire (Figure 9–90) and opened windows (Figure 9–91) on the west sides of the areas of fire and open windows that were present shortly following the aircraft impact and fireballs. On the 79th floor this fire growth took place from the large fire burning on a pile of debris just to the east of the center of the face. Despite the presence of this sustained fire, westward fire spread on this floor was relatively slow and sporadic. The fire spread on the 82nd floor occurred just to the west of the cold spot (an area on the 80th, 81st, and 82nd floors between columns 238 and 250). Fire spread into this area was not observed until around 9:54 a.m. On the 83rd floor fire spread occurred in discrete segments that suggested fire was spreading across a series of rooms. The first large fire appeared just above the cold spot around 9:29 a.m. None of the fires that spread to the west on the north face appeared to reach the western edge of the tower by the time of collapse.

The fire behavior observed on the south face of WTC 2 seemed to be determined to a large extent by the locations of small fires ignited in and around the aircraft impact cavity by the fireball following the impact. The locations of some of these initial fires are indicated by the fire distribution map for the face around 9:04 a.m. included in Figure 9-90.

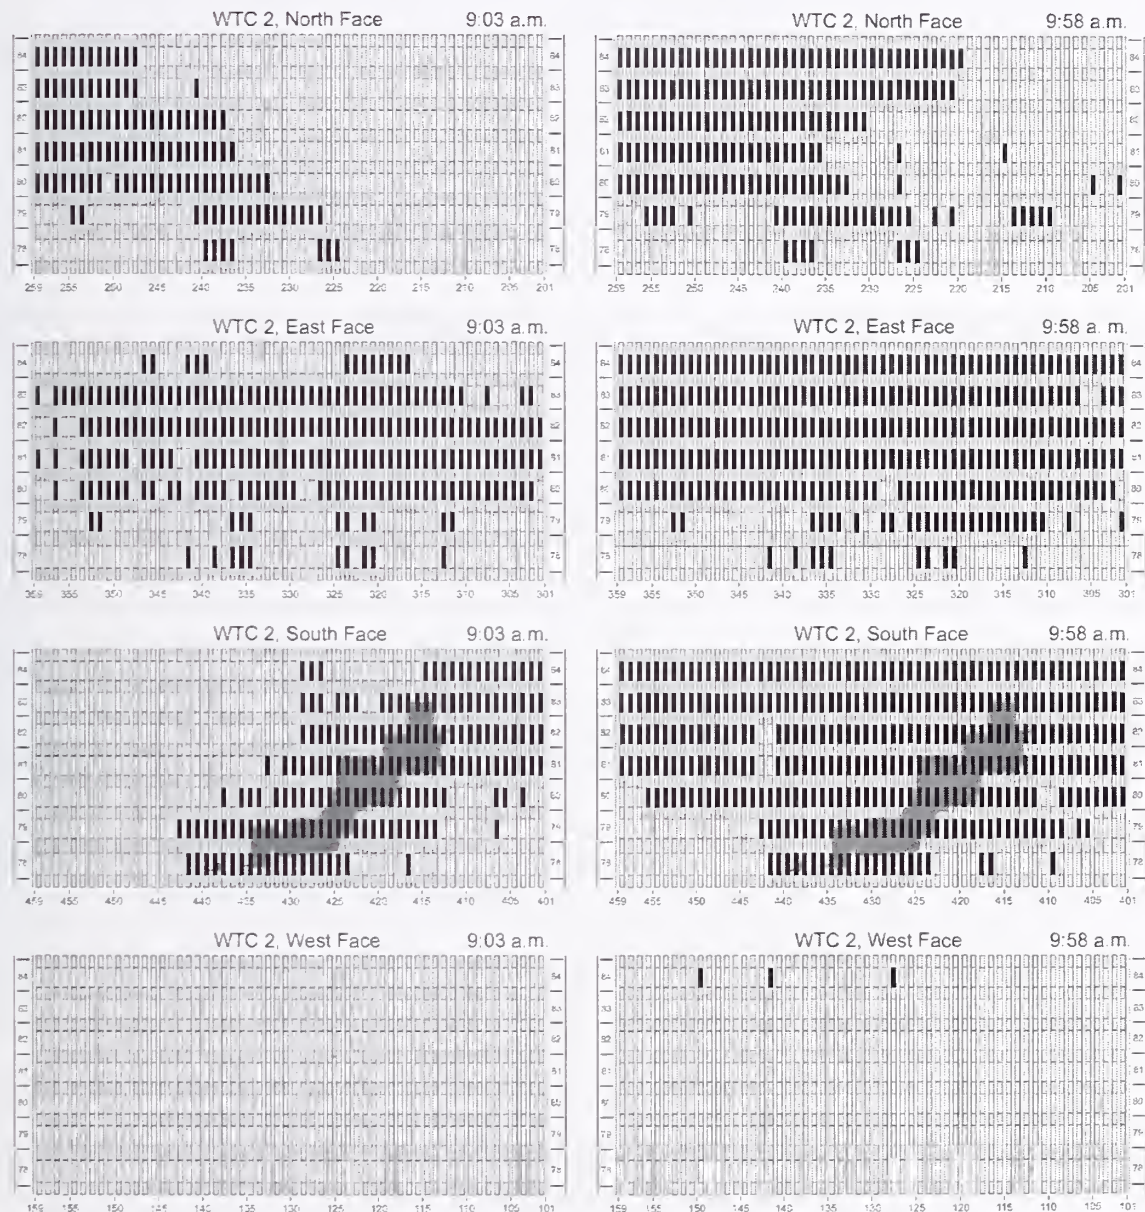
Similar to the analyses included in Chapter 8, changes in window condition can also be used as a rough indicator of fire spread. This analysis method has been used to complement the integrated fire data. The results are shown in Figure 9–91. It should be kept in mind that this approach only reveals fire spread that occurs to locations where windows were originally unopened. This is particularly important for WTC 2 because the number of windows opened by the aircraft impact and subsequent fireballs was much larger than for WTC 1. Even so, the analysis does provide a good estimate for fire spread into areas where window glass was still in place immediately following the aircraft impact.

Figure 9-91. Maps for the 78th through the 84th floors compare missing window glass for the four faces of WTC 2 at two times, immediately following the aircraft impact at 9:02:59 a.m. and just prior to the collapse of WTC 1 at 9:58:59 a.m.

The façade maps of window conditions for the south face shown in Figure 9-91 also provide a good indication of the how the fires tended to move away from the aircraft impact cavity between the time of aircraft impact and tower collapse. In particular, the result of the rapid fire spread on the 80th floor stands out. As evident from Table 9-2, the number of open windows on the face increased by roughly 45 % during the period between the aircraft impact and collapse.

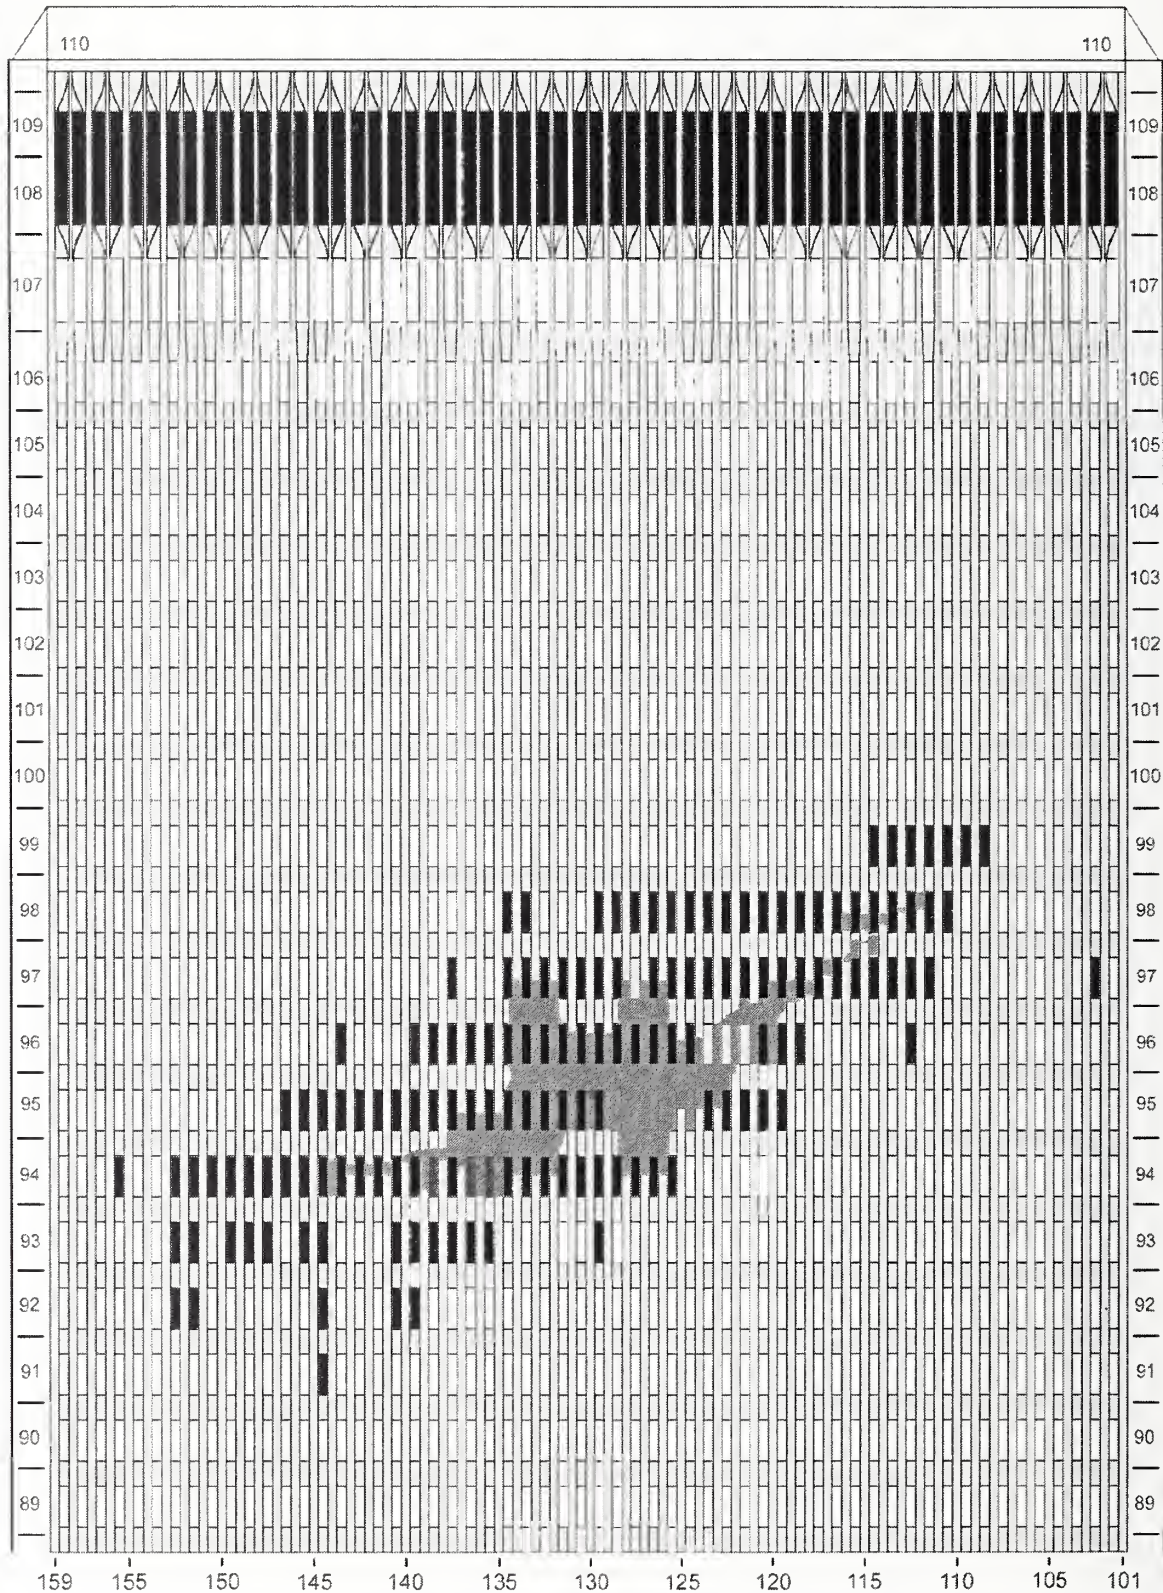
Figure C-1. Diagram of the north face of WTC 1 for floors 89 to 110 at 8:47 a.m. showing the condition of windows and locations of fires.

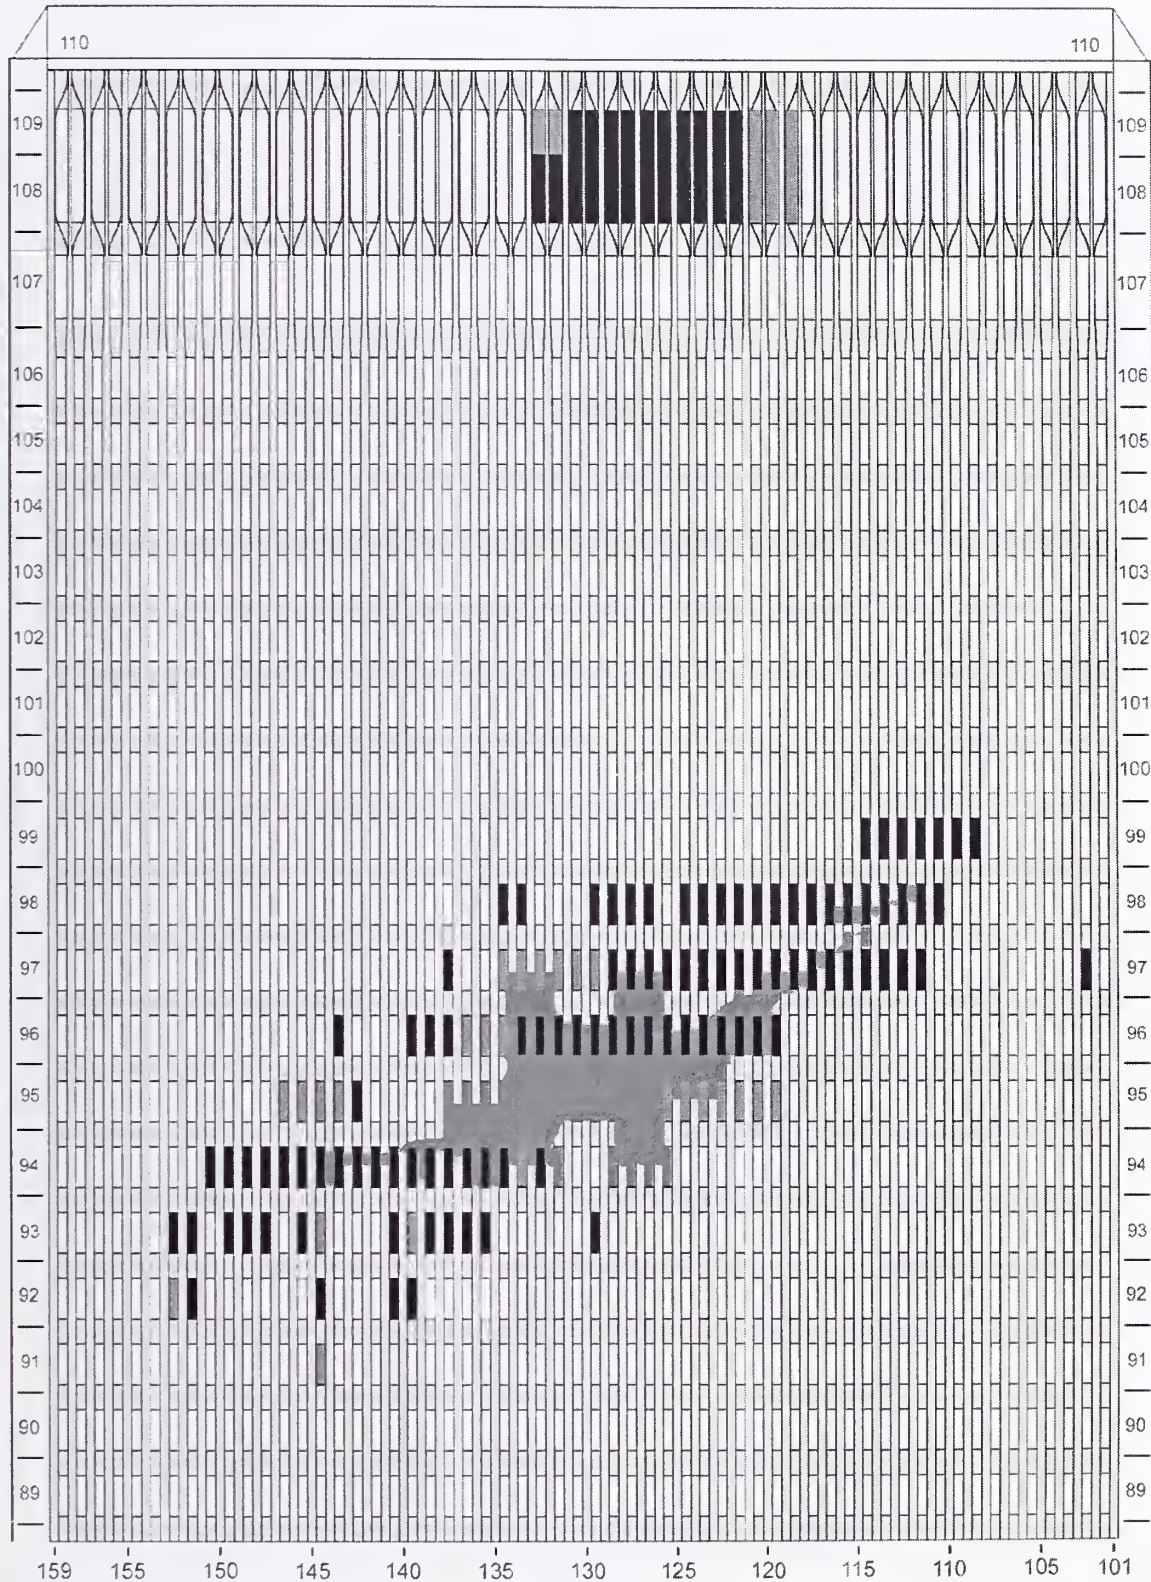
Figure C-2. Diagram of the north face of WTC 1 for floors 89 to 110 at 8:47 a.m. showing windows where smoke was observed and those that were hidden from view.

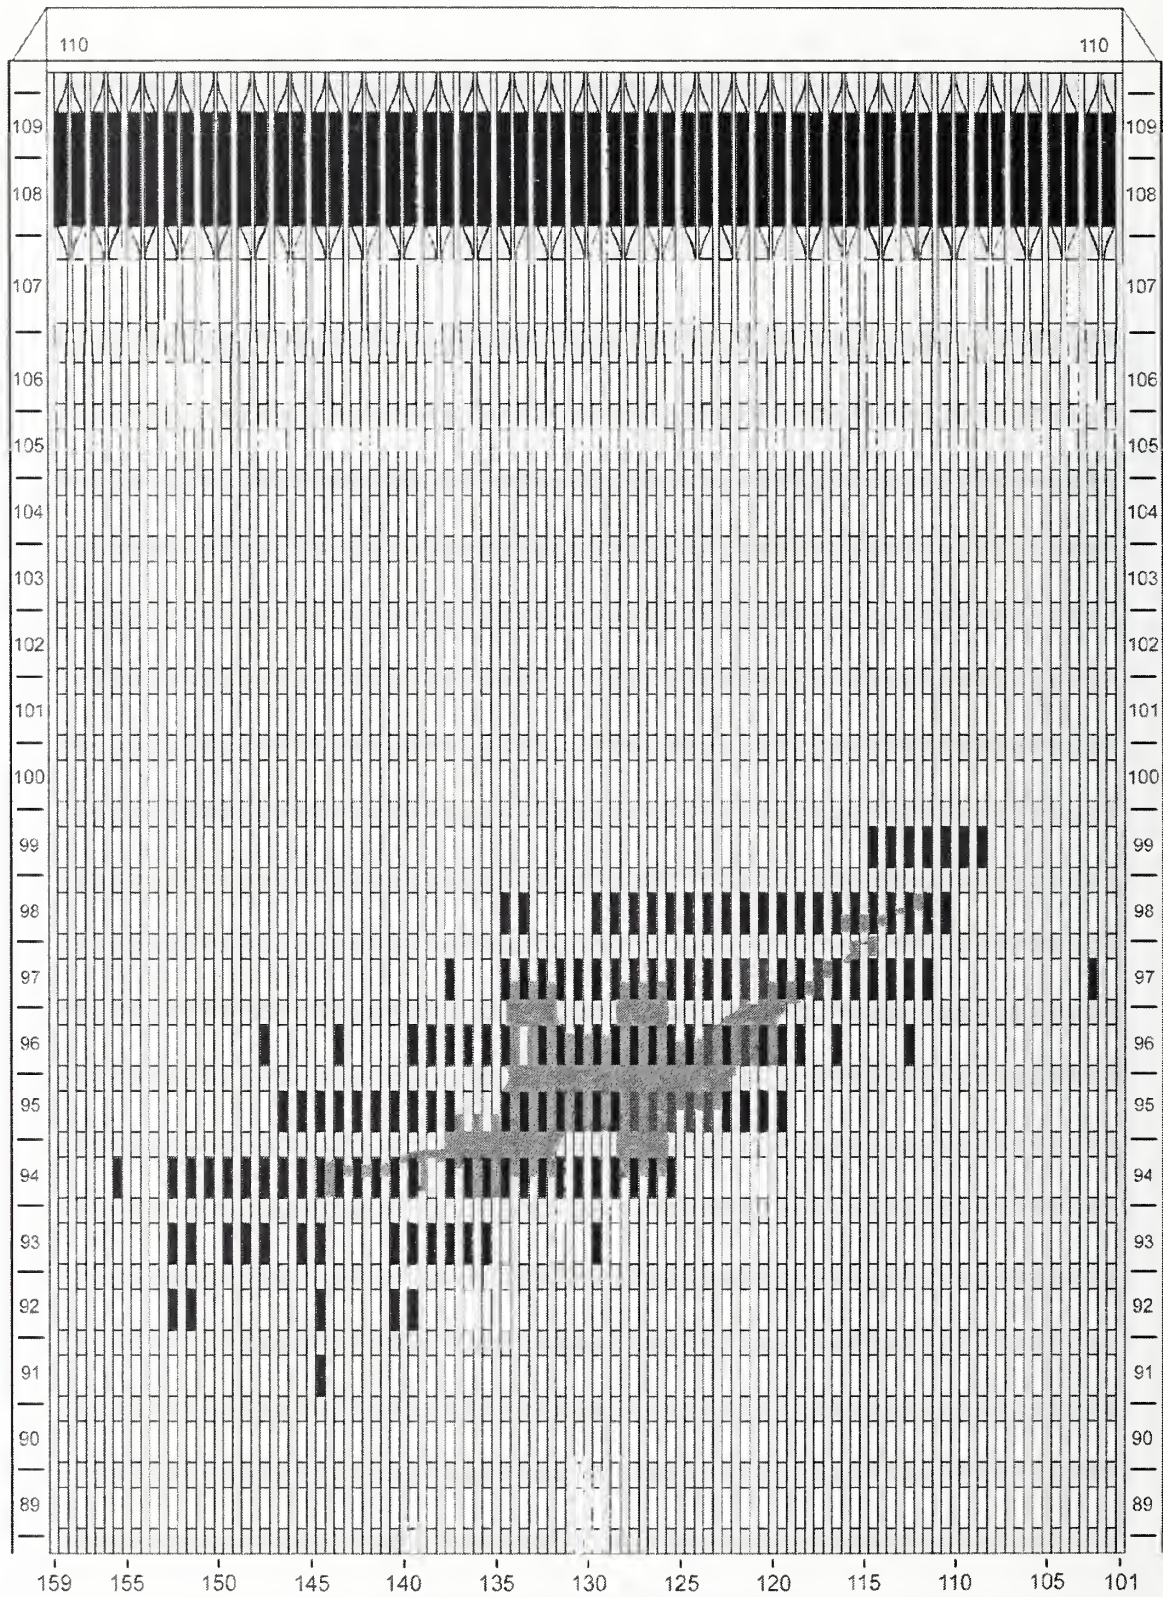
Figure C-3. Diagram of the north face of WTC 1 for floors 89 to 110 at 8:48 a.m. showing the condition of windows and locations of fires.

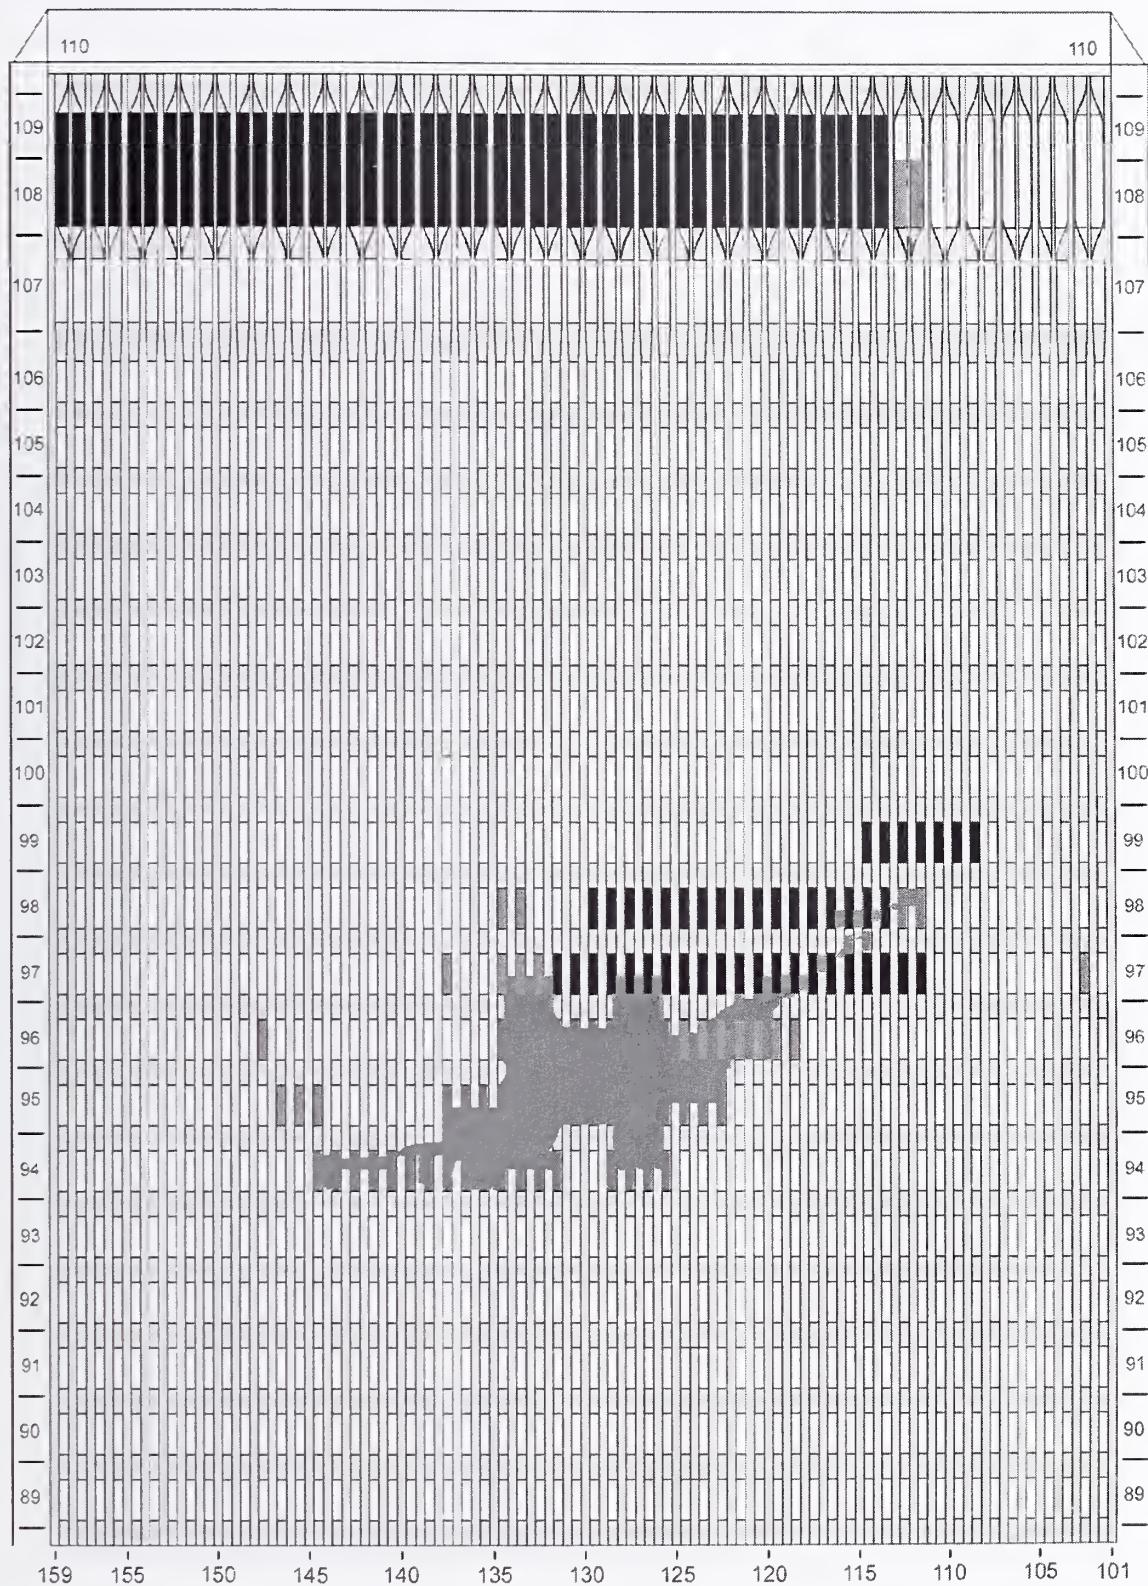
Figure C-4. Diagram of the north face of WTC 1 for floors 89 to 110 at 8:48 a.m. showing windows where smoke was observed and those that were hidden from view.

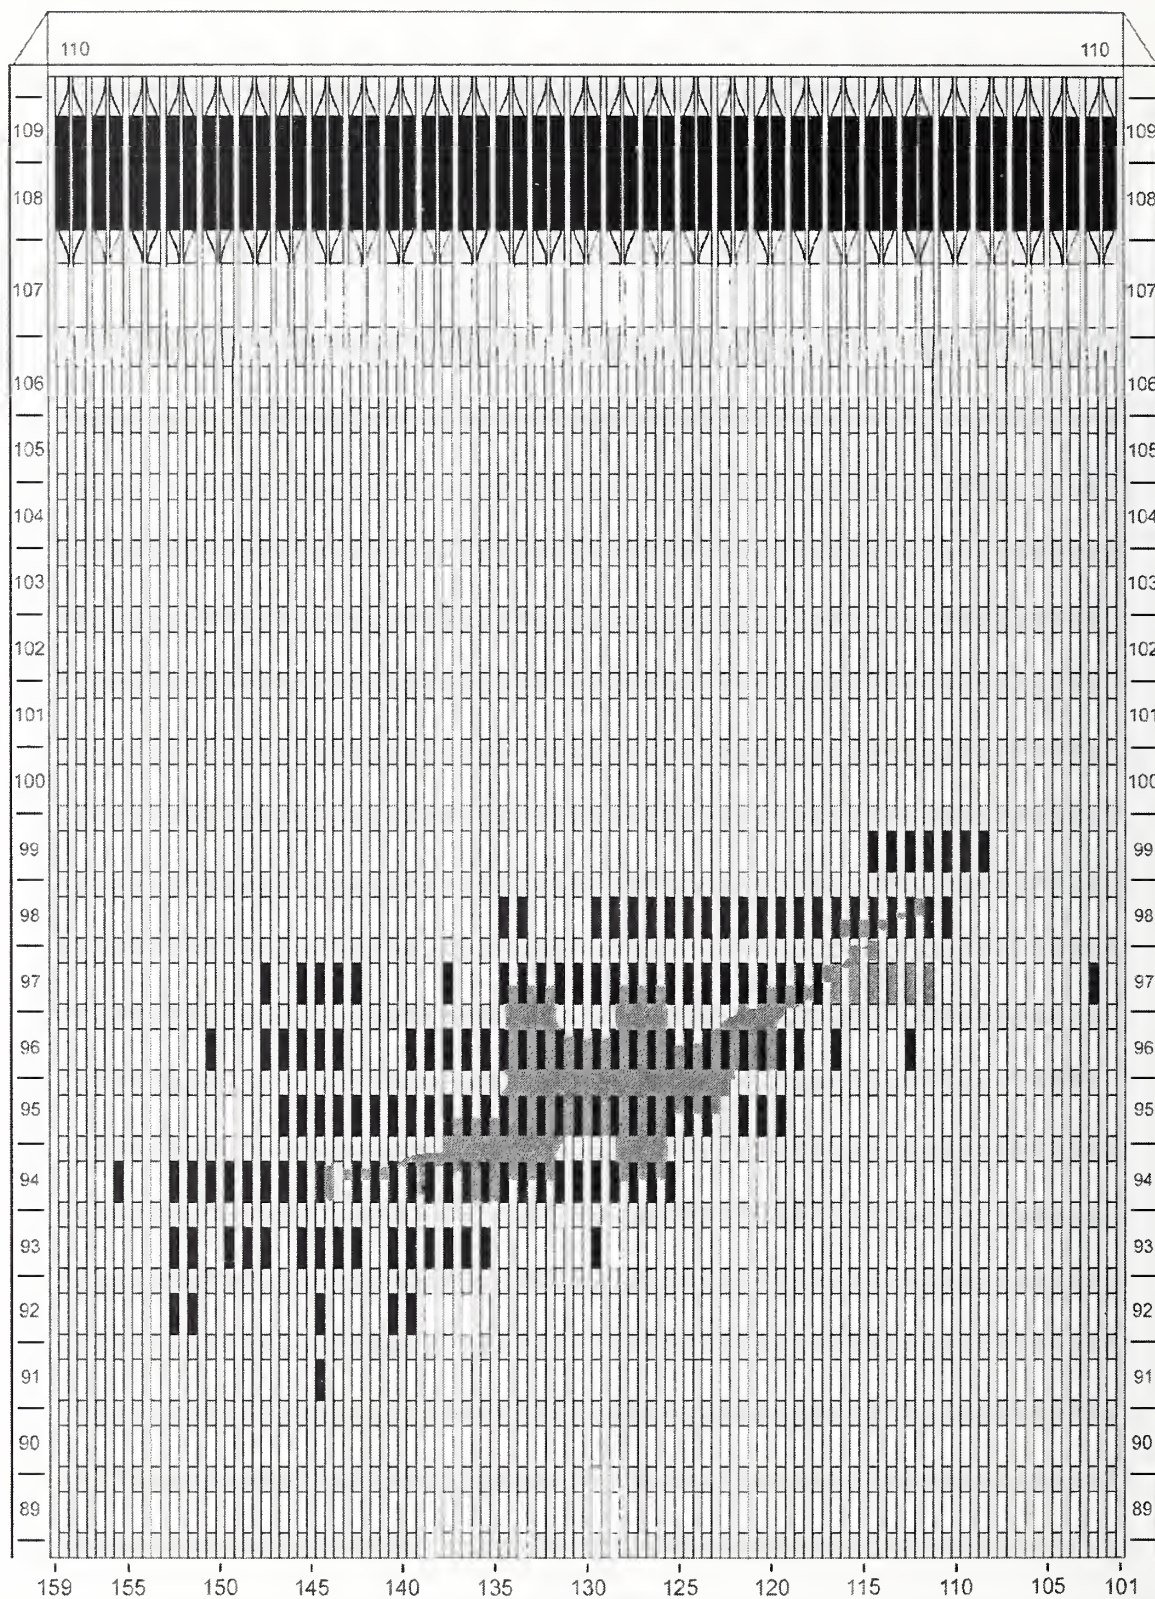
Figure C-5. Diagram of the north face of WTC 1 for floors 89 to 110 at 8:50 a.m. showing the condition of windows and locations of fires.

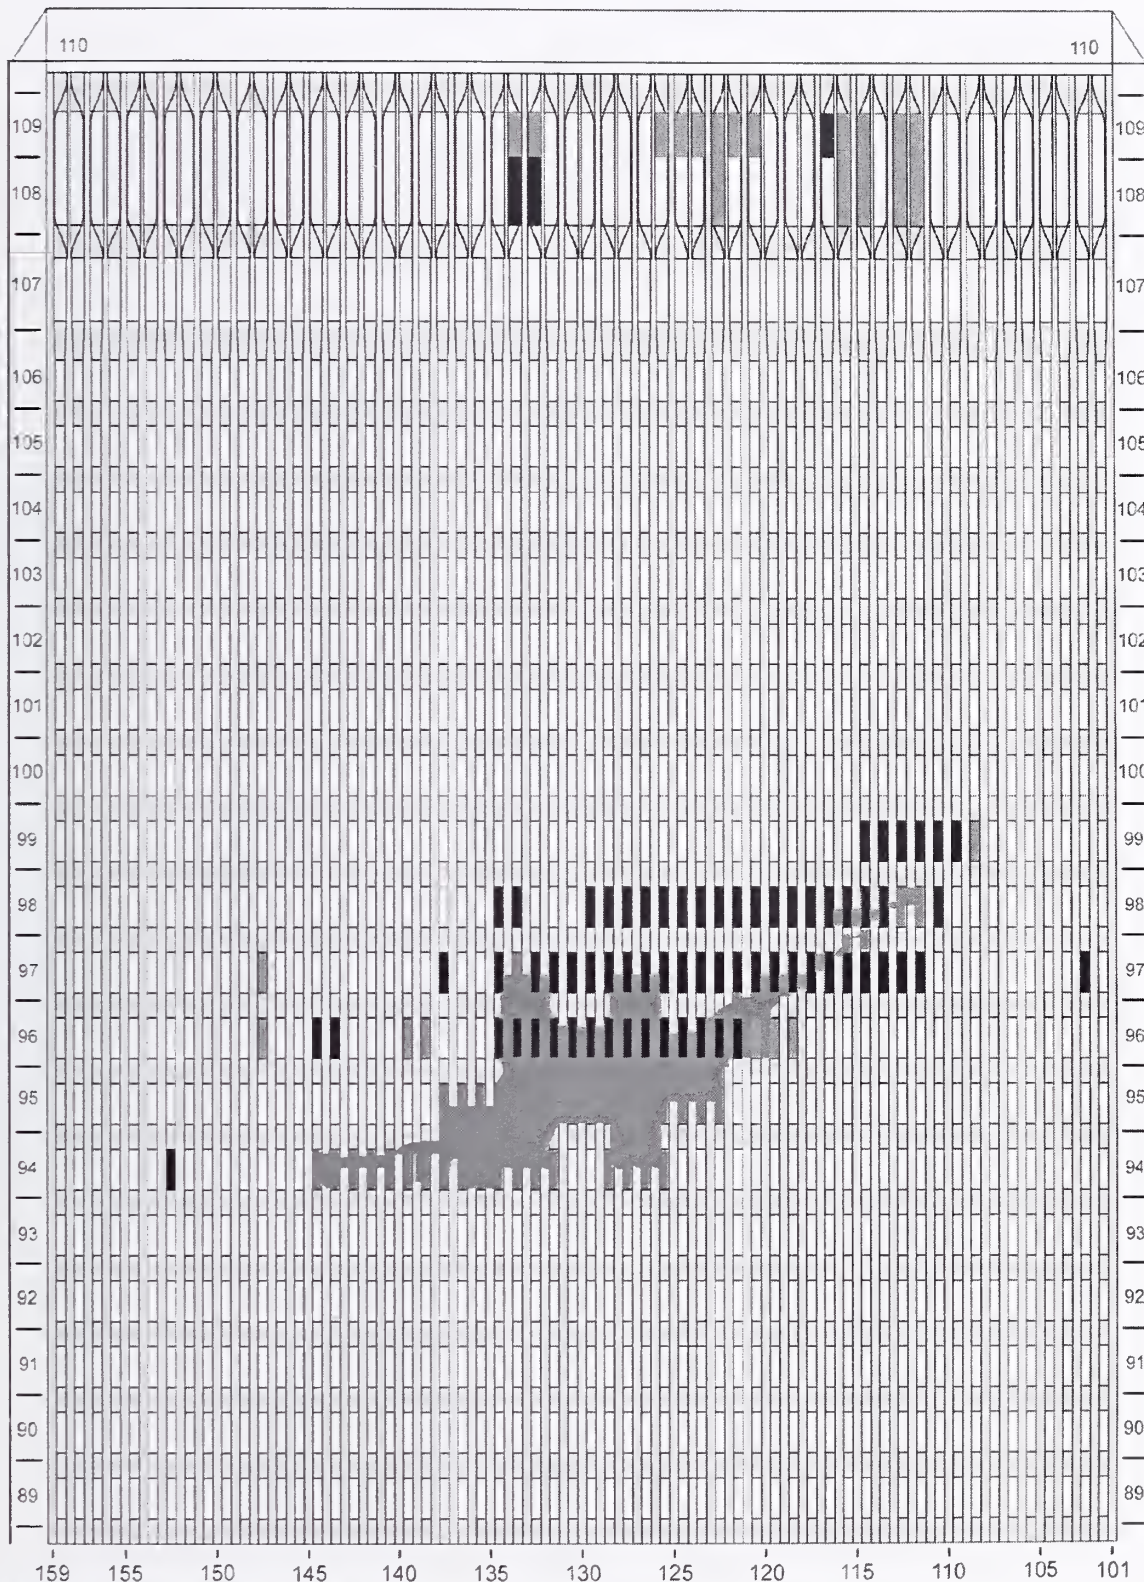
Figure C-6. Diagram of the north face of WTC 1 for floors 89 to 110 at 8:50 a.m. showing windows where smoke was observed and those that were hidden from view.
