**NIST NCSTAR 1-5A
Federal Building and Fire Safety Investigation of
the World Trade Center Disaster**

**Visual Evidence, Damage Estimates,
And Timeline Analysis**

(Chapter 9 - Appendix C)

FIRE BEHAVIOR IN WORLD TRADE CENTER 2

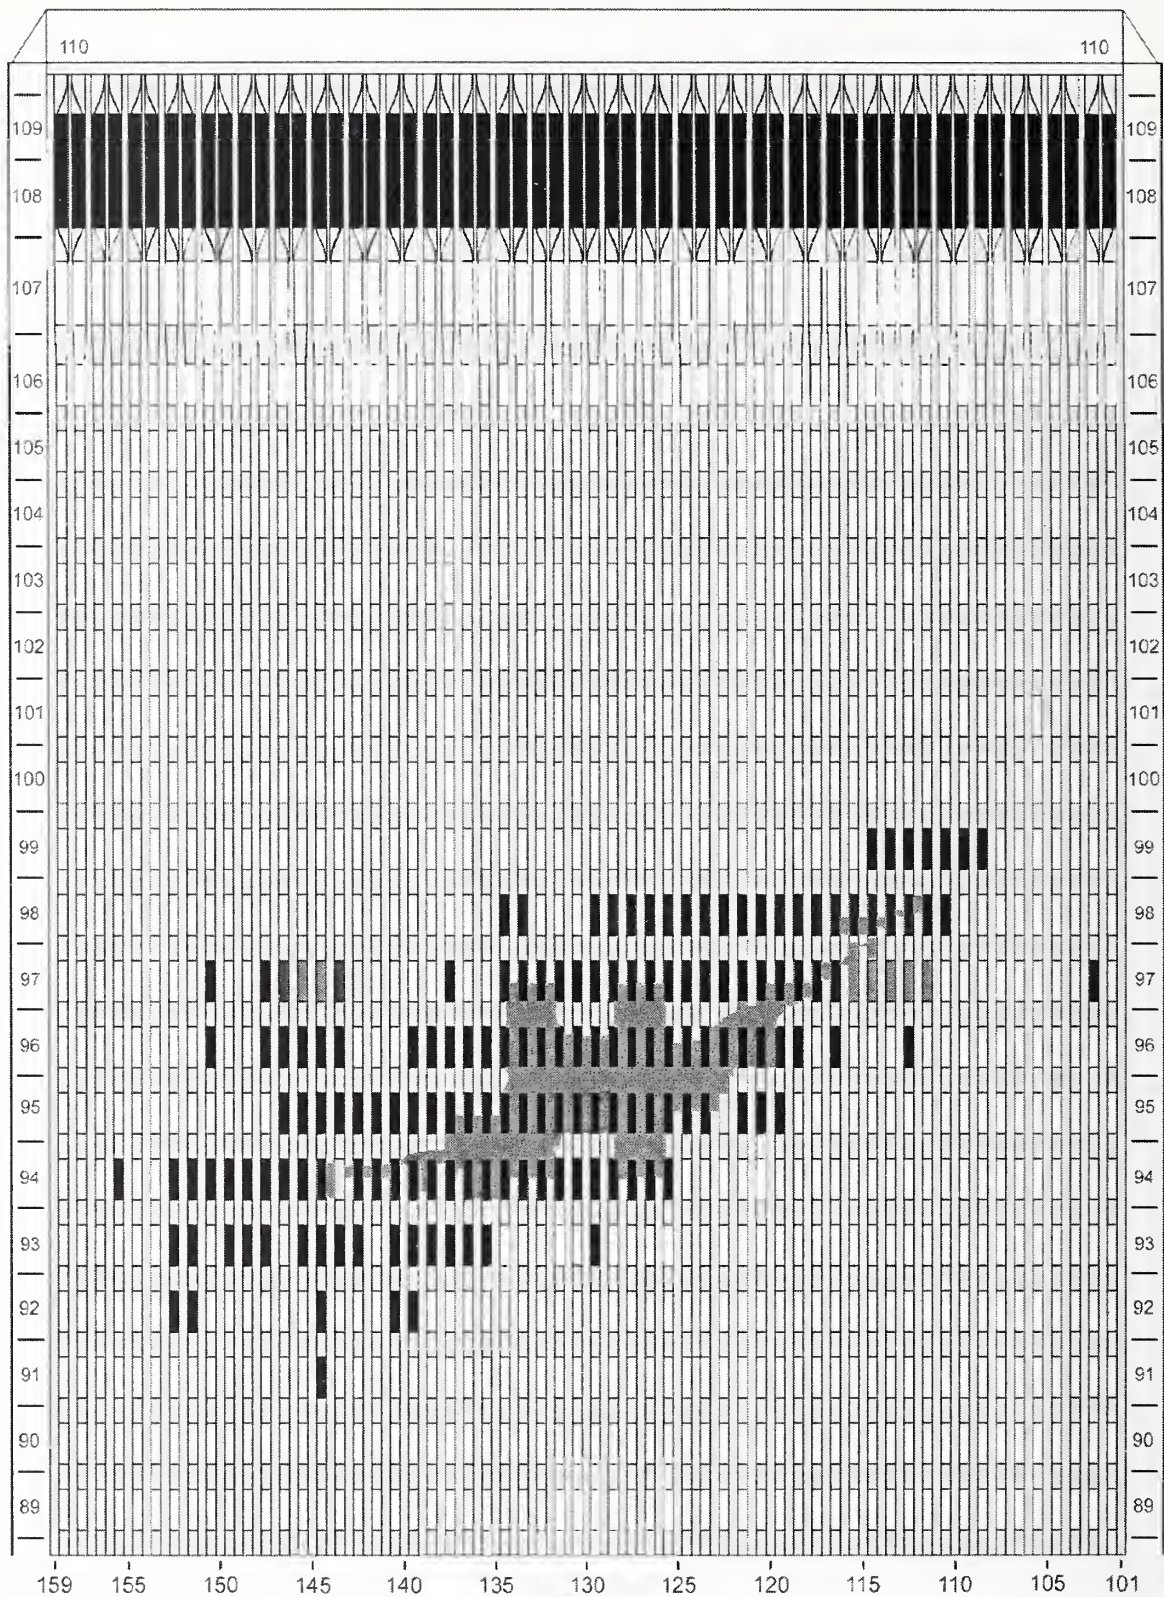
Figure C-7. Diagram of the north face of WTC 1 for floors 89 to 110 at 8:52 a.m. showing the condition of windows and locations of fires.

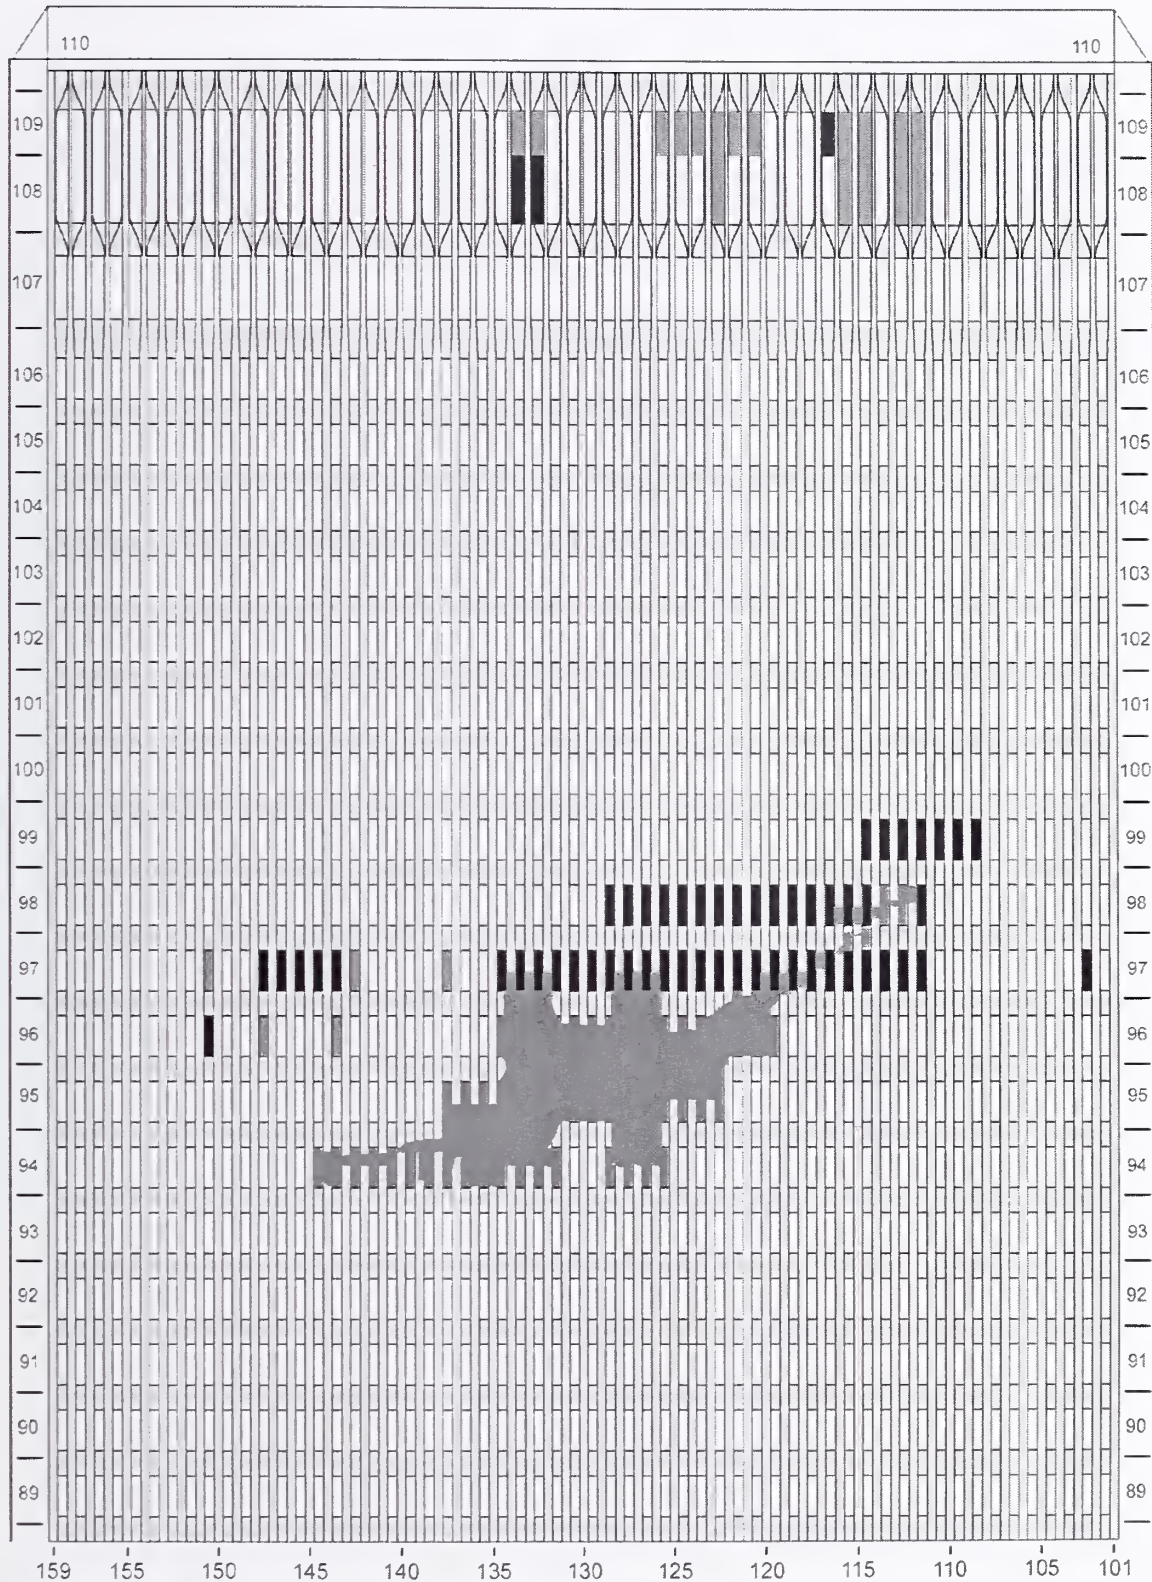
Figure C-8. Diagram of the north face of WTC 1 for floors 89 to 110 at 8:52 a.m. showing windows where smoke was observed and those that were hidden from view.

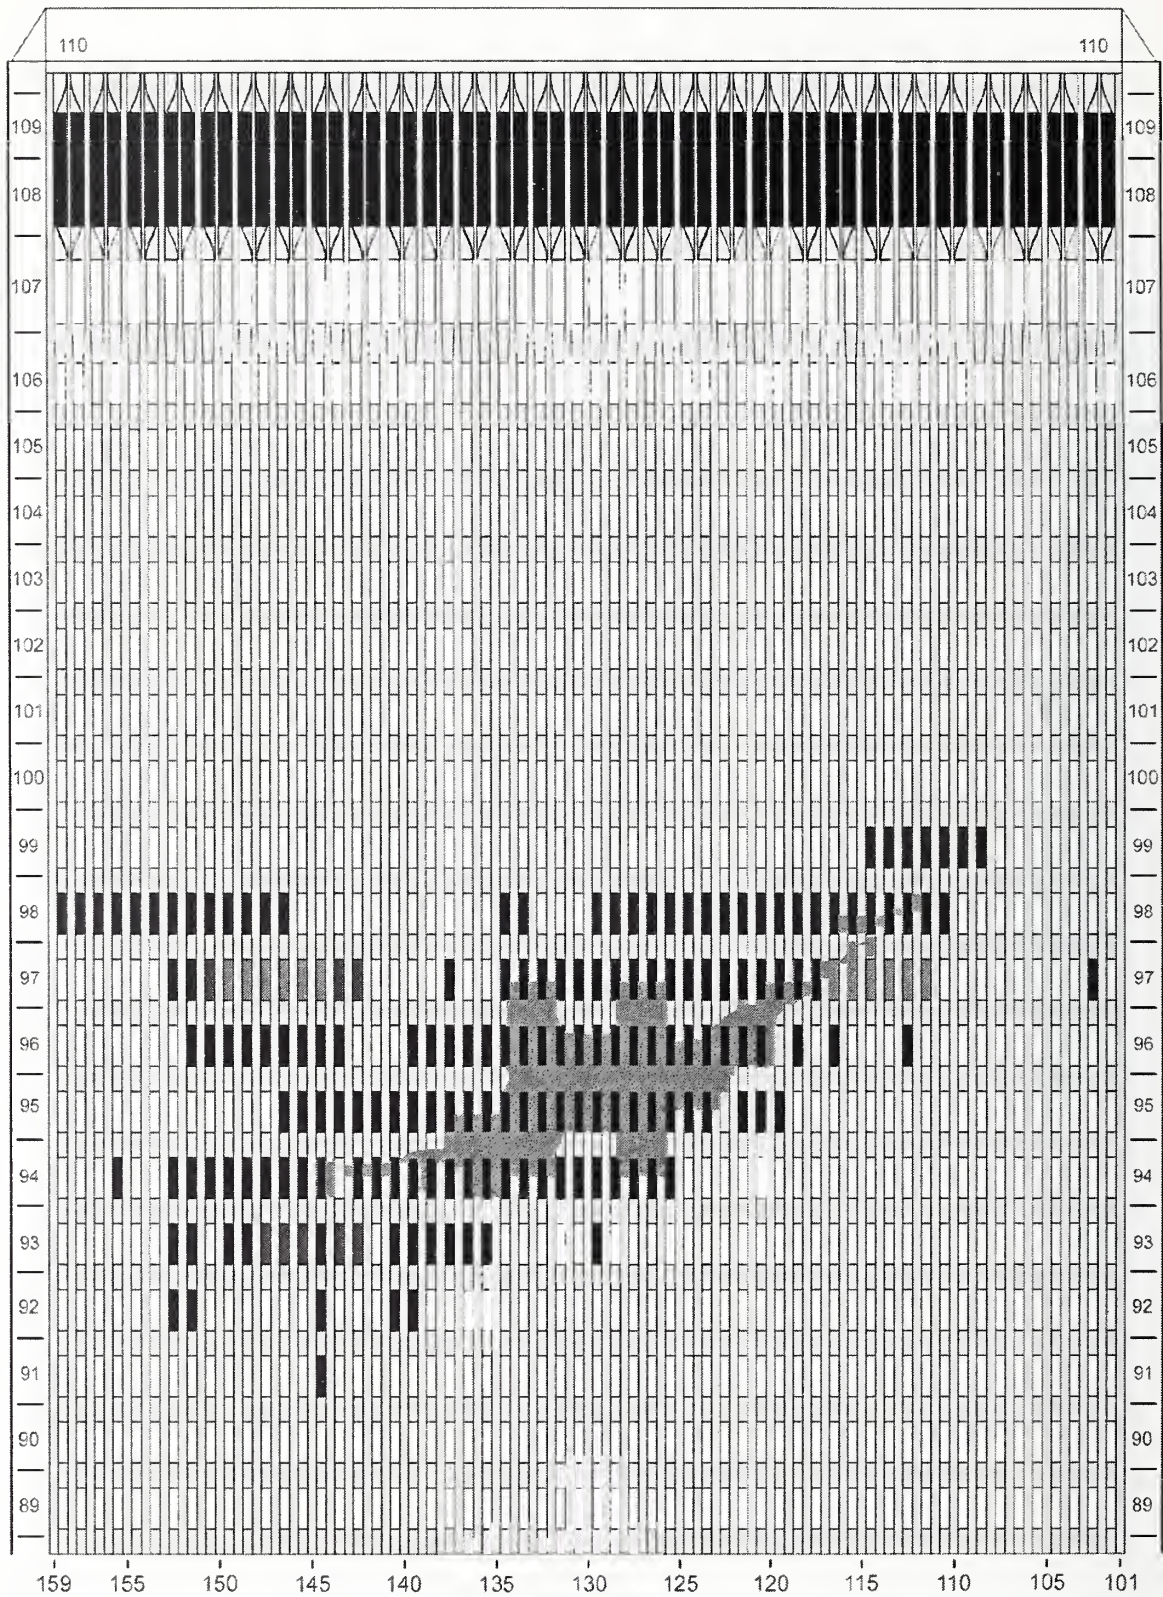
Figure C-9. Diagram of the north face of WTC 1 for floors 89 to 110 at 8:54 a.m. showing the condition of windows and locations of fires.

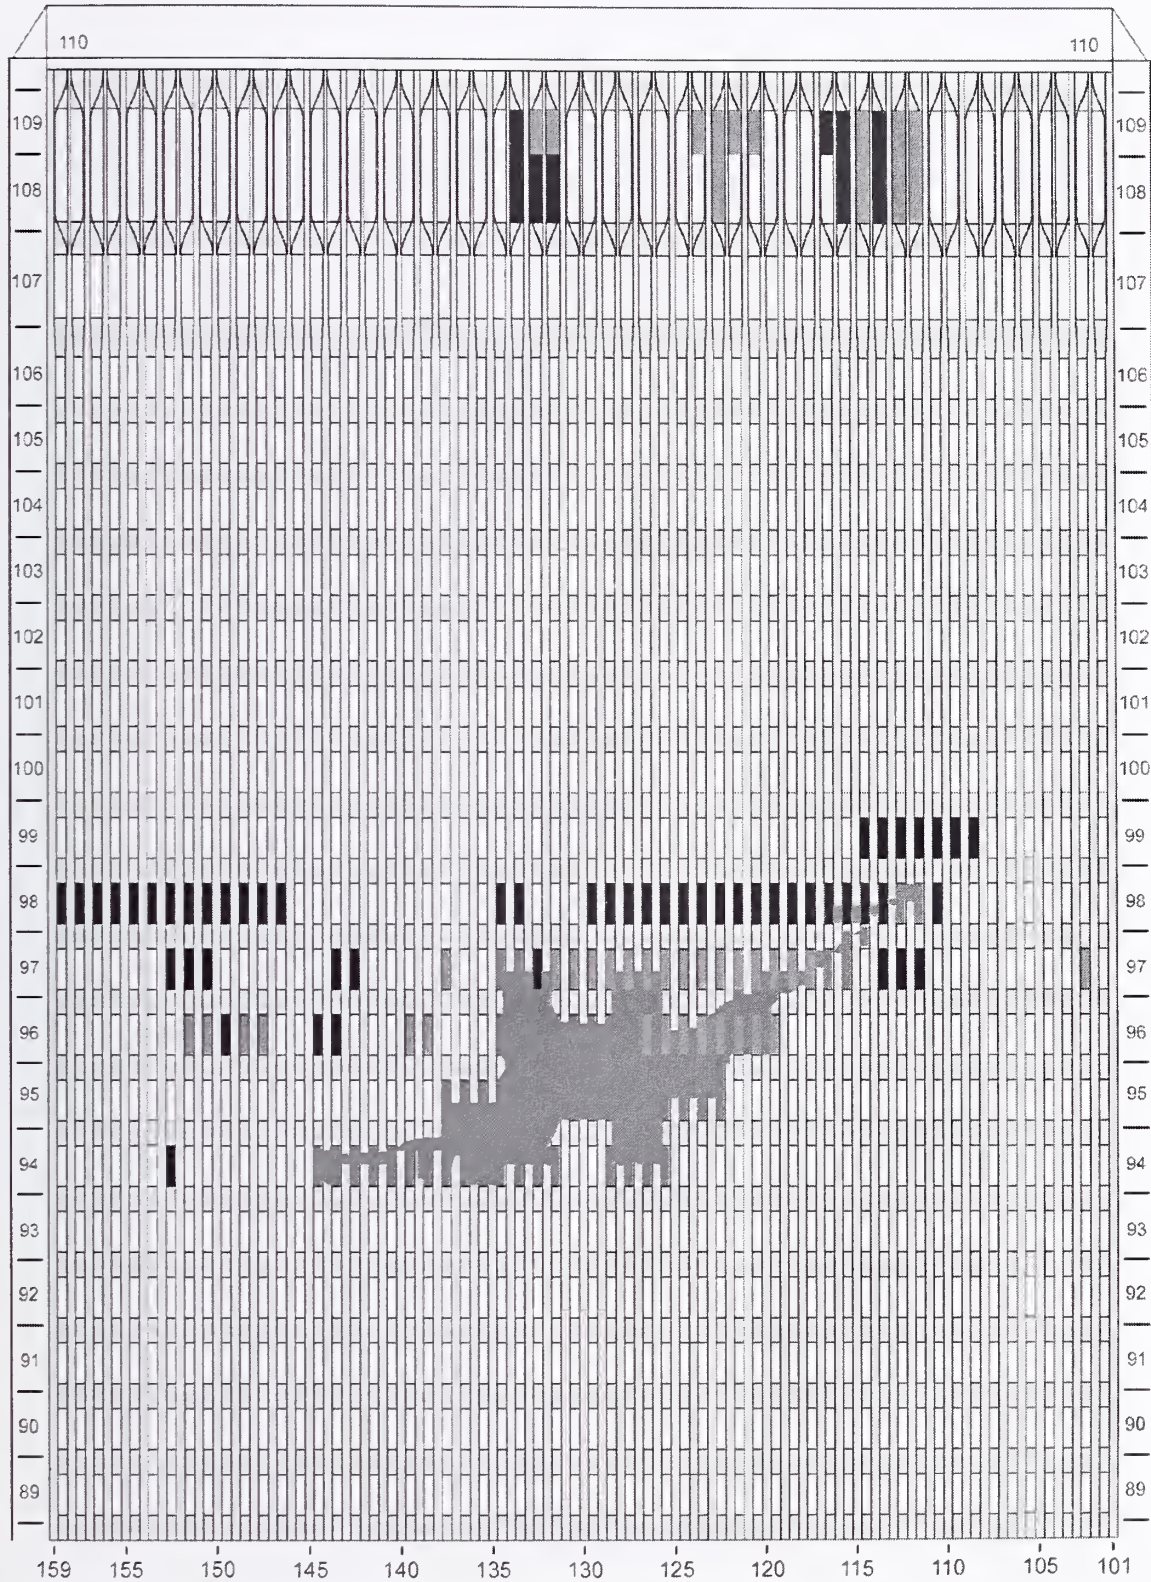
Figure C-10. Diagram of the north face of WTC 1 for floors 89 to 110 at 8:54 a.m. showing windows where smoke was observed and those that were hidden from view.

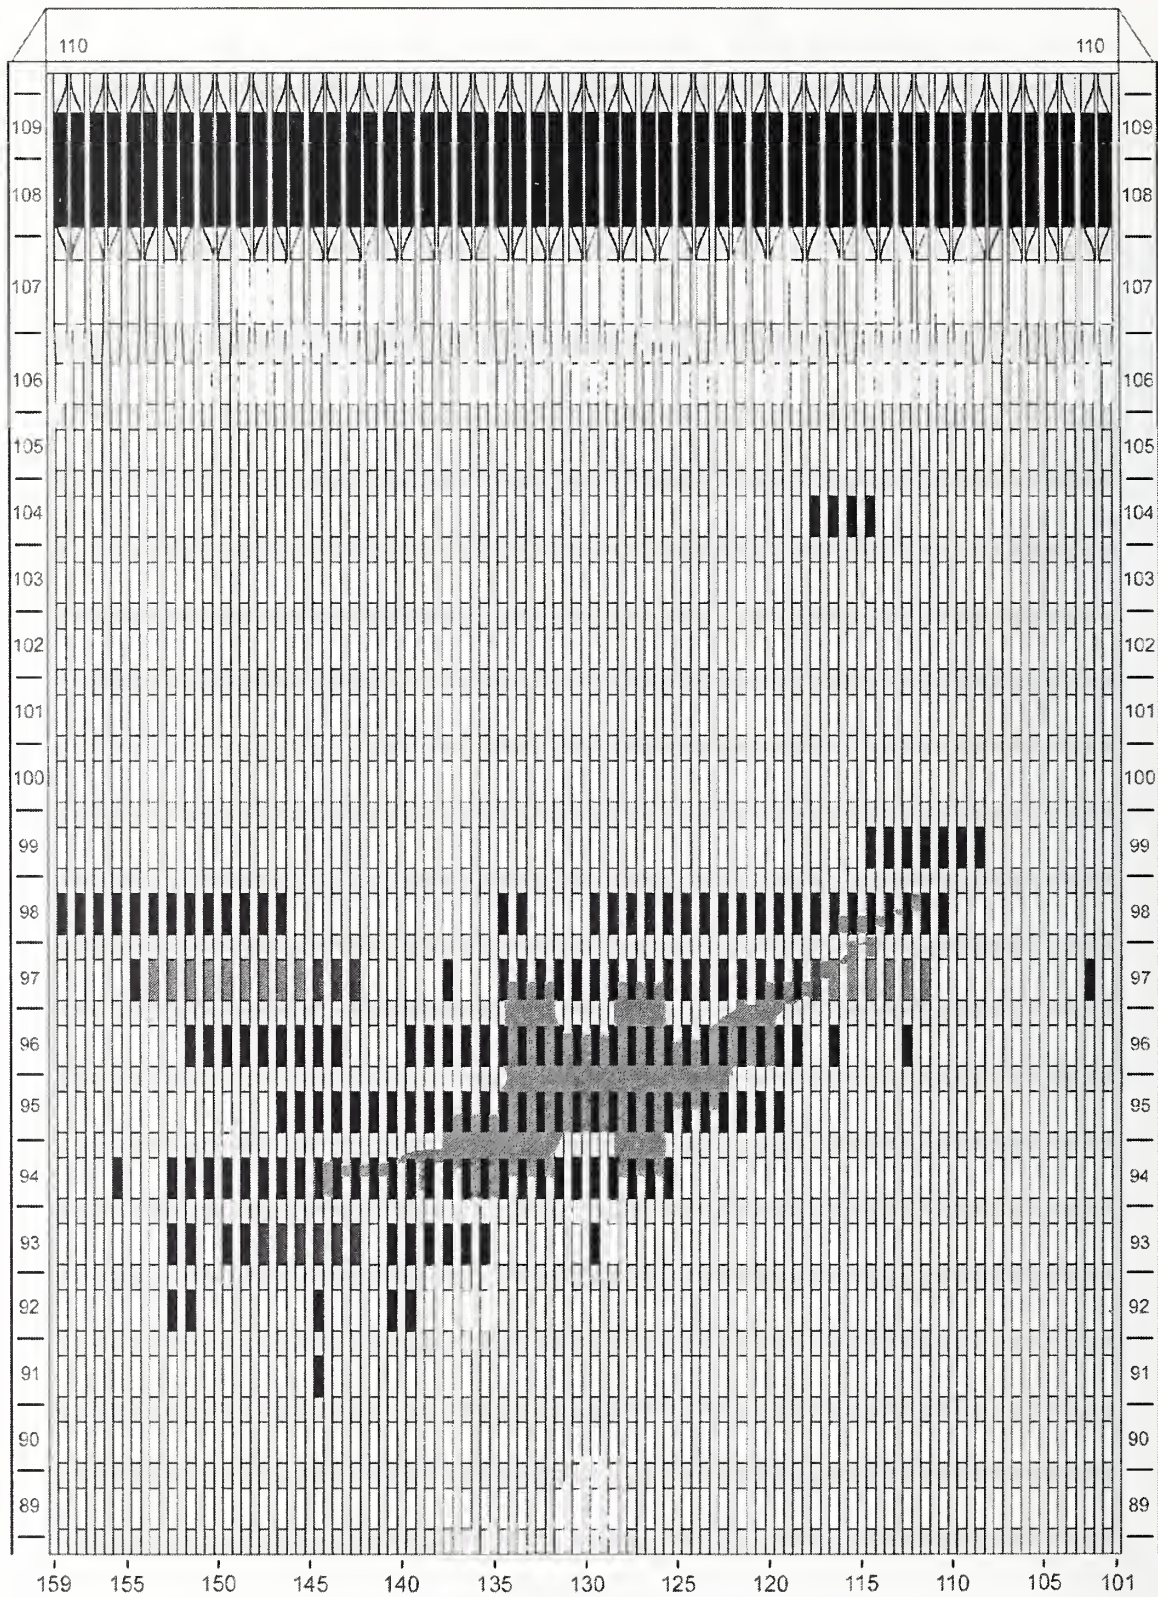
Figure C-11. Diagram of the north face of WTC 1 for floors 89 to 110 at 8:56 a.m. showing the condition of windows and locations of lines.

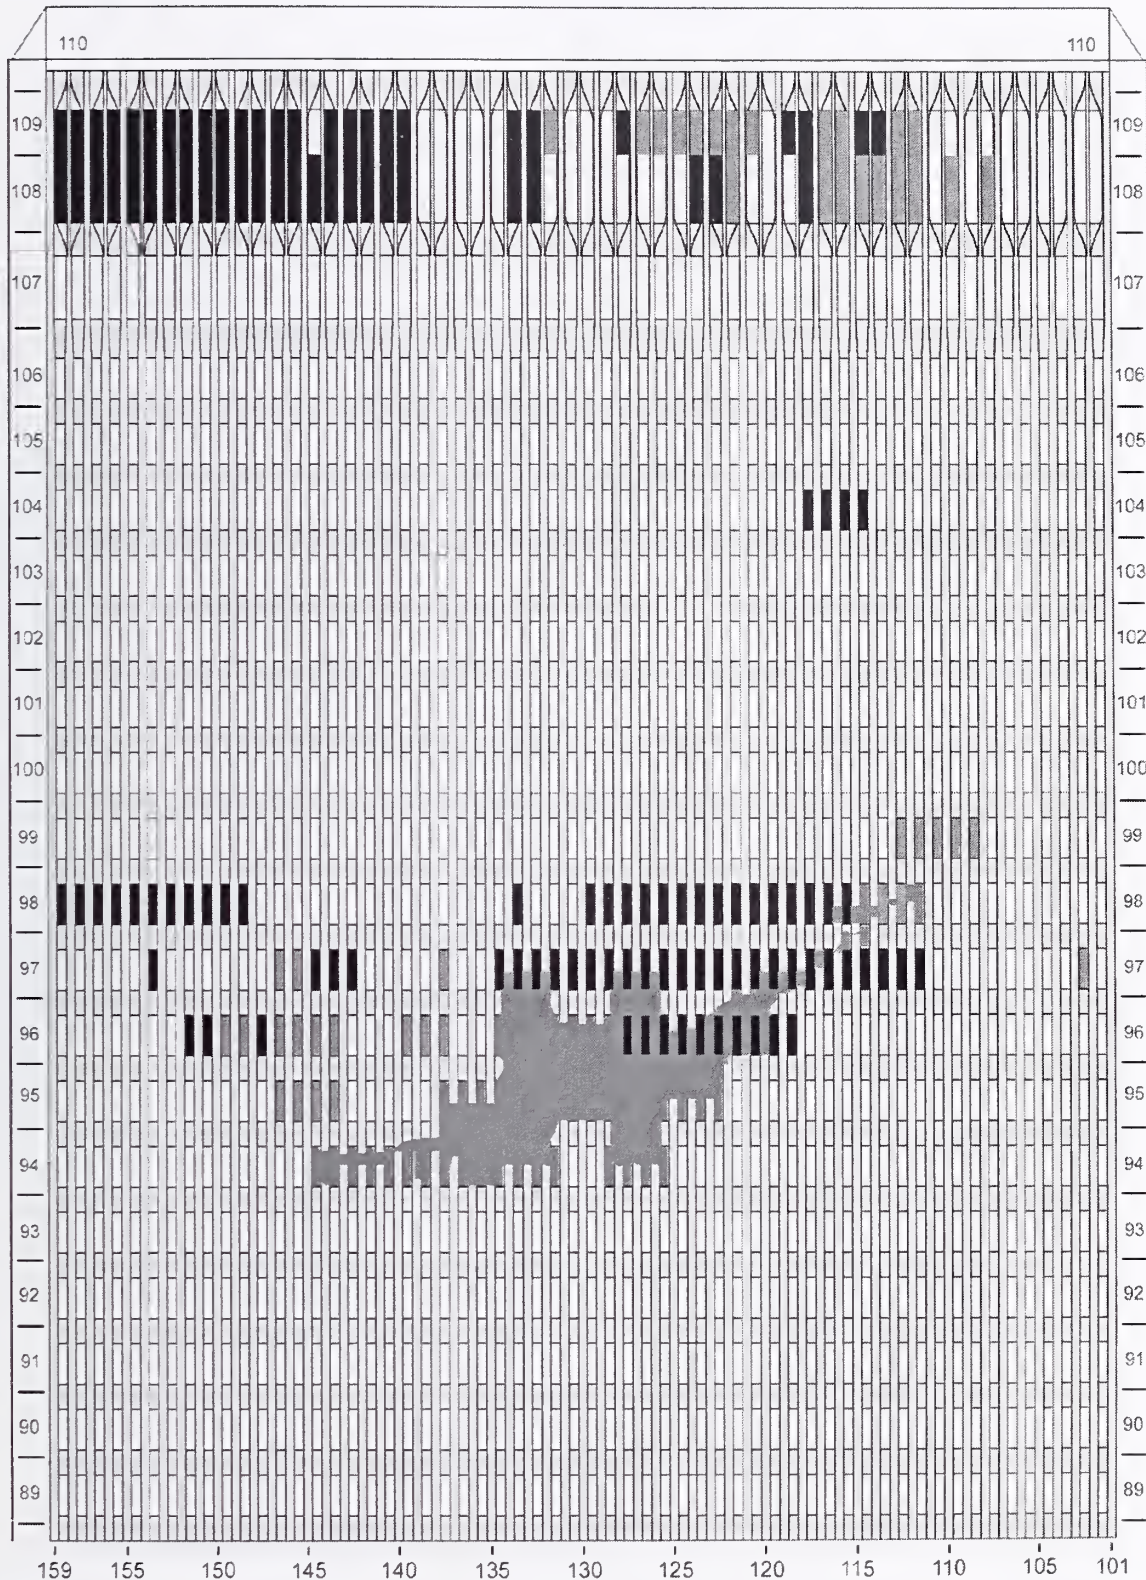
Figure C-12. Diagram of the north face of WTC 1 for floors 89 to 110 at 8:56 a.m. showing windows where smoke was observed and those that were hidden from view.

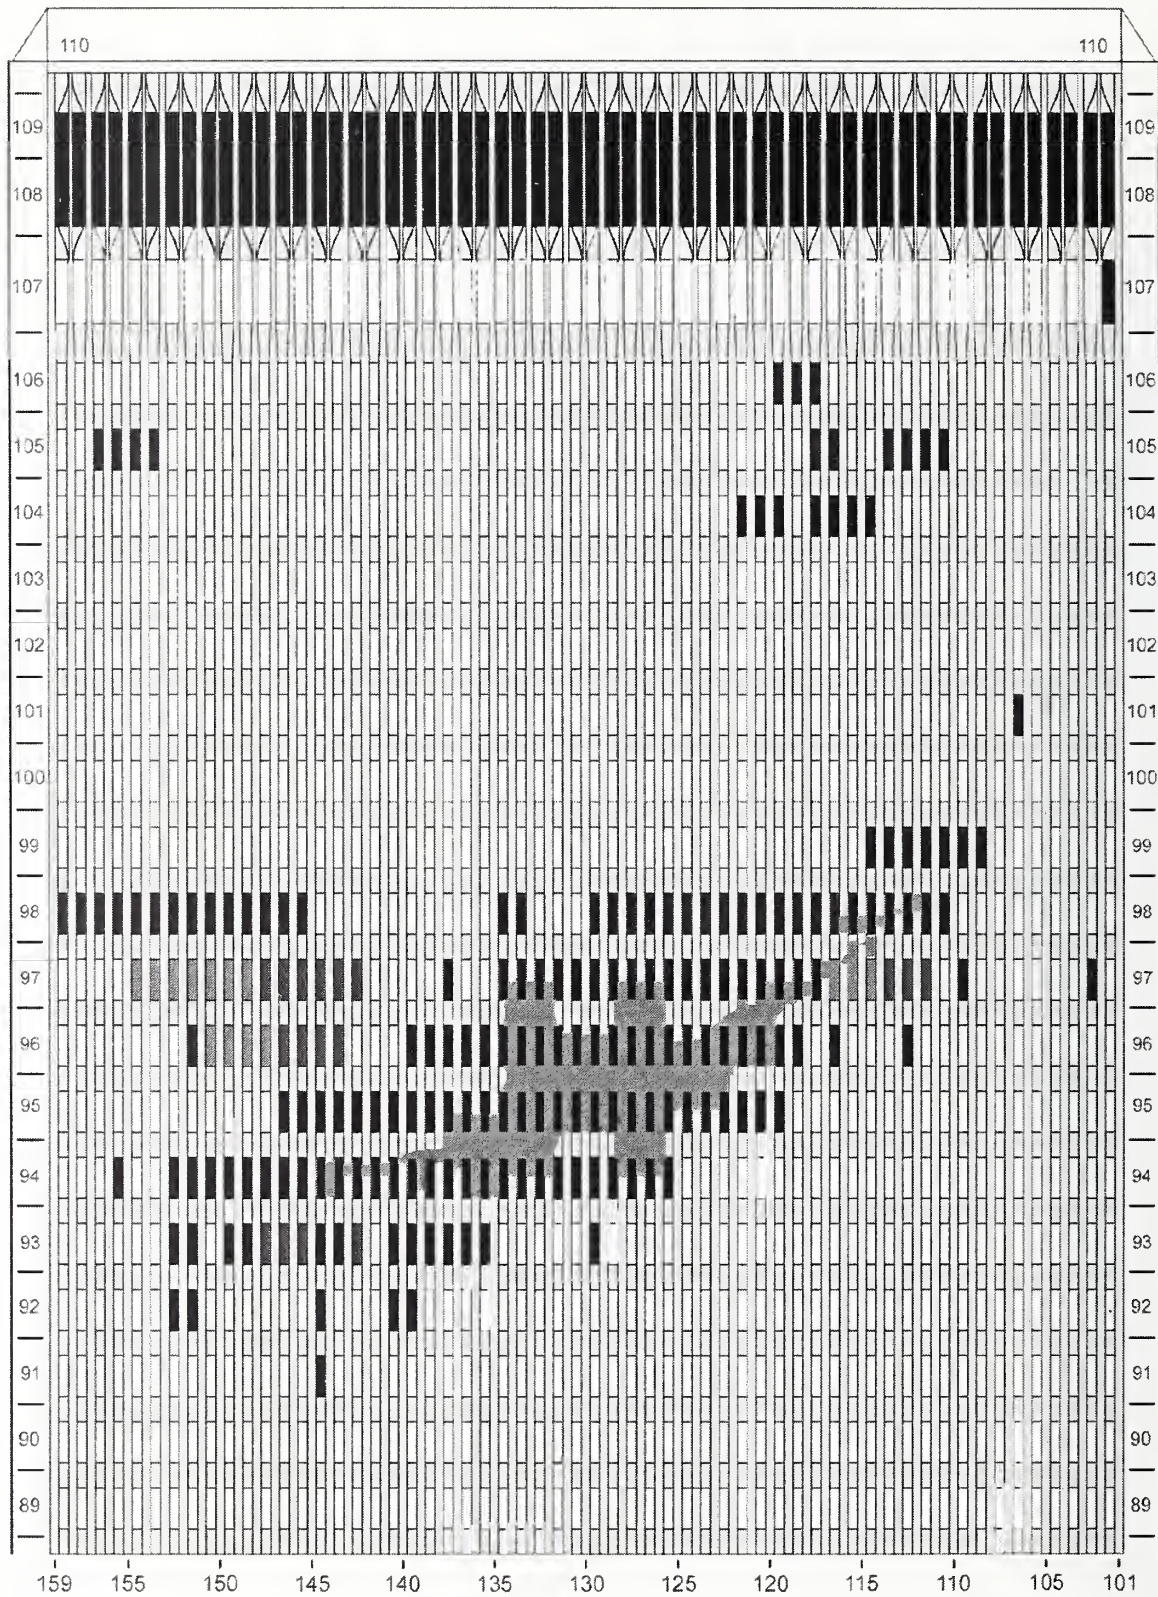
Figure C-13. Diagram of the north face of WTC 1 for floors 89 to 110 at 8:58 a.m. showing the condition of windows and locations of fires.

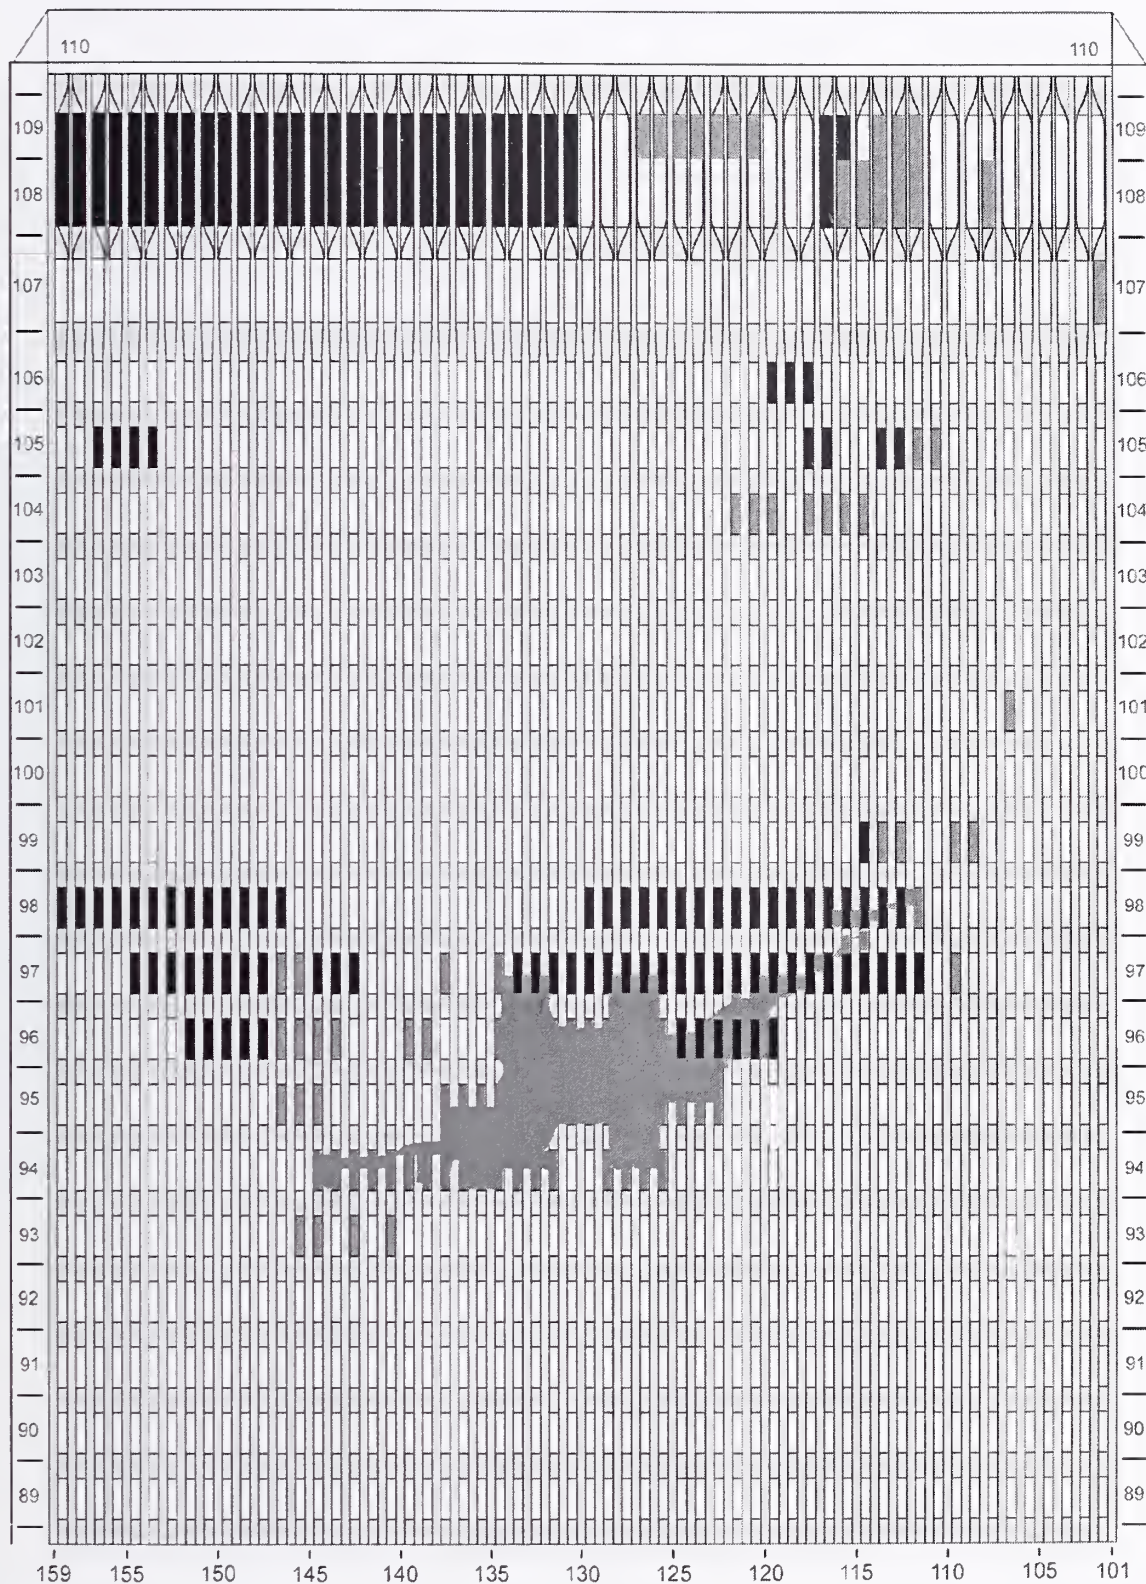
Figure C-14. Diagram of the north face of WTC 1 for floors 89 to 110 at 8:58 a.m. showing windows where smoke was observed and those that were hidden from view.

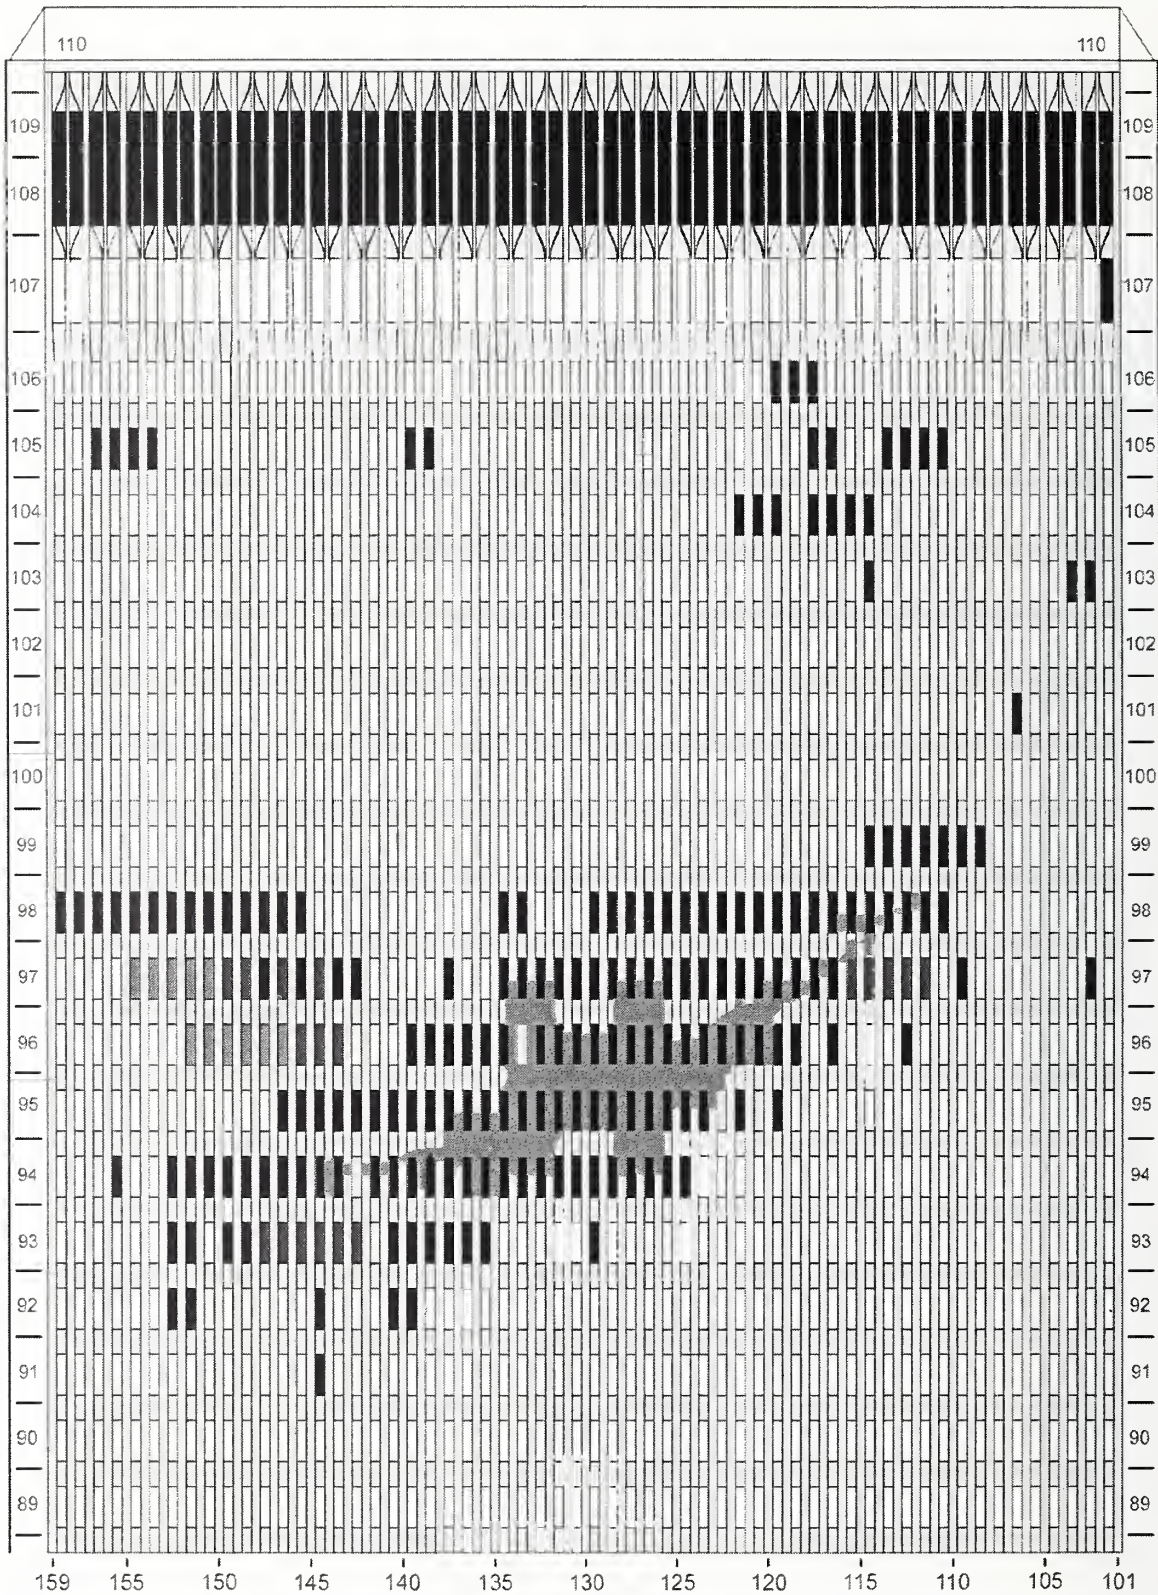
Figure C-15. Diagram of the north face of WTC 1 for floors 89 to 110 at 9:00 a.m. showing the condition of windows and locations of fires.

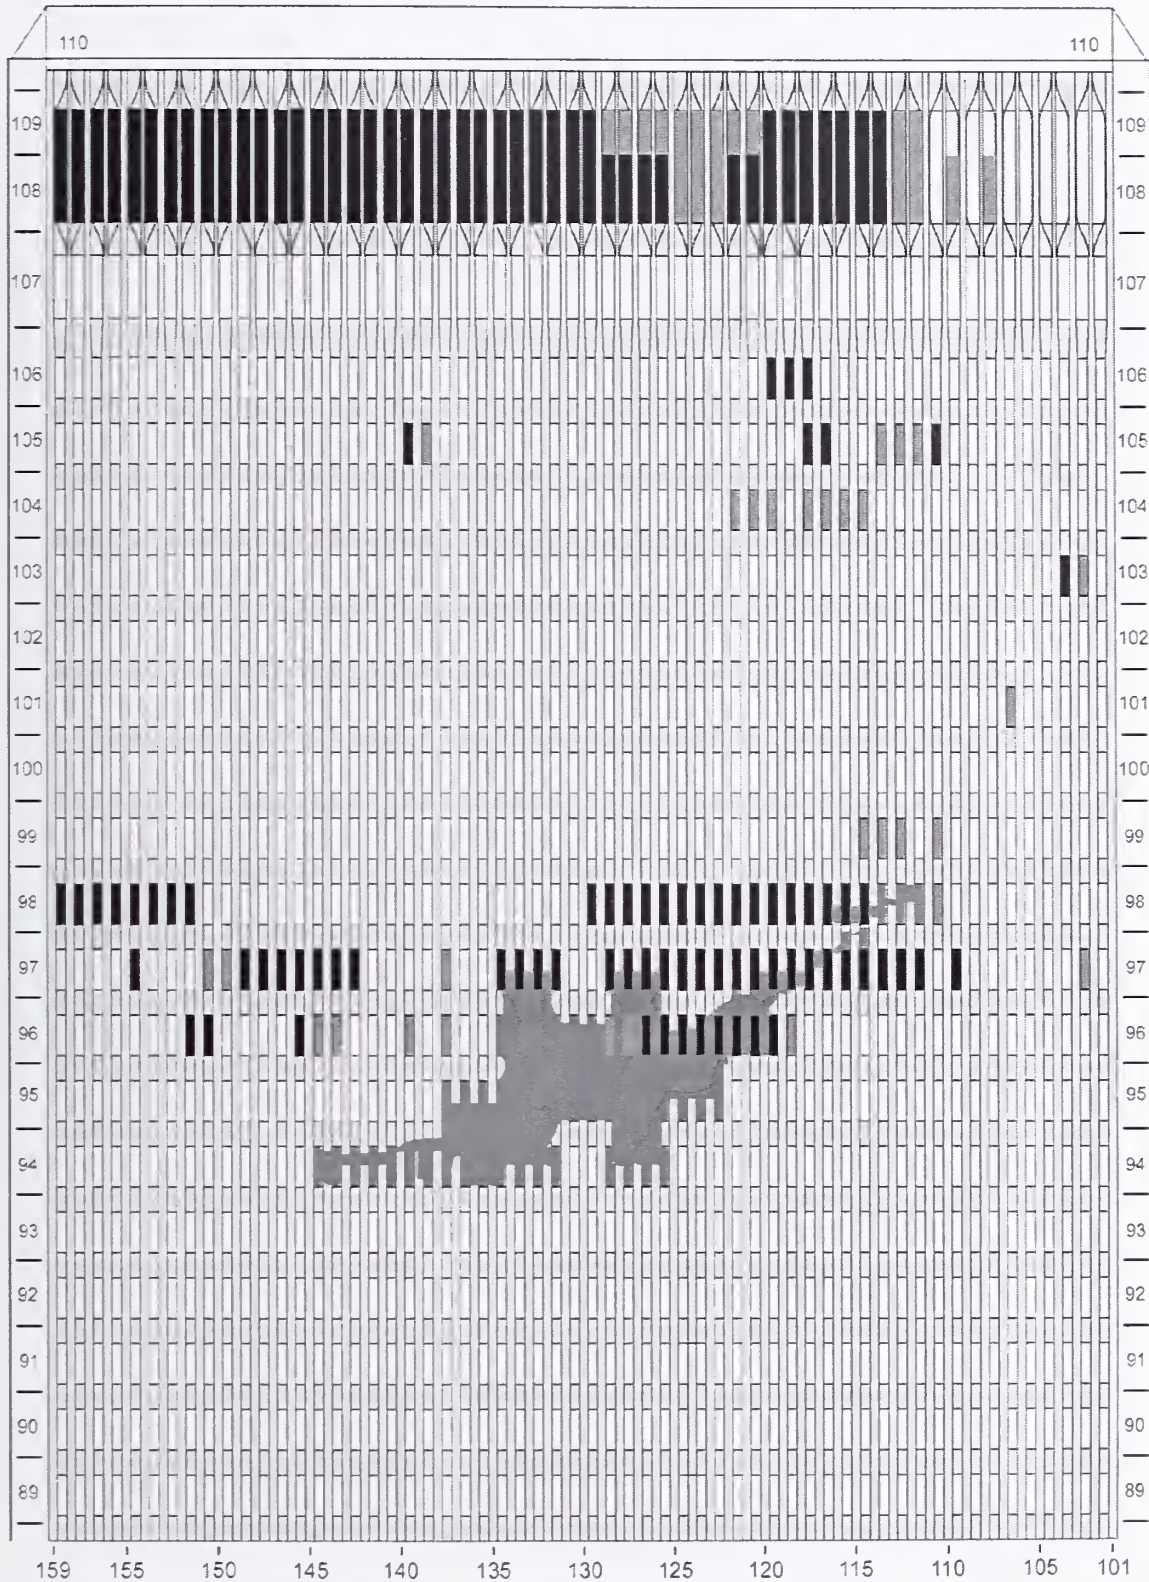
Figure C-16. Diagram of the north face of WTC 1 for floors 89 to 110 at 9:00 a.m. showing windows where smoke was observed and those that were hidden from view.

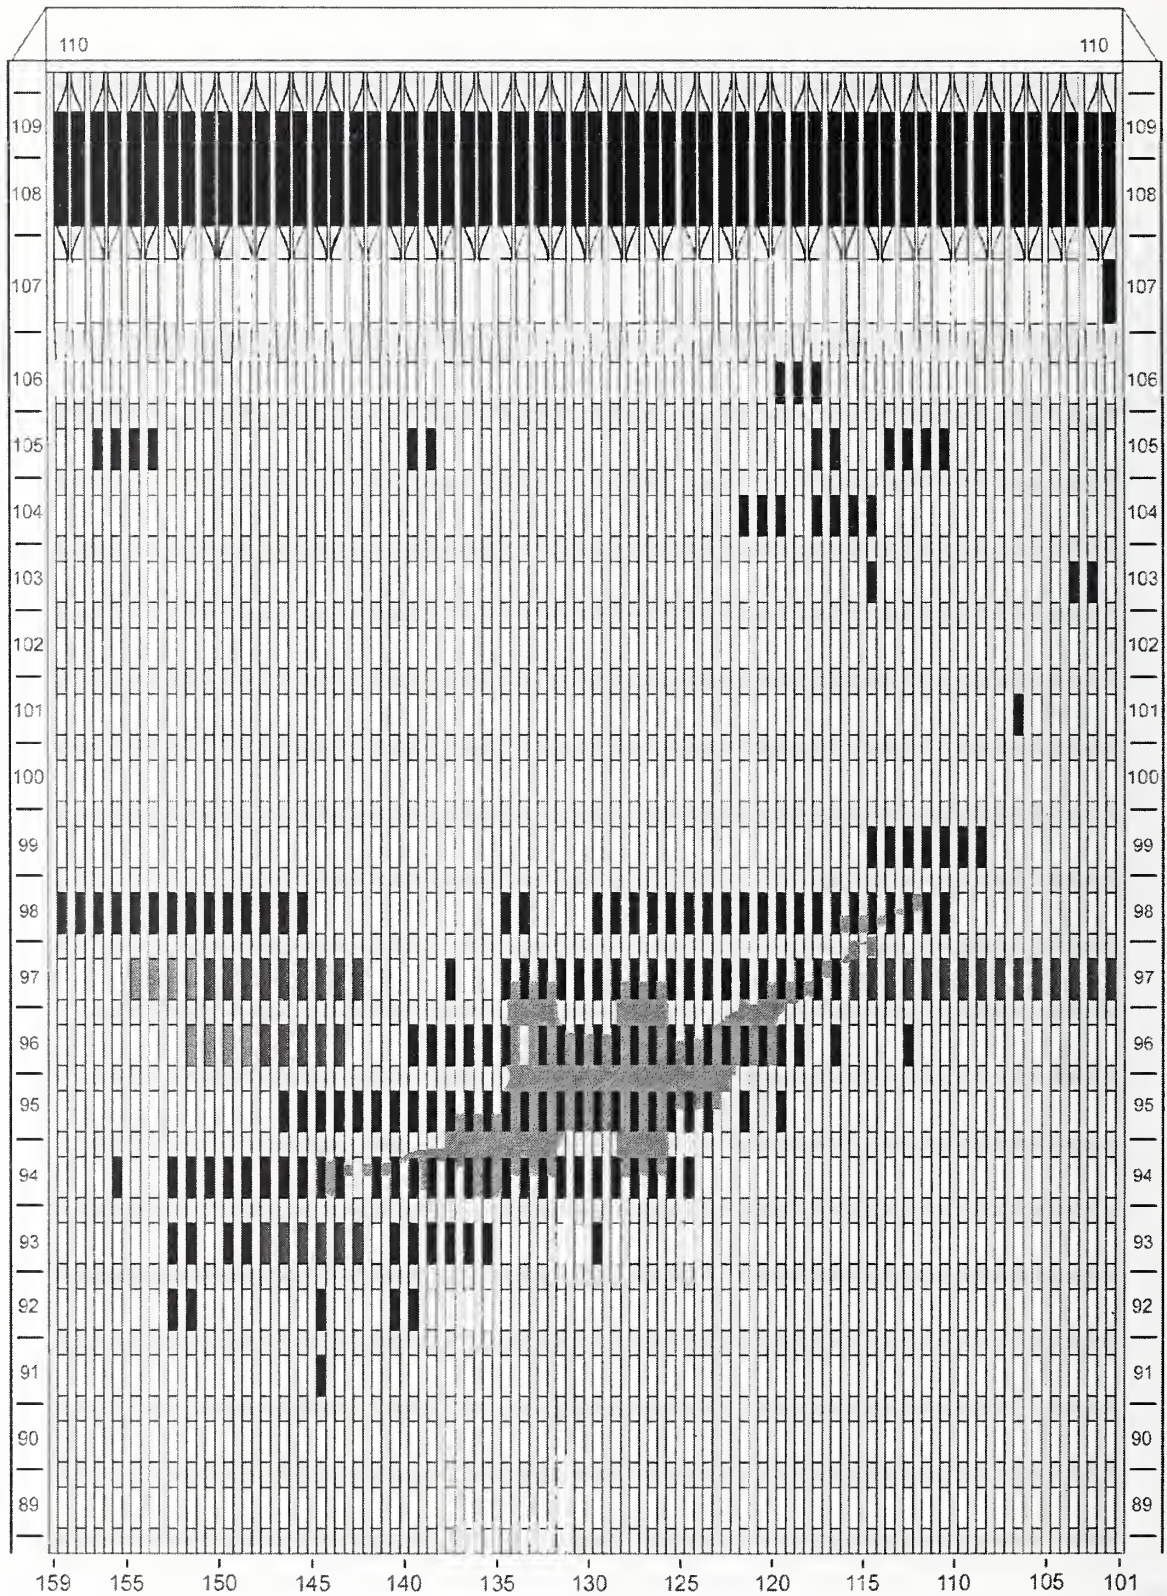
Figure C-17. Diagram of the north face of WTC 1 for floors 89 to 110 at 9:02 a.m. showing the condition of windows and locations of fires.

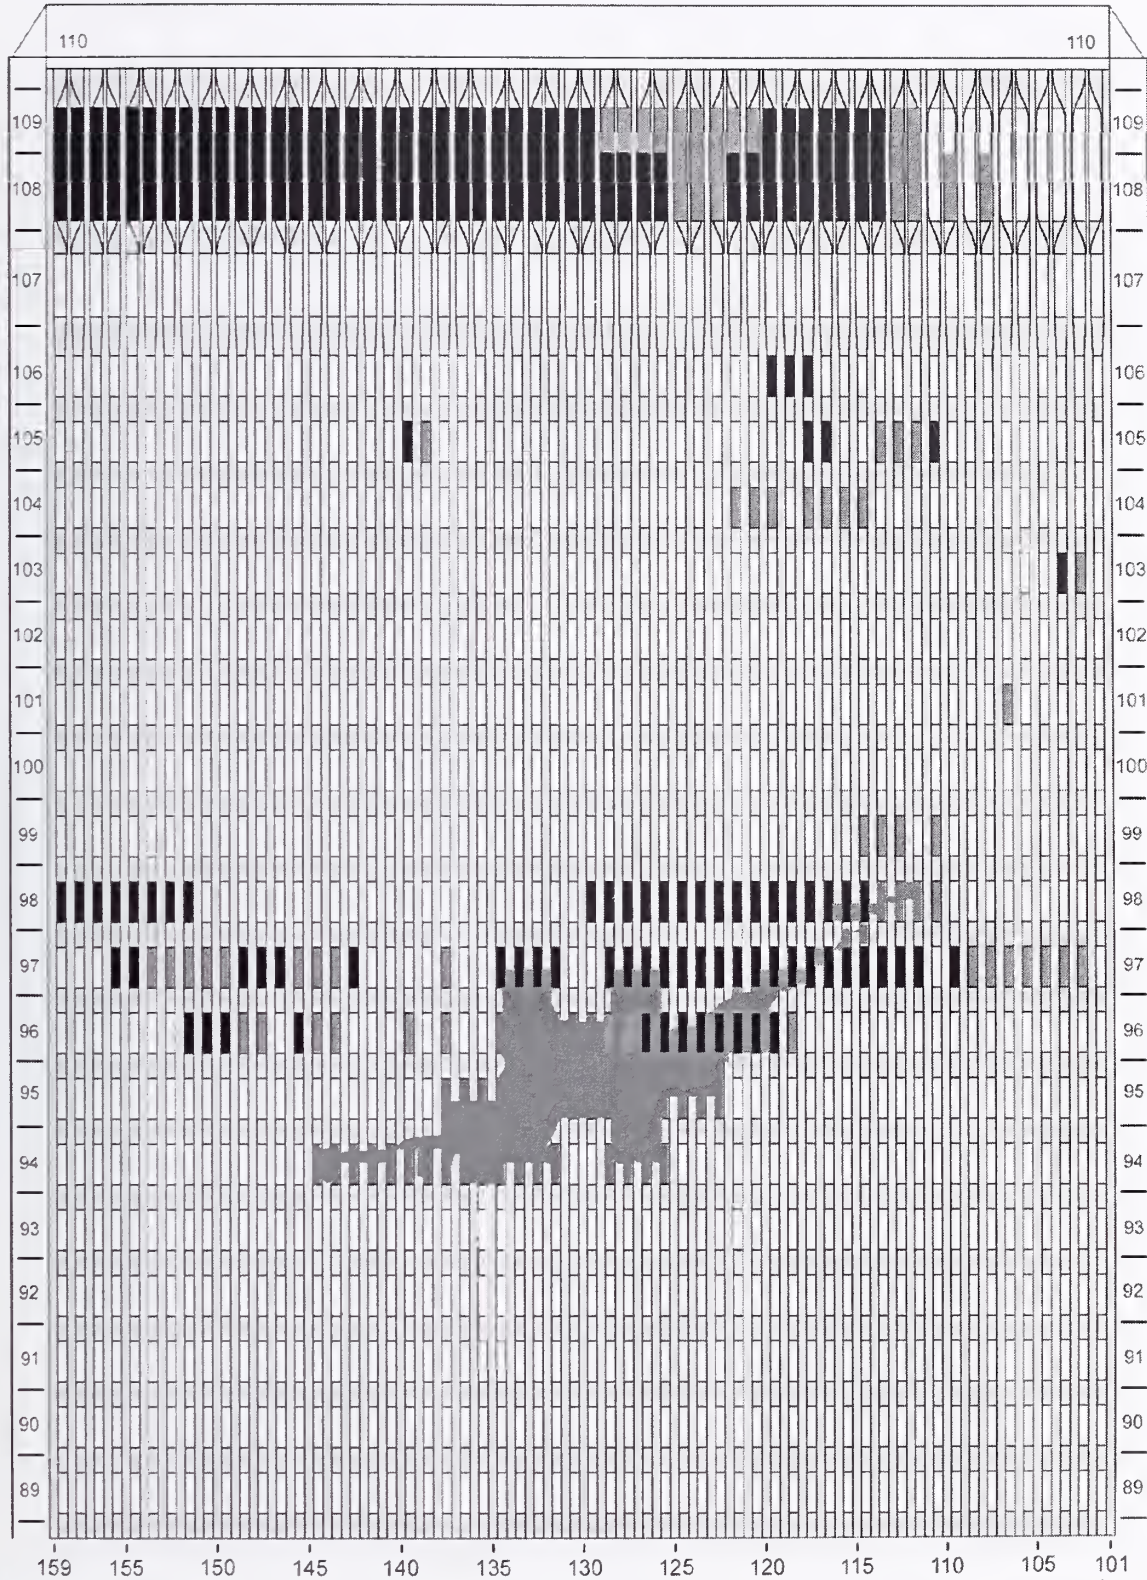
Figure C-18. Diagram of the north face of WTC 1 for floors 89 to 110 at 9:02 a.m. showing windows where smoke was observed and those that were hidden from view.
