**NIST NCSTAR 1-5A
Federal Building and Fire Safety Investigation of
the World Trade Center Disaster**

**Visual Evidence, Damage Estimates,
And Timeline Analysis**

(Chapter 9 - Appendix C)

FIRE BEHAVIOR IN WORLD TRADE CENTER 2

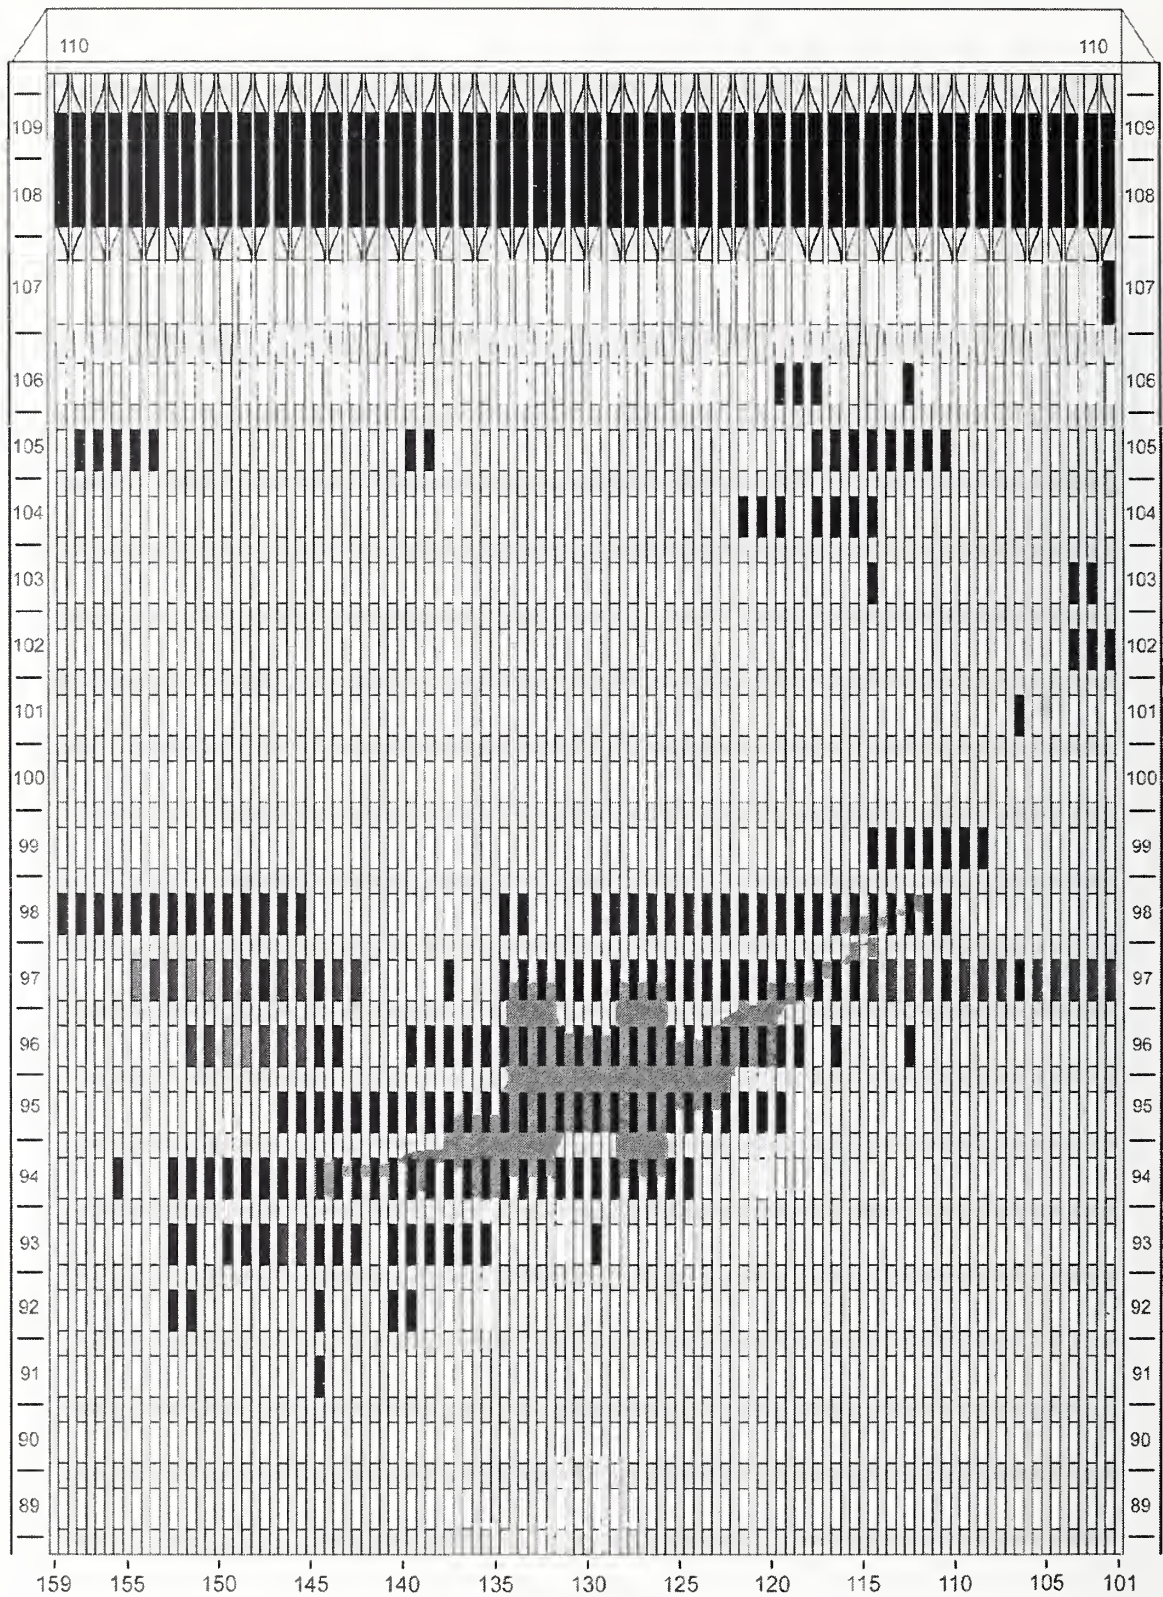
Figure C-19. Diagram of the north face of WTC 1 for floors 89 to 110 at 9:04 a.m. showing the condition of windows and locations of fires.

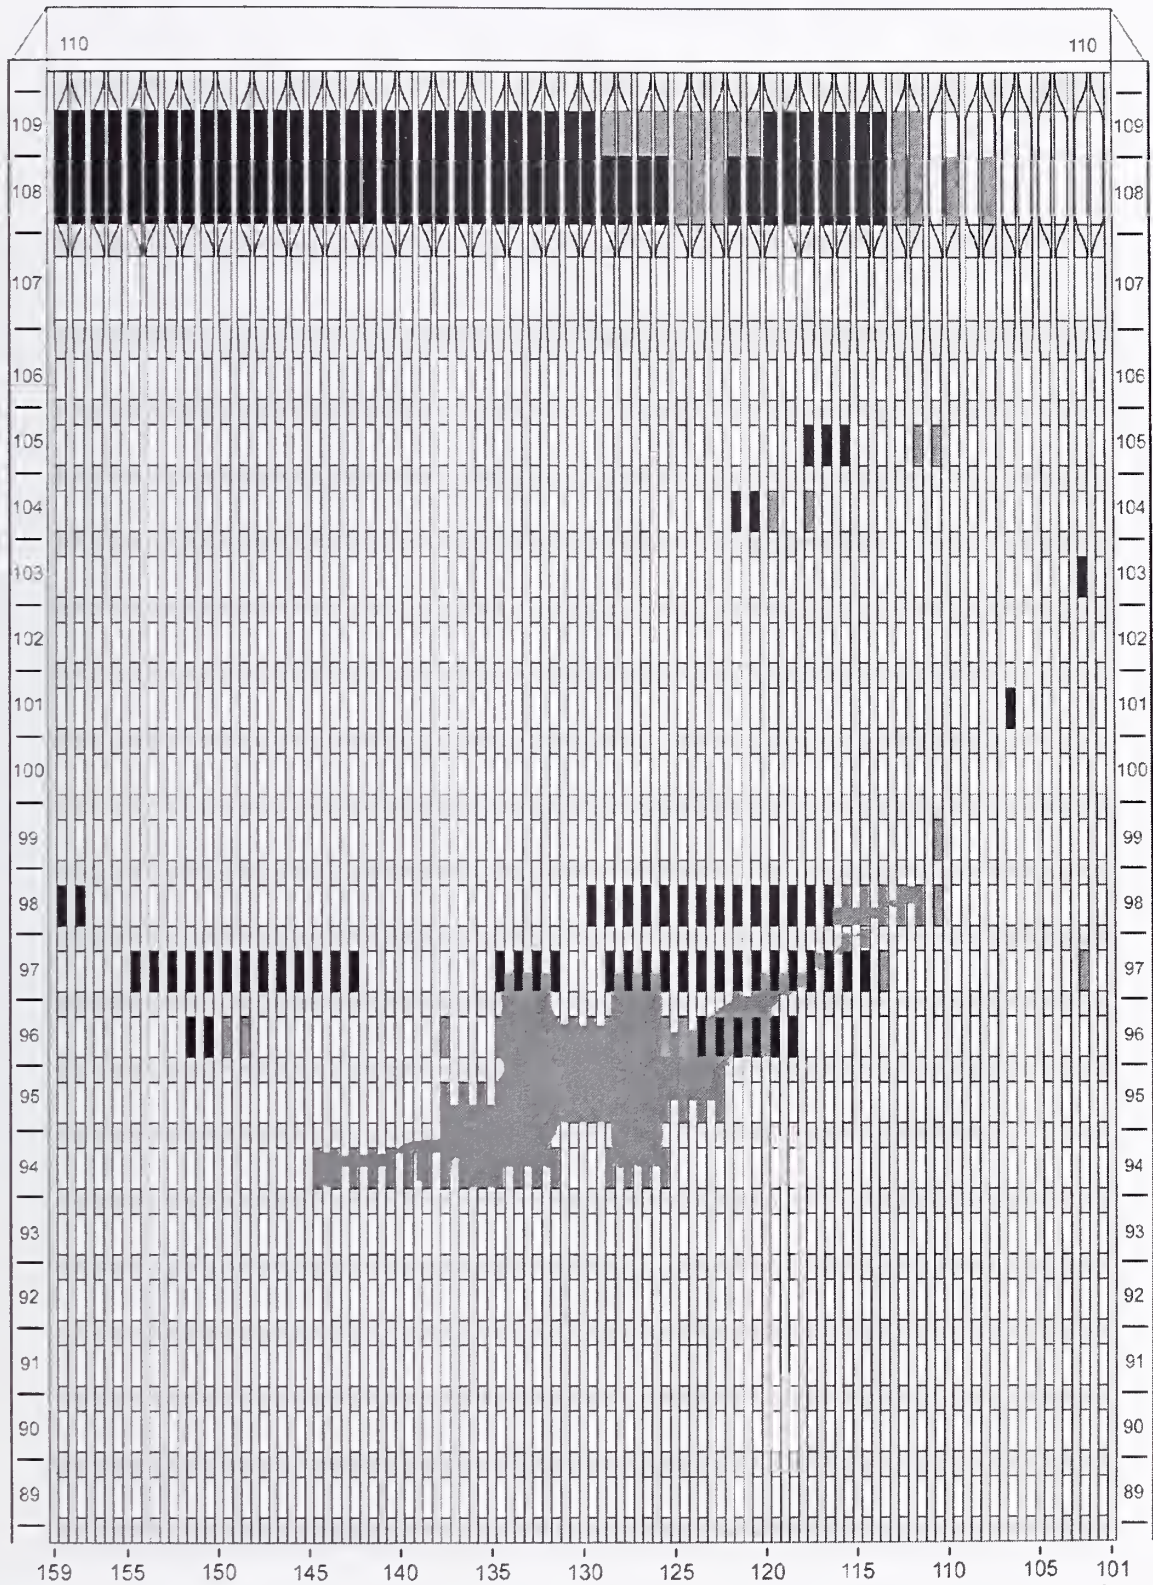
Figure C-20. Diagram of the north face of WTC 1 for floors 89 to 110 at 9:04 a.m. showing windows where smoke was observed and those that were hidden from view.

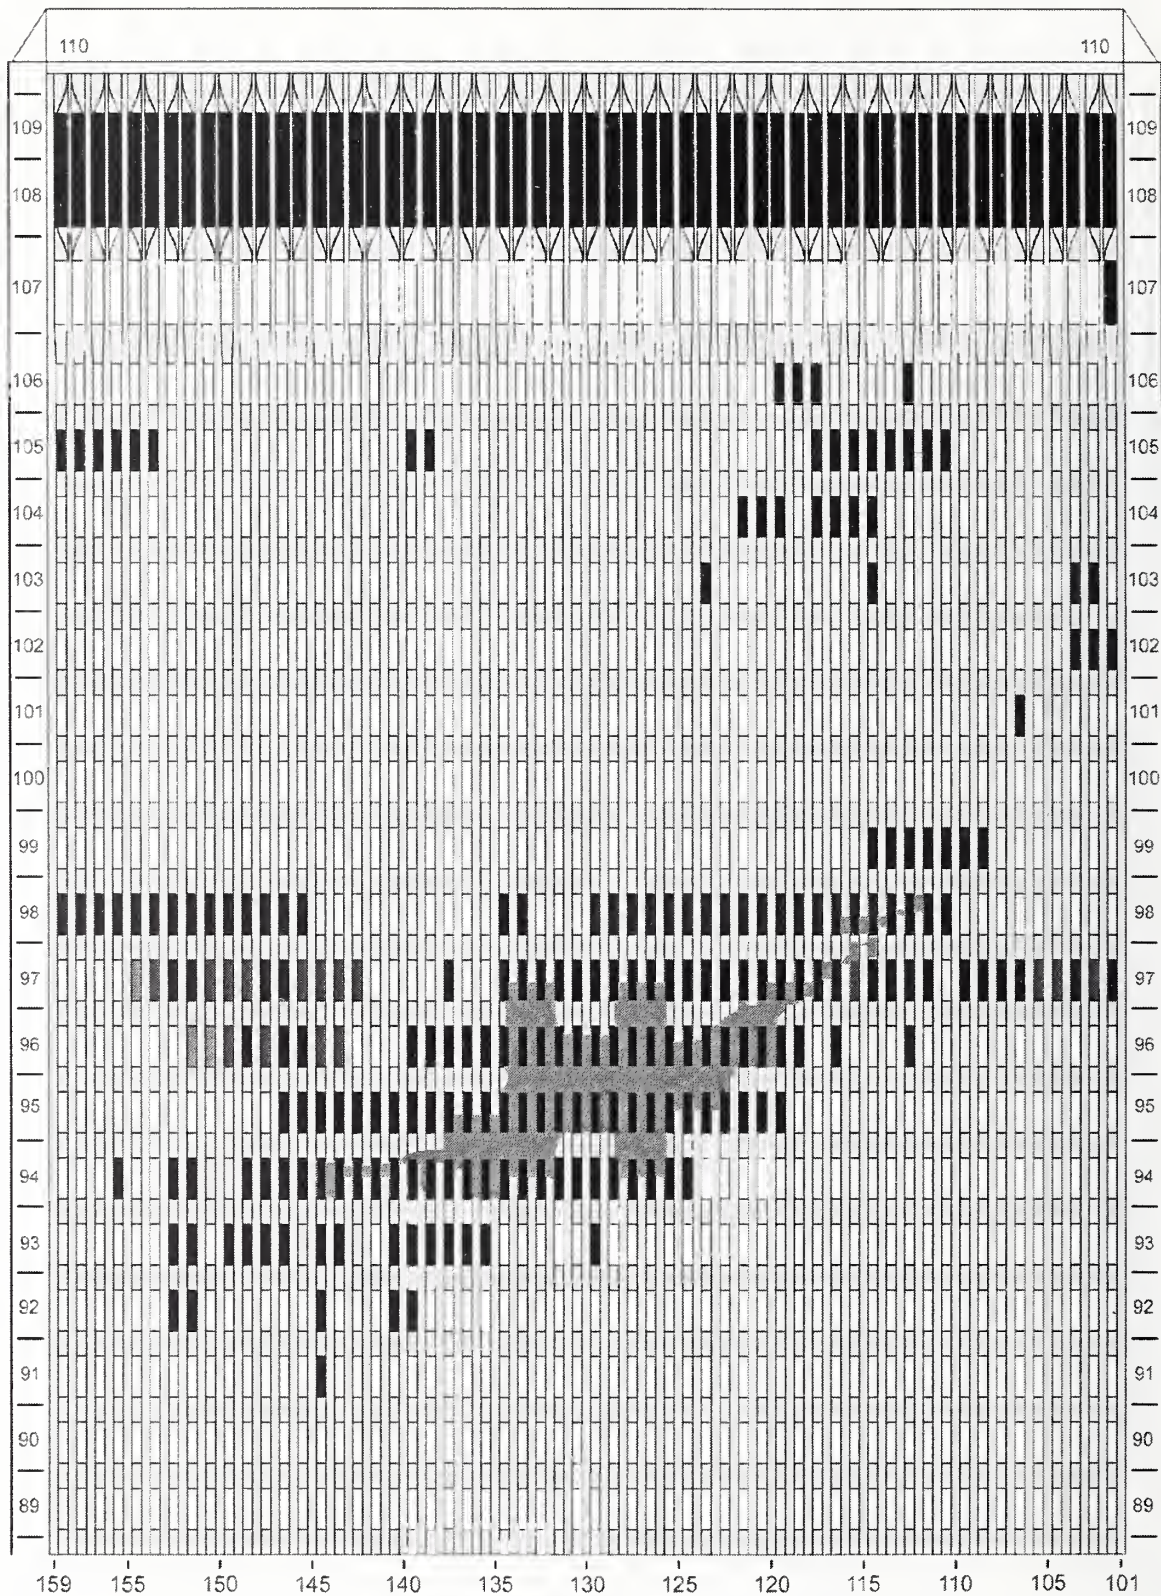
Figure C-21. Diagram of the north face of WTC 1 for floors 89 to 110 at 9:10 a.m. showing the condition of windows and locations of fires.

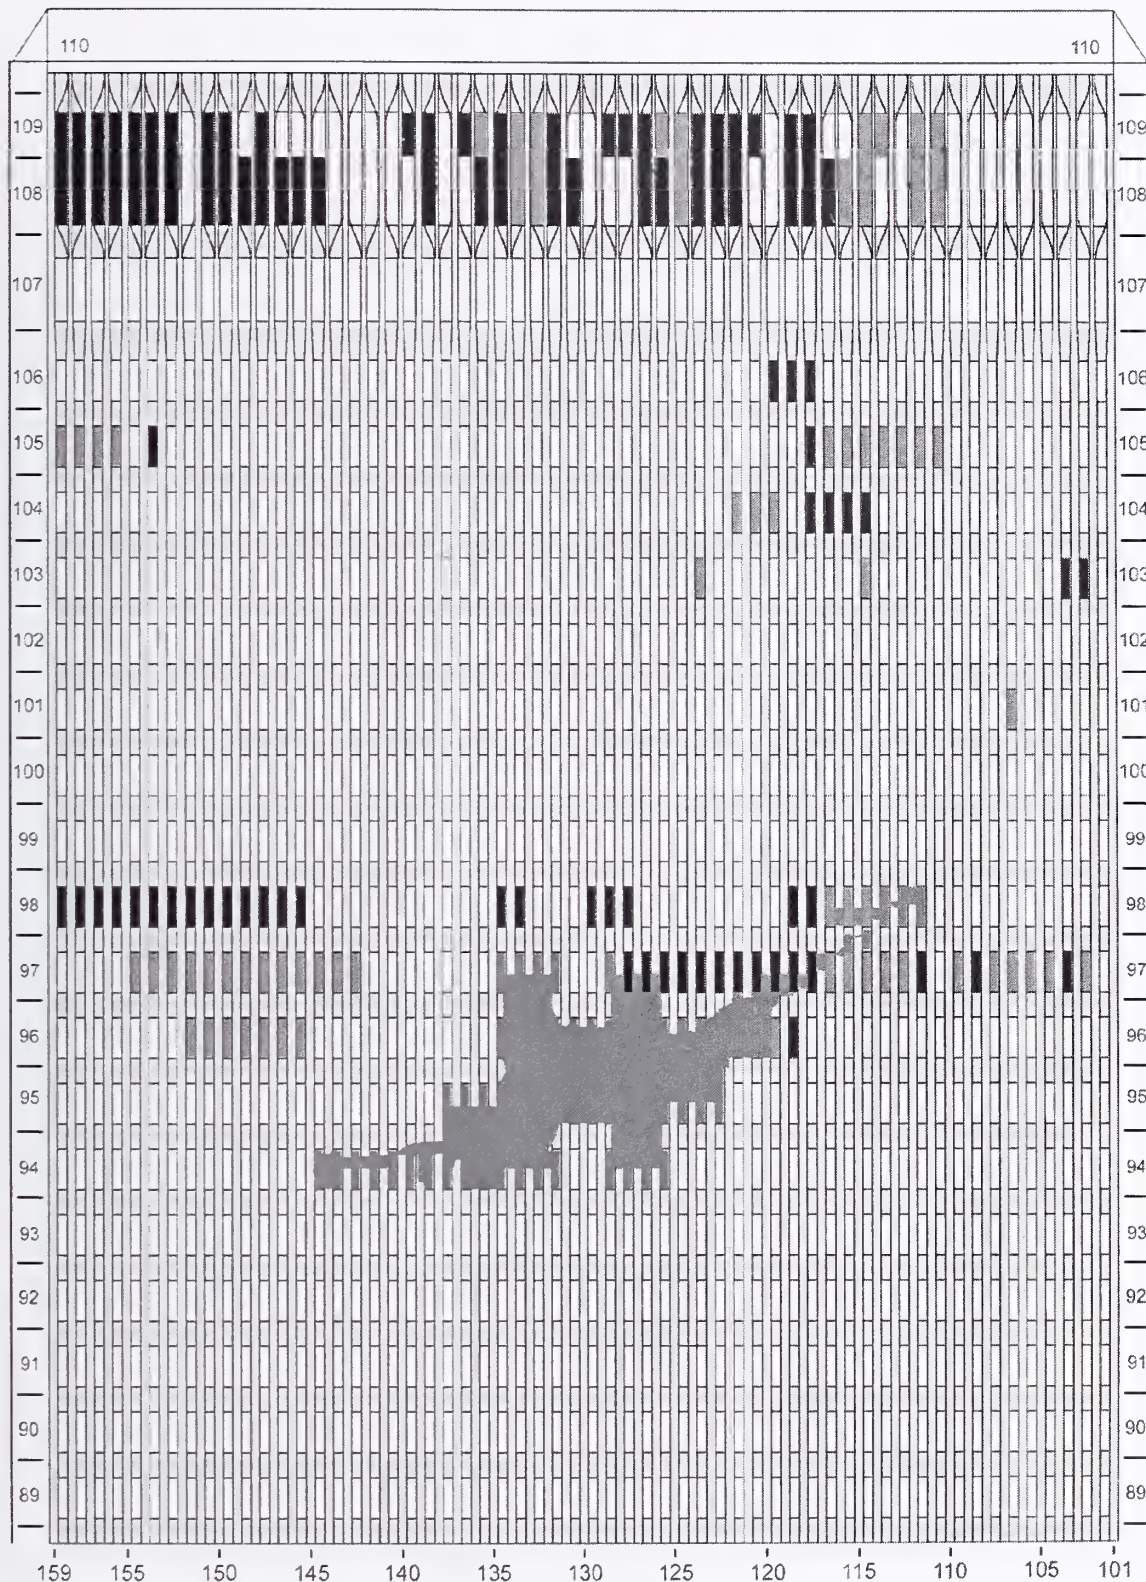
Figure C-22. Diagram of the north face of WTC 1 for floors 89 to 110 at 9:10 a.m. showing windows where smoke was observed and those that were hidden from view.

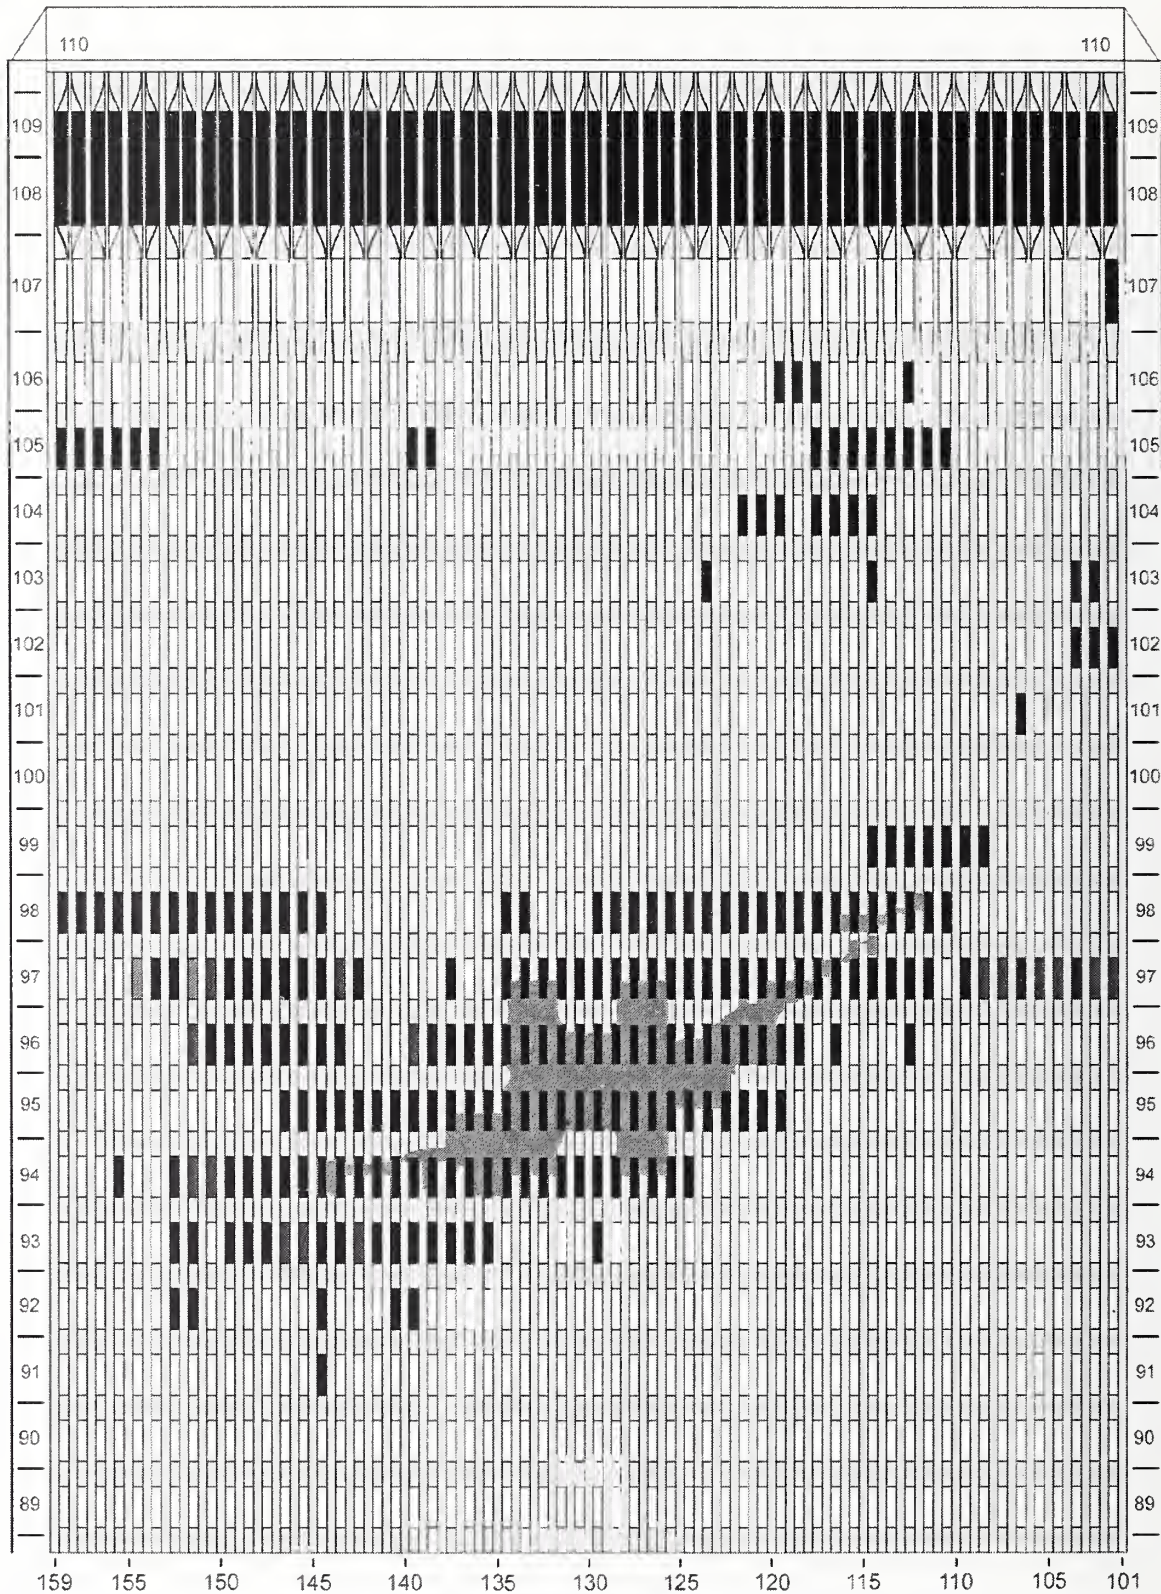
Figure C-23. Diagram of the north face of WTC 1 for floors 89 to 110 at 9:14 a.m. showing the condition of windows and locations of fires.

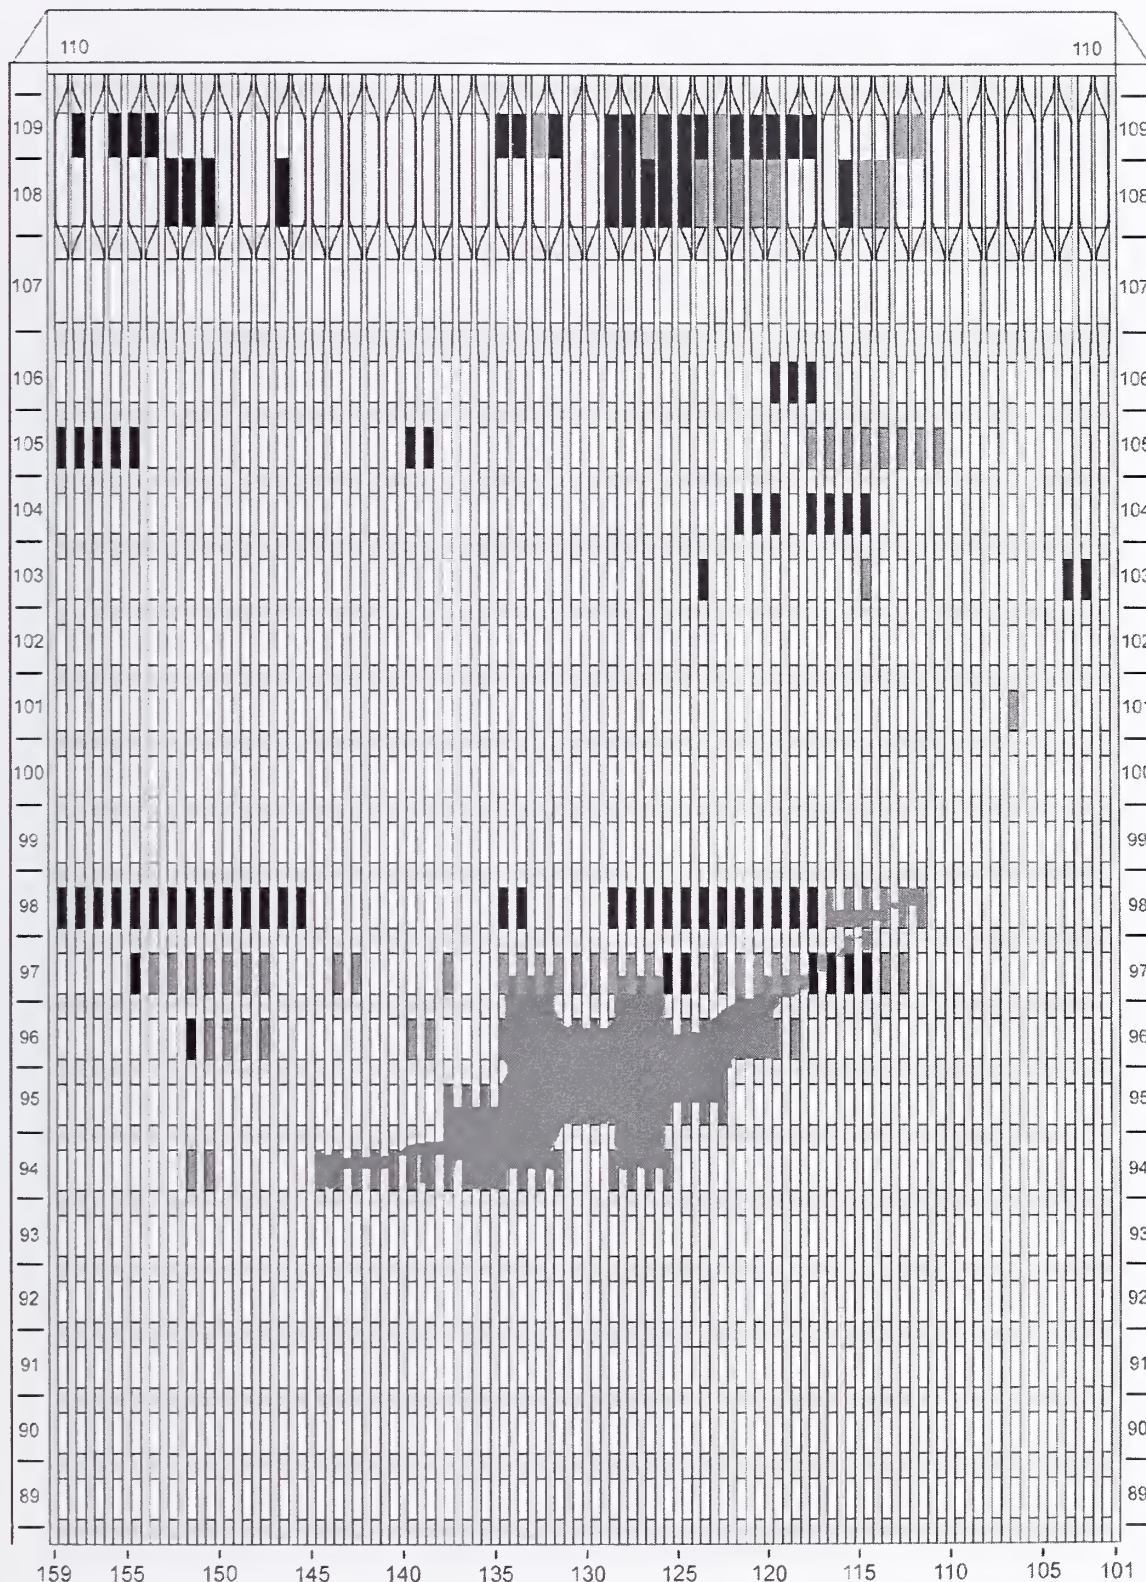
Figure C-24. Diagram of the north face of WTC 1 for floors 89 to 110 at 9:14 a.m. showing windows where smoke was observed and those that were hidden from view.

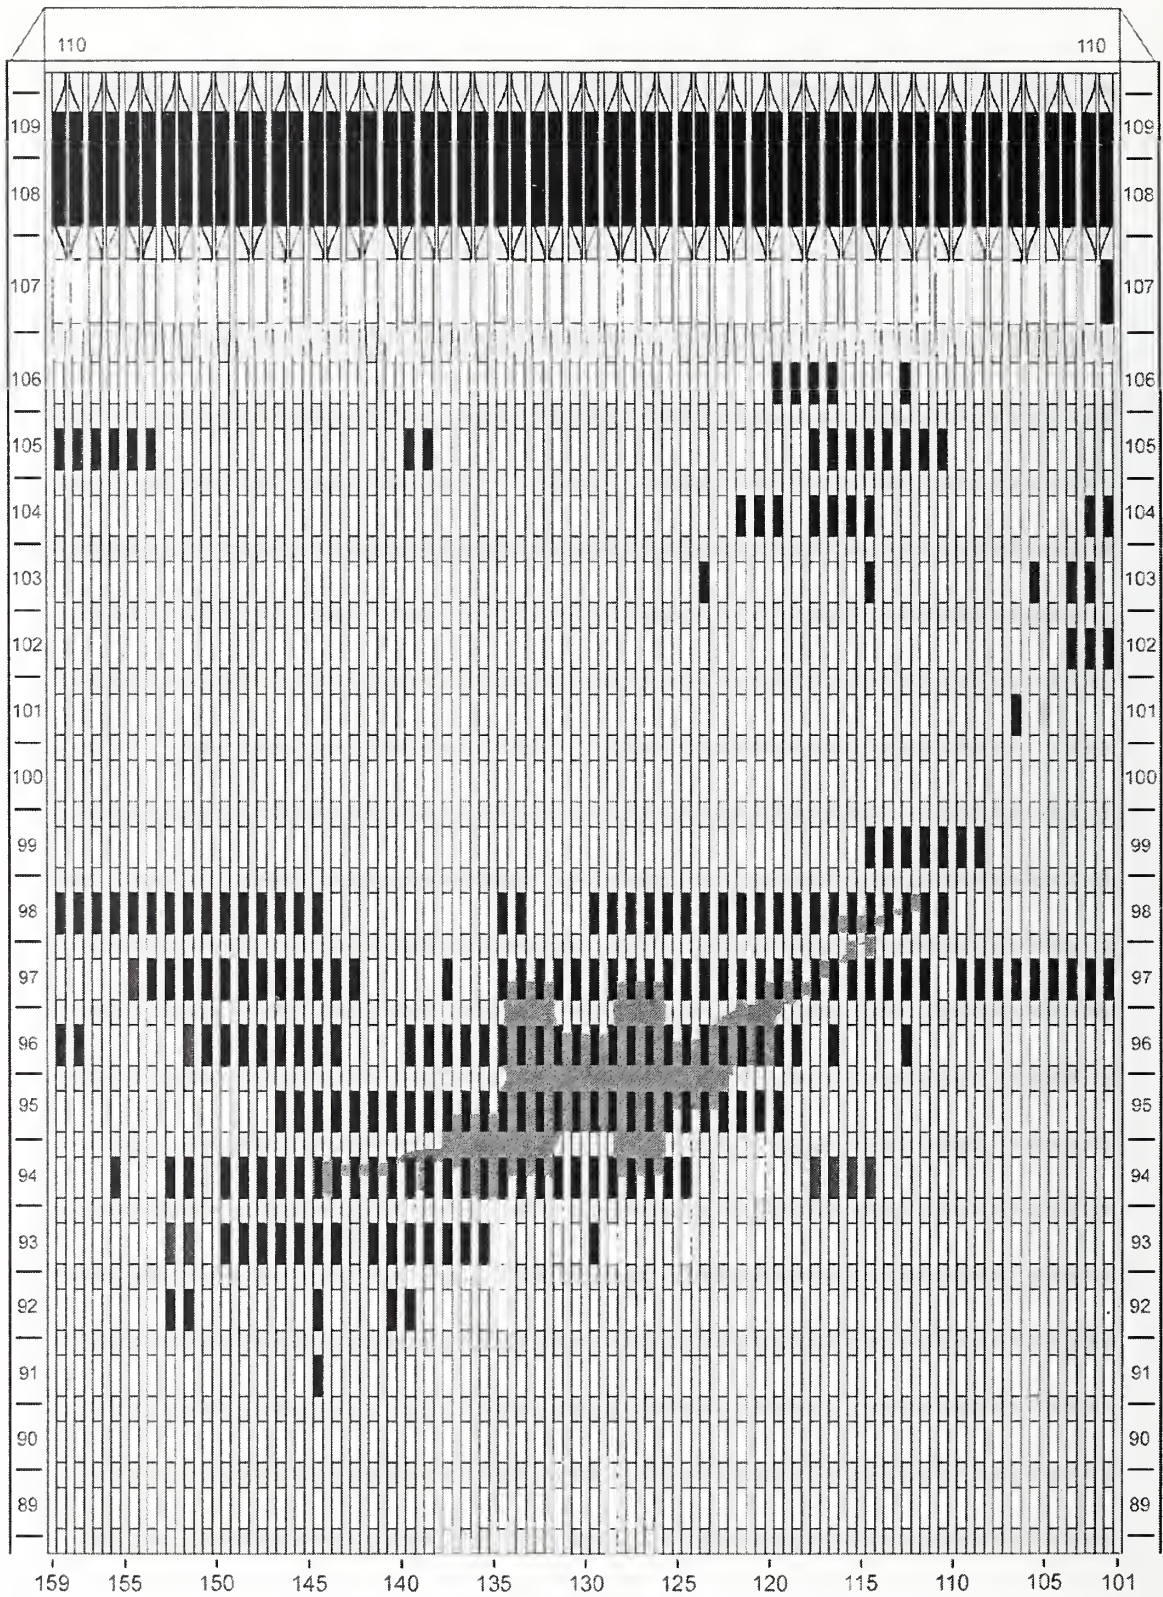
Figure C-25. Diagram of the north face of WTC 1 for floors 89 to 110 at 9:18 a.m. showing the condition of windows and locations of fires.

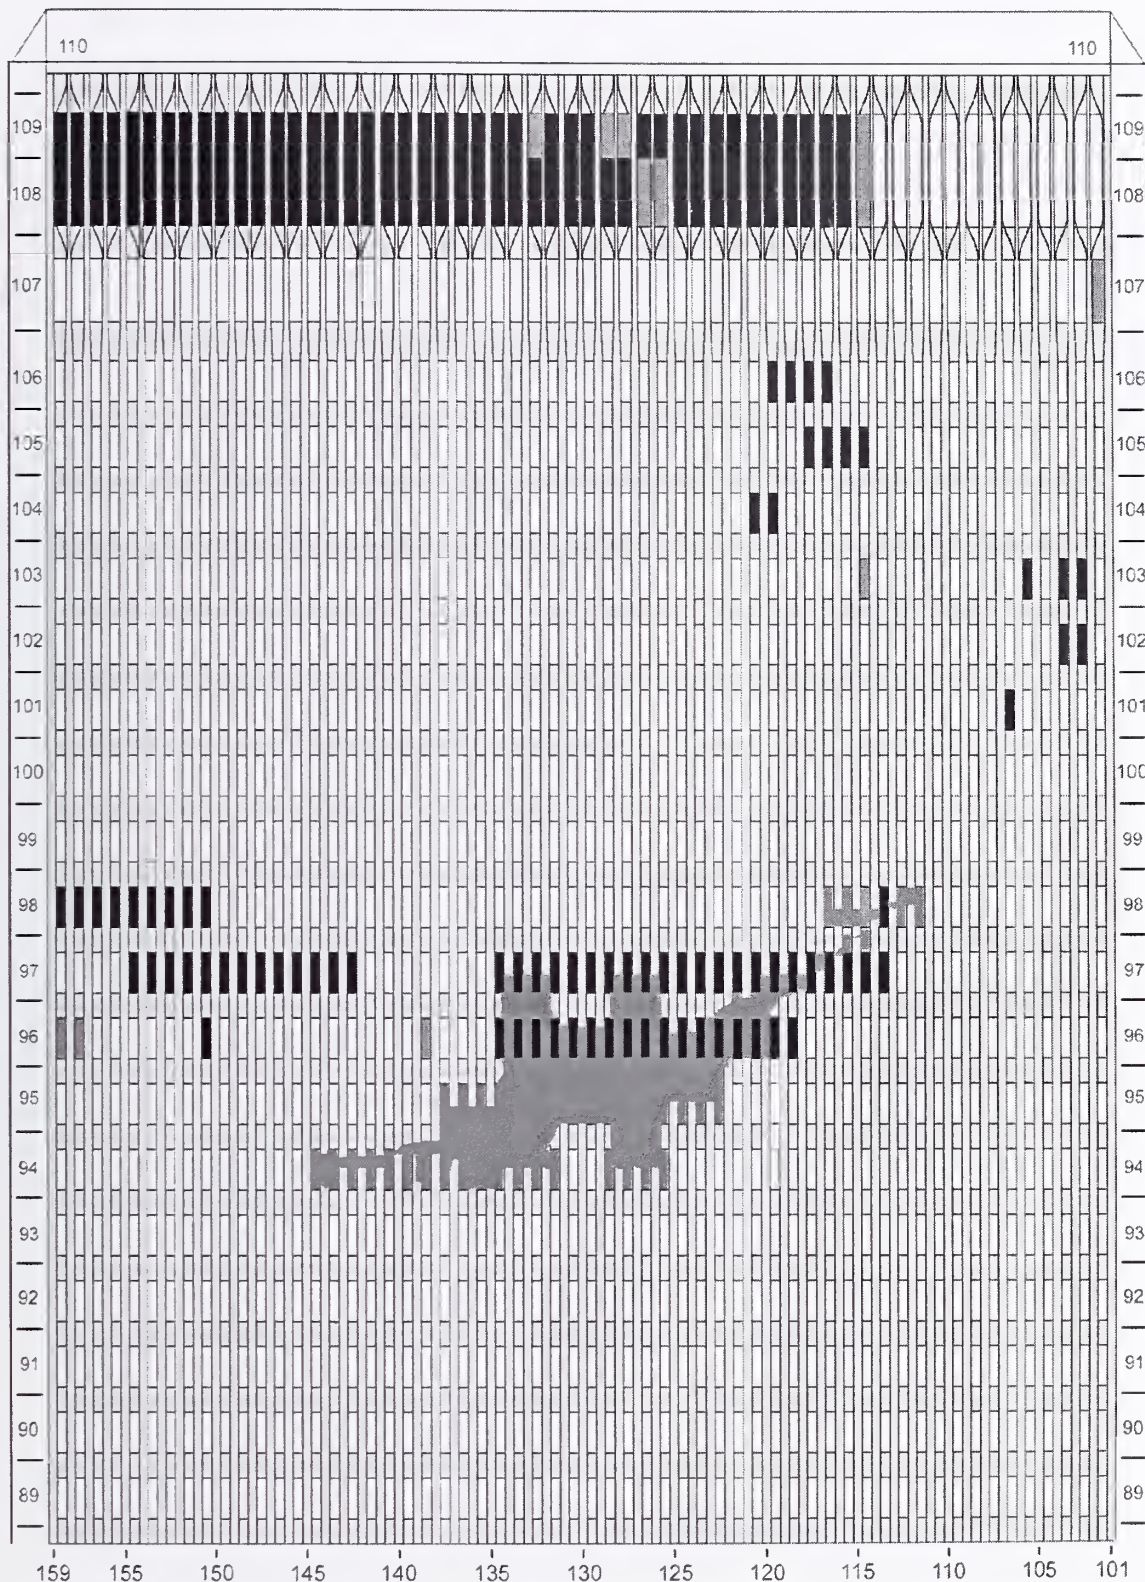
Figure C-26. Diagram of the north face of WTC 1 for floors 89 to 110 at 9:18 a.m. showing windows where smoke was observed and those that were hidden from view.

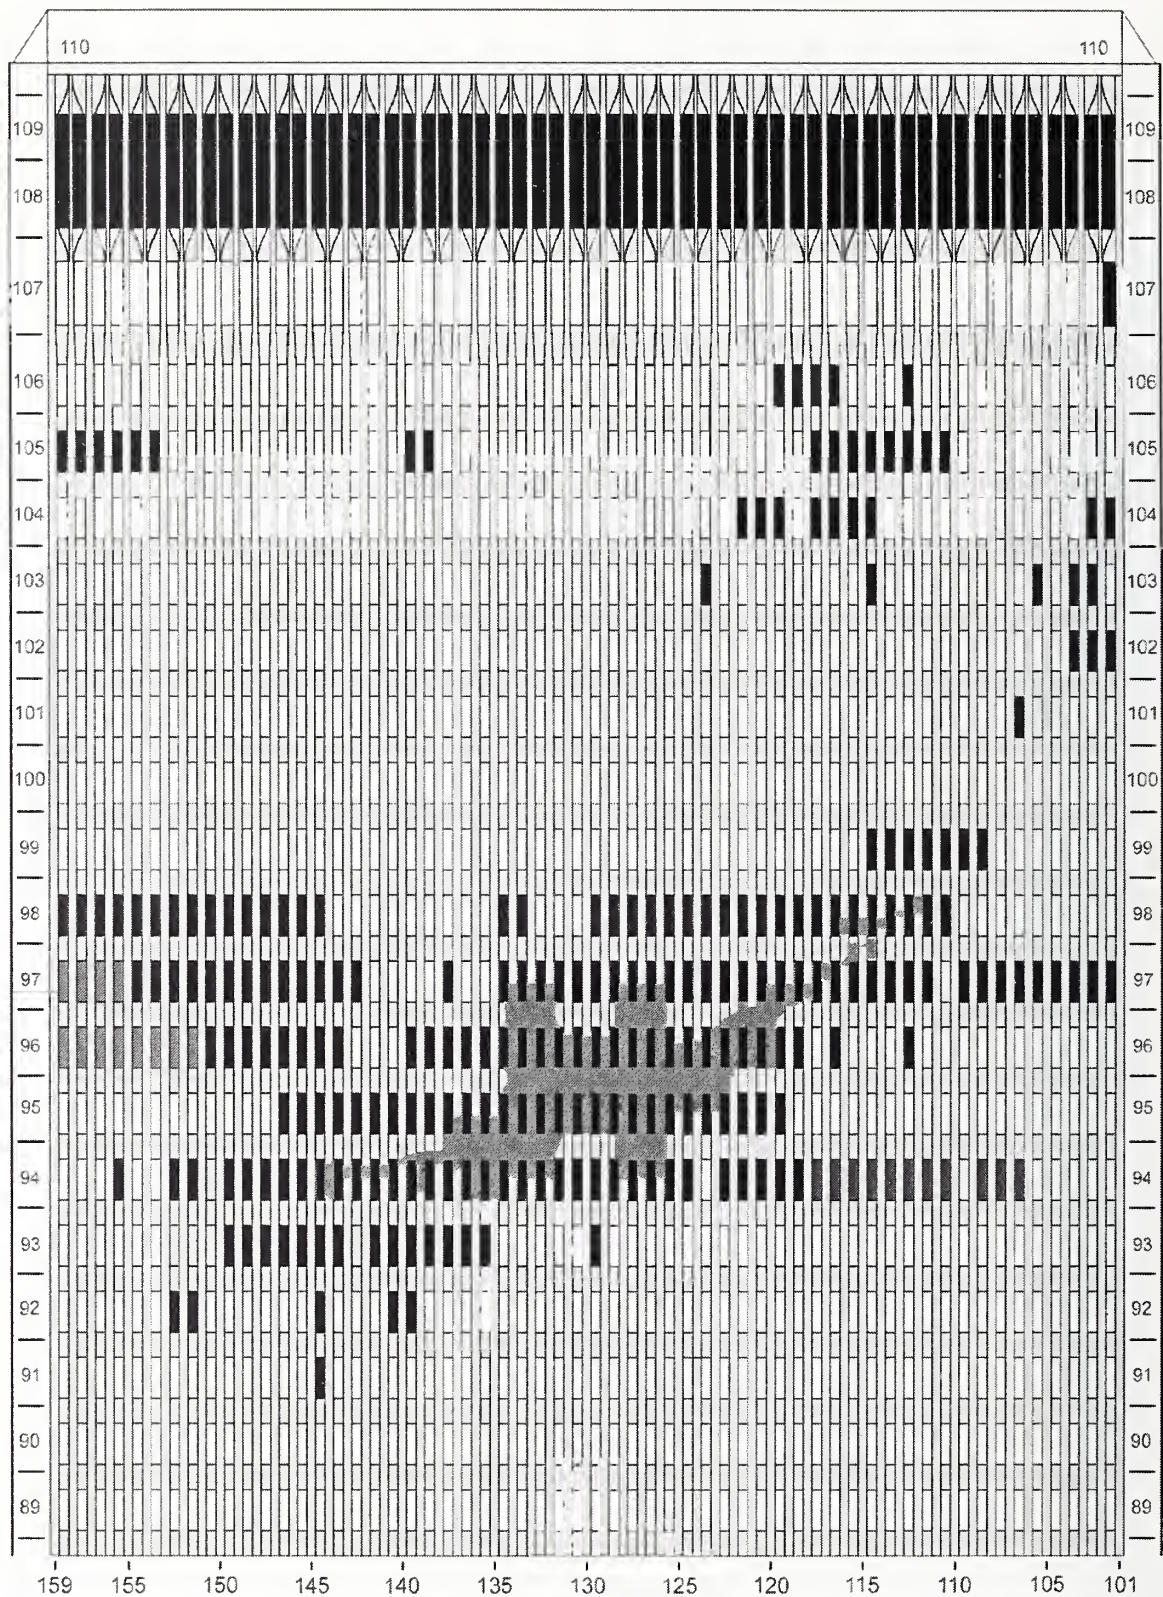
Figure C-27. Diagram of the north face of WTC 1 for floors 89 to 110 at 9:20 a.m. showing the condition of windows and locations of fires.

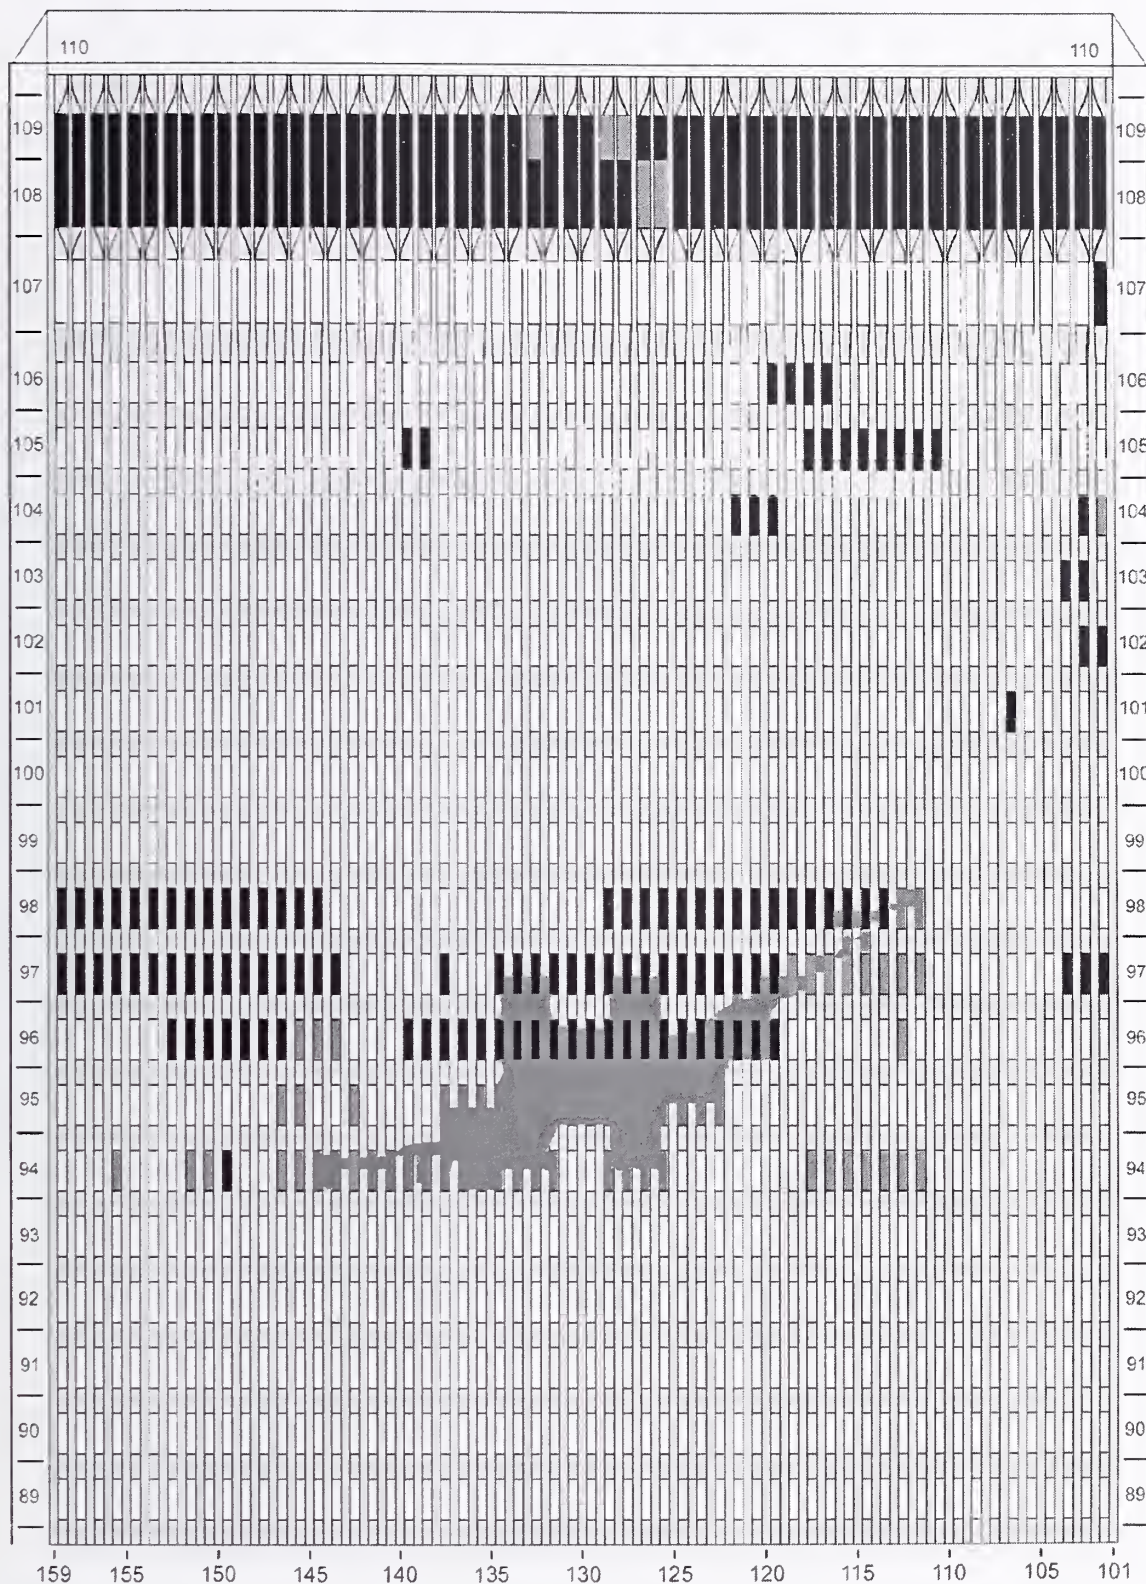
Figure C-28. Diagram of the north face of WTC 1 for floors 89 to 110 at 9:20 a.m. showing windows where smoke was observed and those that were hidden from view.

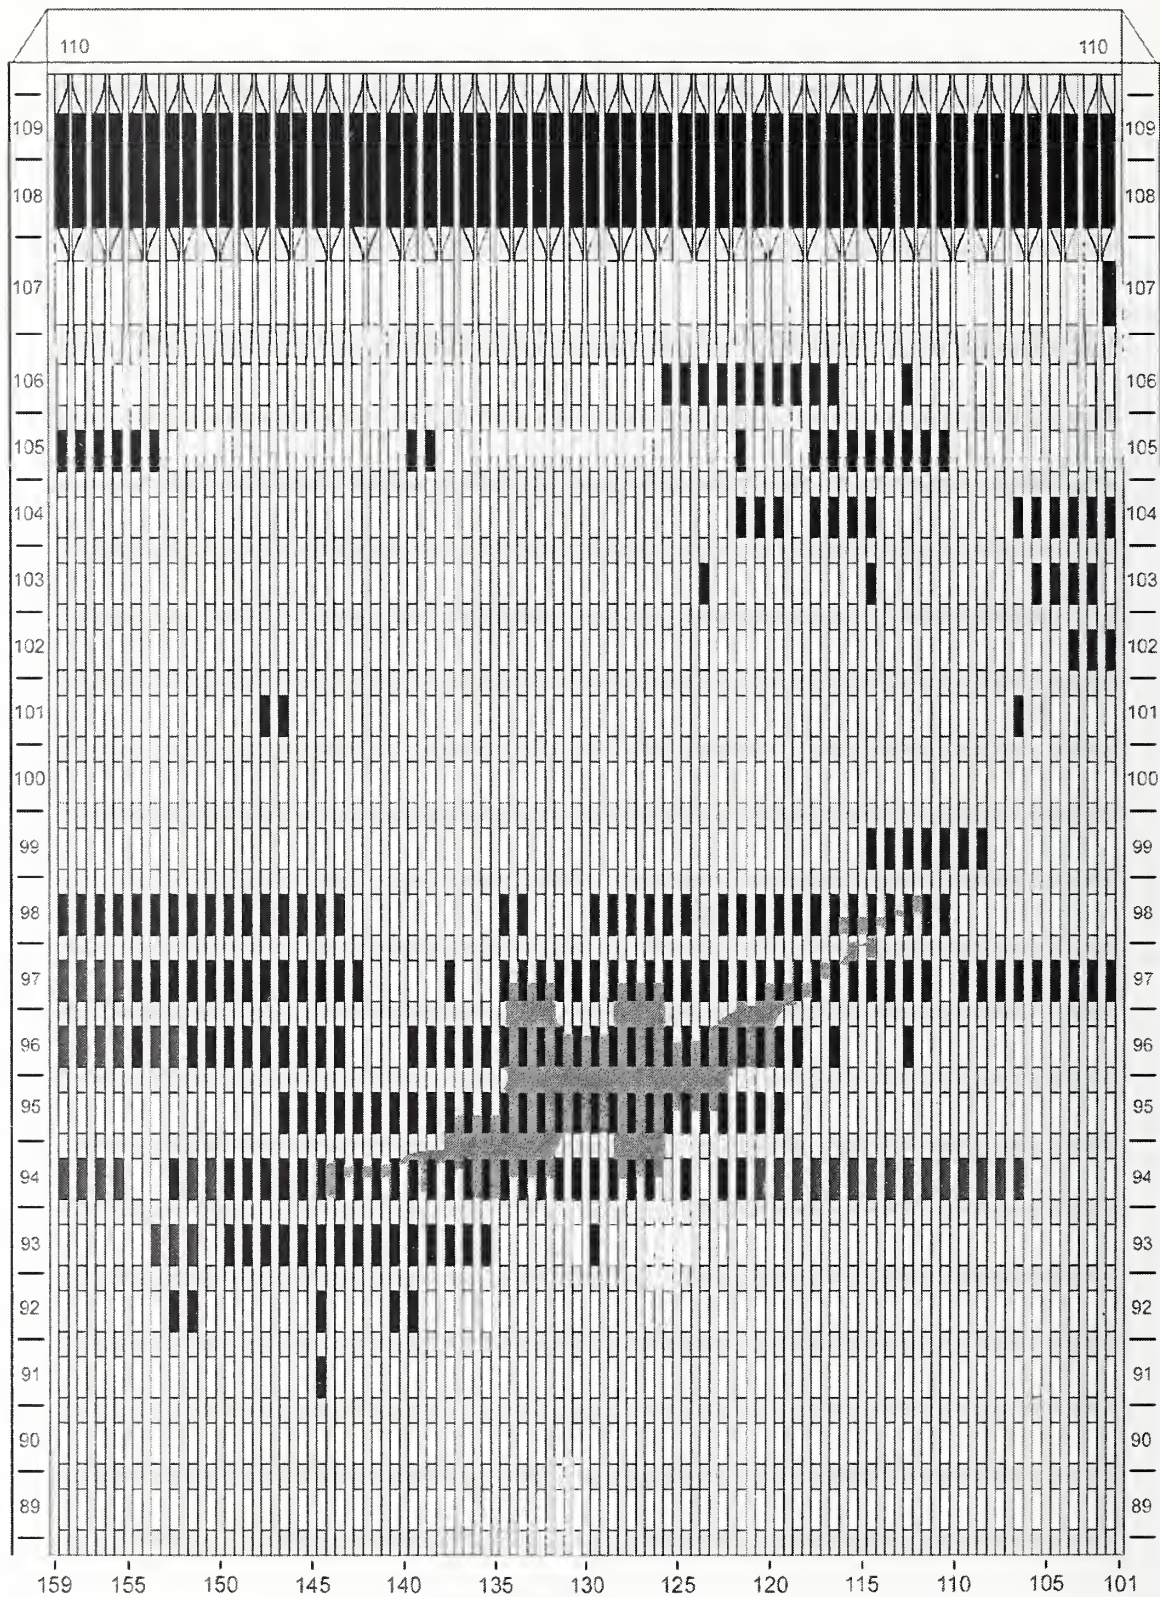
Figure C-29. Diagram of the north face of WTC 1 for floors 89 to 110 at 9:26 a.m. showing the condition of windows and locations of fires.

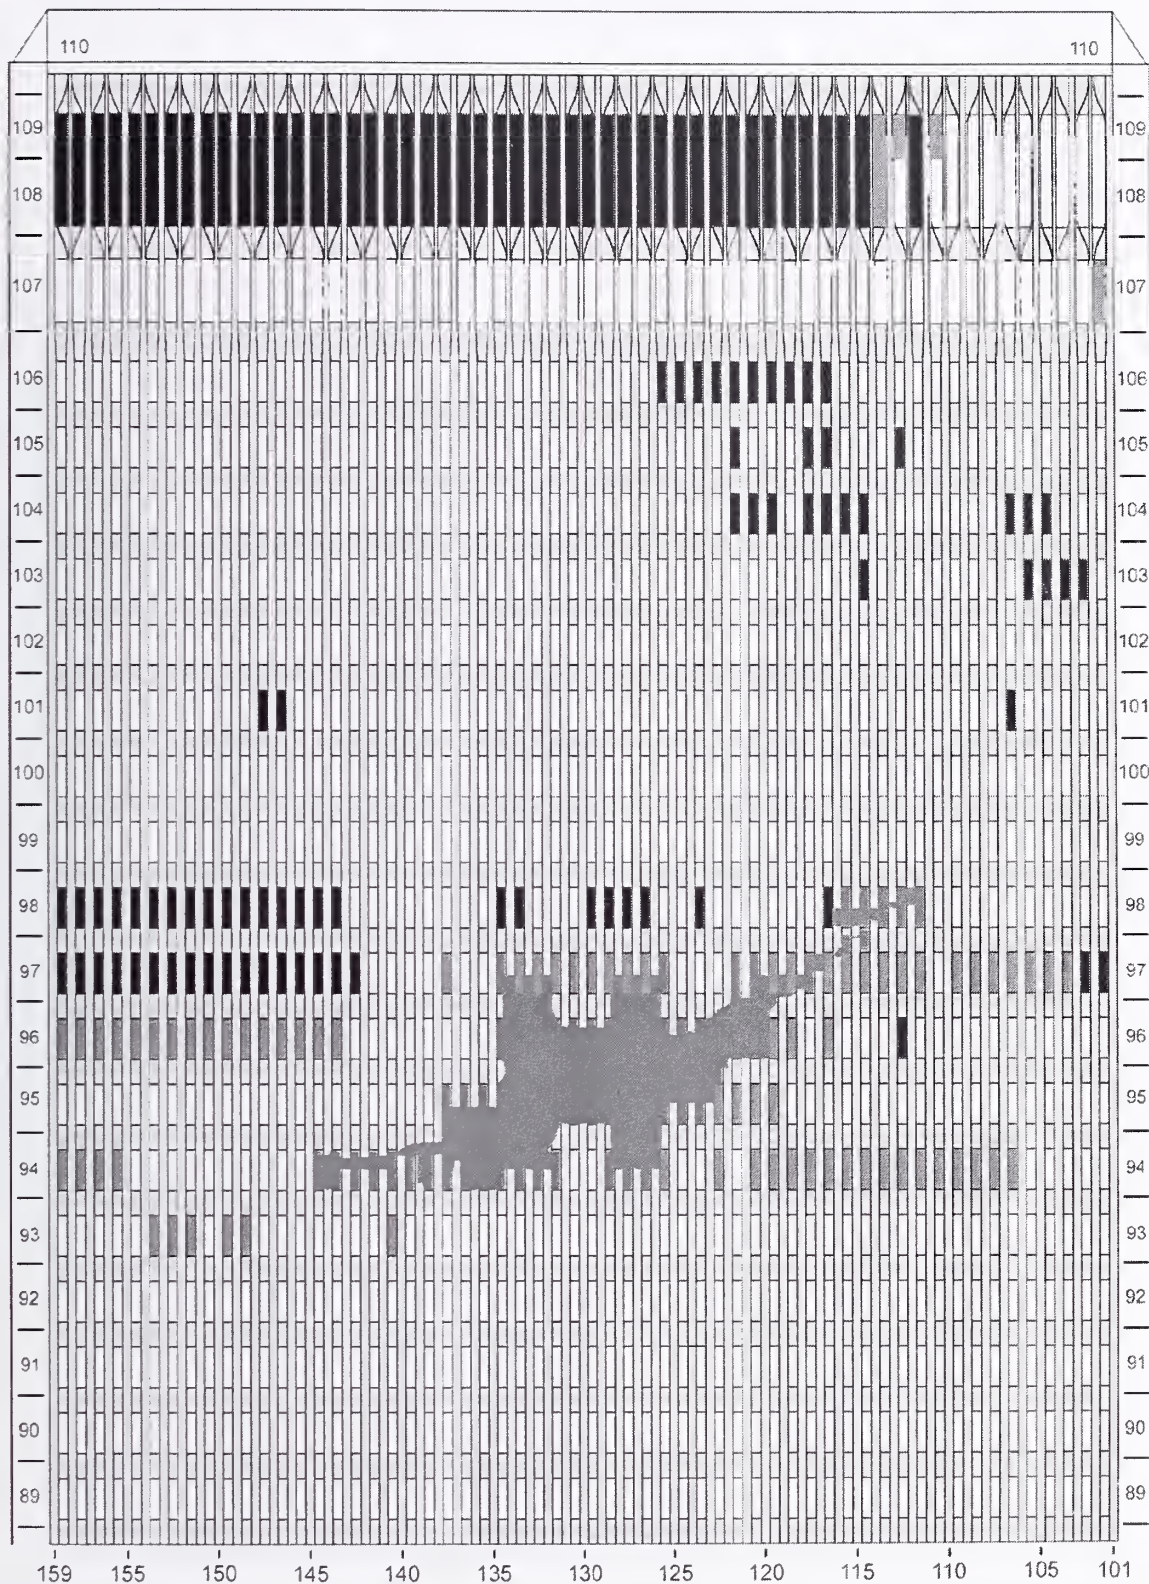
Figure C-30. Diagram of the north face of WTC 1 for floors 89 to 110 at 9:26 a.m. showing windows where smoke was observed and those that were hidden from view.
