**NIST NCSTAR 1-5A
Federal Building and Fire Safety Investigation of
the World Trade Center Disaster**

**Visual Evidence, Damage Estimates,
And Timeline Analysis**

(Chapter 9 - Appendix C)

FIRE BEHAVIOR IN WORLD TRADE CENTER 2

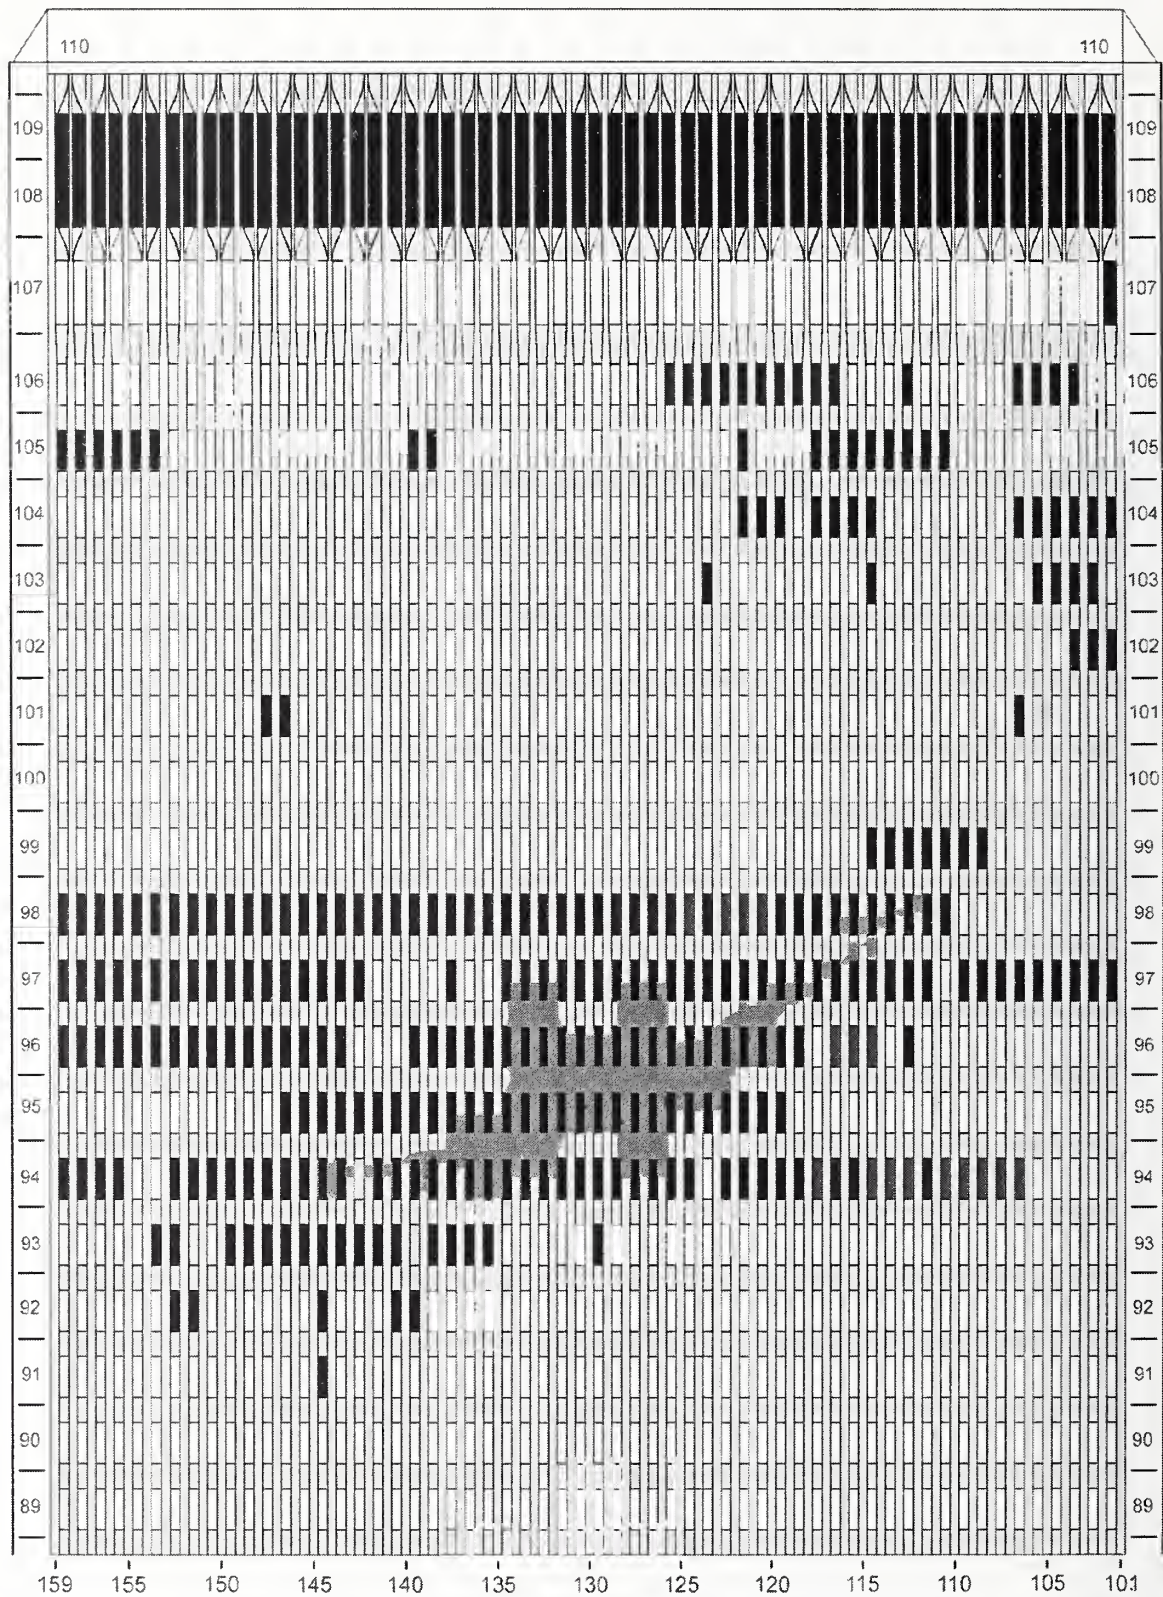
Figure C-31. Diagram of the north face of WTC 1 for floors 89 to 110 at 9:32 a.m. showing the condition of windows and locations of fires.

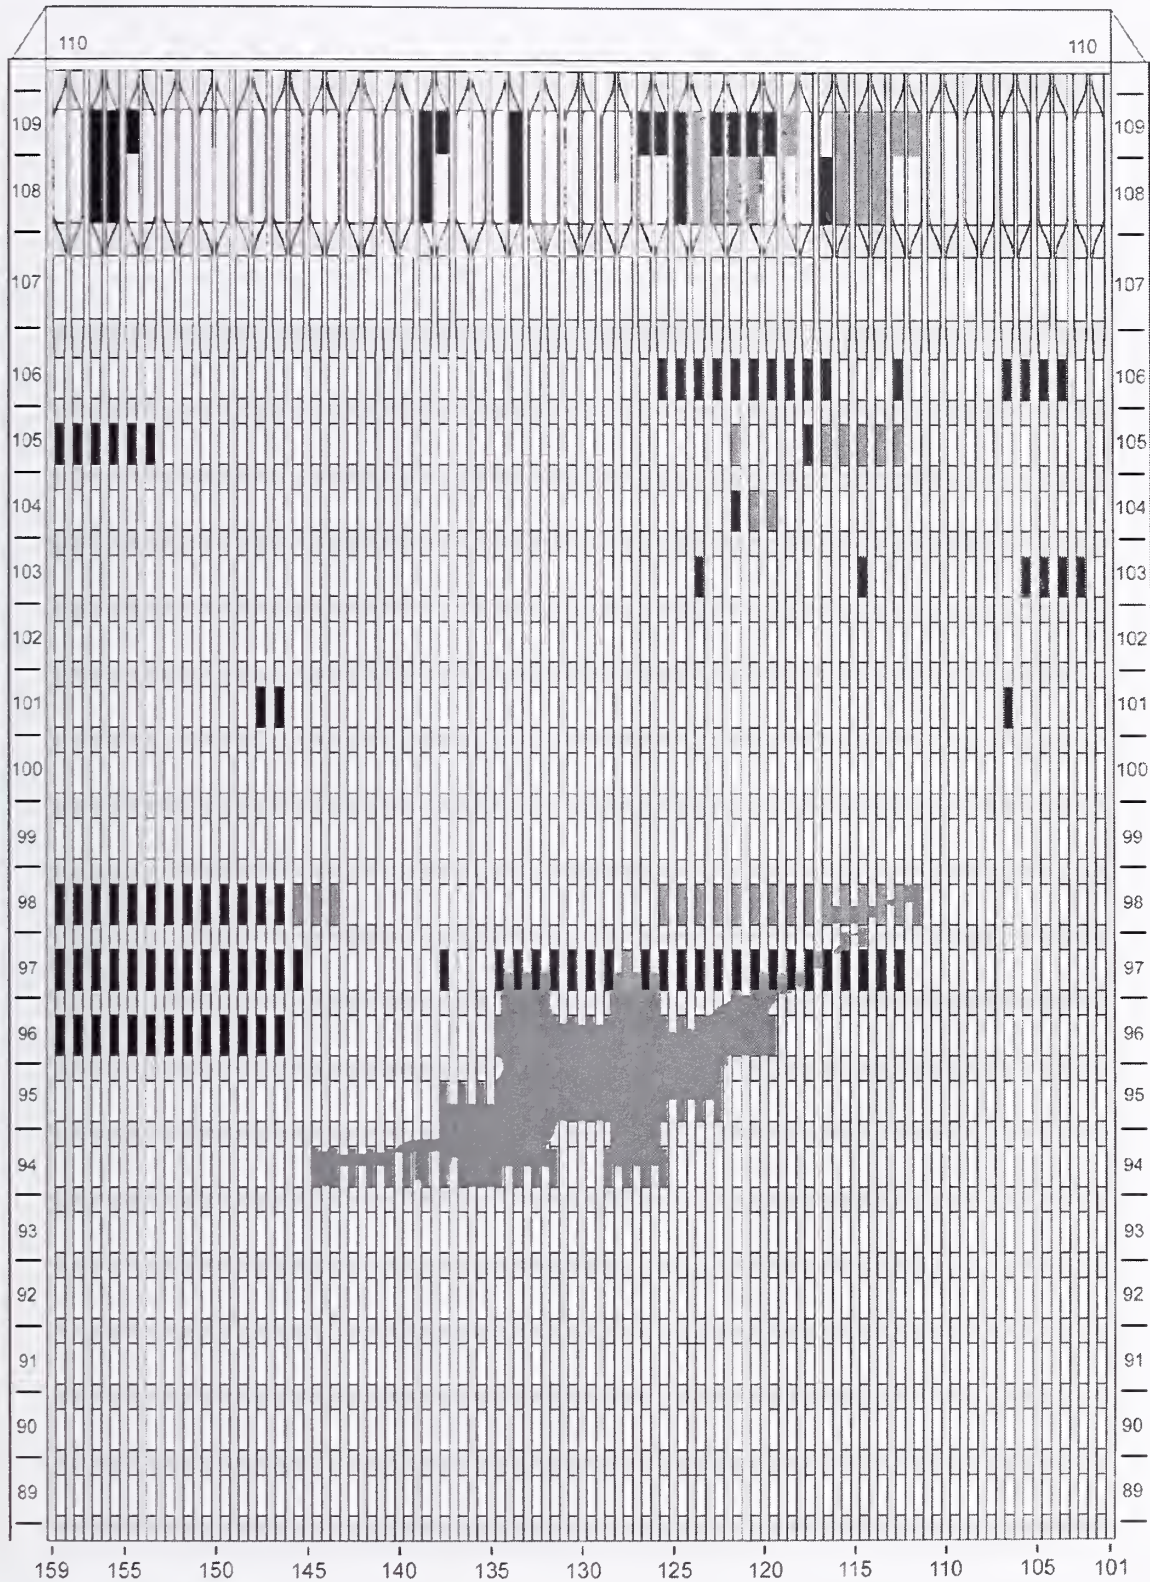
Figure C-32. Diagram of the north face of WTC 1 for floors 89 to 110 at 9:32 a.m. showing windows where smoke was observed and those that were hidden from view.

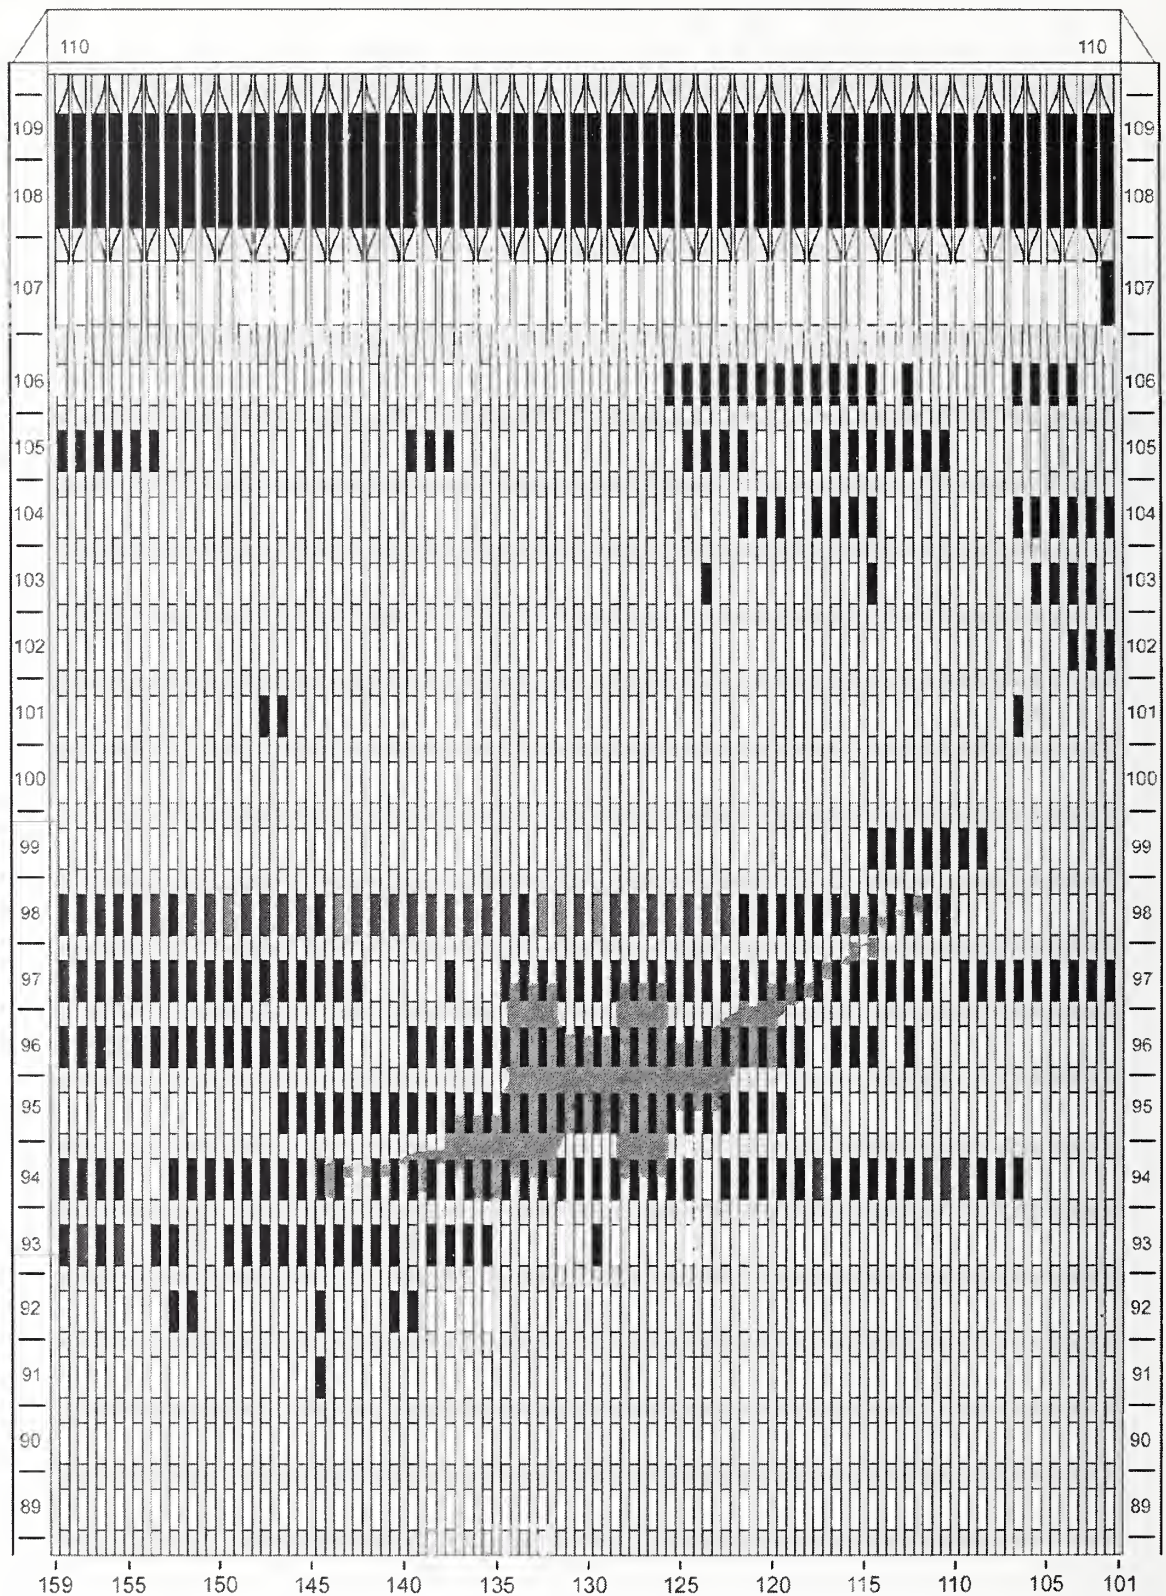
Figure C-33. Diagram of the north face of WTC 1 for floors 89 to 110 at 9:38 a.m. showing the condition of windows and locations of fires.

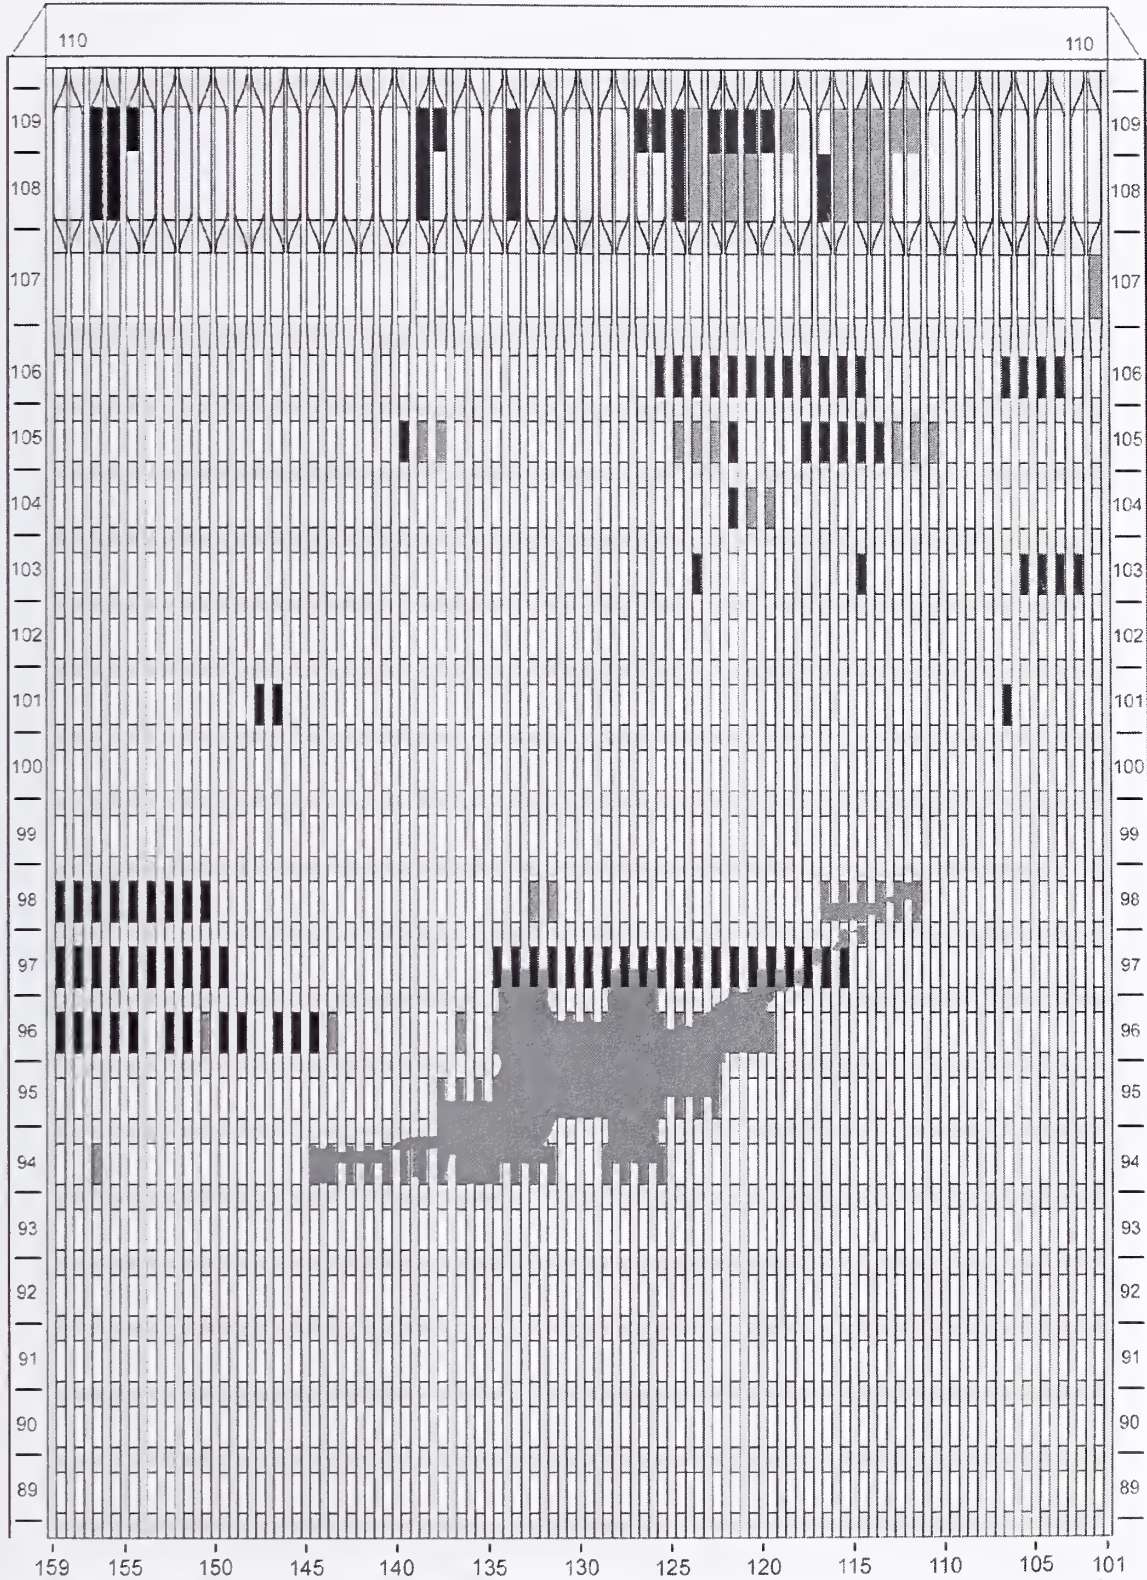
Figure C-34. Diagram of the north face of WTC 1 for floors 89 to 110 at 9:38 a.m. showing windows where smoke was observed and those that were hidden from view.

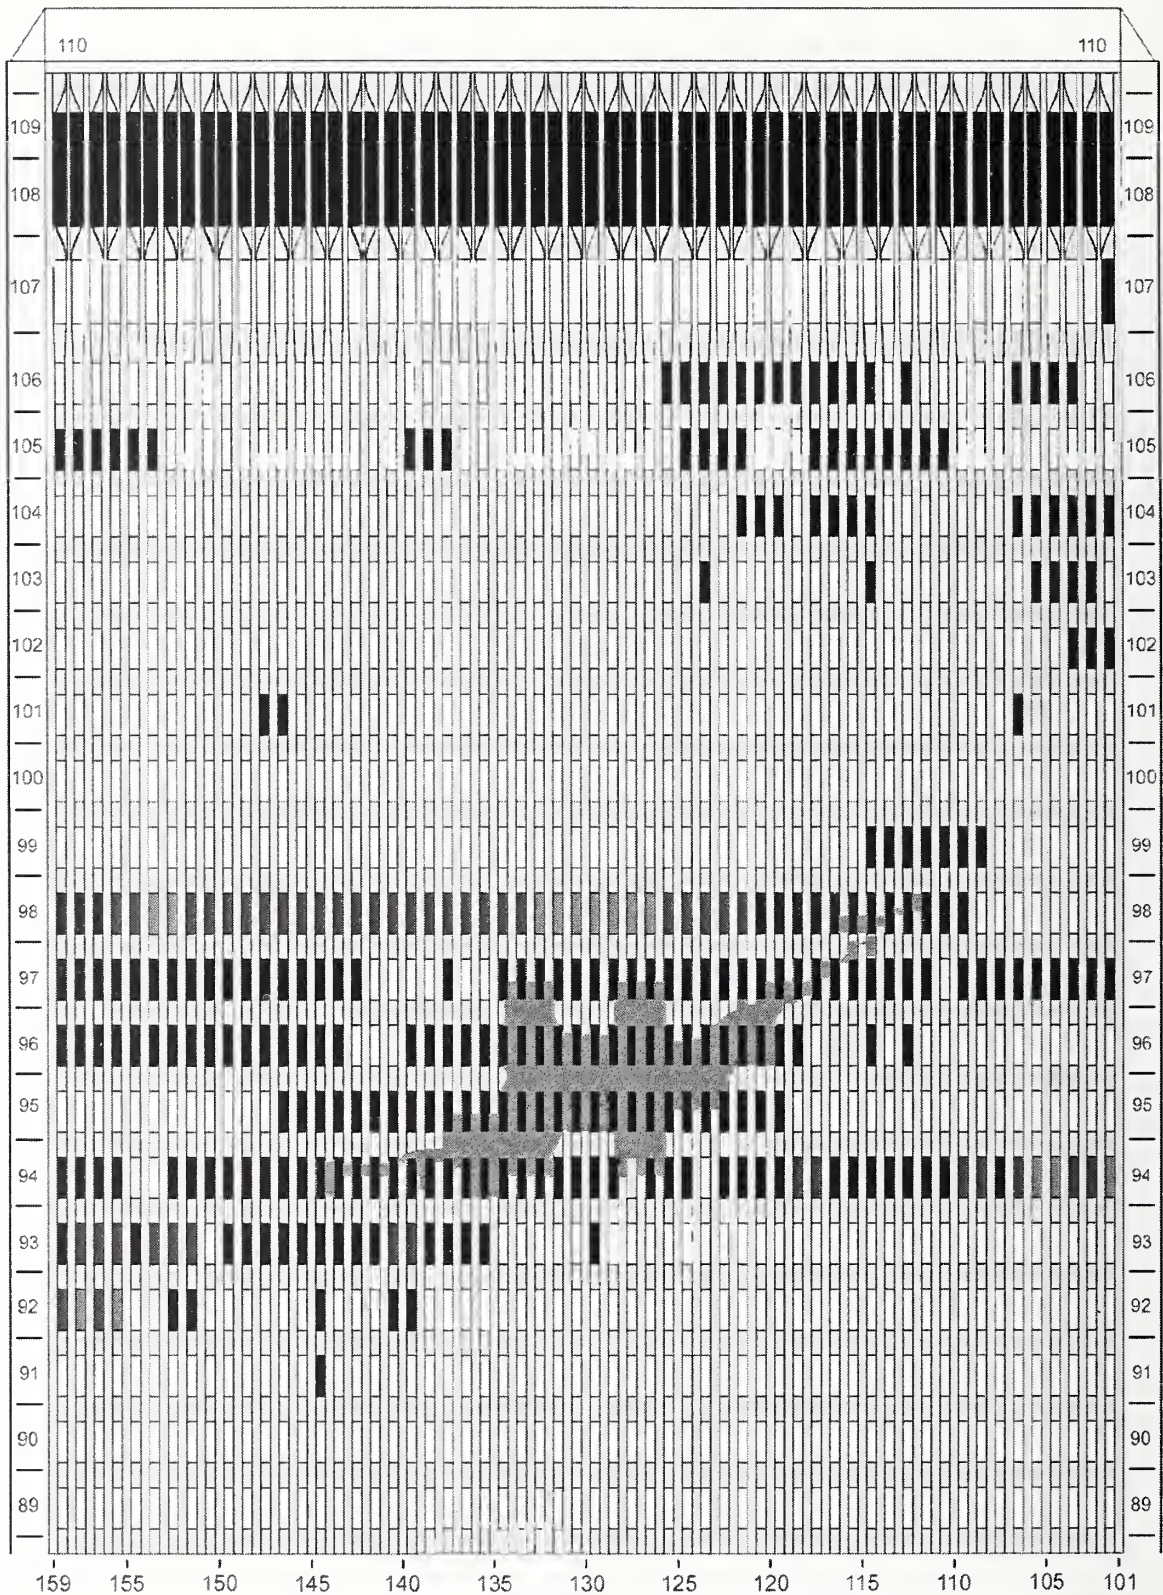
Figure C-35. Diagram of the north face of WTC 1 for floors 89 to 110 at 9:42 a.m. showing the condition of windows and locations of fires.

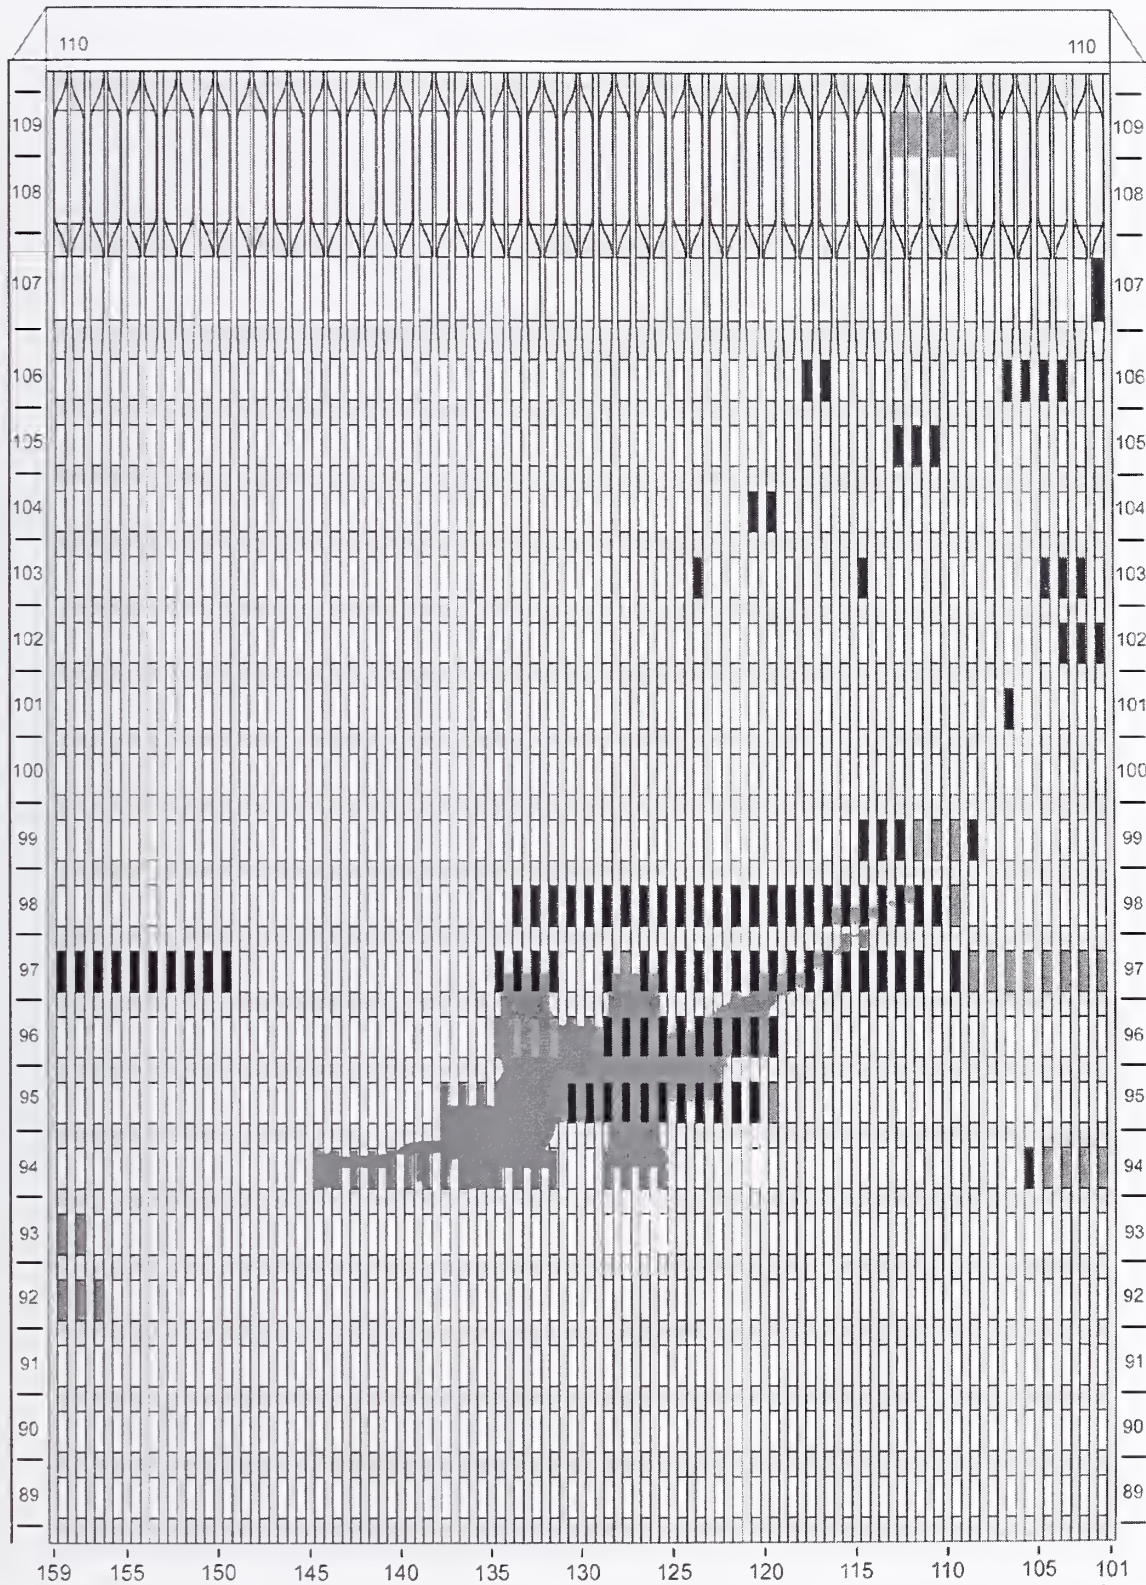
Figure C-36. Diagram of the north face of WTC 1 for floors 89 to 110 at 9:42 a.m. showing windows where smoke was observed and those that were hidden from view.

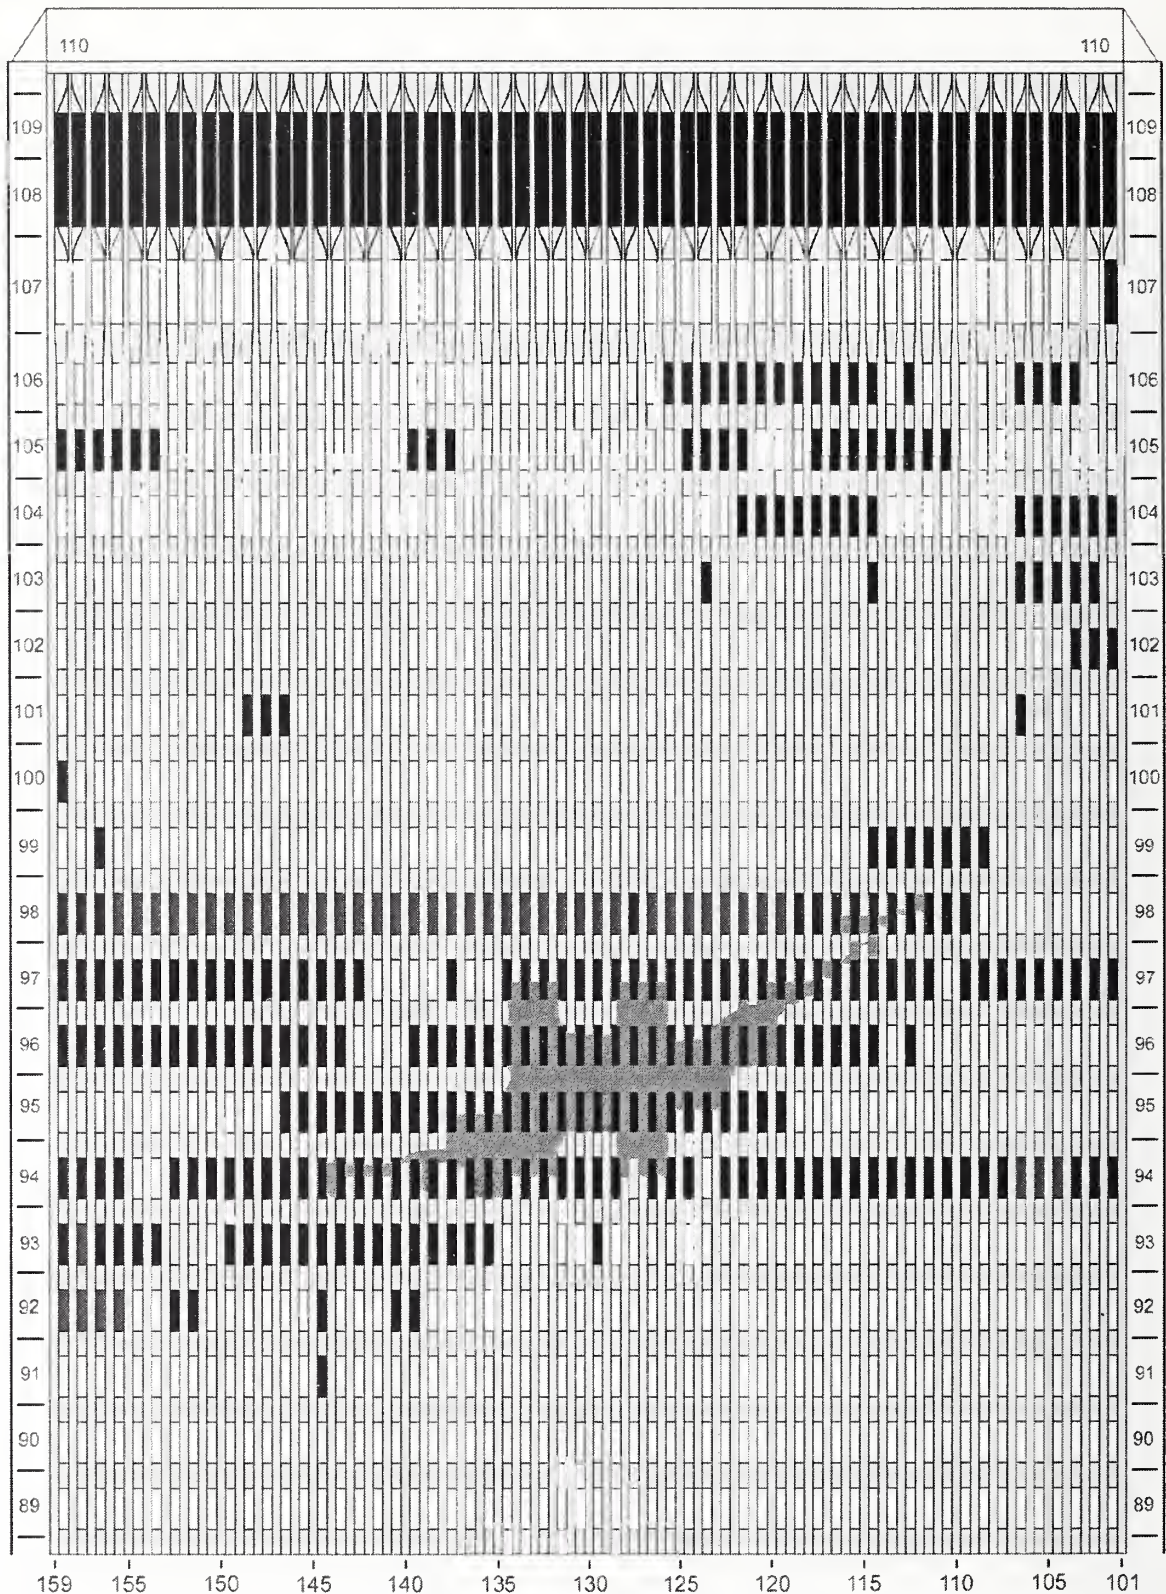
Figure C-37. Diagram of the north face of WTC 1 for floors 89 to 110 at 9:46 a.m. showing the condition of windows and locations of fires.

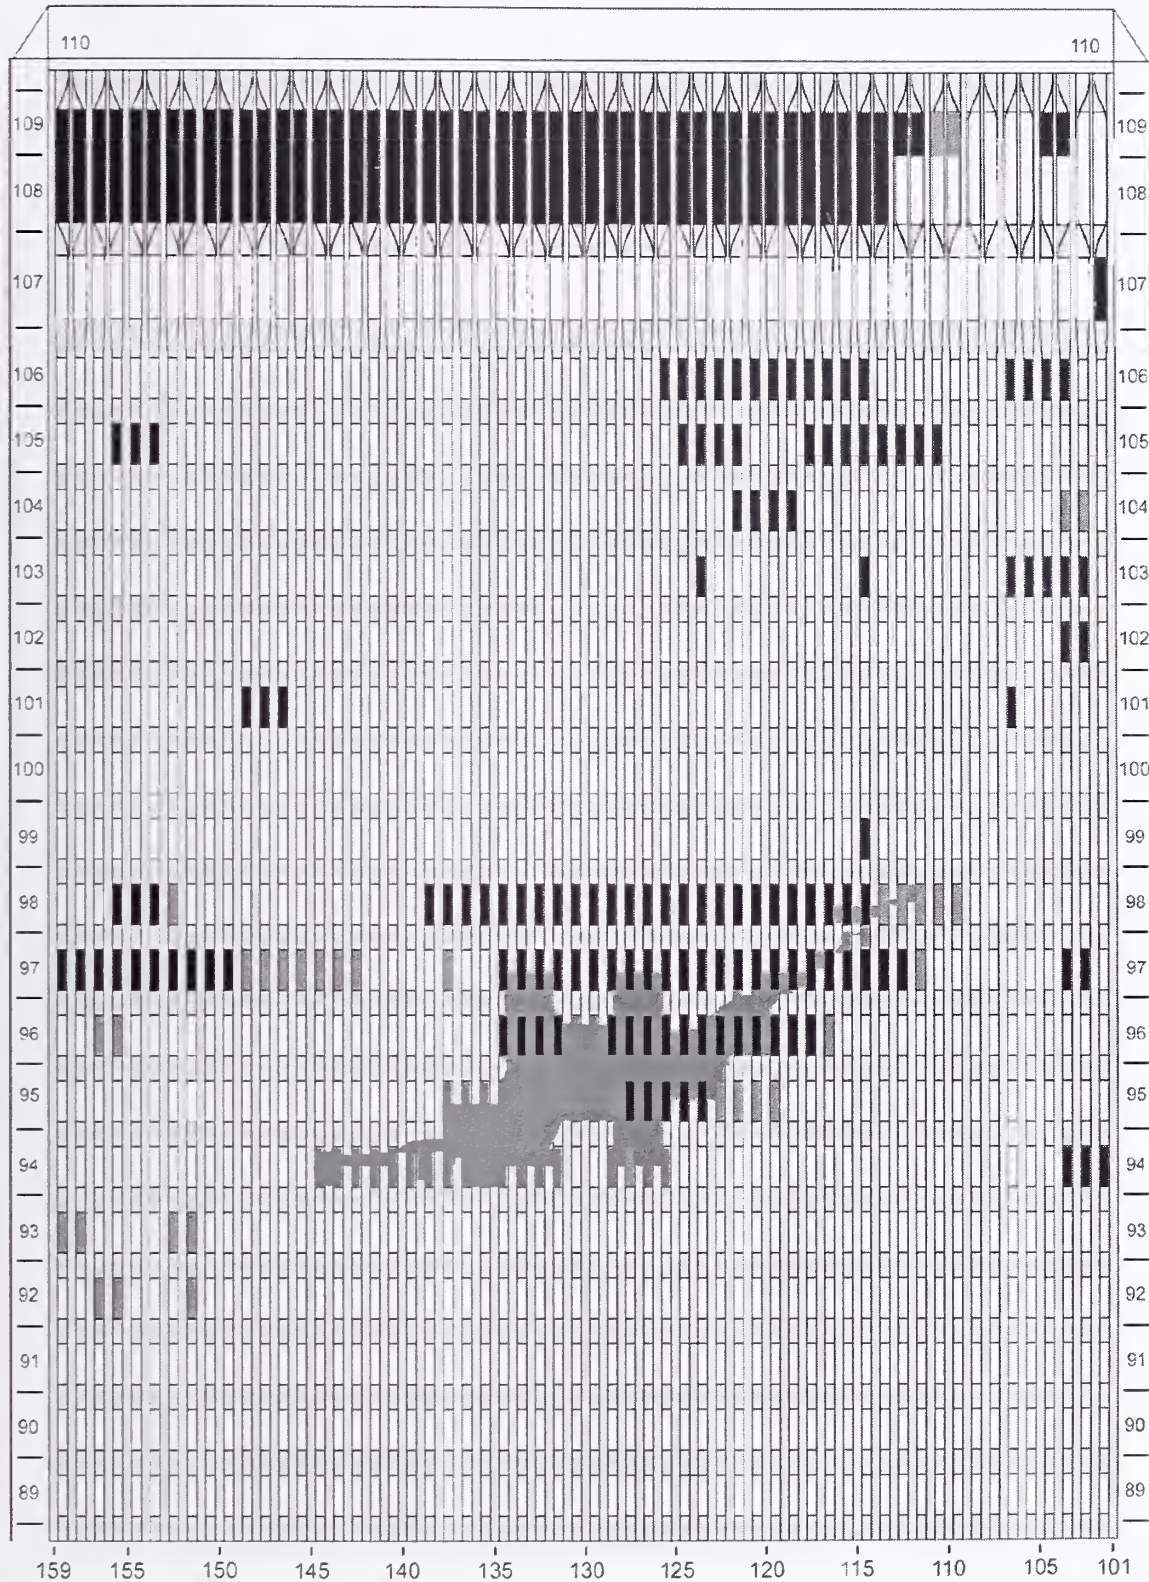
Figure C-38. Diagram of the north face of WTC 1 for floors 89 to 110 at 9:46 a.m. showing windows where smoke was observed and those that were hidden from view.

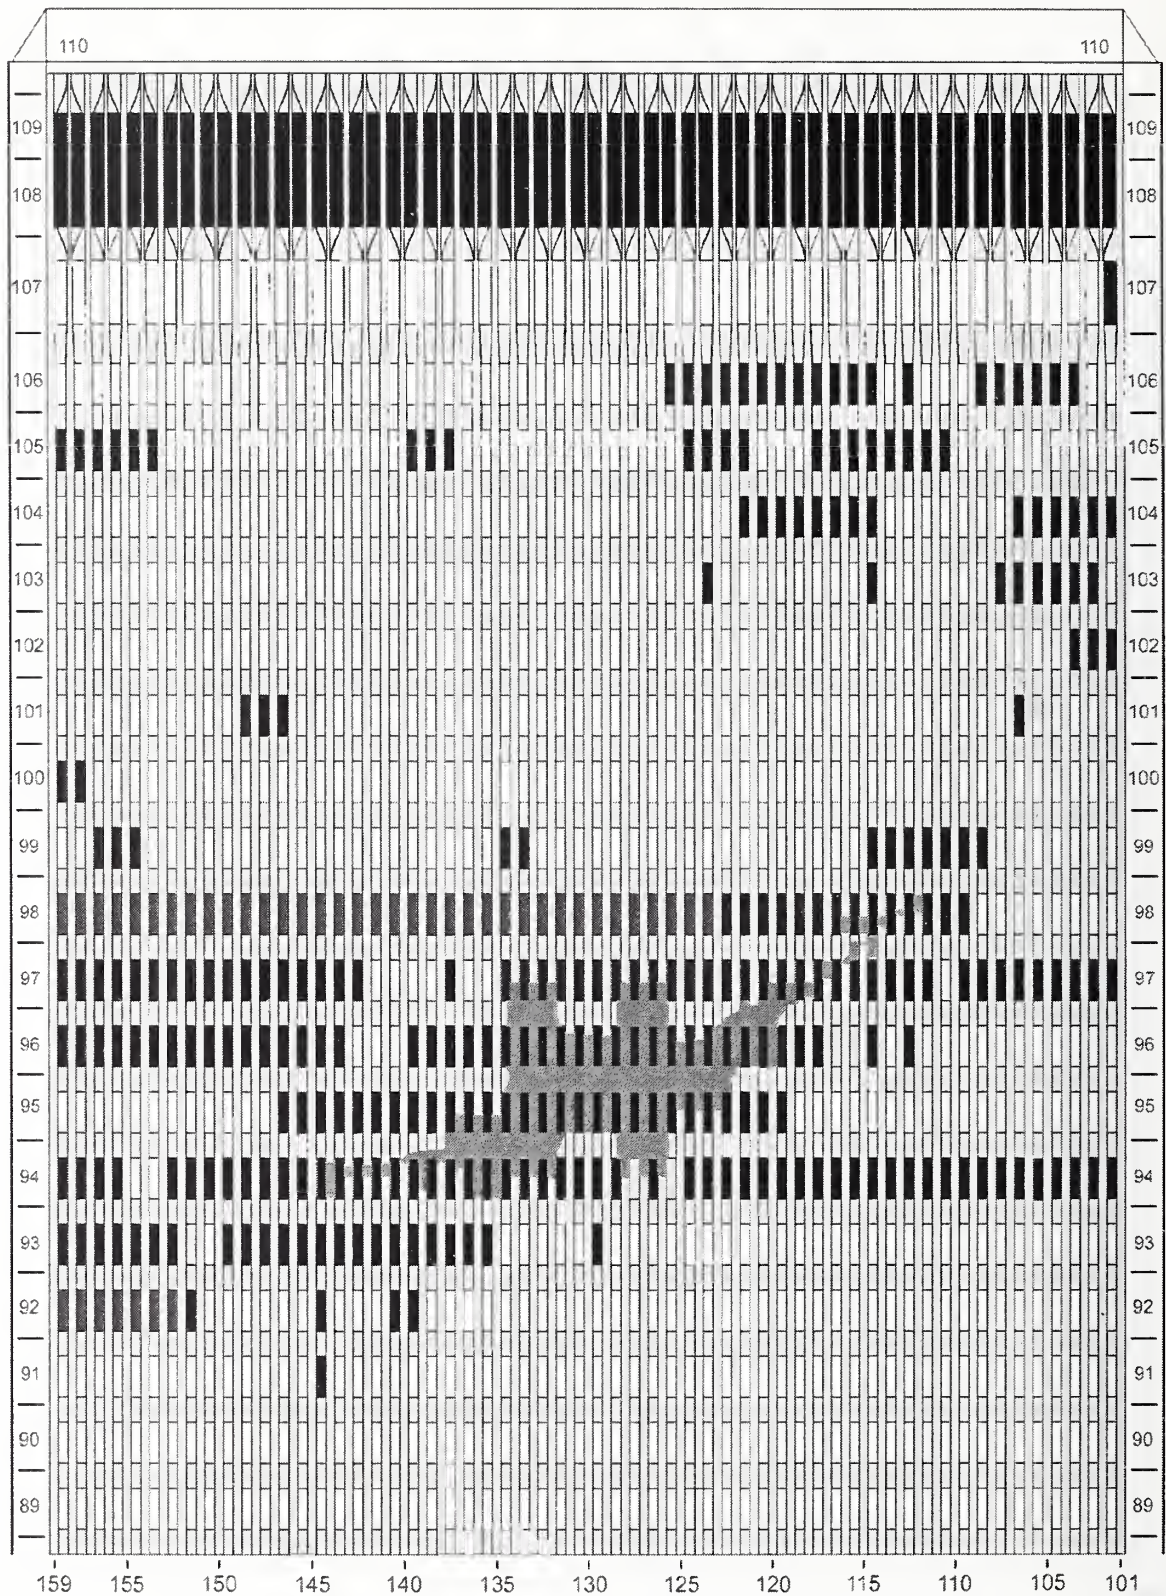
Figure C-39. Diagram of the north face of WTC 1 for floors 89 to 110 at 9:52 a.m. showing the condition of windows and locations of fires.

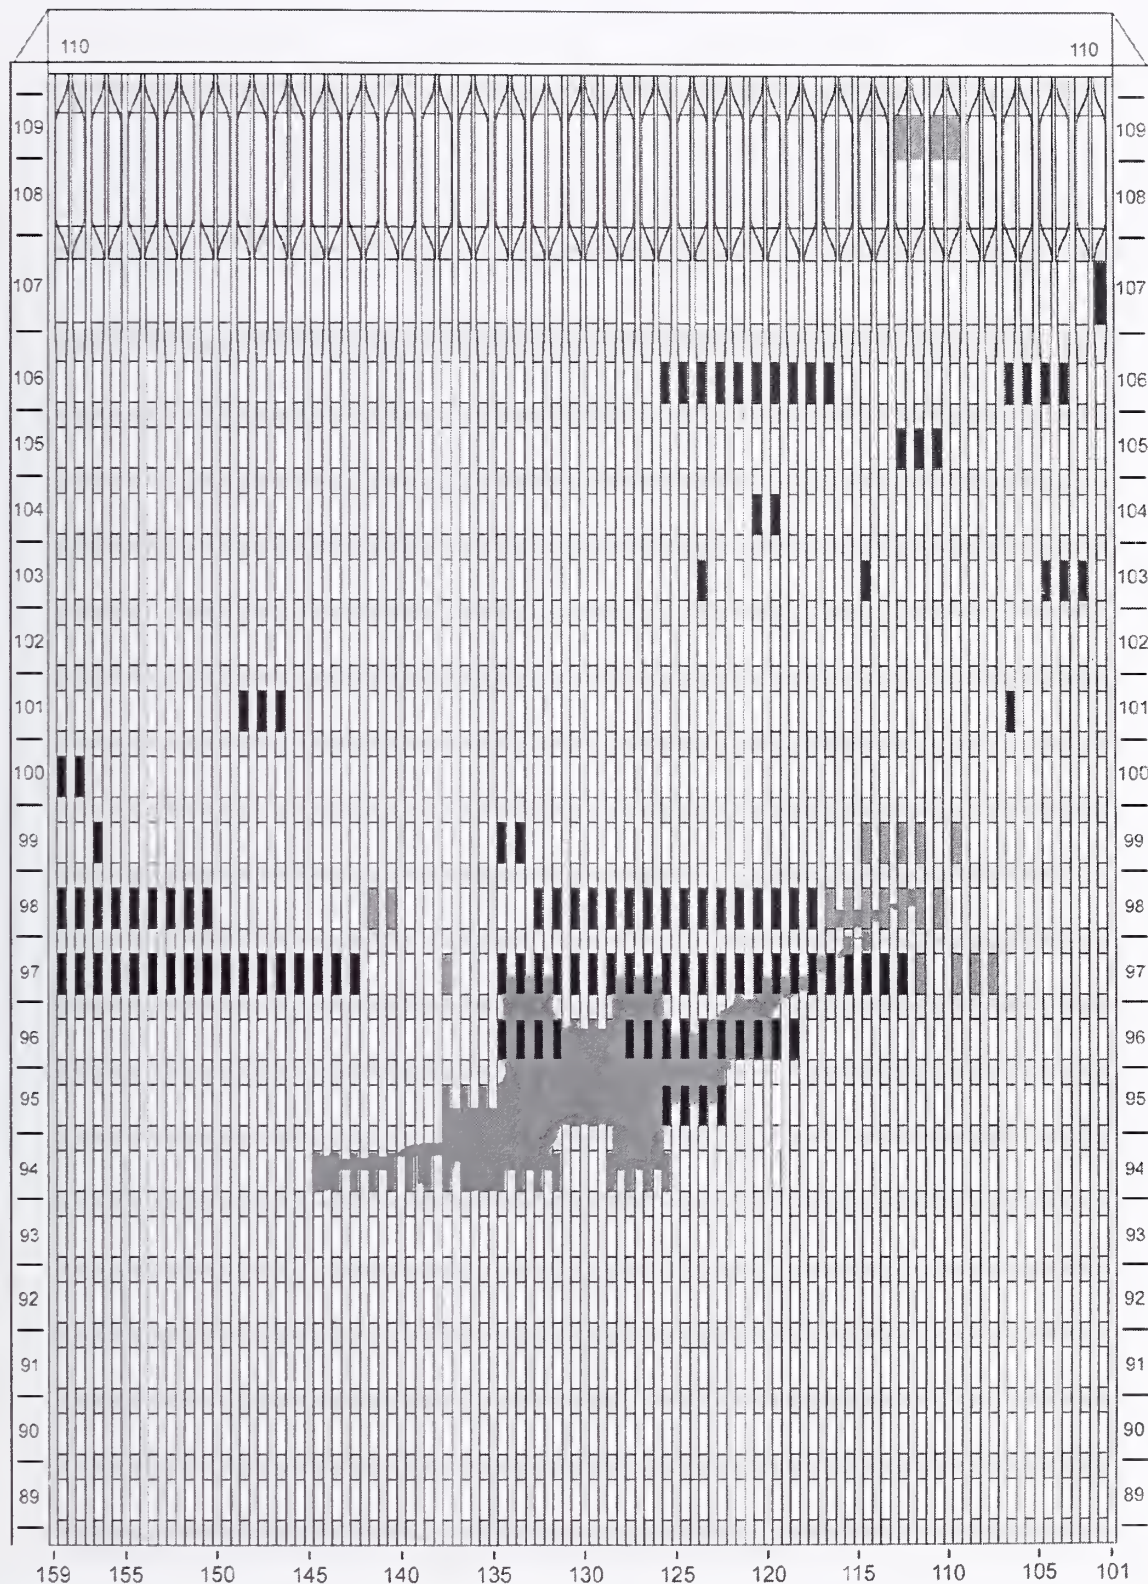
Figure C-40. Diagram of the north face of WTC 1 for floors 89 to 110 at 9:52 a.m. showing windows where smoke was observed and those that were hidden from view.

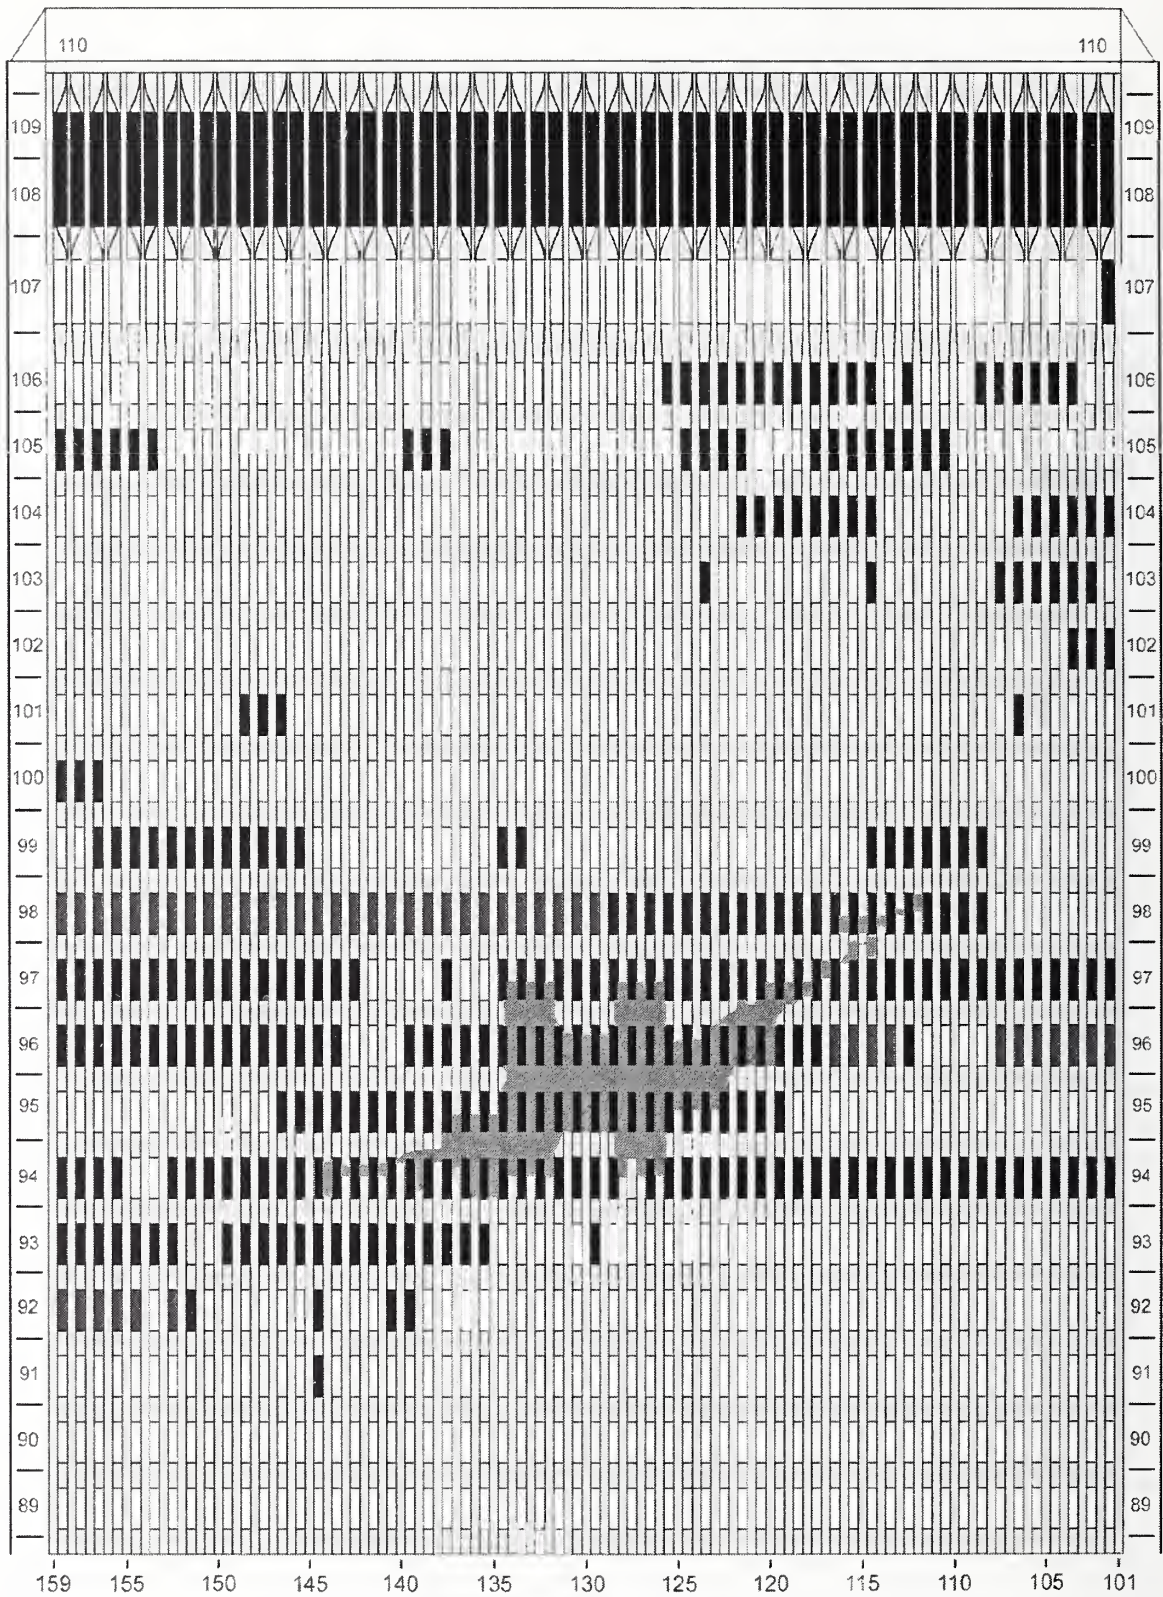
Figure C-41. Diagram of the north face of WTC 1 for floors 89 to 110 at 9:54 a.m. showing the condition of windows and locations of fires.

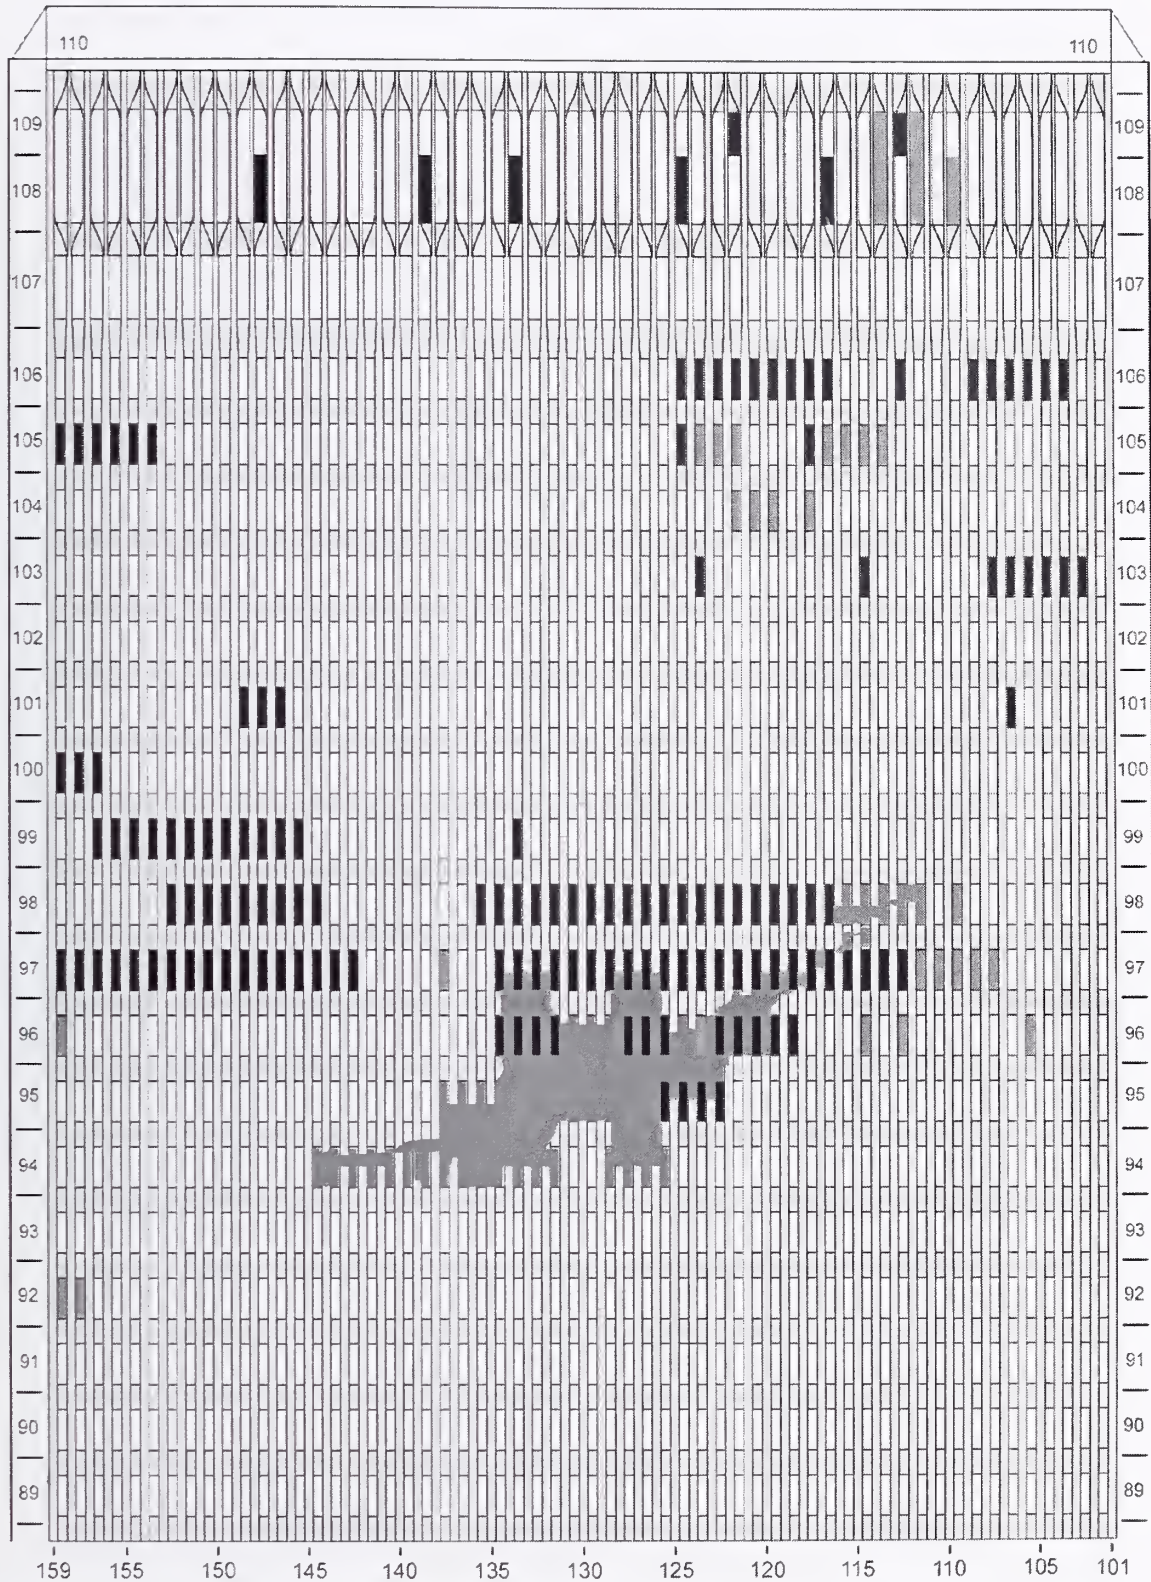
Figure C-42. Diagram of the north face of WTC 1 for floors 89 to 110 at 9:54 a.m. showing windows where smoke was observed and those that were hidden from view.
