**NIST NCSTAR 1-5A
Federal Building and Fire Safety Investigation of
the World Trade Center Disaster**

**Visual Evidence, Damage Estimates,
And Timeline Analysis**

(Chapter 9 - Appendix C)

FIRE BEHAVIOR IN WORLD TRADE CENTER 2

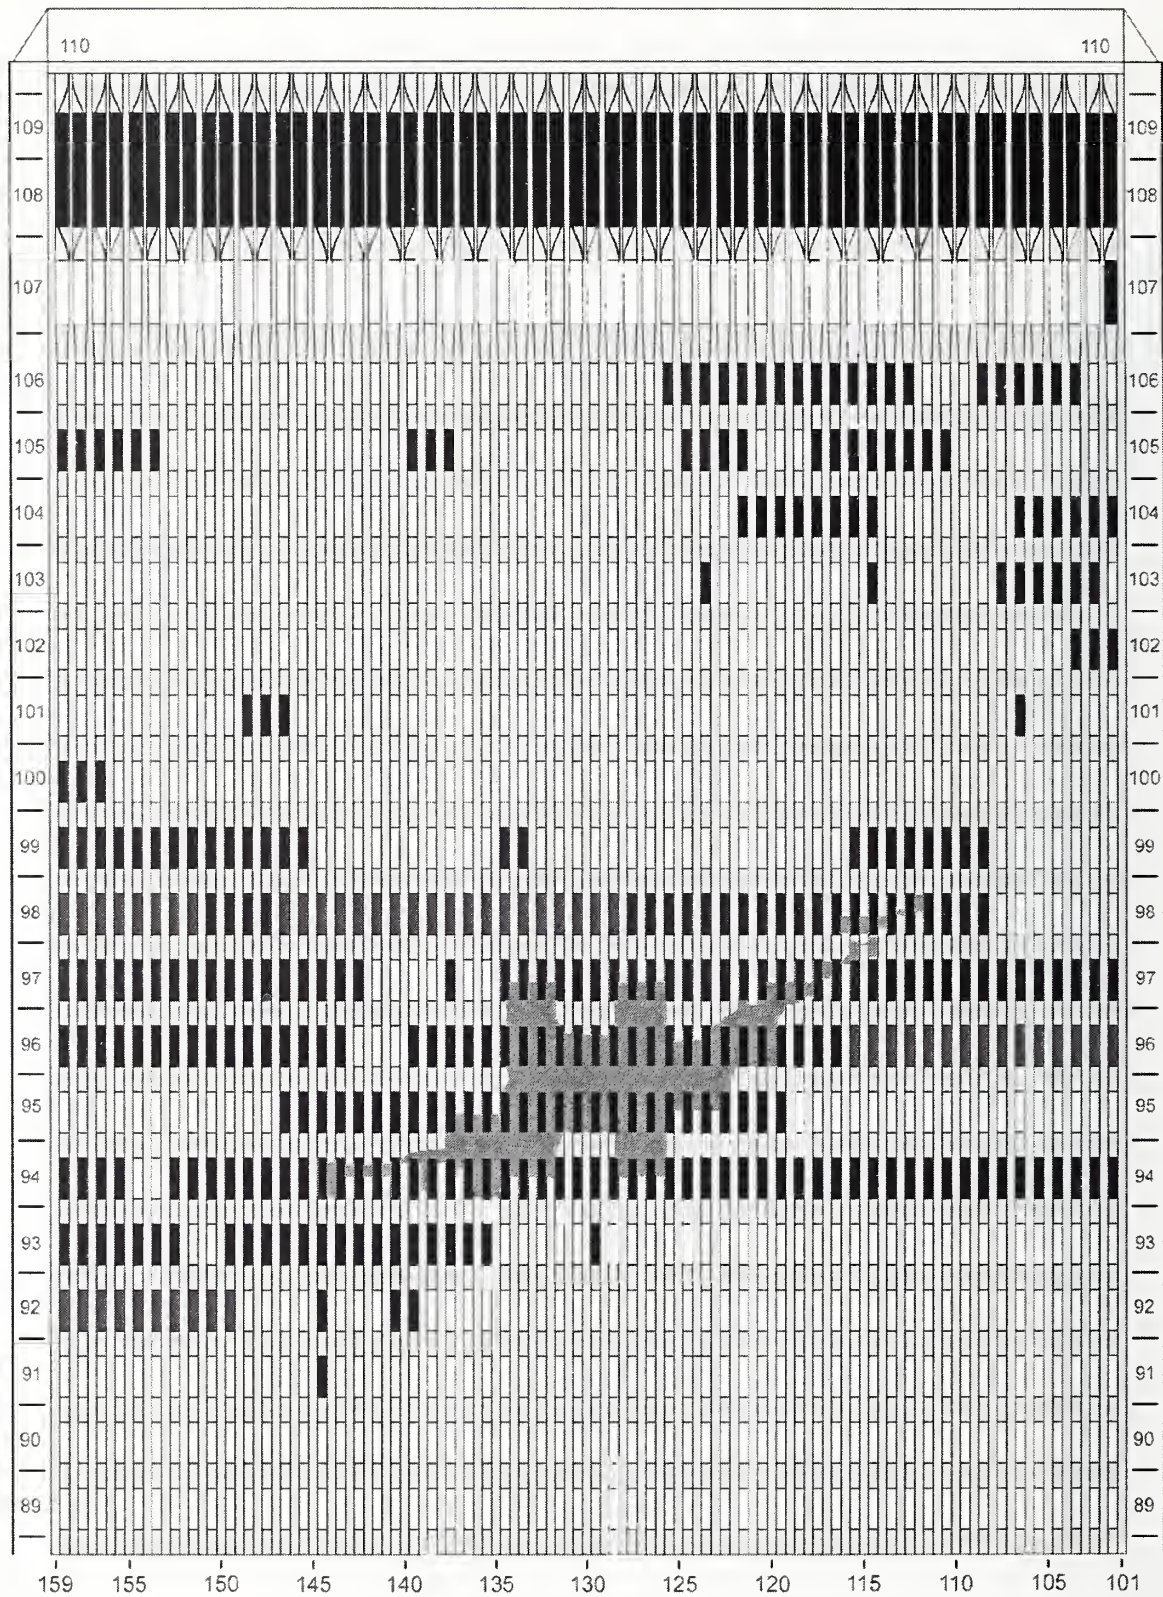
Figure C-43. Diagram of the north face of WTC 1 for floors 89 to 110 at 9:58 a.m. showing the condition of windows and locations of fires.

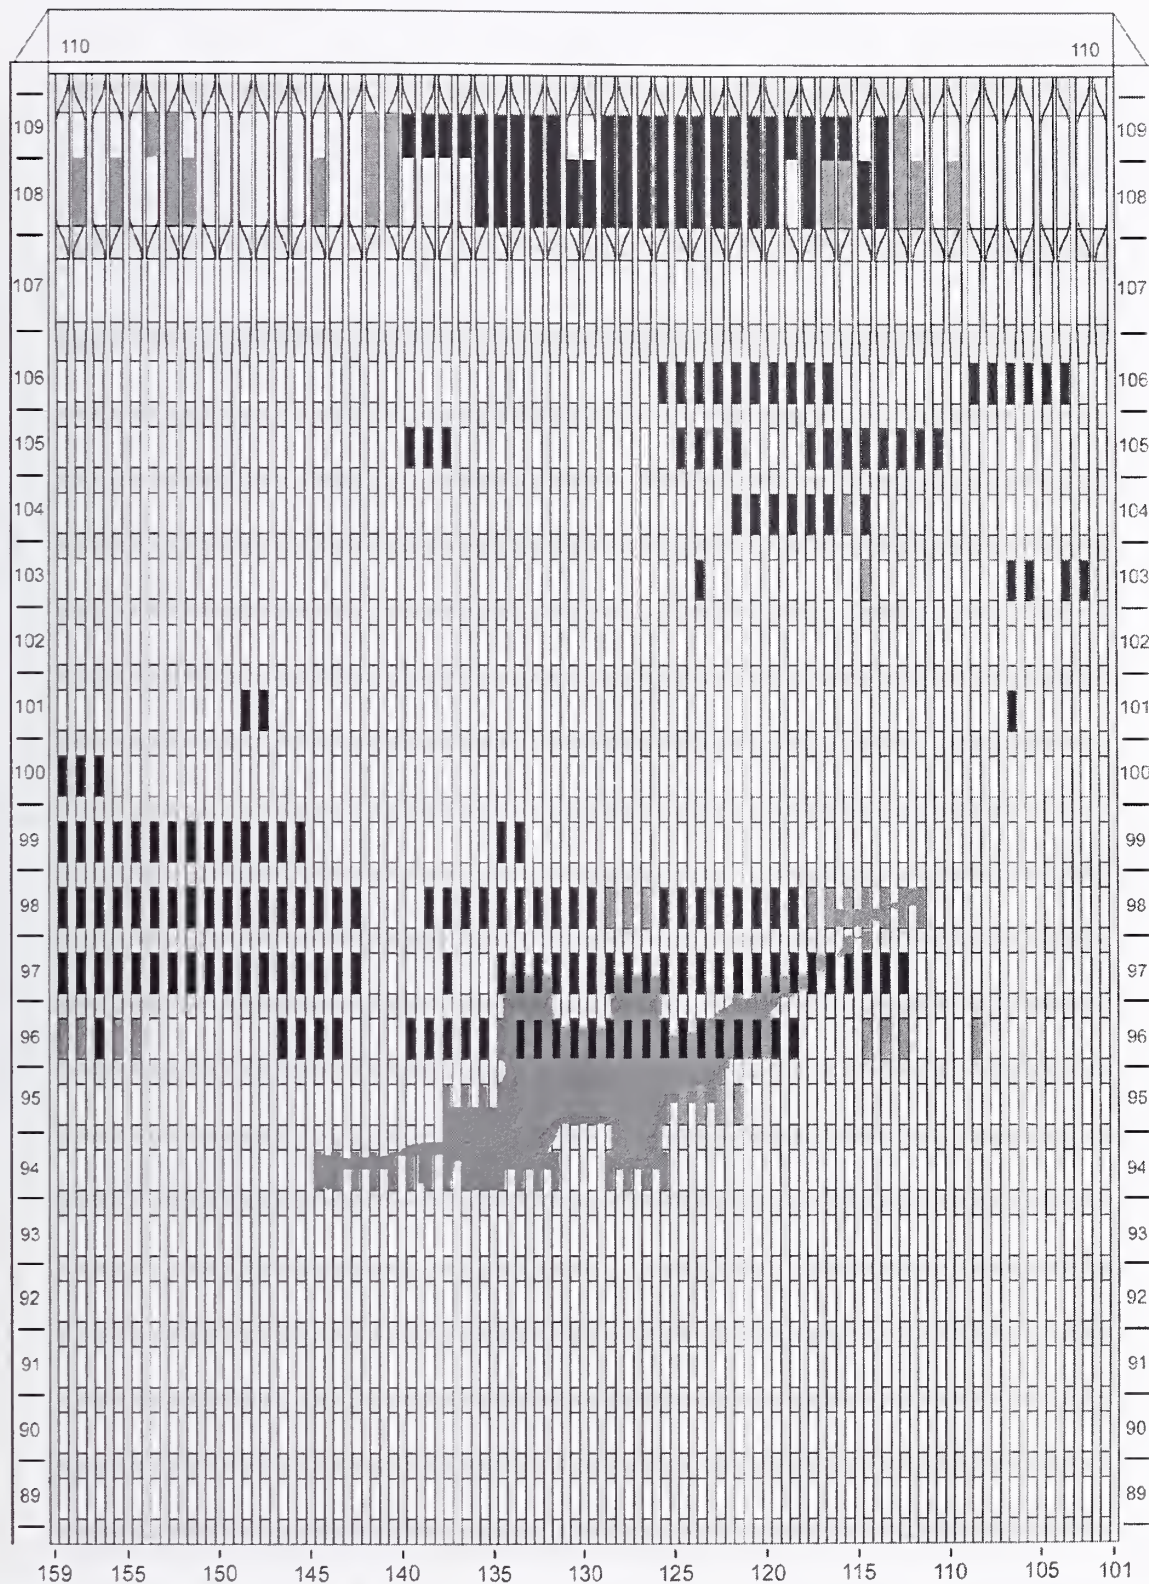
Figure C-44. Diagram of the north face of WTC 1 for floors 89 to 110 at 9:58 a.m. showing windows where smoke was observed and those that were hidden from view.

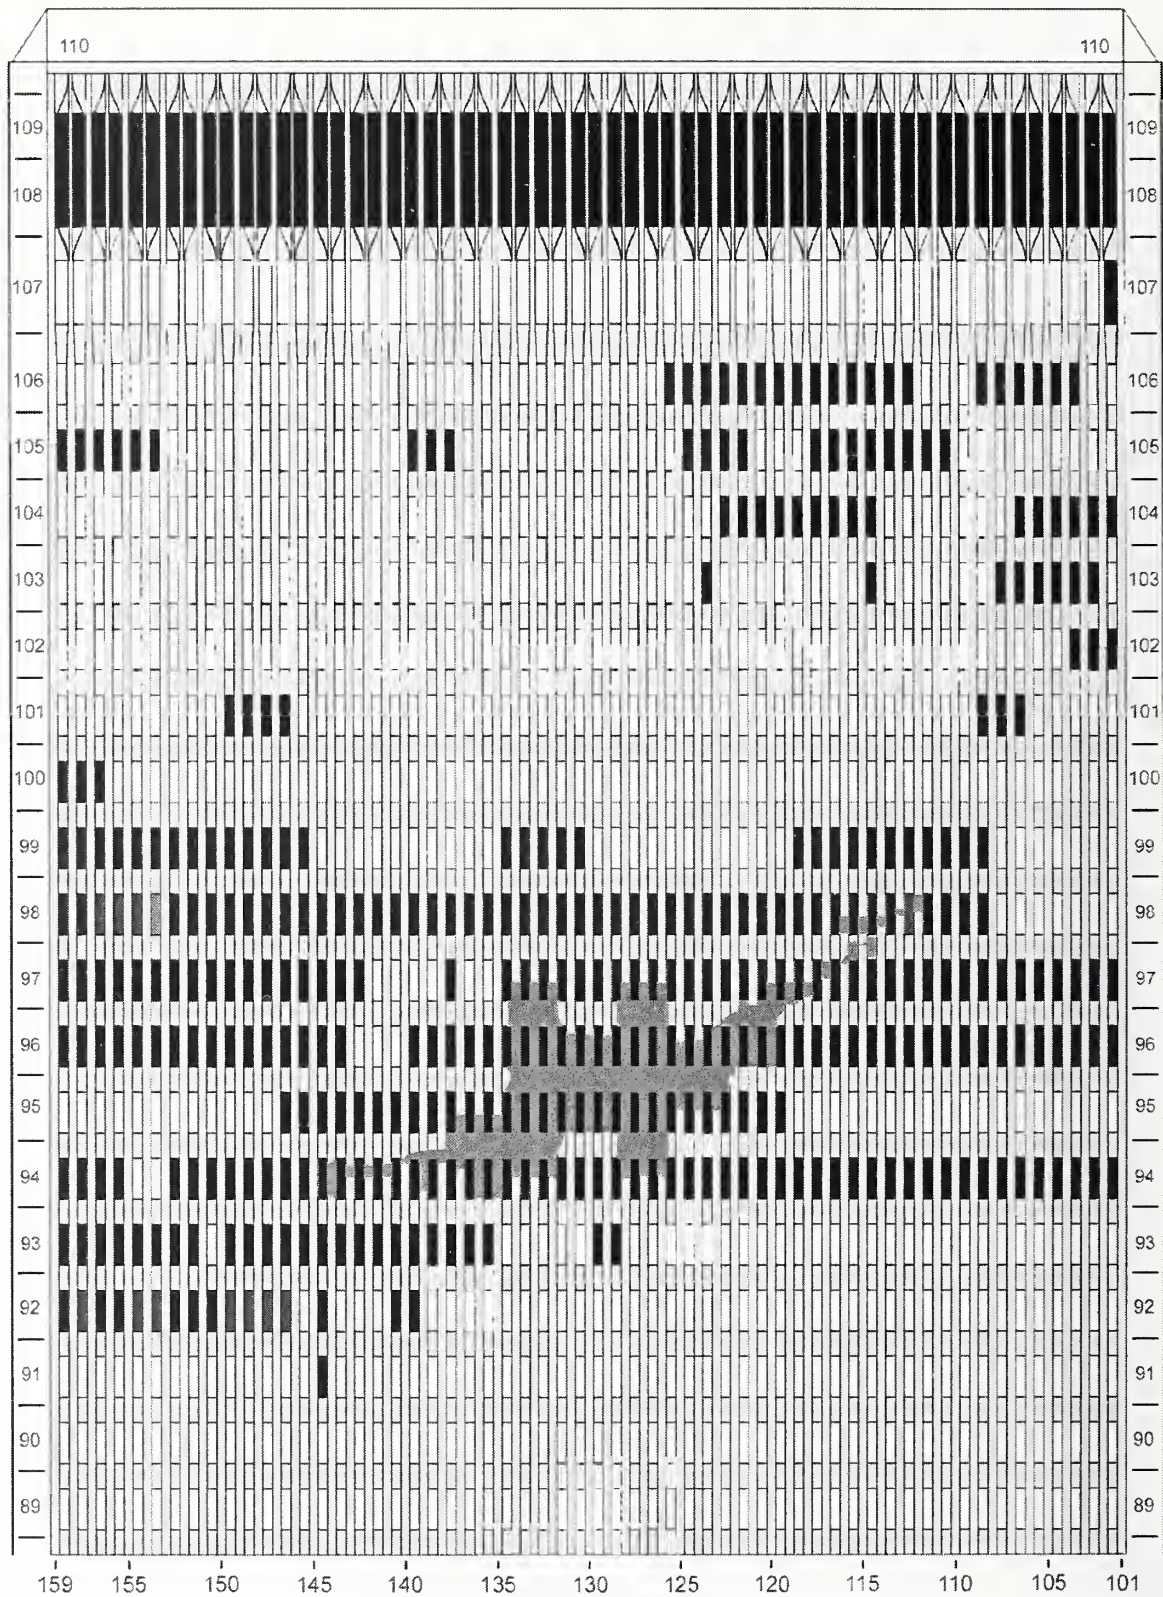
Figure C-45. Diagram of the north face of WTC 1 for floors 89 to 110 at 10:04 a.m. showing the condition of windows and locations of fires.

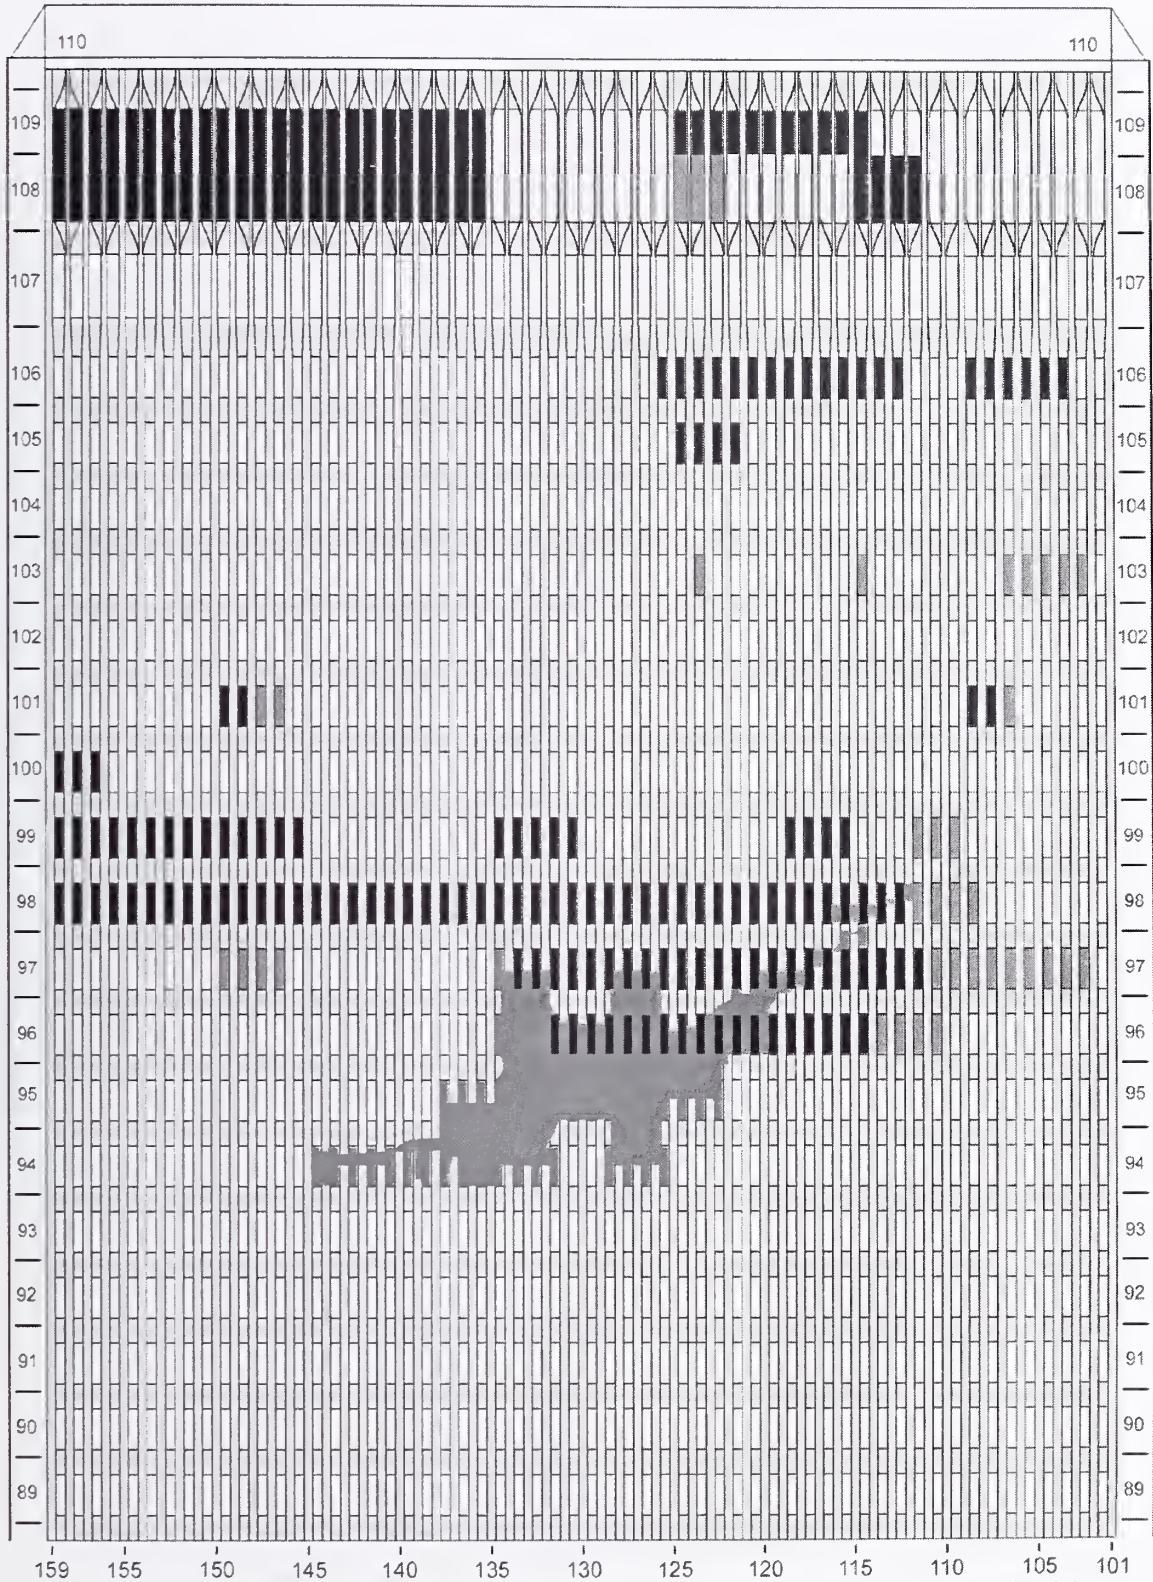
Figure C-46. Diagram of the north face of WTC 1 for floors 89 to 110 at 10:04 a.m. showing windows where smoke was observed and those that were hidden from view.

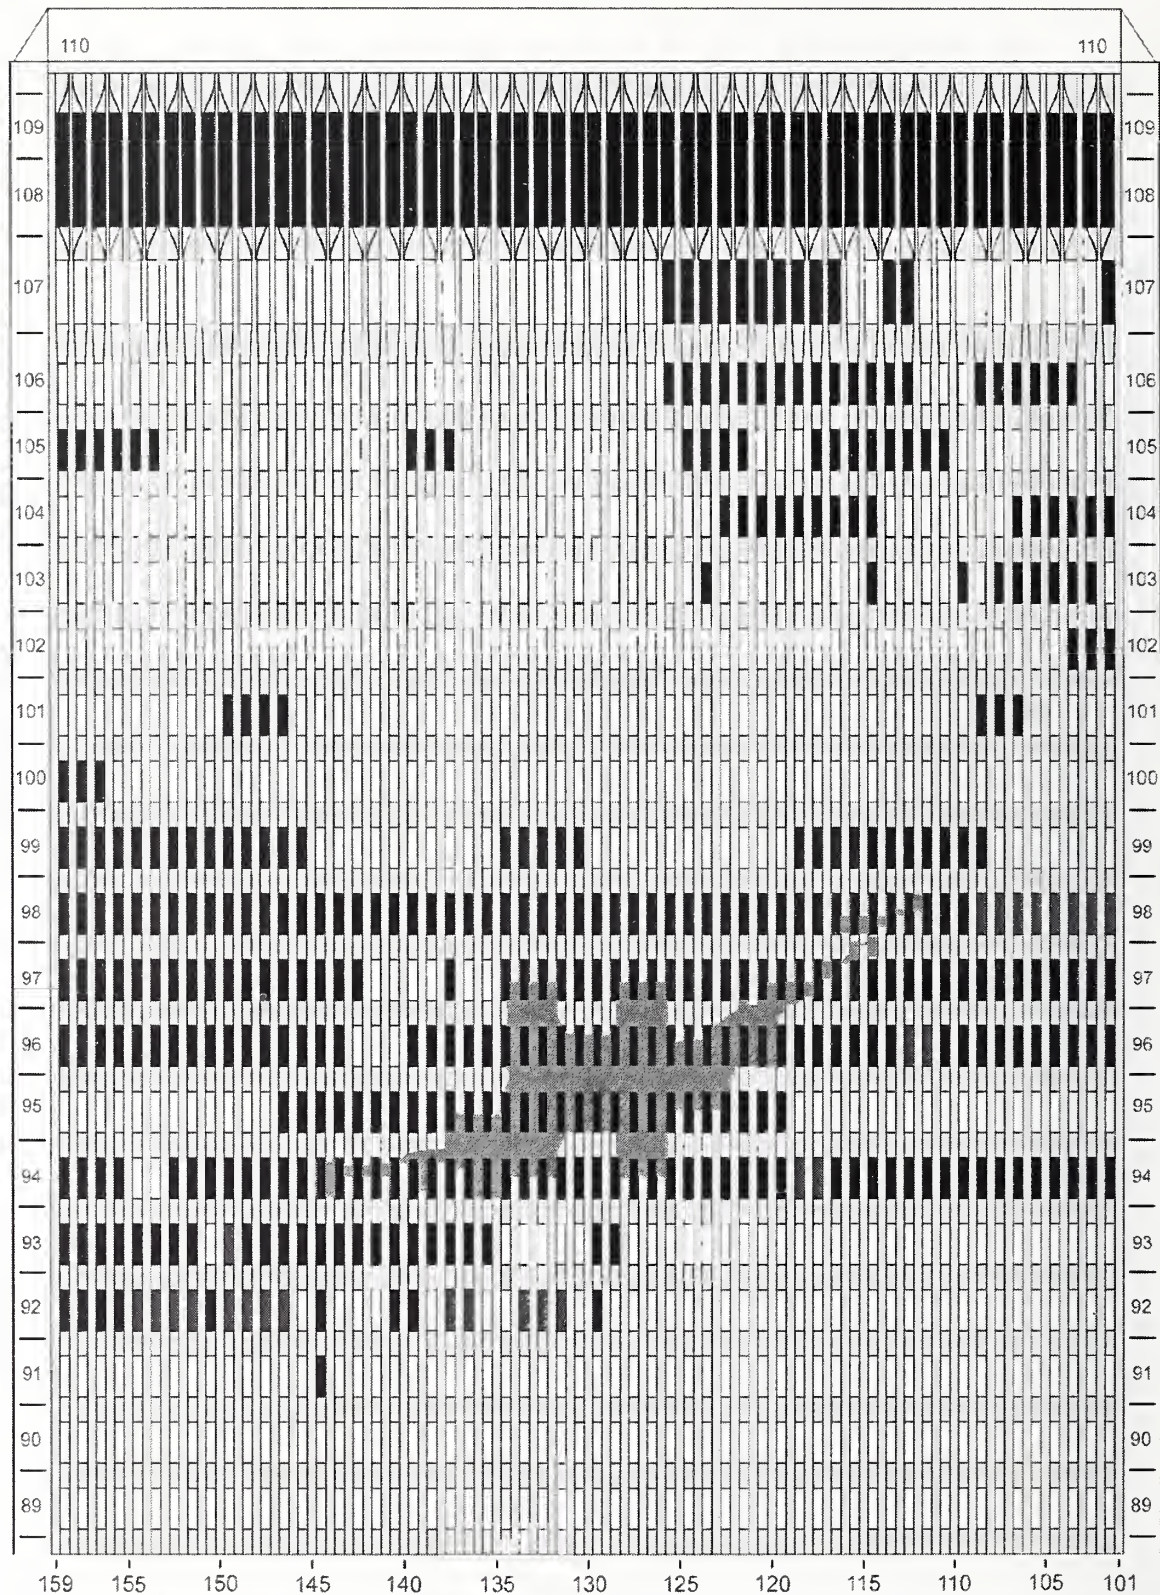
Figure C-47. Diagram of the north face of WTC 1 for floors 89 to 110 at 10:10 a.m. showing the condition of windows and locations of fires.

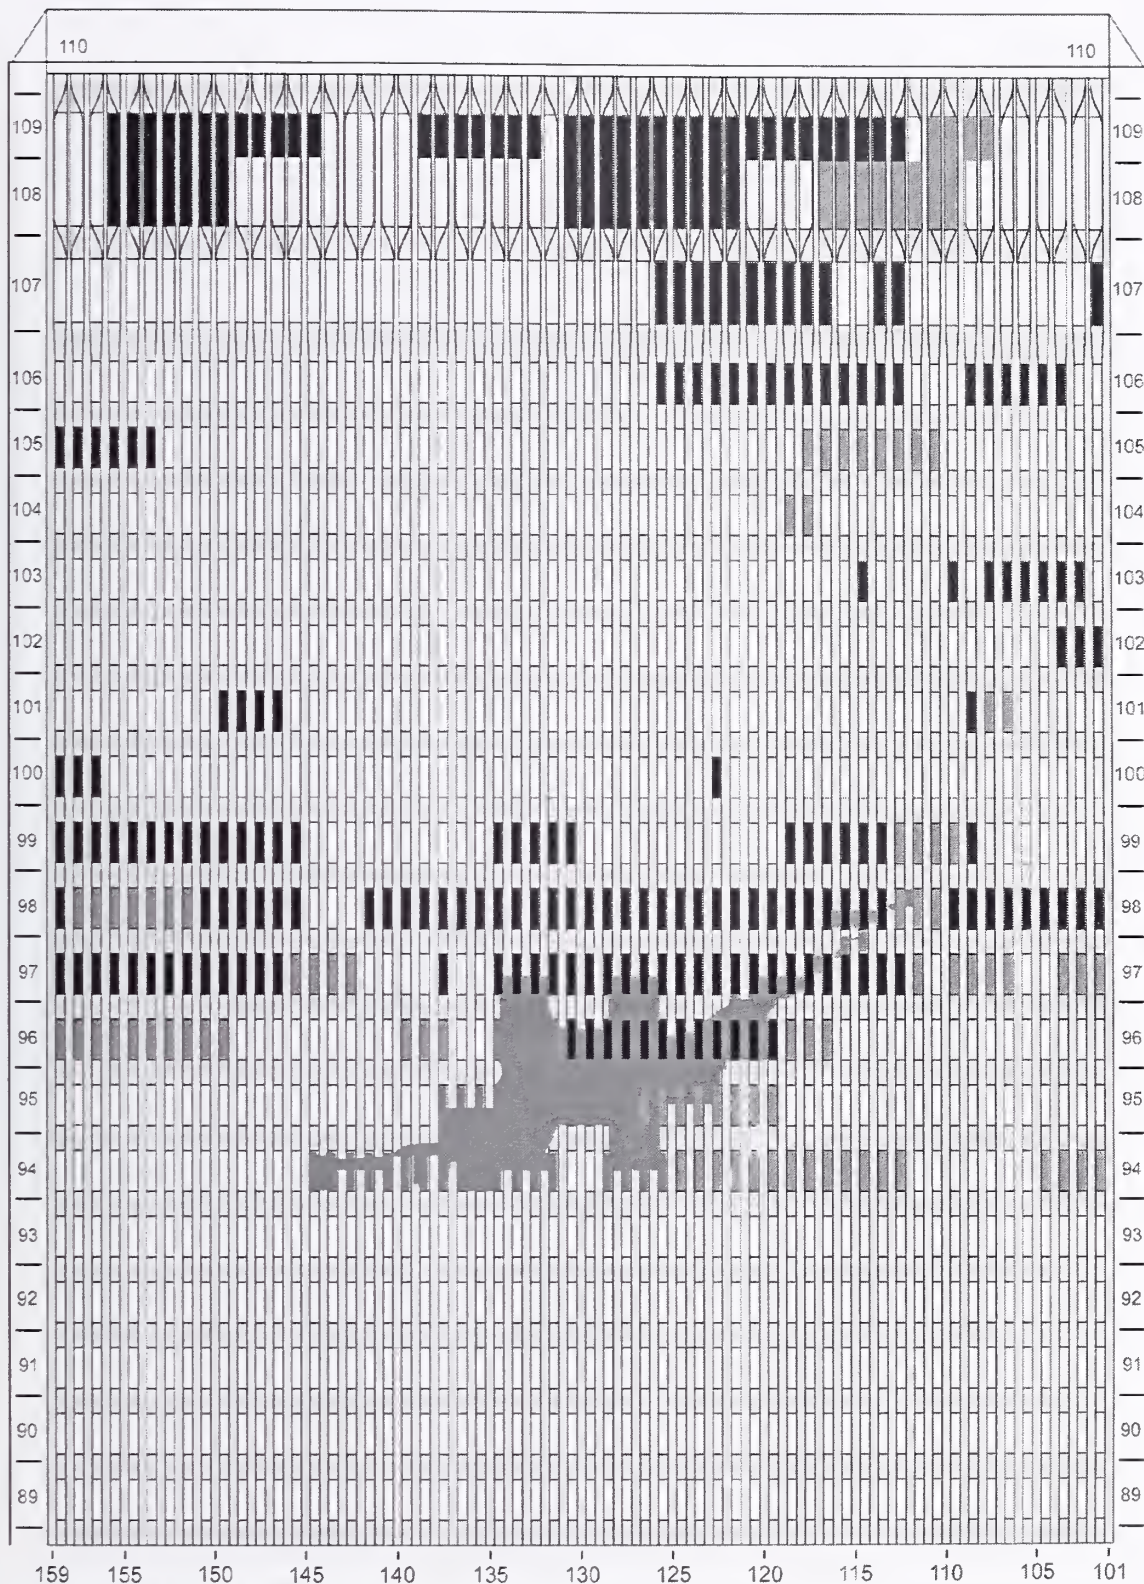
Figure C- 48. Diagram of the north face of WTC 1 for floors 89 to 110 at 10:10 a.m. showing windows where smoke was observed and those that were hidden from view.

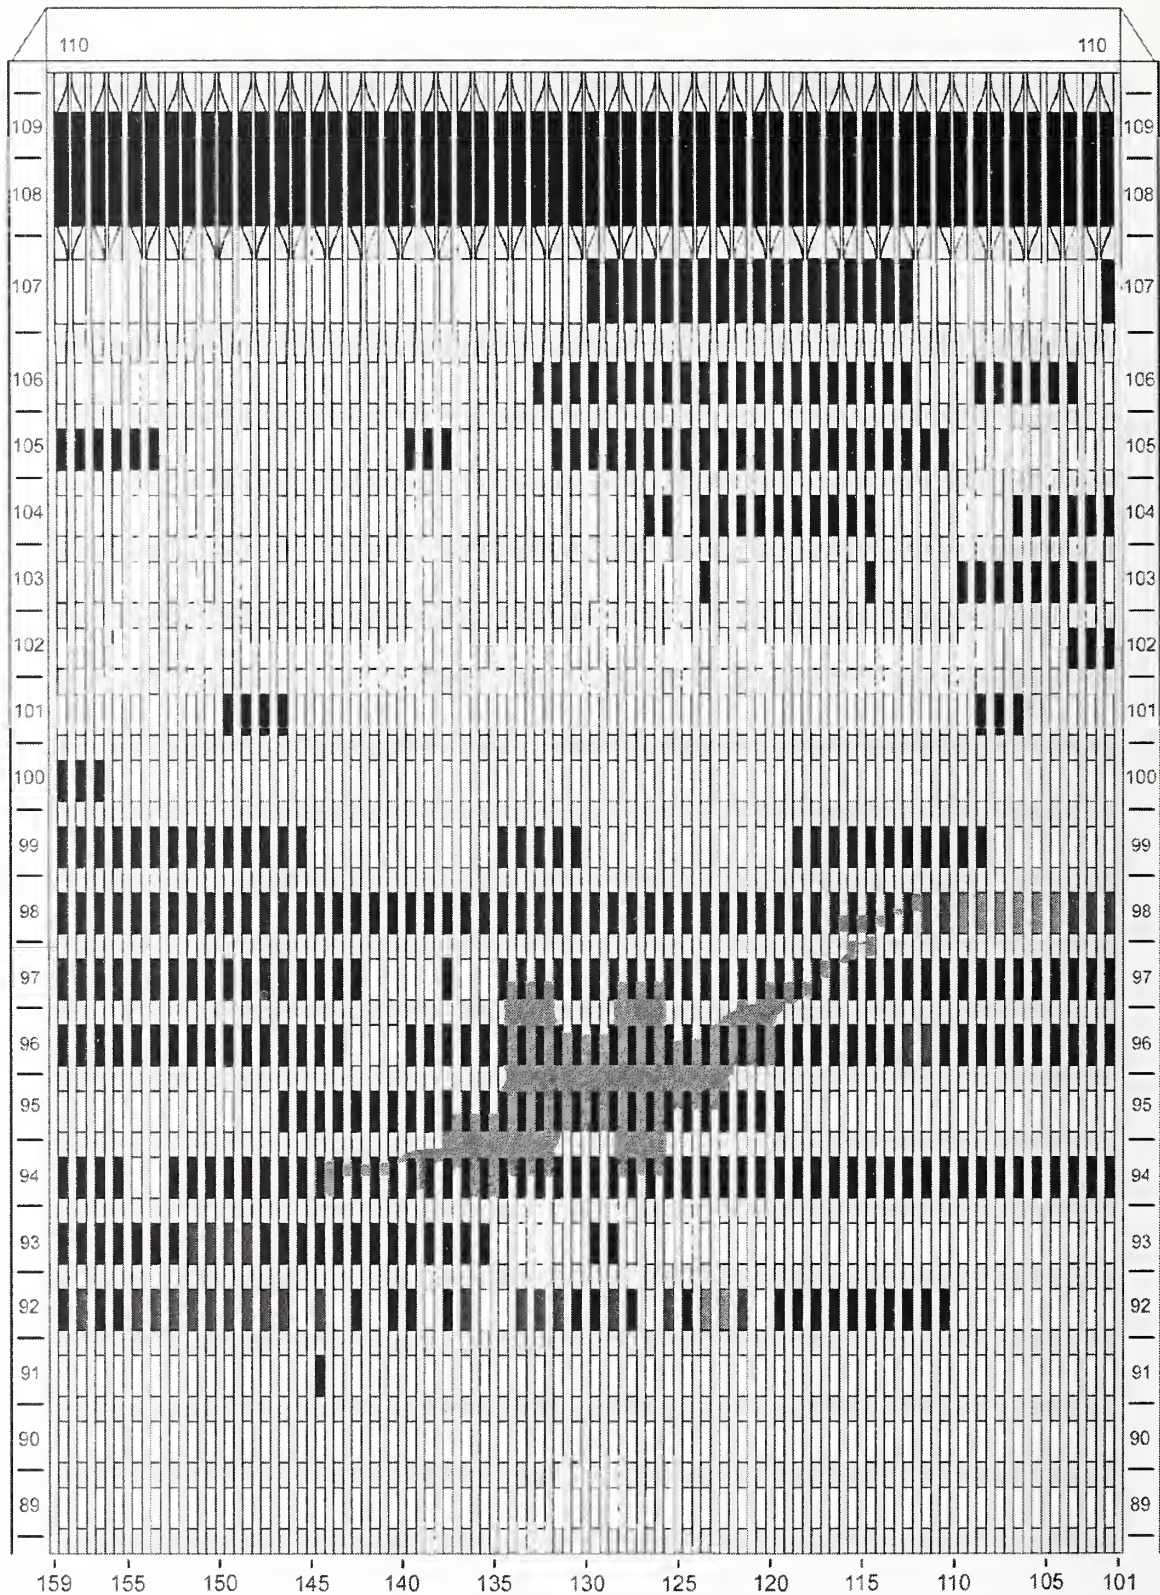
Figure C-49. Diagram of the north face of WTC 1 for floors 89 to 110 at 10:14 a.m. showing the condition of windows and locations of fires.

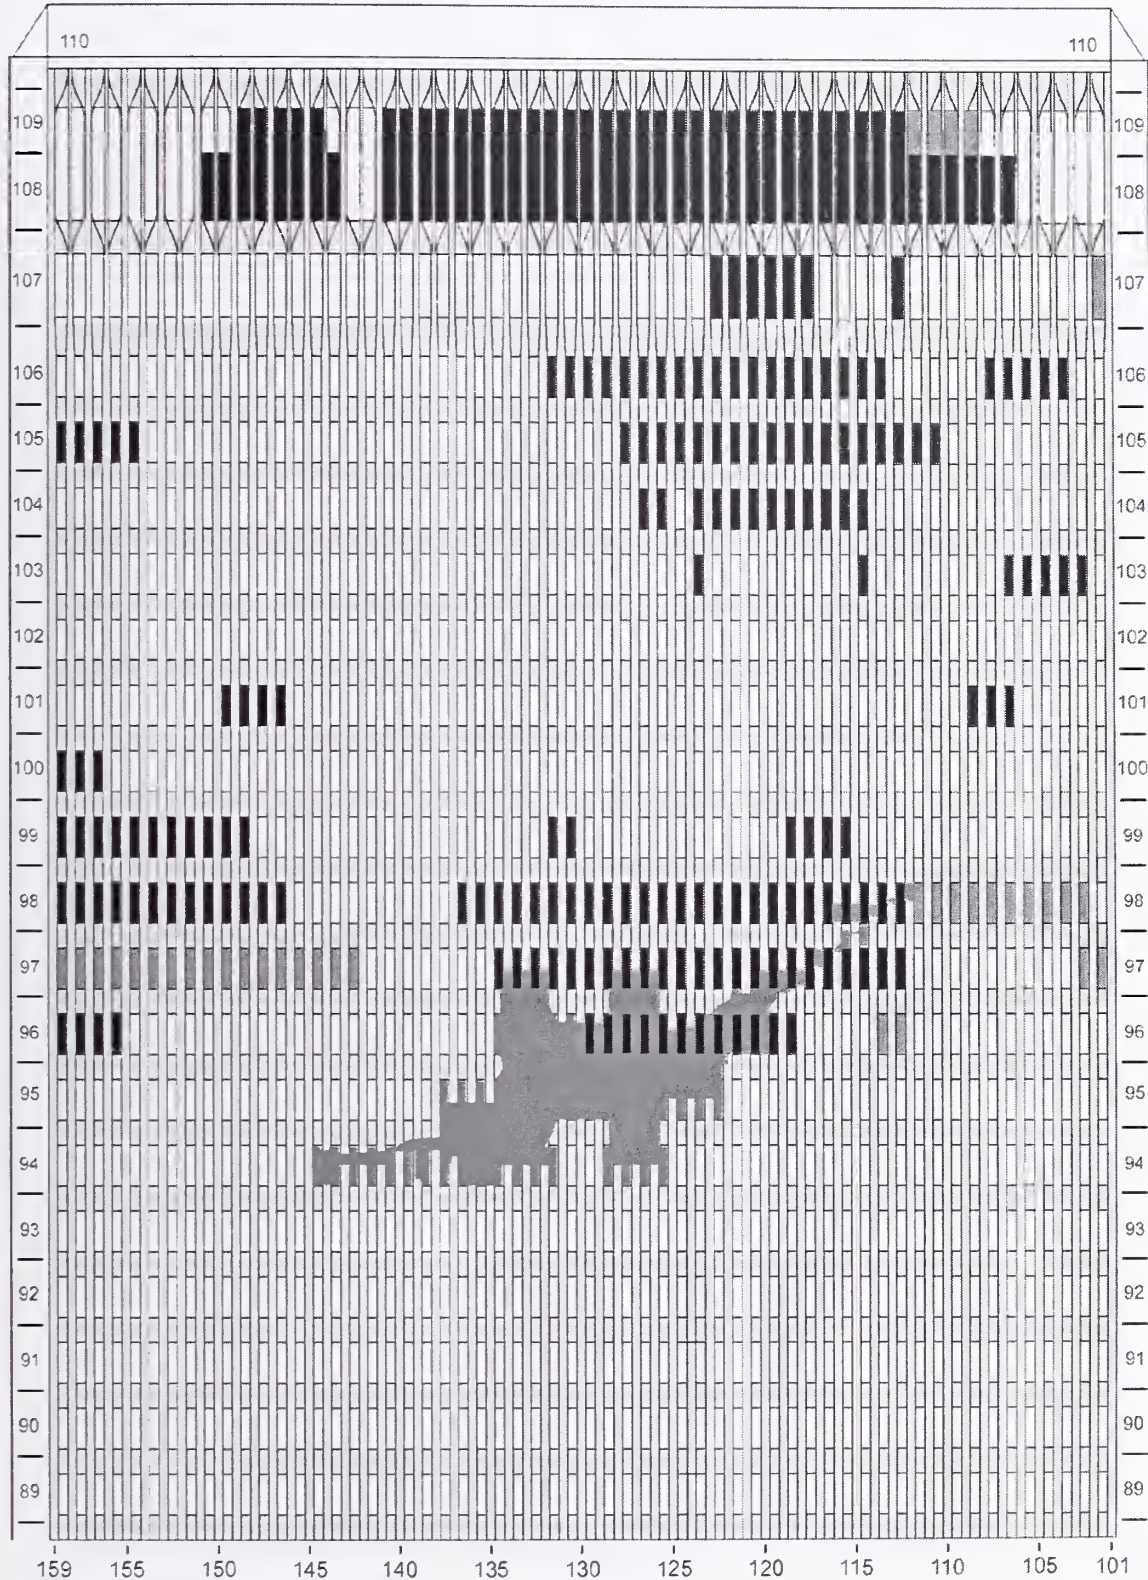
Figure C-50. Diagram of the north face of WTC 1 for floors 89 to 110 at 10:14 a.m. showing windows where smoke was observed and those that were hidden from view.

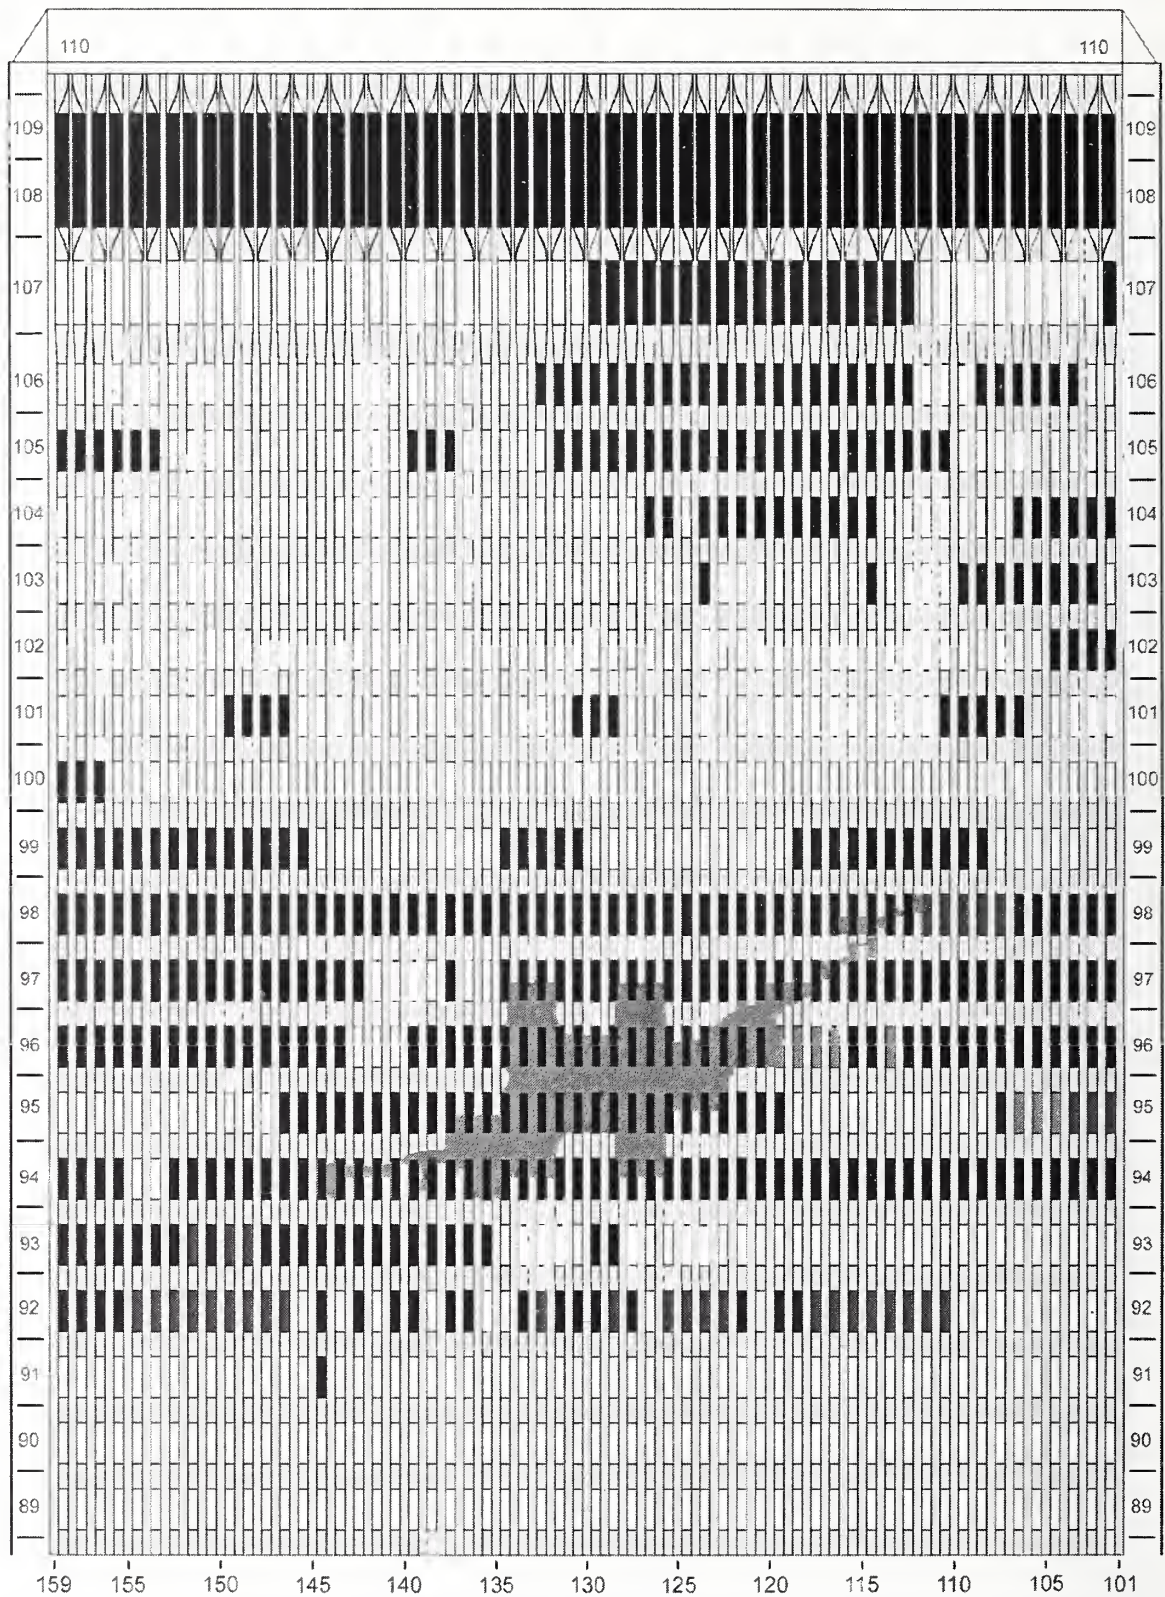
Figure C-51. Diagram of the north face of WTC 1 for floors 89 to 110 at 10:18 a.m. showing the condition of windows and locations of fires.

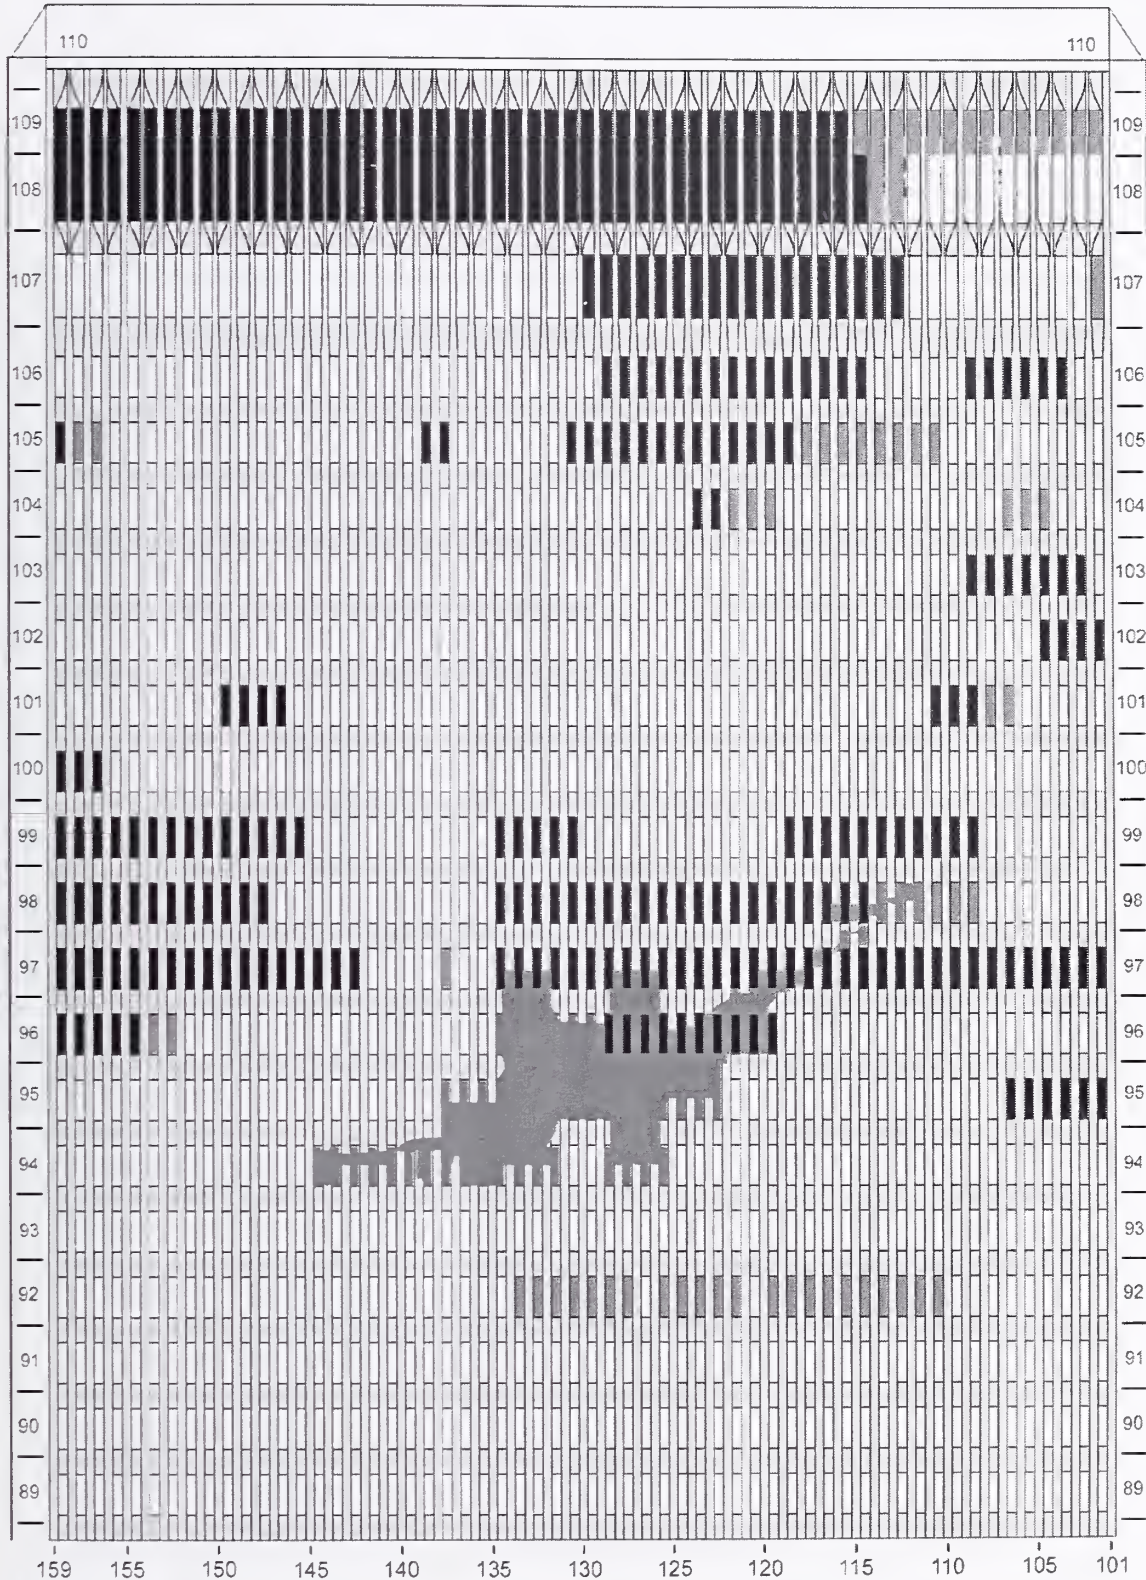
Figure C-52. Diagram of the north face of WTC 1 for floors 89 to 110 at 10:18 a.m. showing windows where smoke was observed and those that were hidden from view.

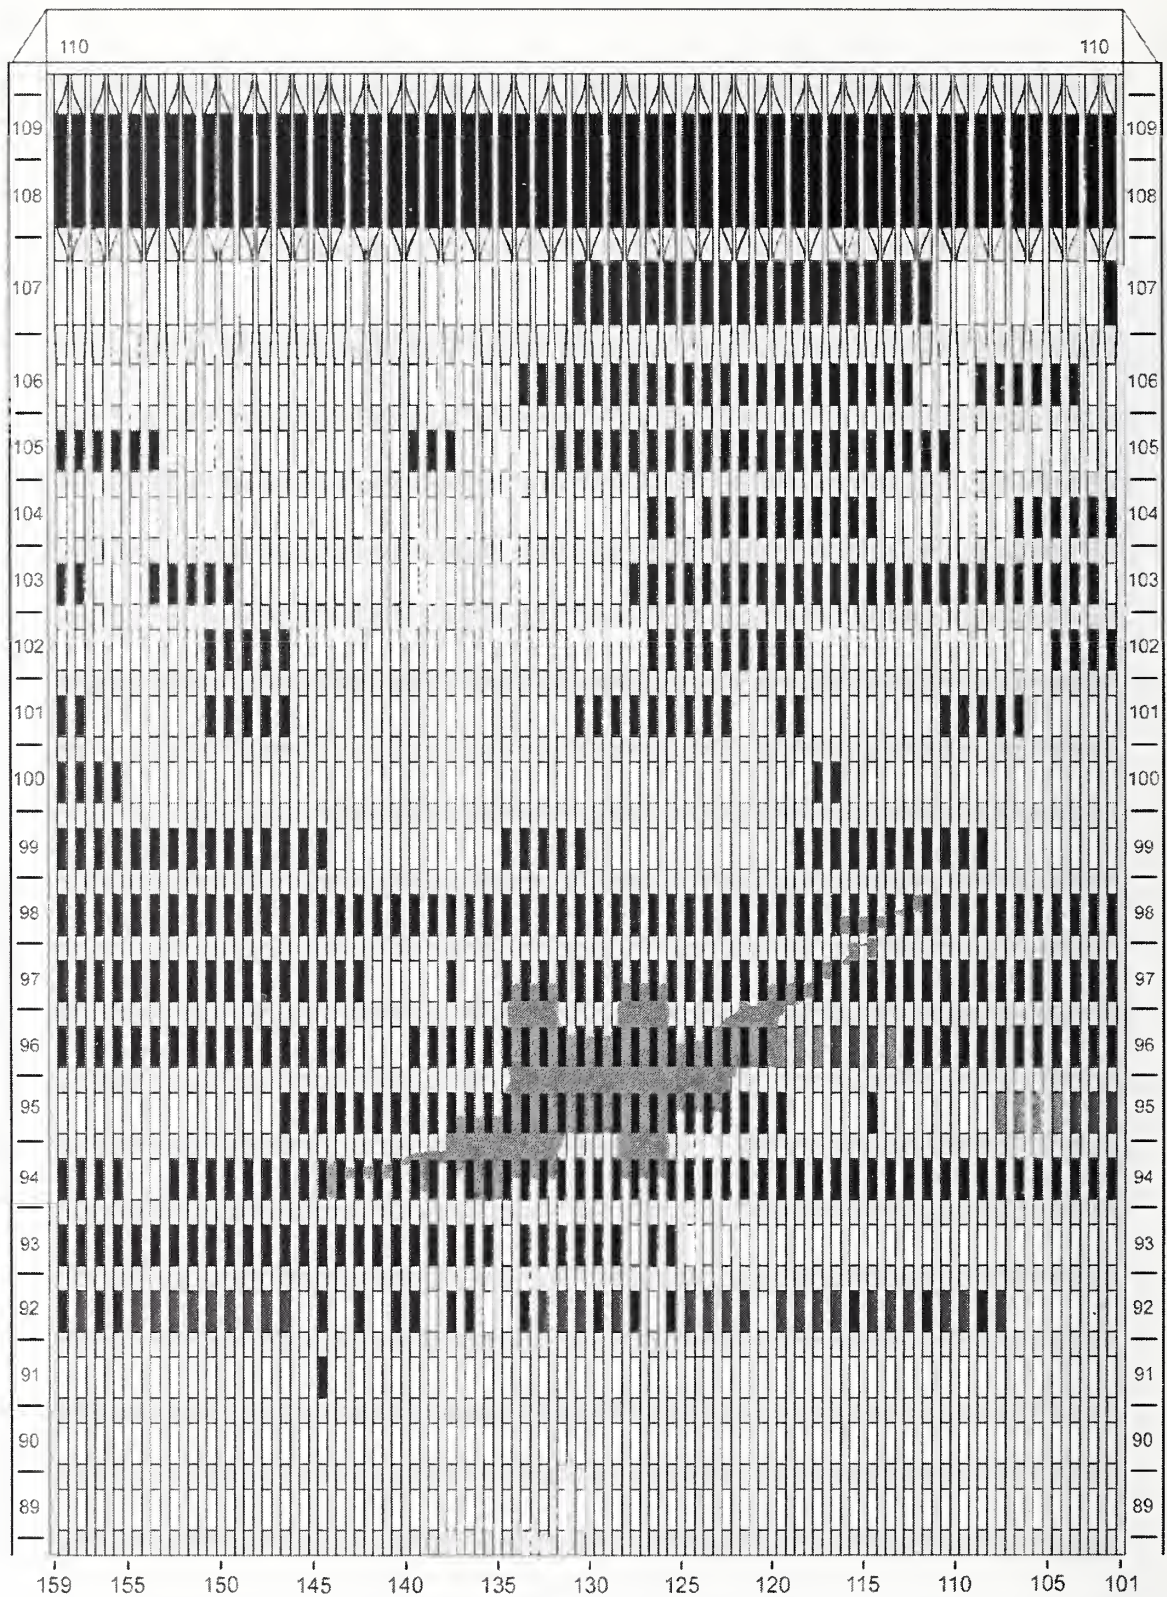
Figure C-53. Diagram of the north face of WTC 1 for floors 89 to 110 at 10:20 a.m. showing the condition of windows and locations of fires.

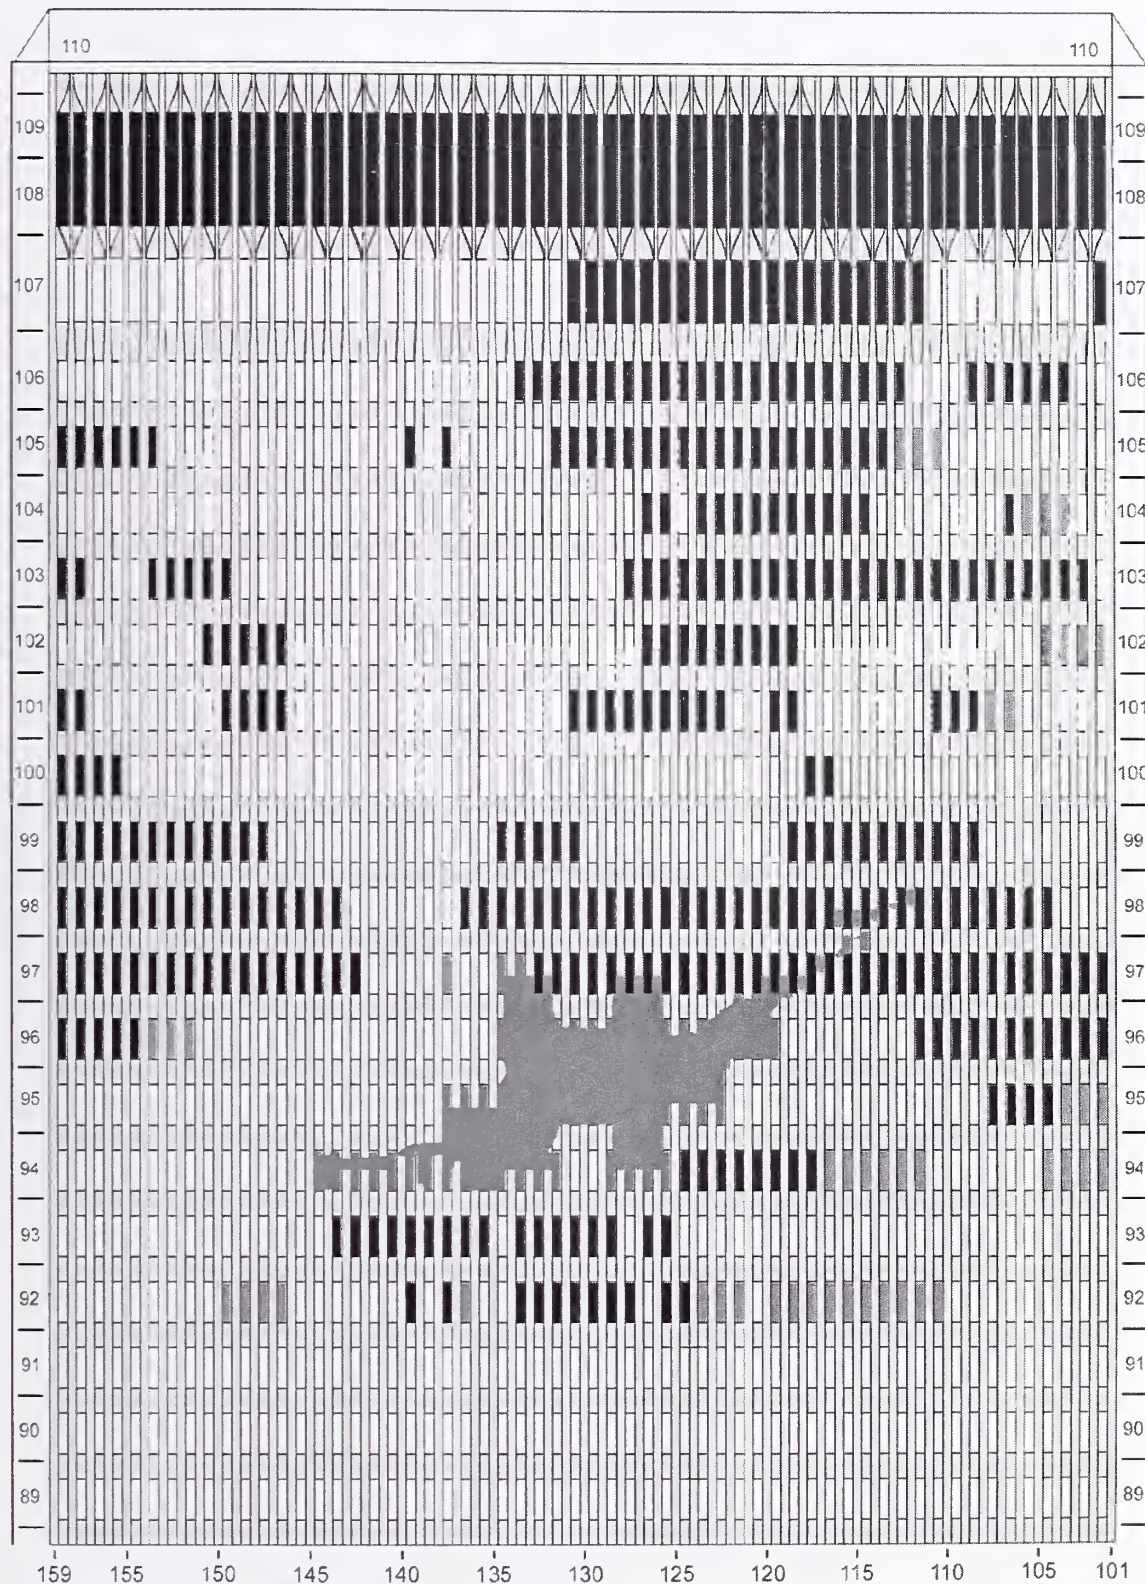
Figure C-54. Diagram of the north face of WTC 1 for floors 89 to 110 at 10:20 a.m. showing windows where smoke was observed and those that were hidden from view.
