**NIST NCSTAR 1-5A
Federal Building and Fire Safety Investigation of
the World Trade Center Disaster**

**Visual Evidence, Damage Estimates,
And Timeline Analysis**

(Chapter 9 - Appendix C)

FIRE BEHAVIOR IN WORLD TRADE CENTER 2

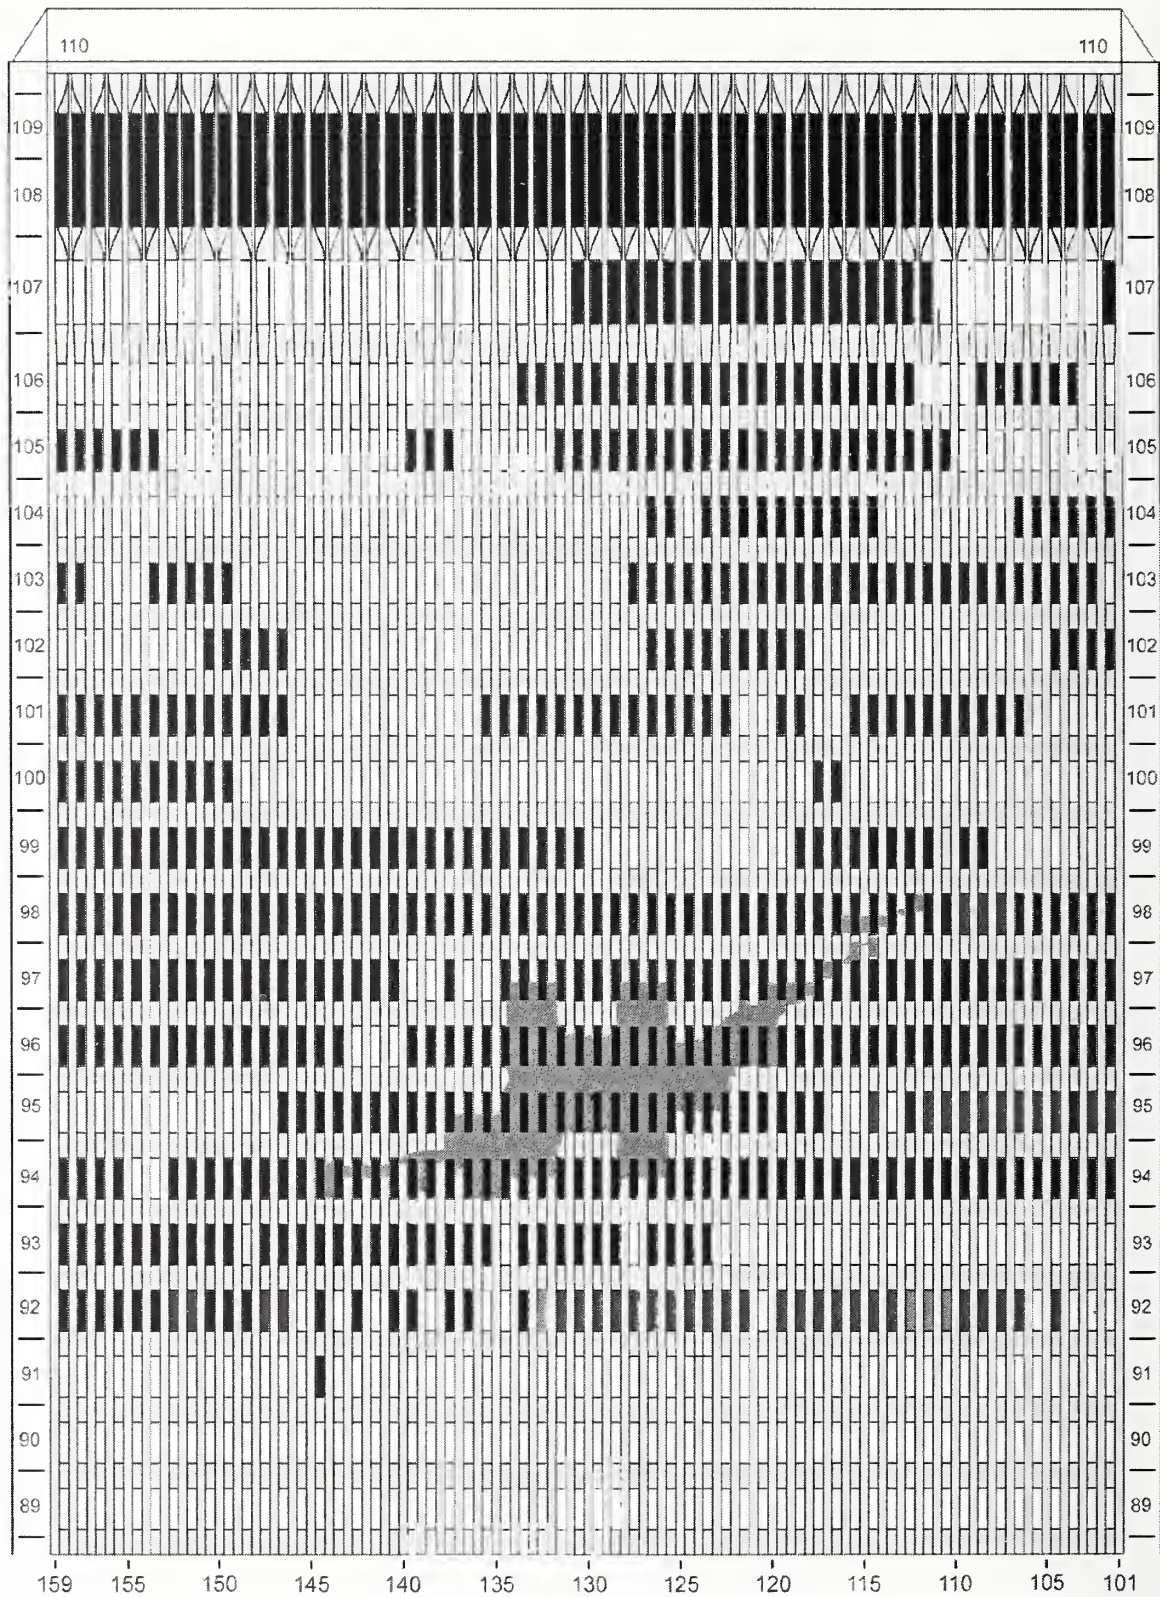
Figure C-55. Diagram of the north face of WTC 1 for floors 89 to 110 at 10:24 a.m. showing the condition of windows and locations of fires.

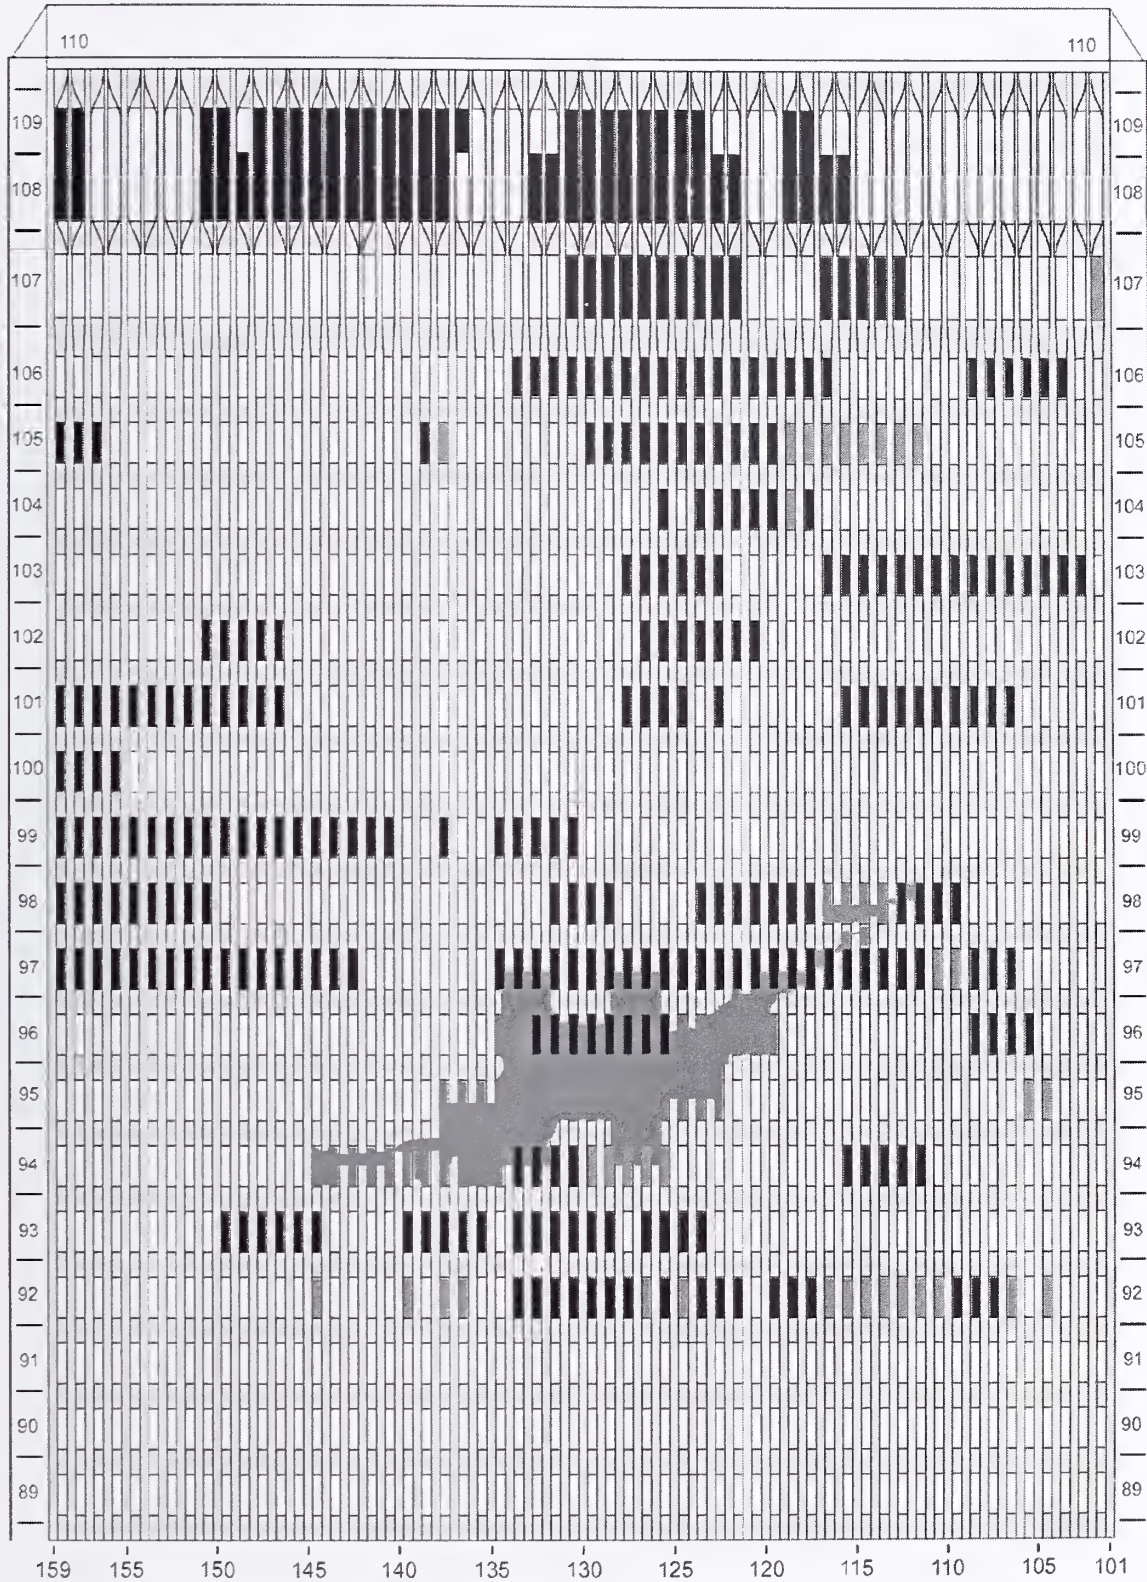
Figure C-56. Diagram of the north face of WTC 1 for floors 89 to 110 at 10:24 a.m. showing windows where smoke was observed and those that were hidden from view.

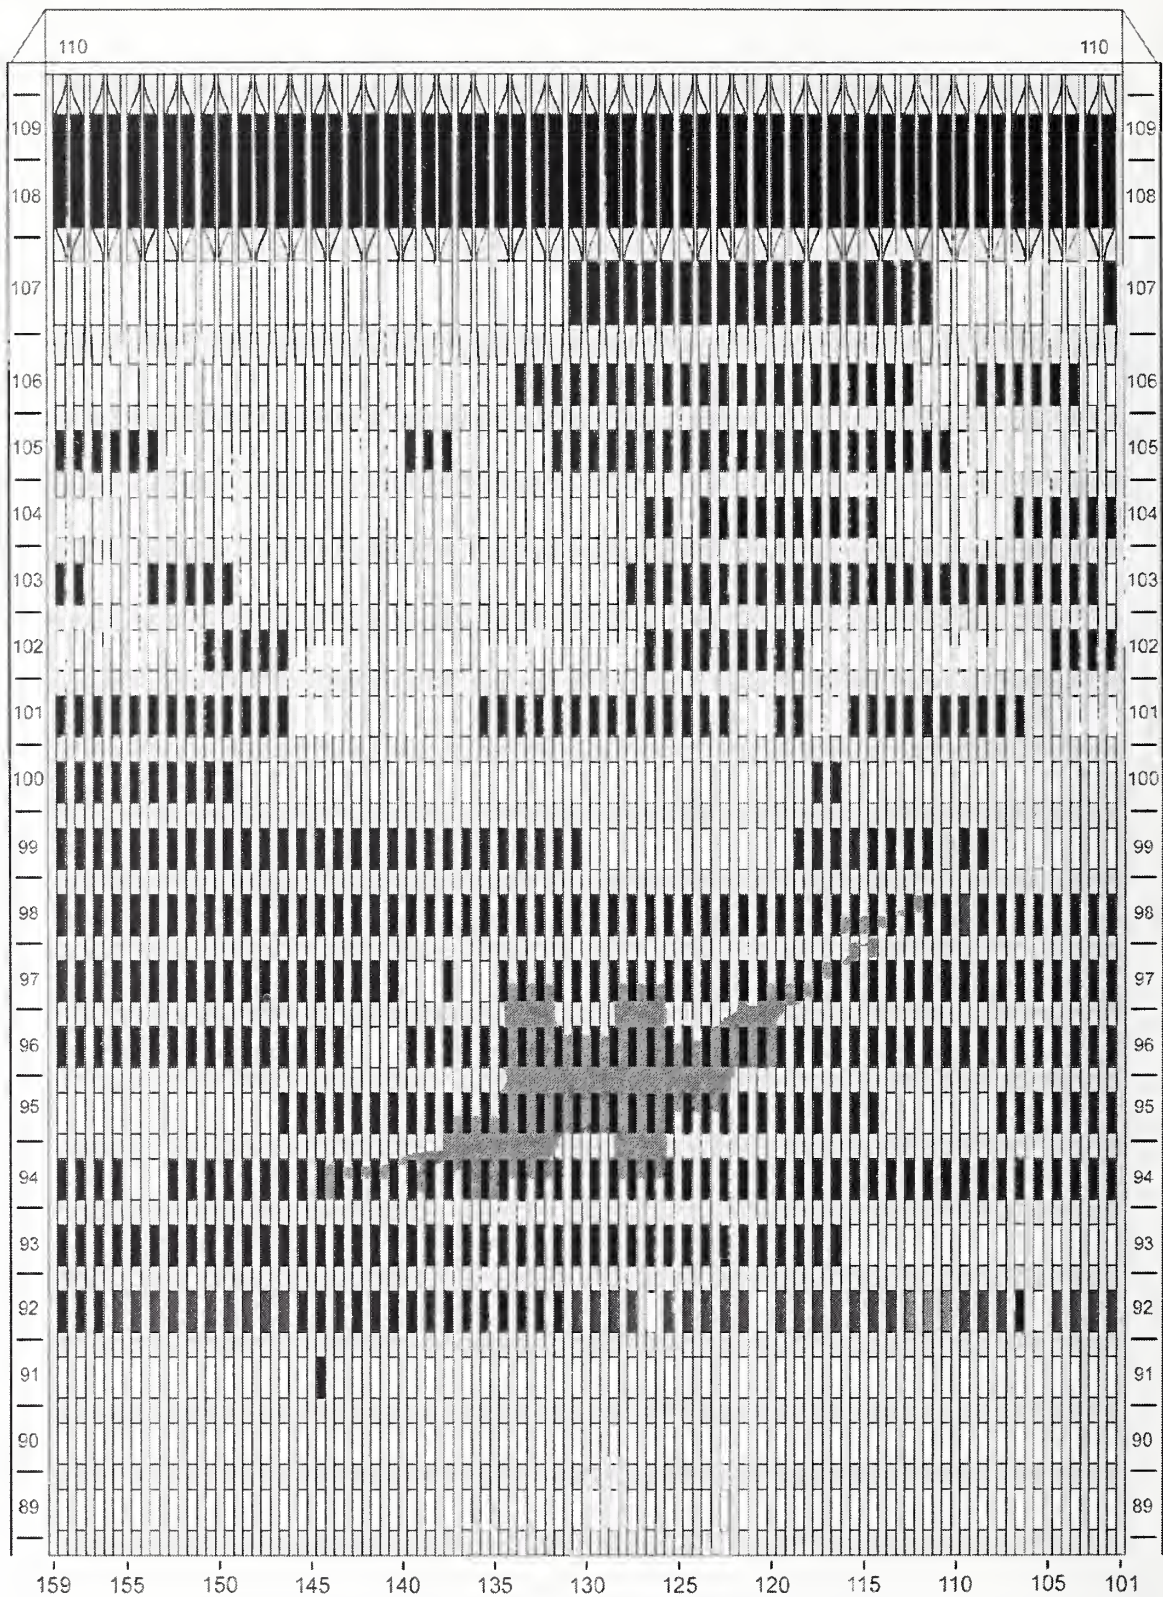
Figure C-57. Diagram of the north face of WTC 1 for floors 89 to 110 at 10:28 a.m. showing the condition of windows and locations of fires.

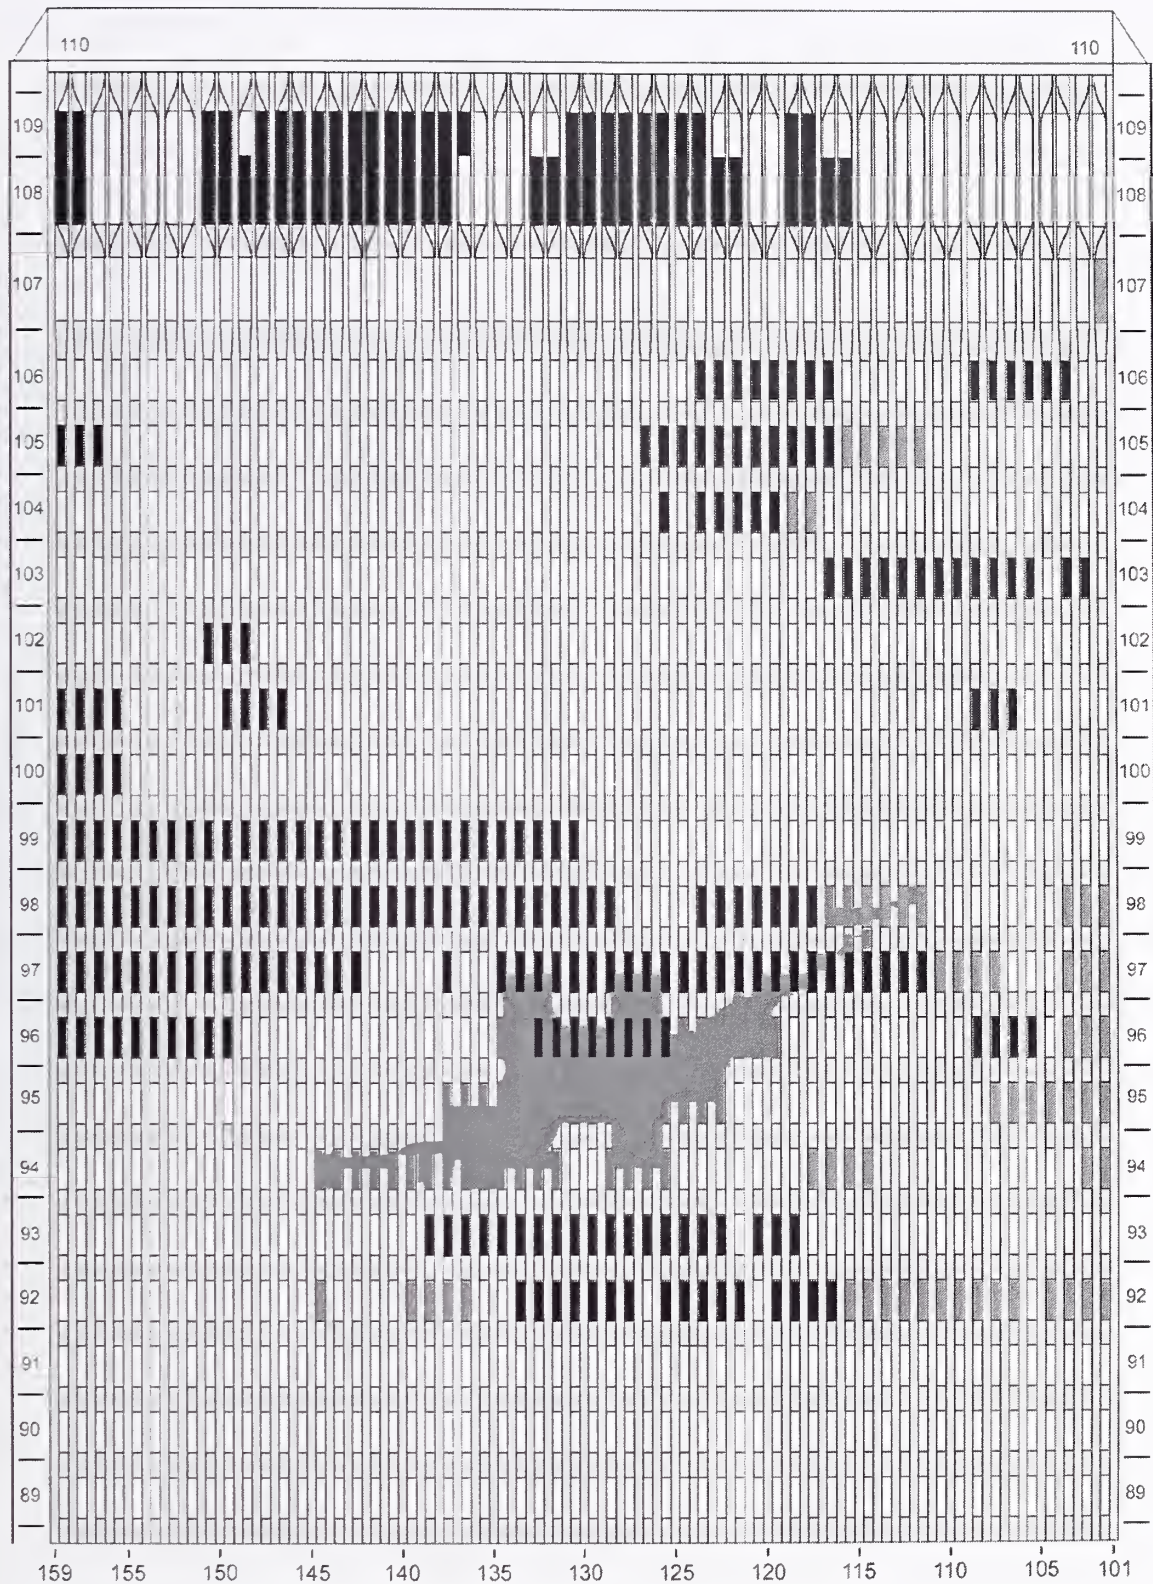
Figure C-58. Diagram of the north face of WTC 1 for floors 89 to 110 at 10:28 a.m. showing windows where smoke was observed and those that were hidden from view.

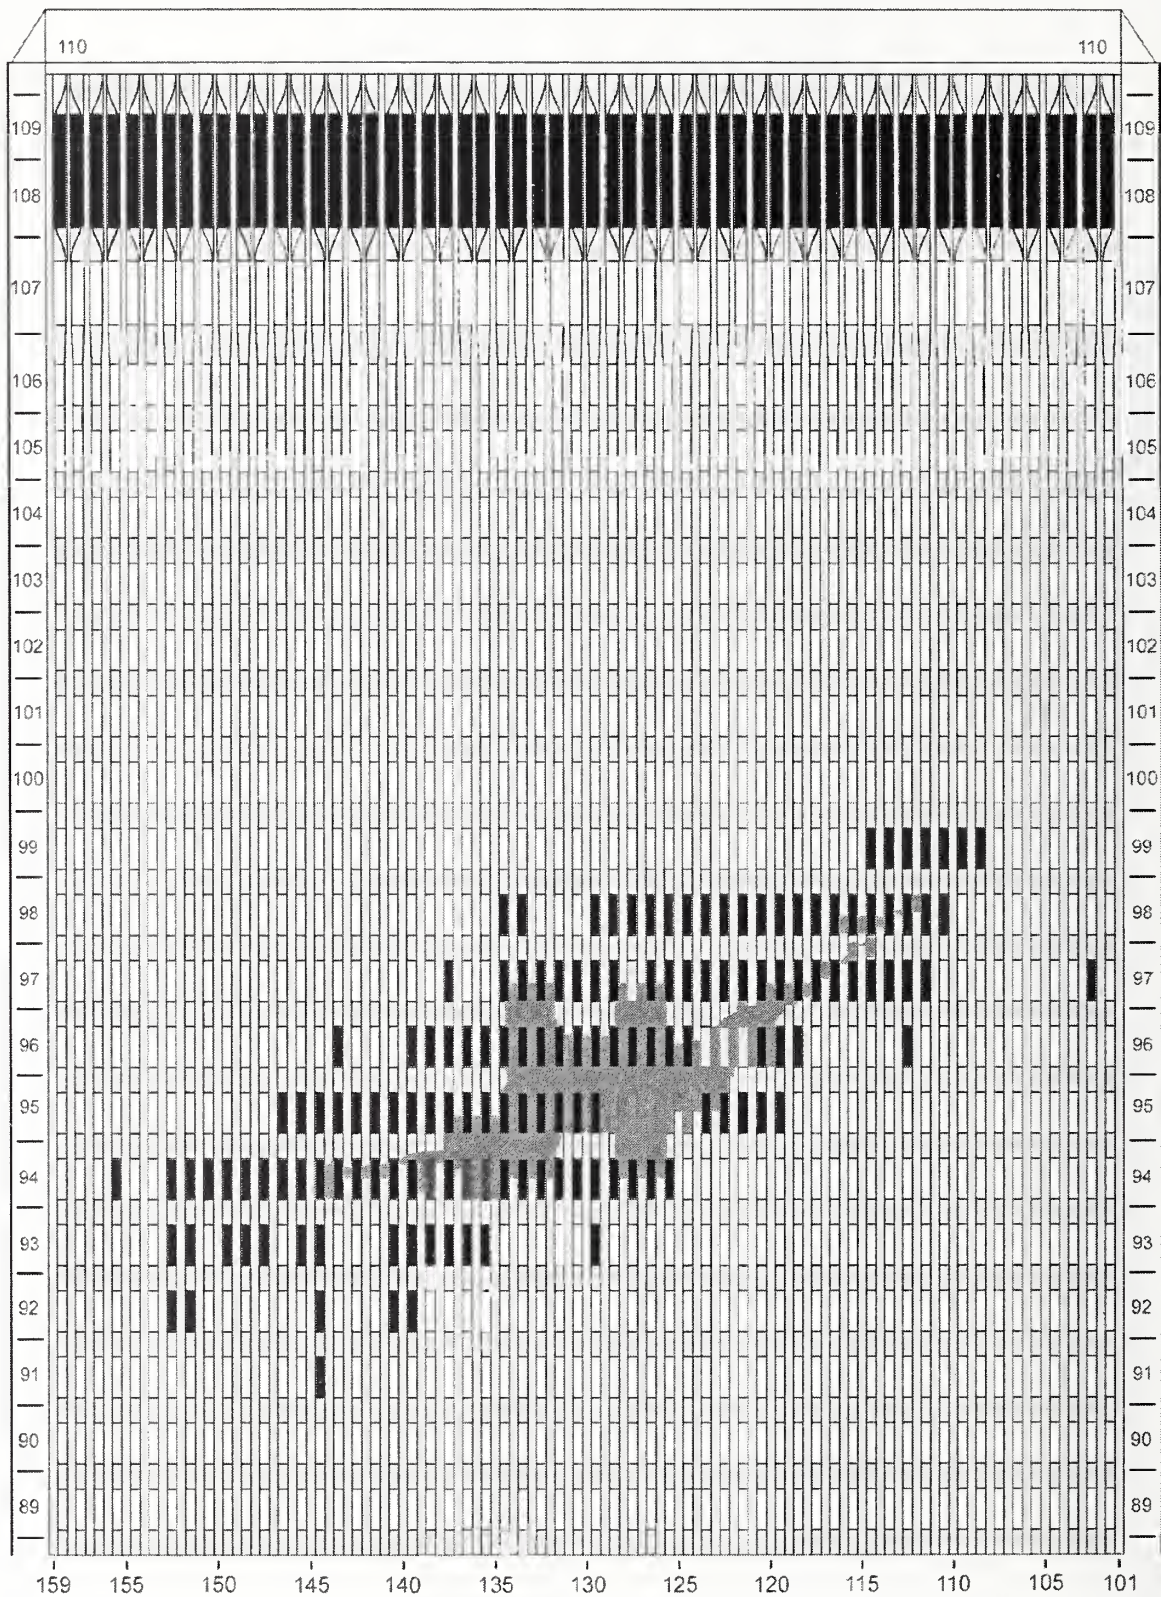
Figure C-1. Diagram of the north face of WTC 1 for floors 89 to 110 at 8:47 a.m. showing the condition of windows and locations of fires.

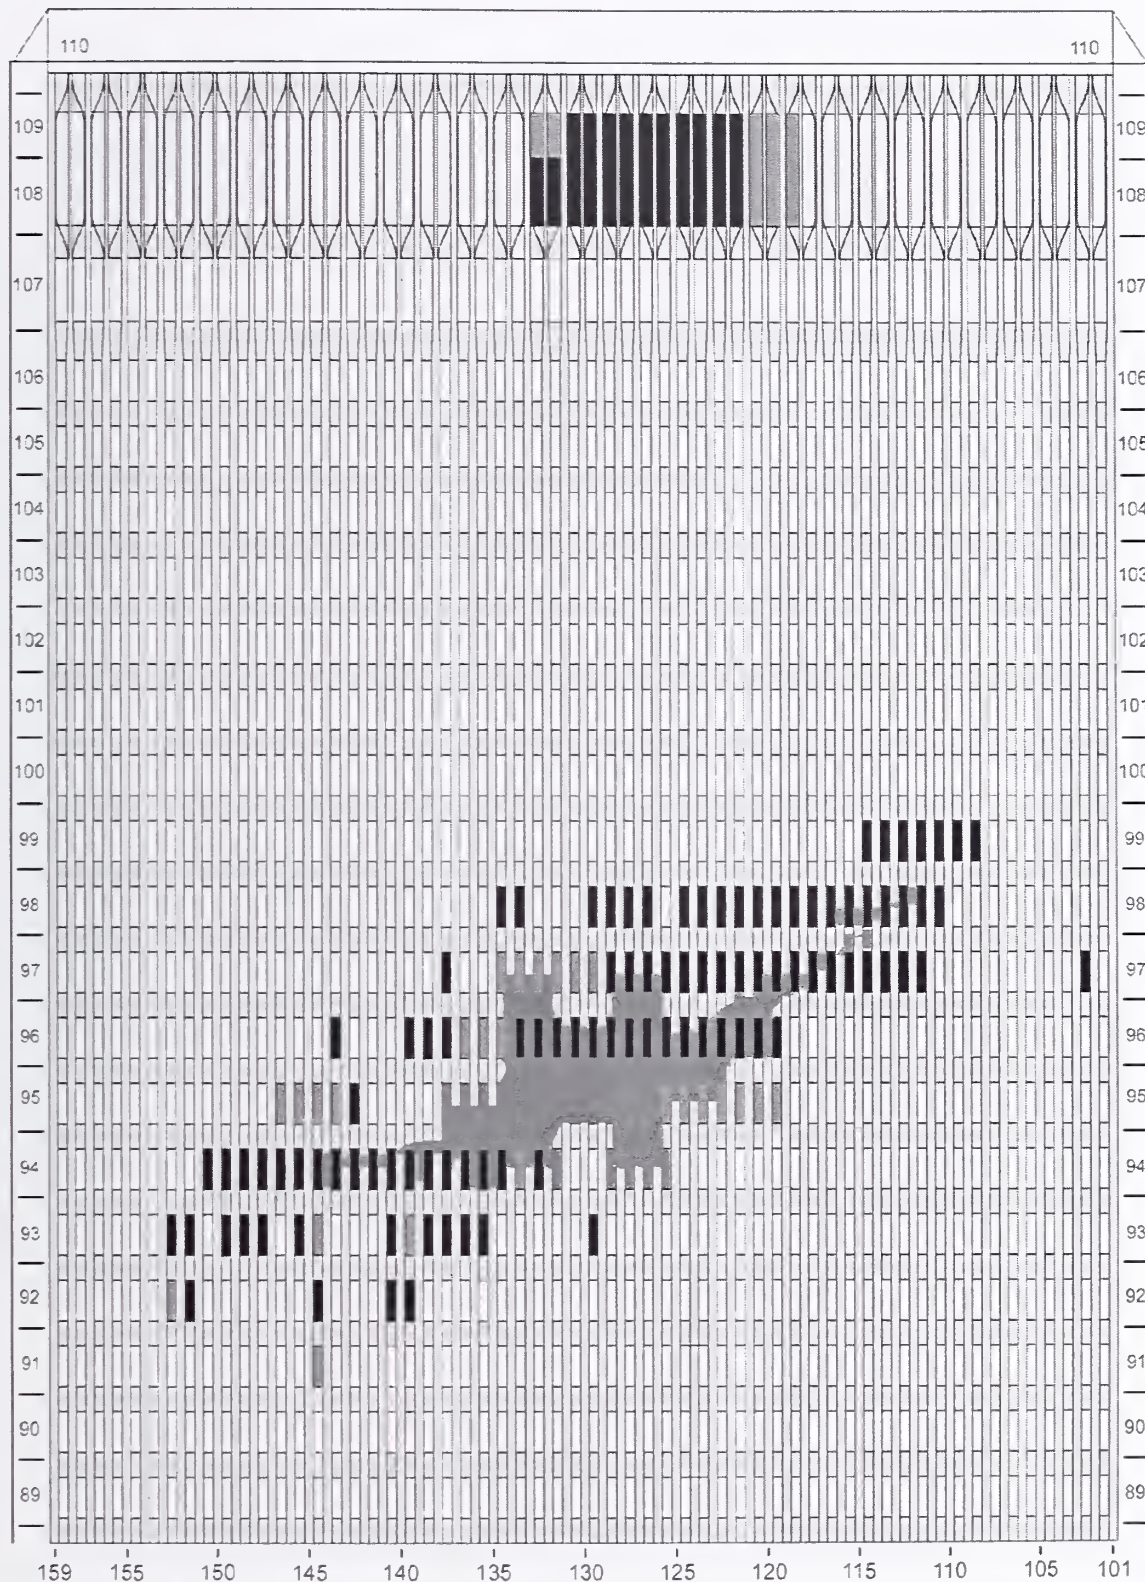
Figure C-2. Diagram of the north face of WTC 1 for floors 89 to 110 at 8:47 a.m. showing windows where smoke was observed and those that were hidden from view.

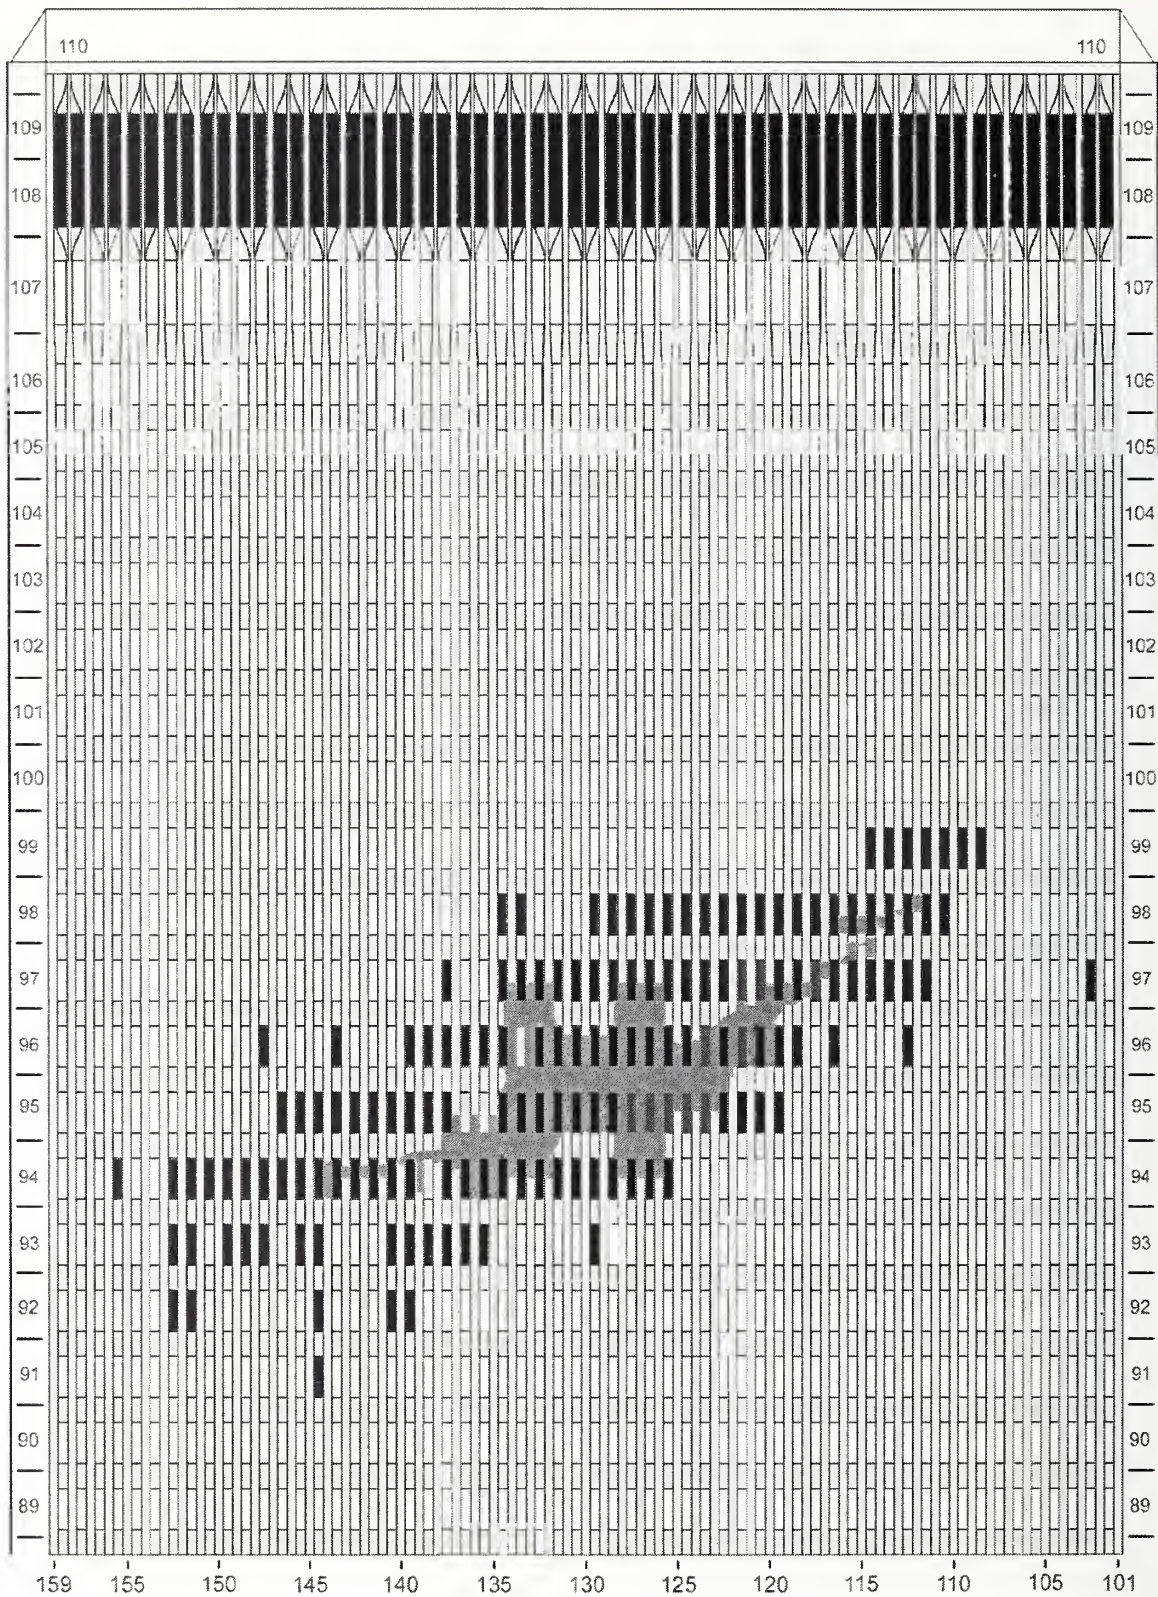
Figure C-3. Diagram of the north face of WTC 1 for floors 89 to 110 at 8:48 a.m. showing the condition of windows and locations of fires.

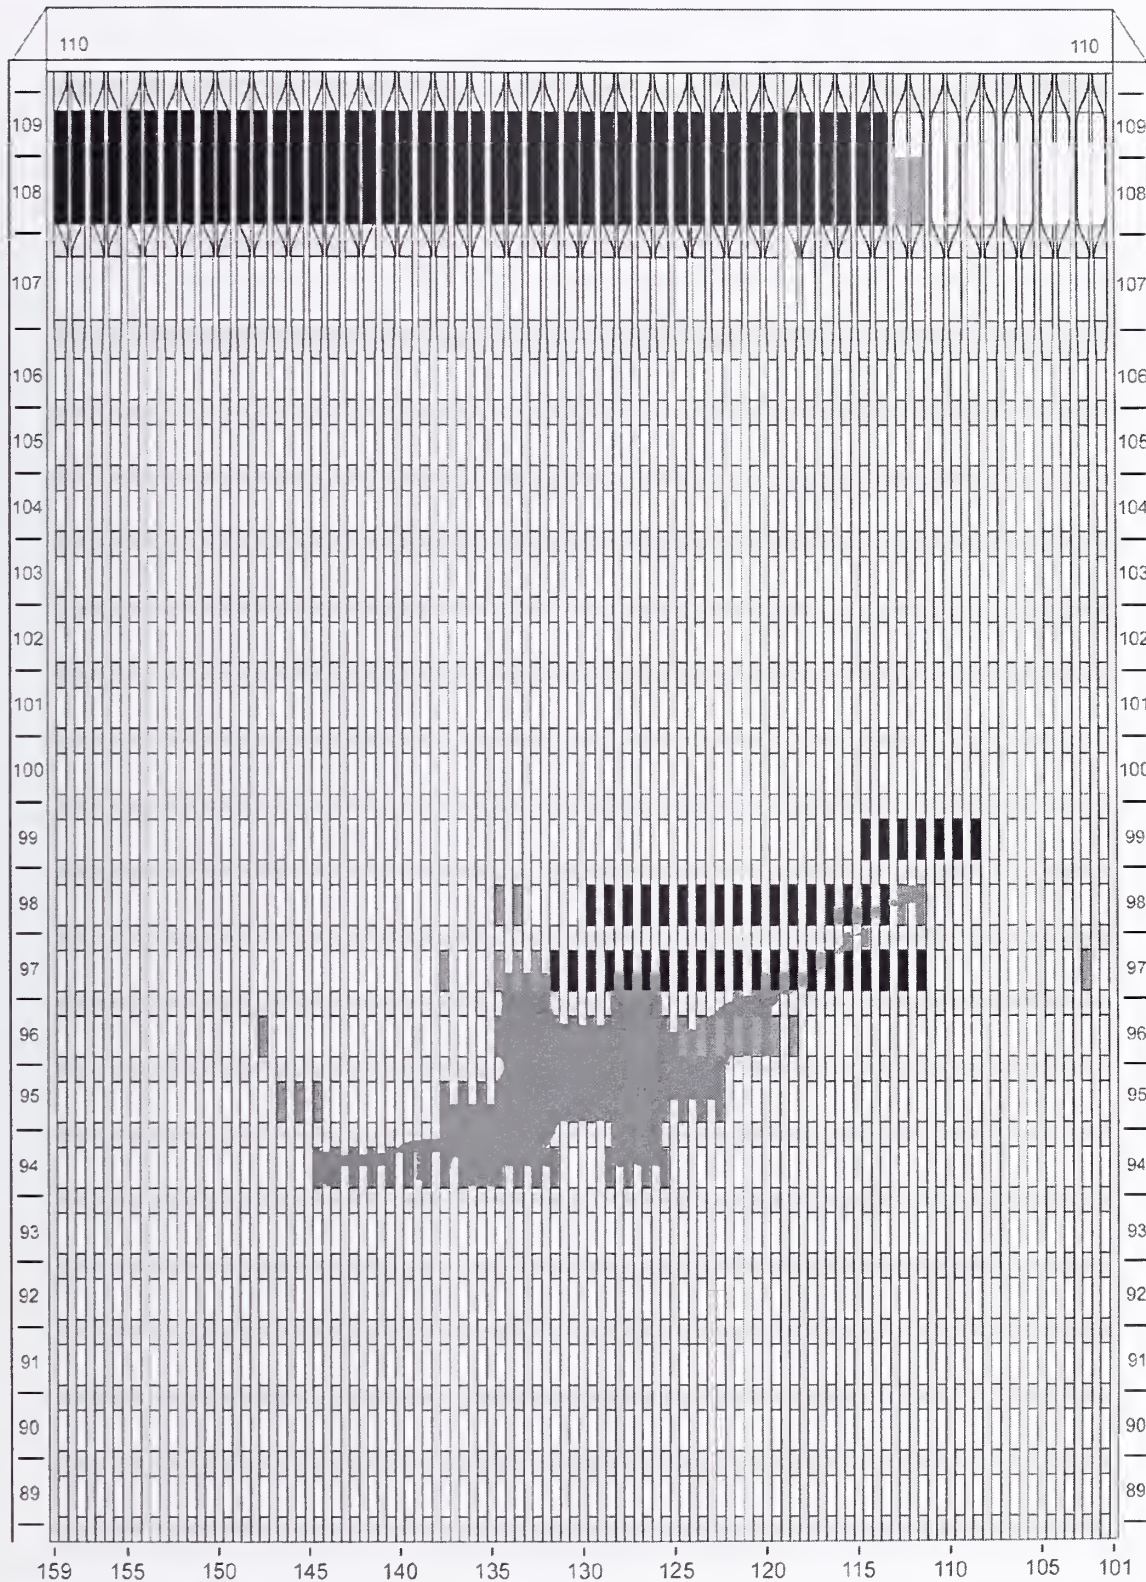
Figure C-4. Diagram of the north face of WTC 1 for floors 89 to 110 at 8:48 a.m. showing windows where smoke was observed and those that were hidden from view.

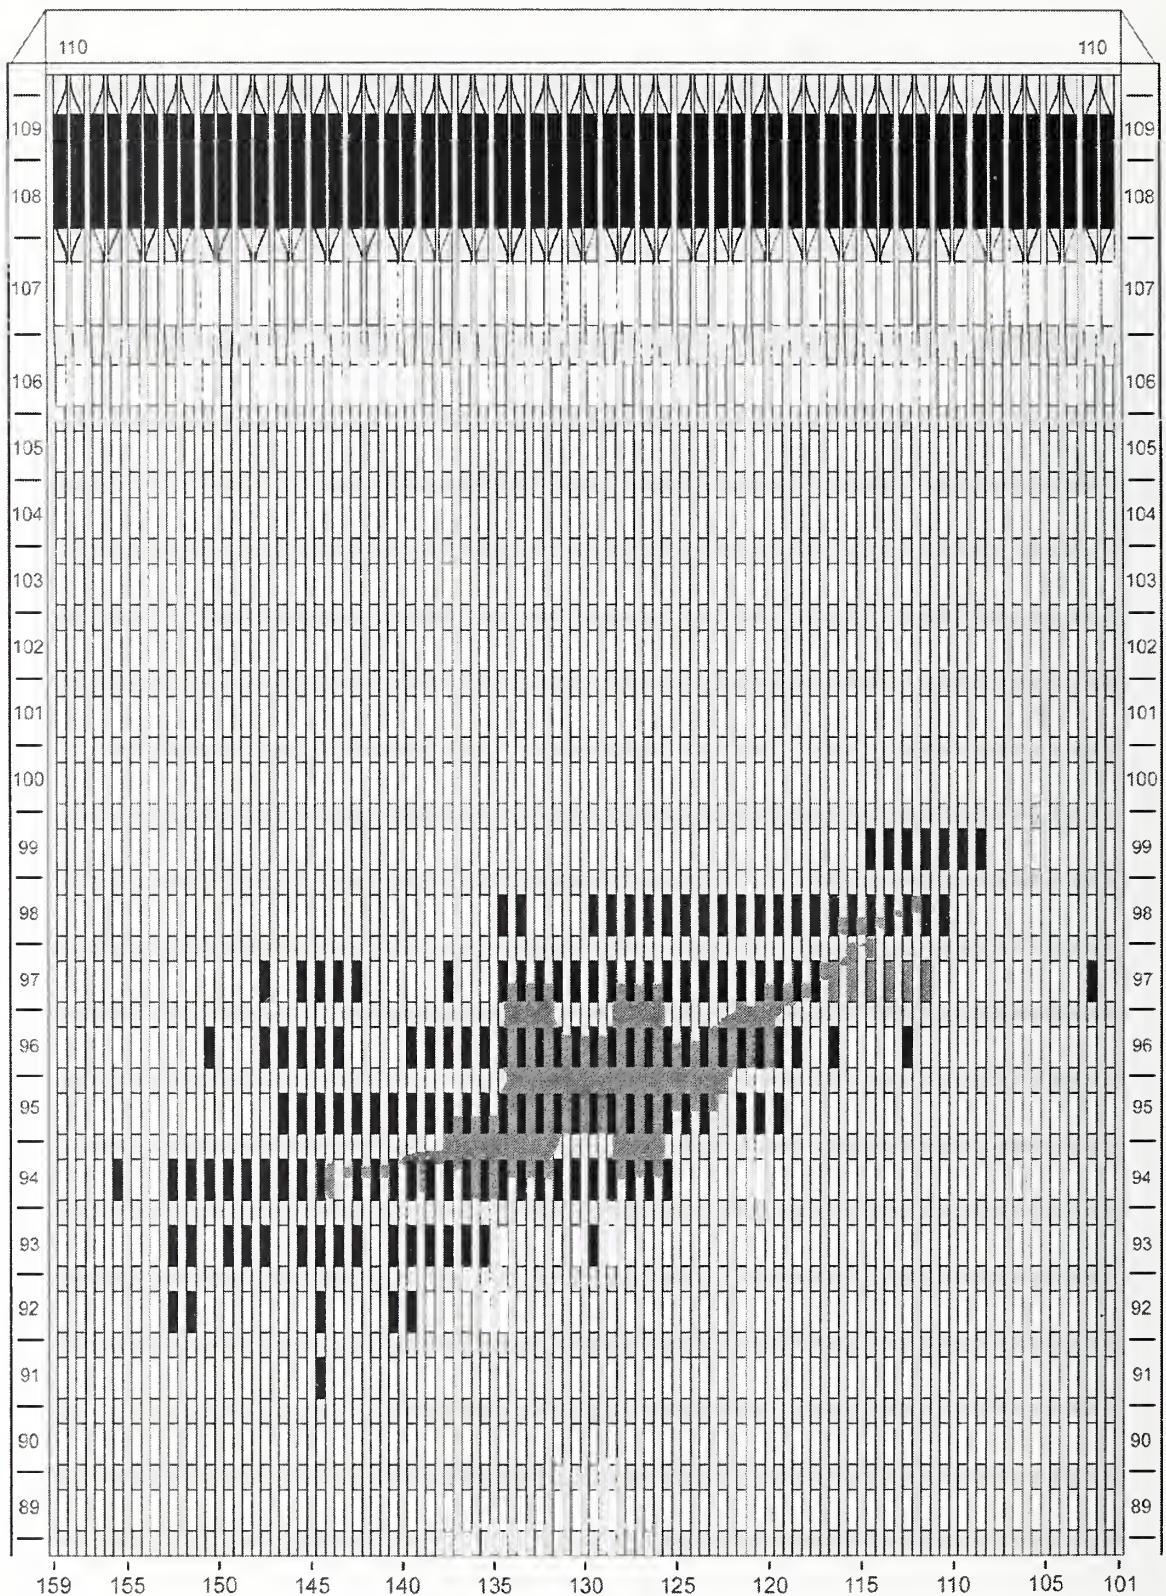
Figure C-5. Diagram of the north face of WTC 1 for floors 89 to 110 at 8:50 a.m. showing the condition of windows and locations of fires.

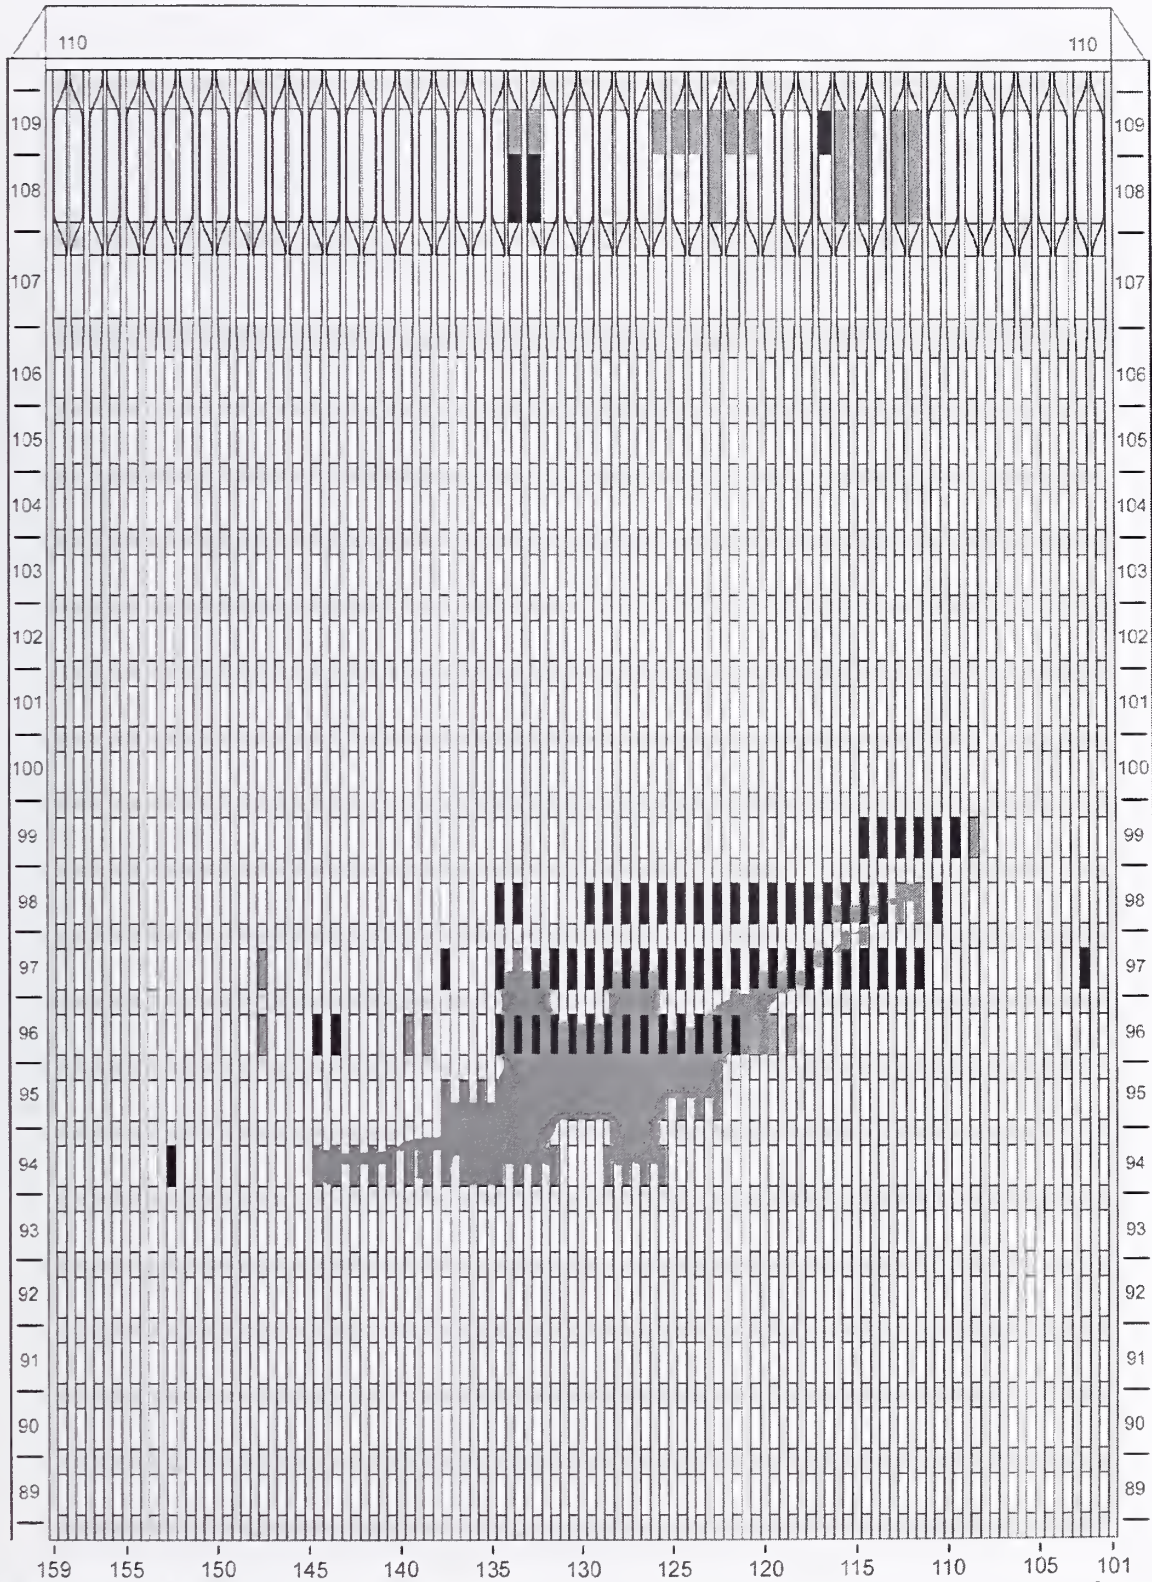
Figure C-6. Diagram of the north face of WTC 1 for floors 89 to 110 at 8:50 a.m. showing windows where smoke was observed and those that were hidden from view.

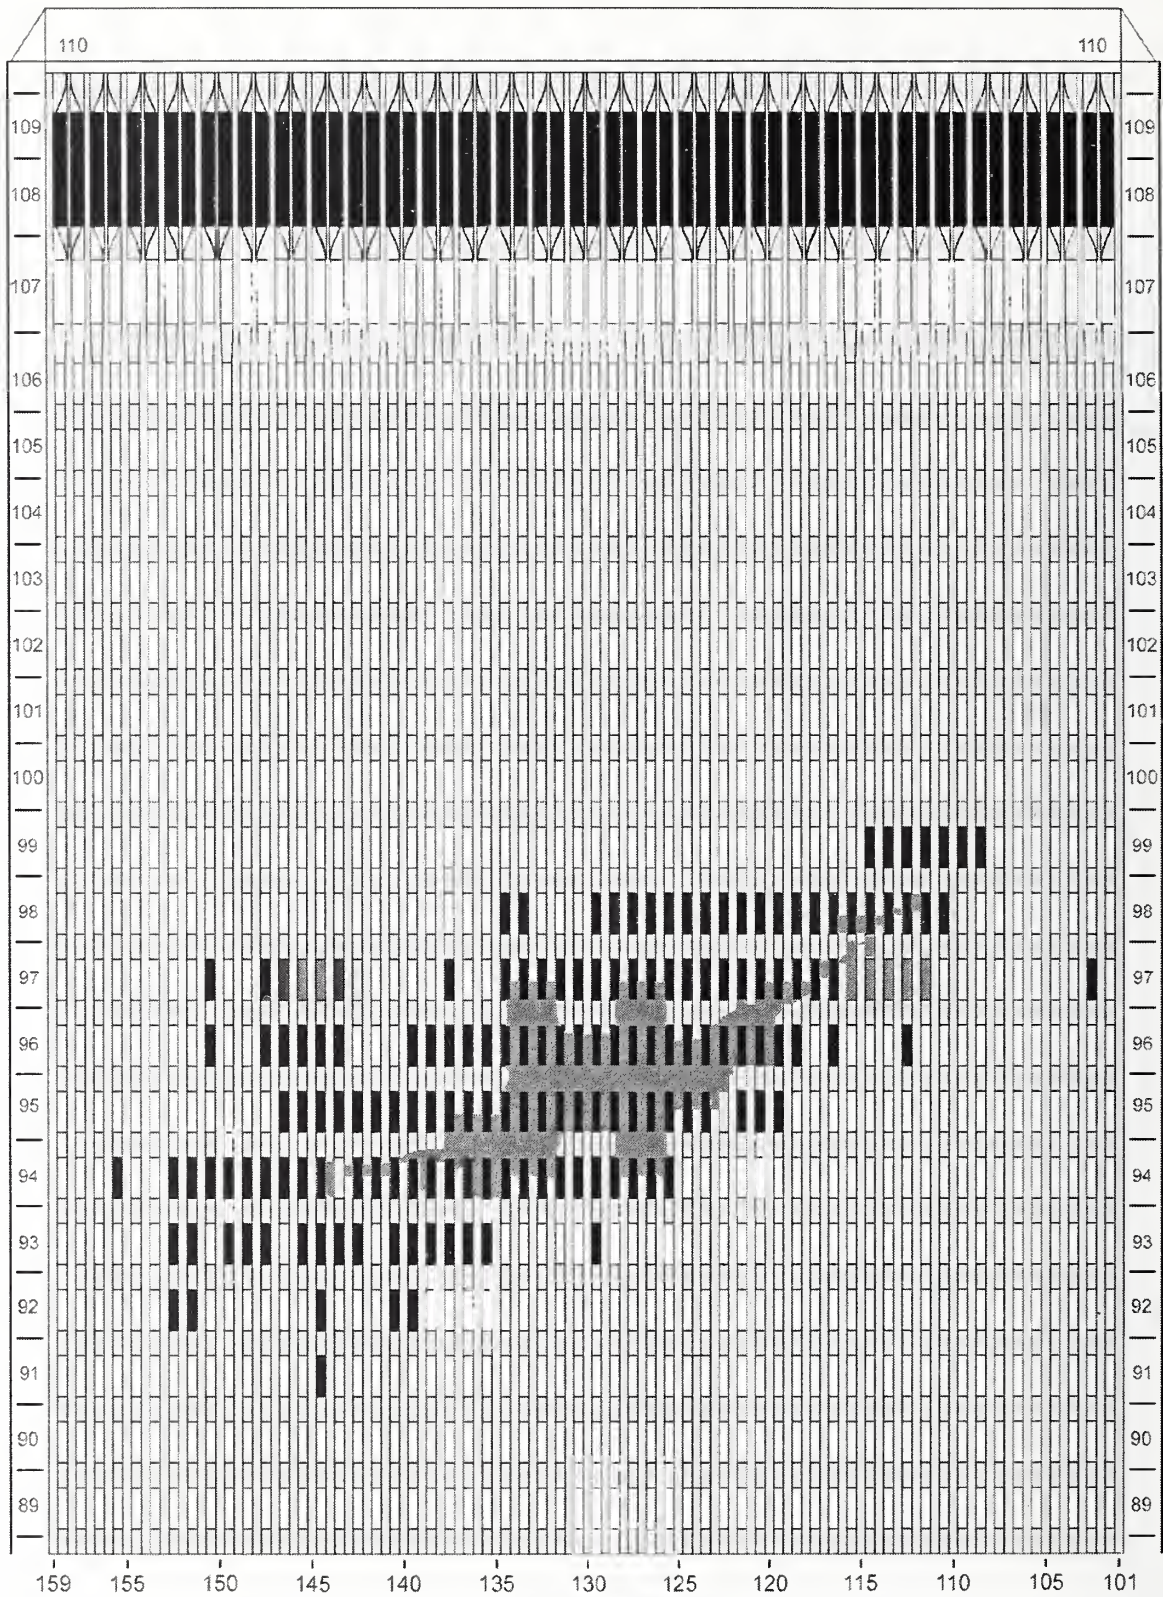
Figure C-7. Diagram of the north face of WTC 1 for floors 89 to 110 at 8:52 a.m. showing the condition of windows and locations of fires.

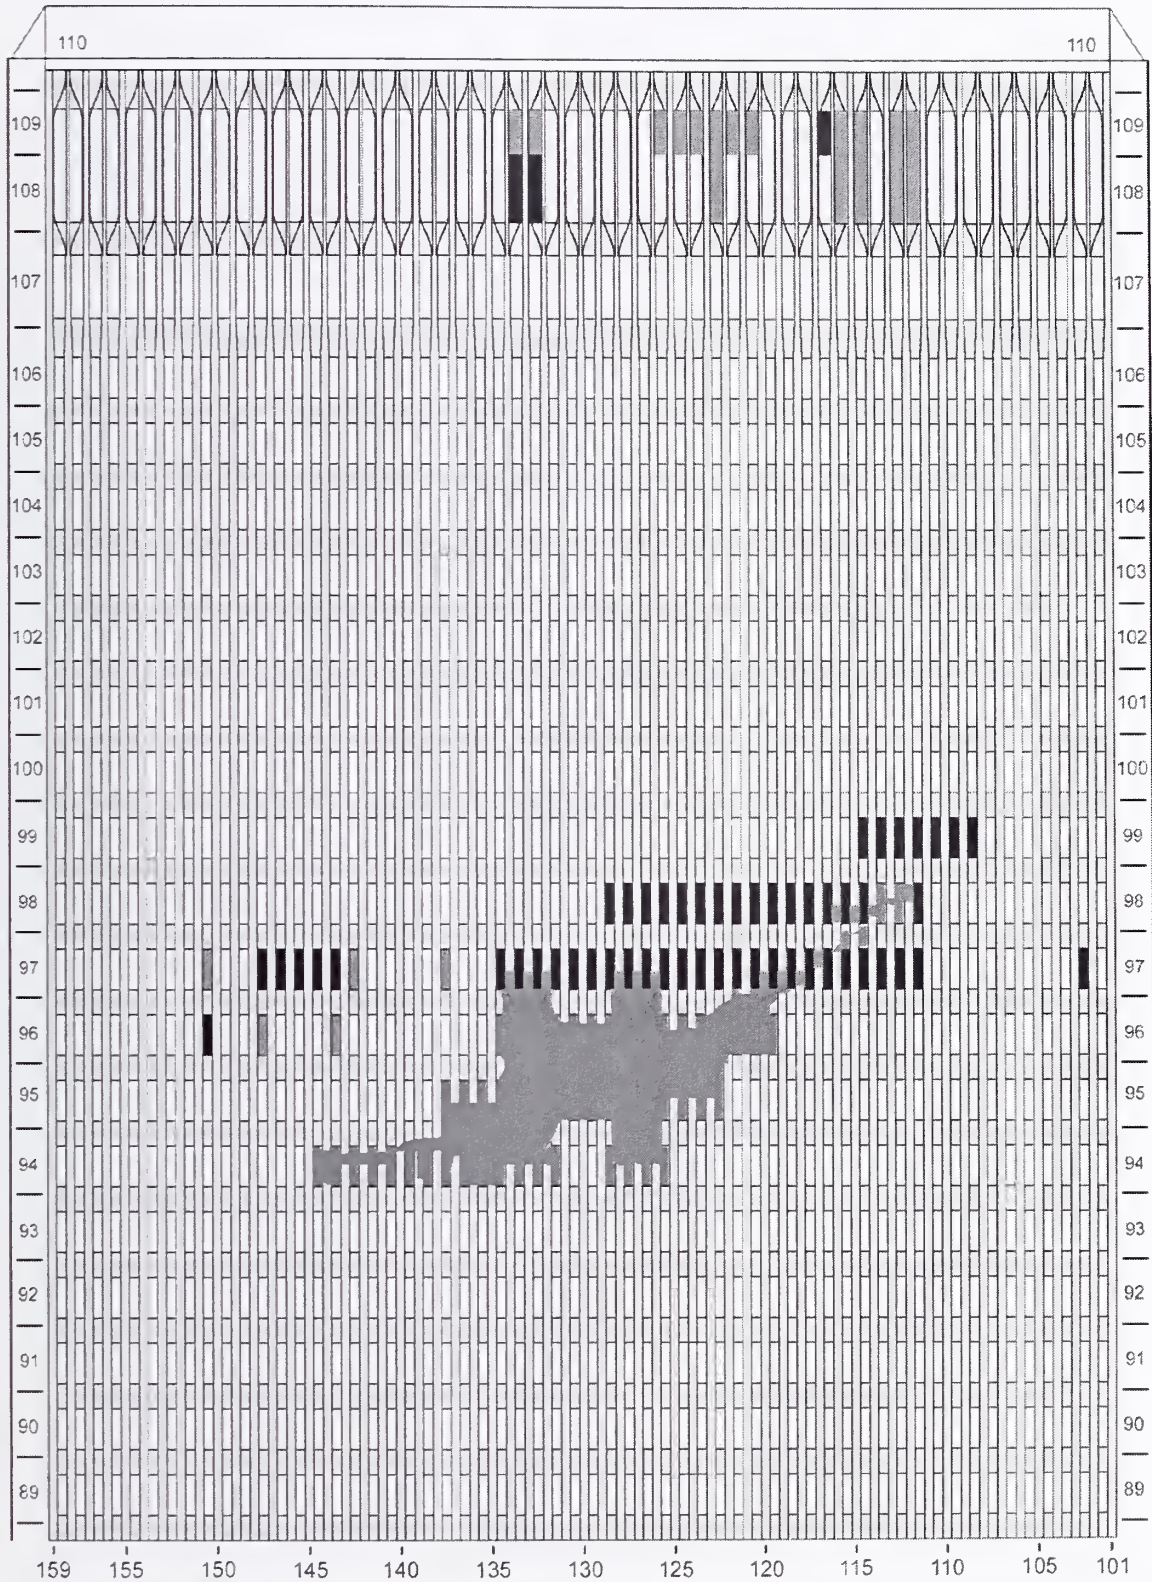
Figure C-8. Diagram of the north face of WTC 1 for floors 89 to 110 at 8:52 a.m. showing windows where smoke was observed and those that were hidden from view.
