**NIST NCSTAR 1-5A
Federal Building and Fire Safety Investigation of
the World Trade Center Disaster**

**Visual Evidence, Damage Estimates,
And Timeline Analysis**

(Chapter 9 - Appendix C)

FIRE BEHAVIOR IN WORLD TRADE CENTER 2

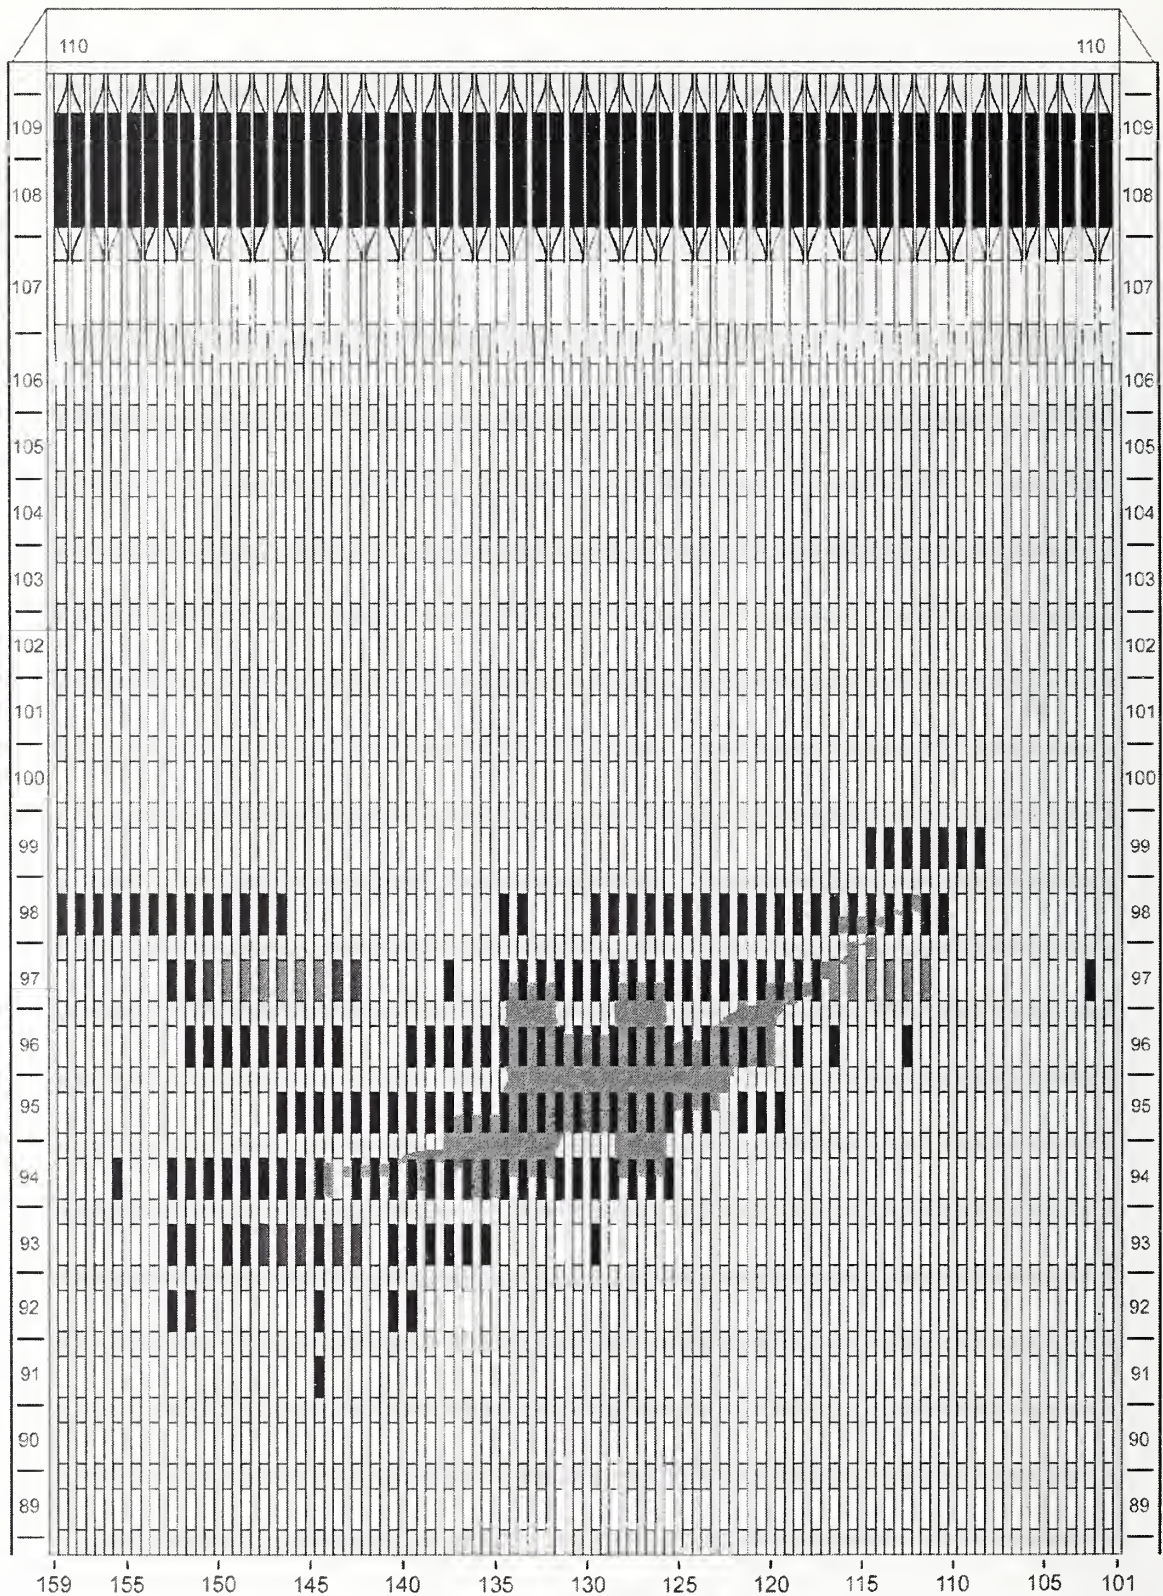
Figure C-9. Diagram of the north face of WTC 1 for floors 89 to 110 at 8:54 a.m. showing the condition of windows and locations of fires.

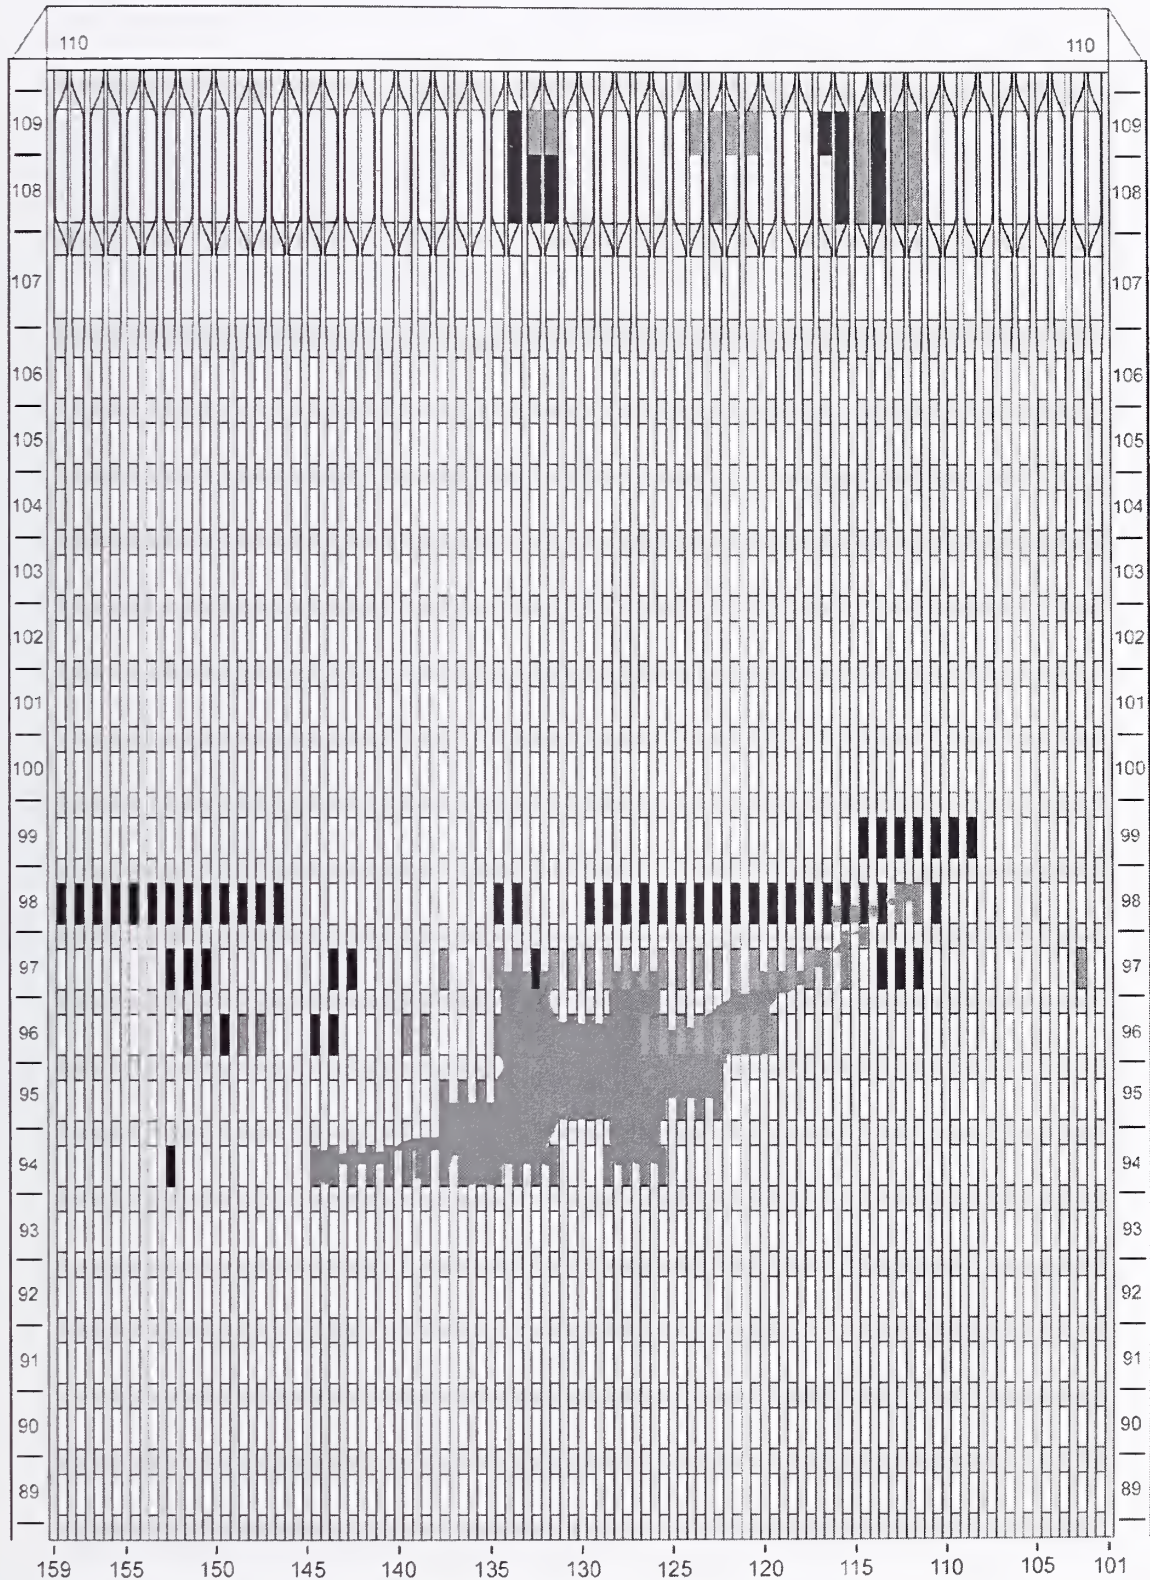
Figure C-10. Diagram of the north face of WTC 1 for floors 89 to 110 at 8:54 a.m. showing windows where smoke was observed and those that were hidden from view.

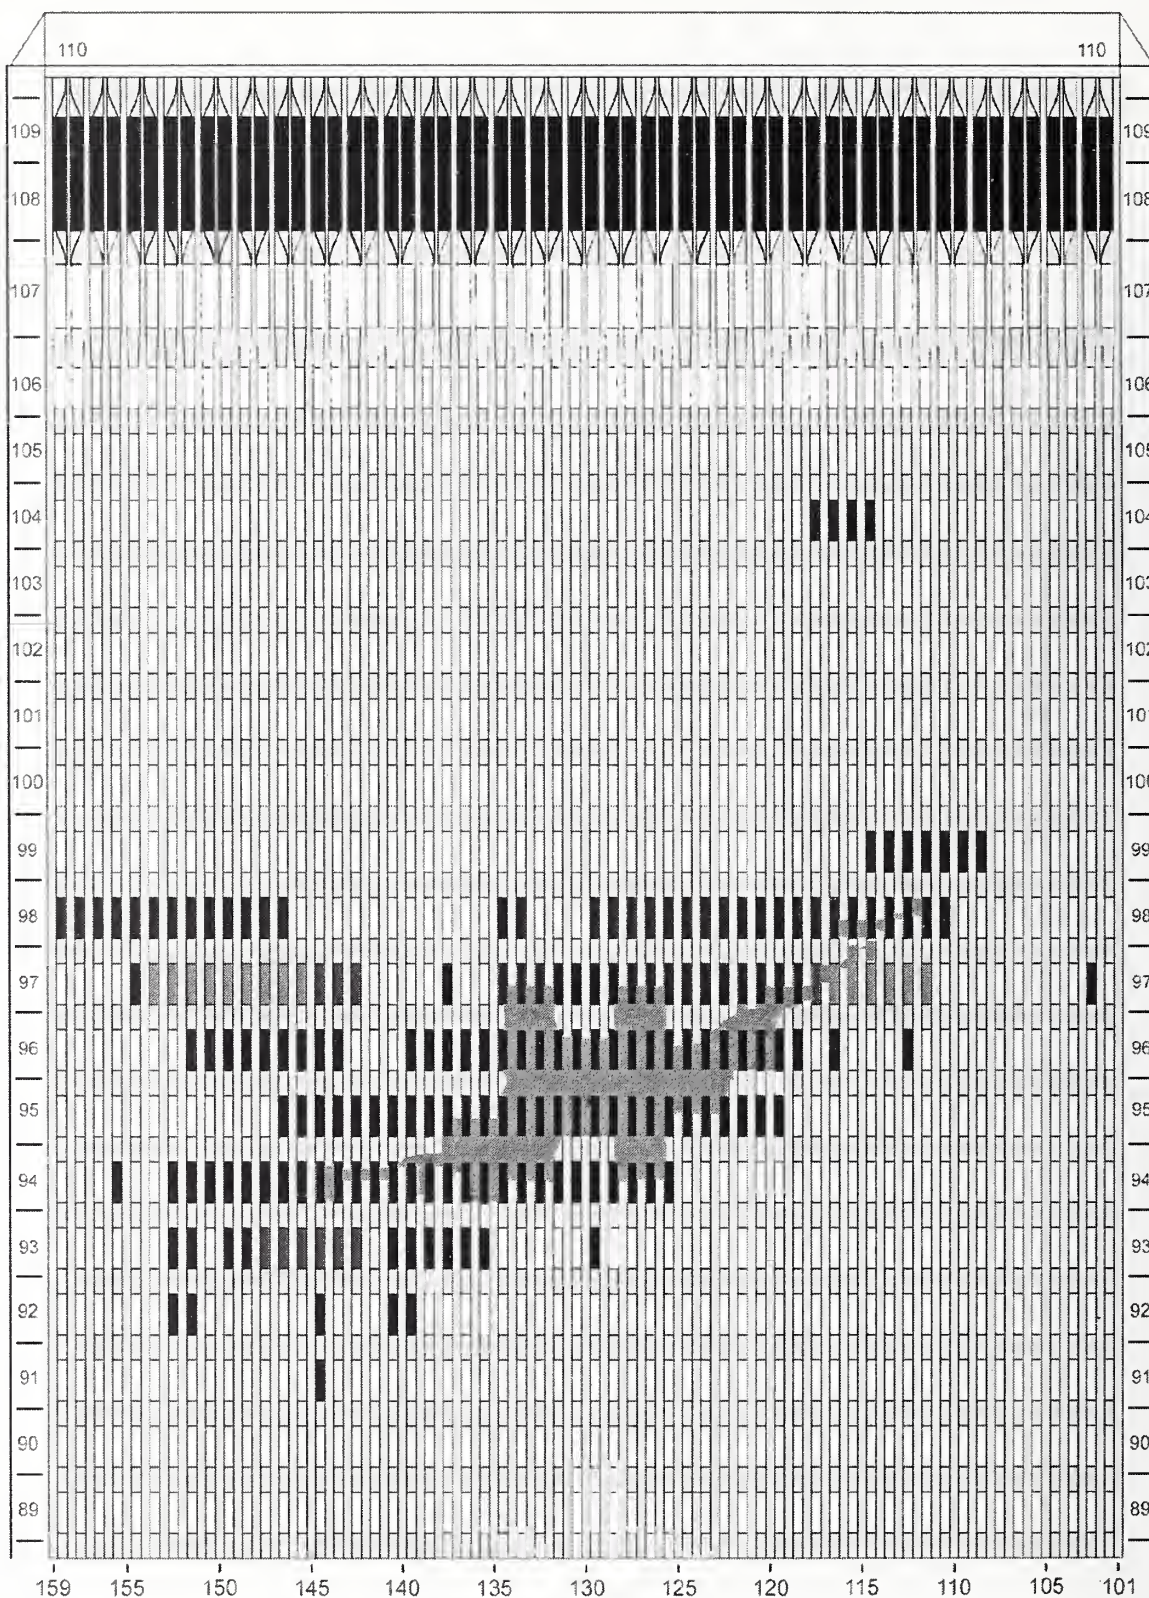
Figure C-11. Diagram of the north face of WTC 1 for floors 89 to 110 at 8:56 a.m. showing the condition of windows and locations of lines.

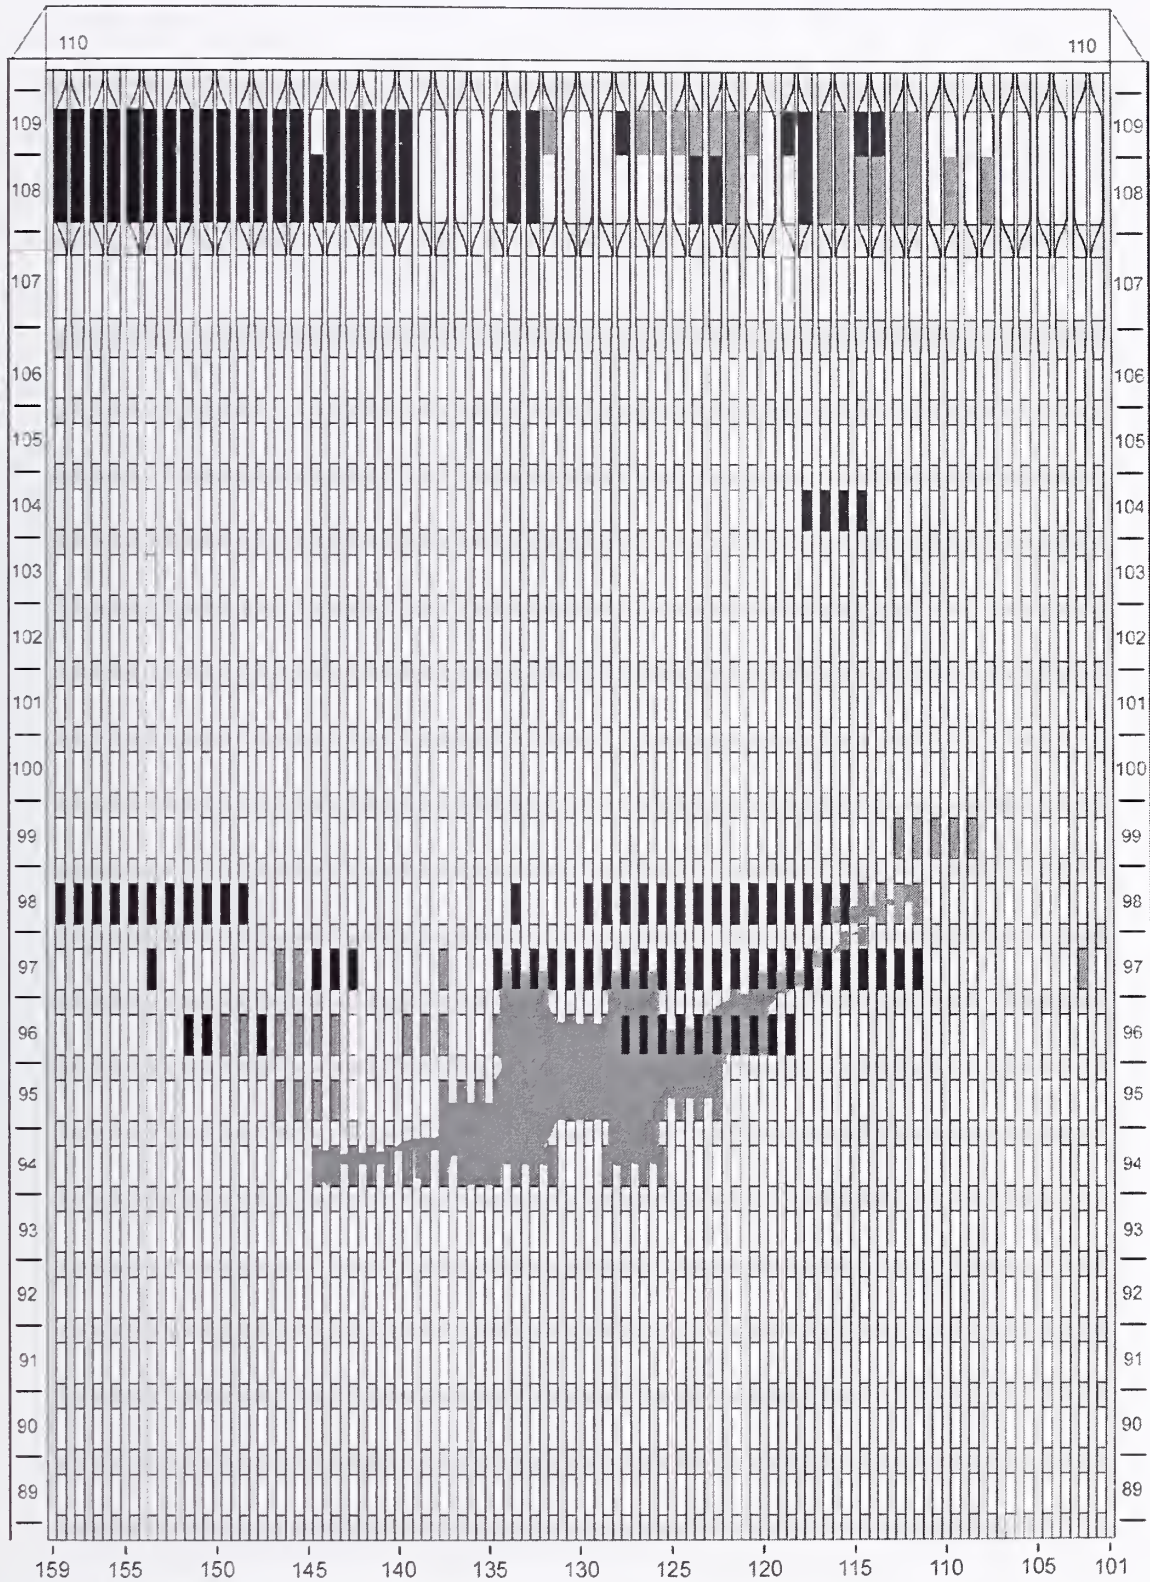
Figure C-12. Diagram of the north face of WTC 1 for floors 89 to 110 at 8:56 a.m. showing windows where smoke was observed and those that were hidden from view.

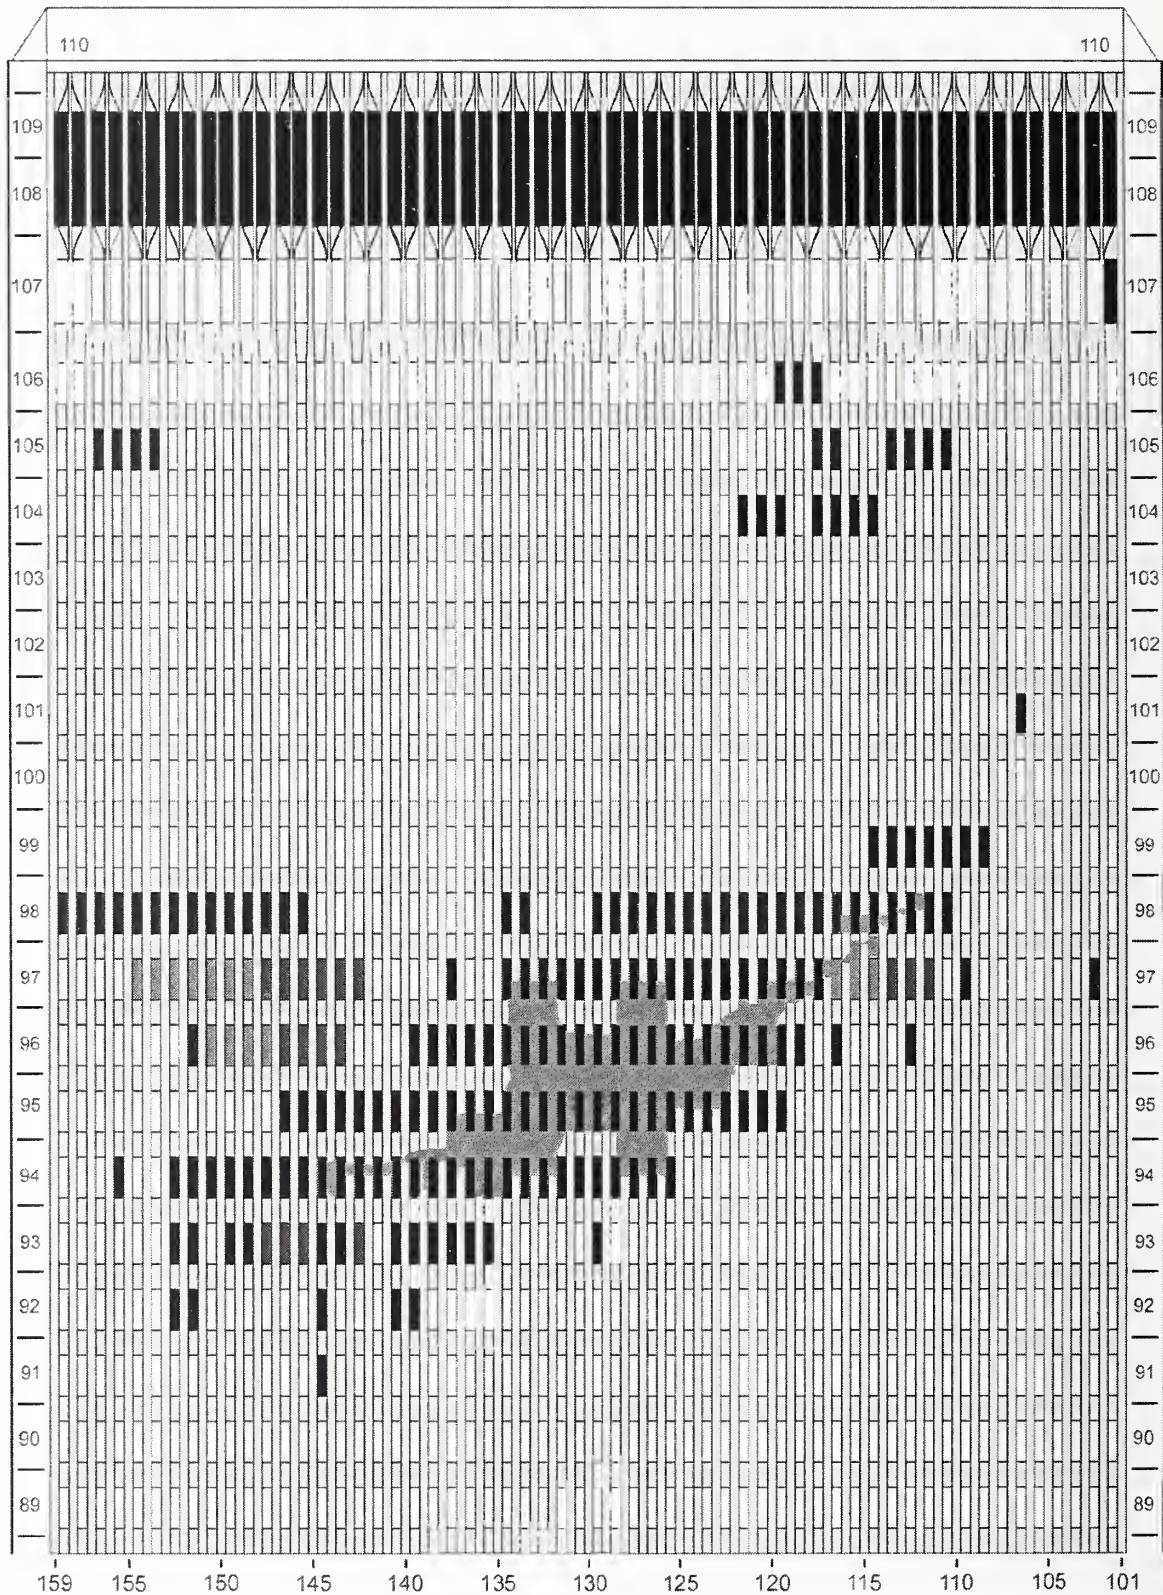
Figure C-13. Diagram of the north face of WTC 1 for floors 89 to 110 at 8:58 a.m. showing the condition of windows and locations of fires.

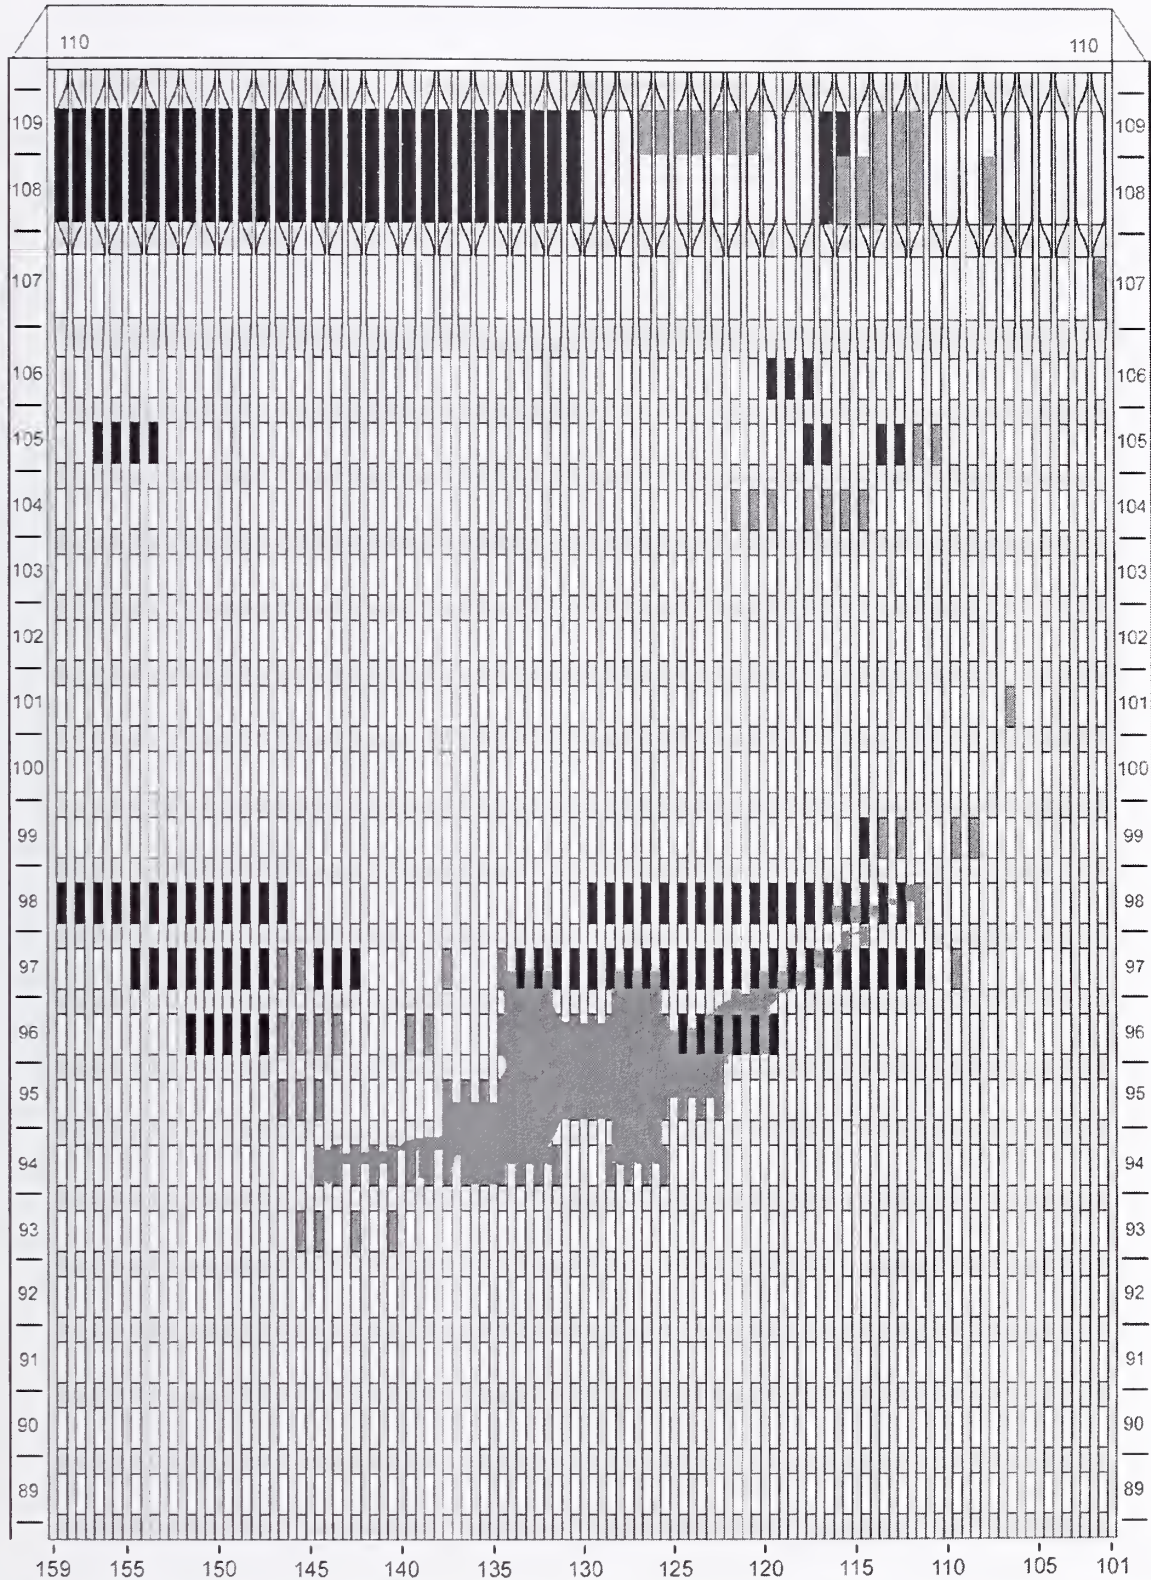
Figure C-14. Diagram of the north face of WTC 1 for floors 89 to 110 at 8:58 a.m. showing windows where smoke was observed and those that were hidden from view.

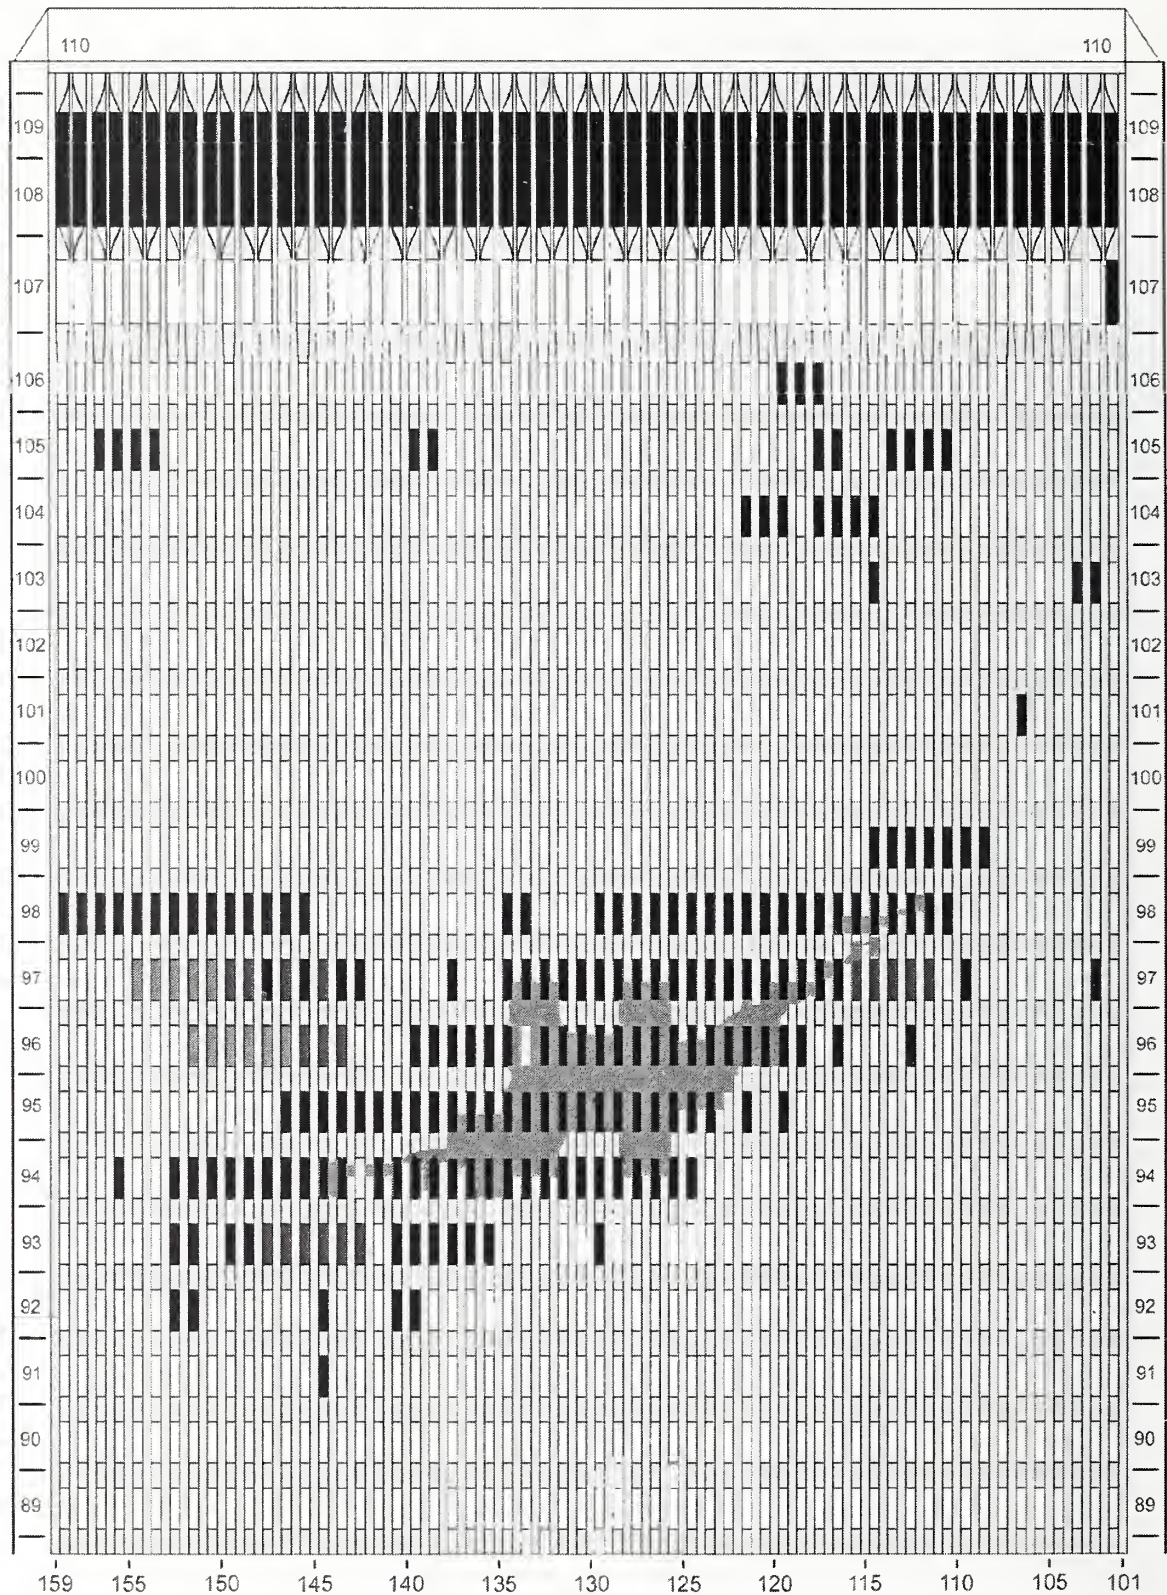
Figure C-15. Diagram of the north face of WTC 1 for floors 89 to 110 at 9:00 a.m. showing the condition of windows and locations of fires.

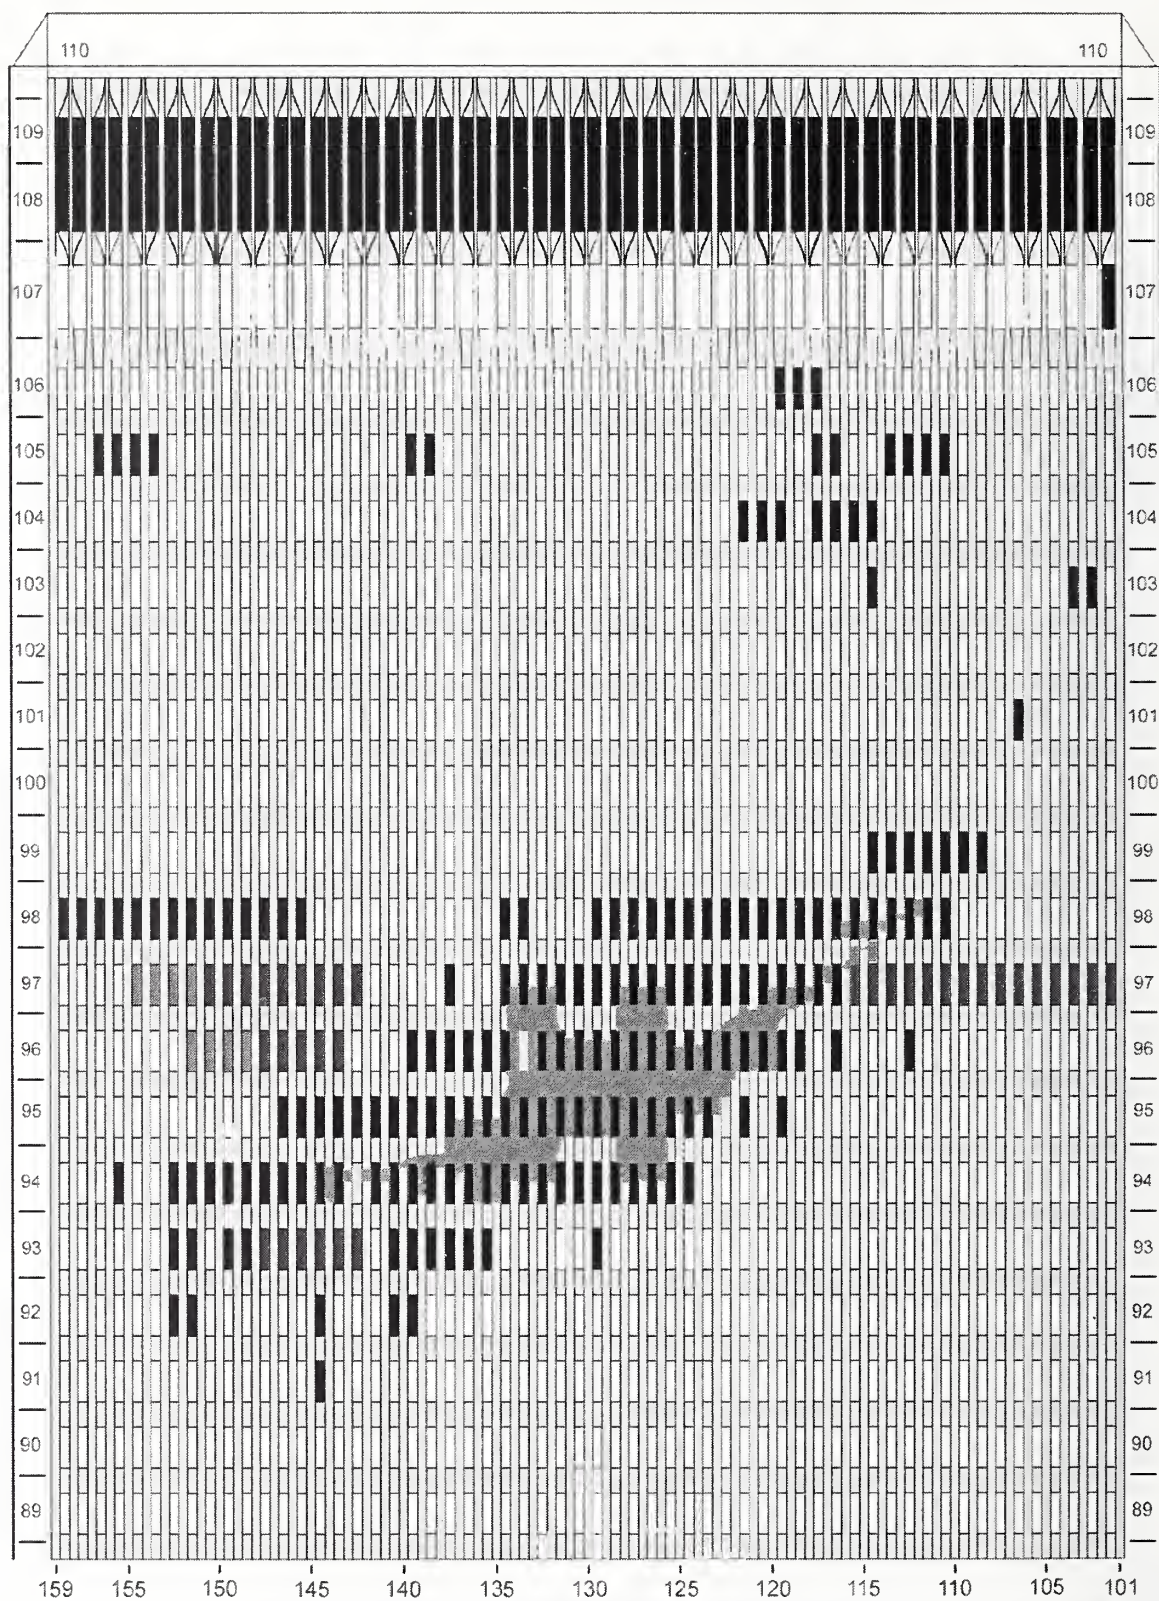
Figure C-17. Diagram of the north face of WTC 1 for floors 89 to 110 at 9:02 a.m. showing the condition of windows and locations of fires.

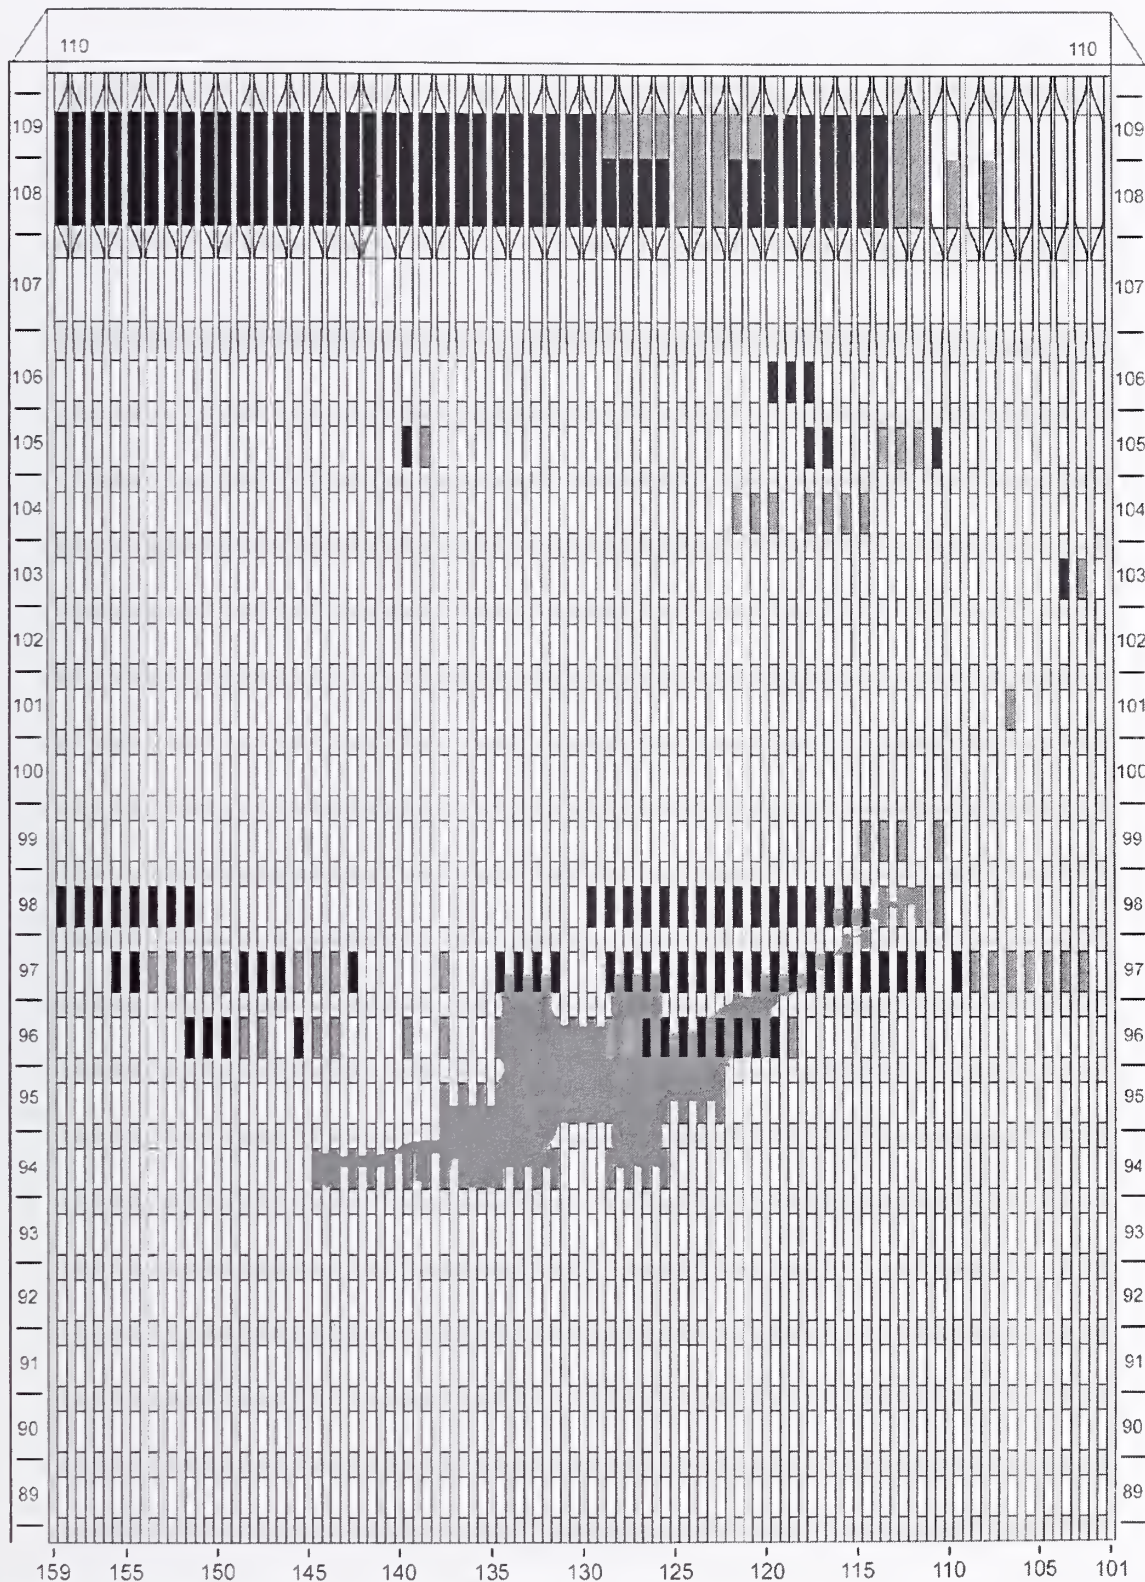
Figure C-18. Diagram of the north face of WTC 1 for floors 89 to 110 at 9:02 a.m. showing windows where smoke was observed and those that were hidden from view.

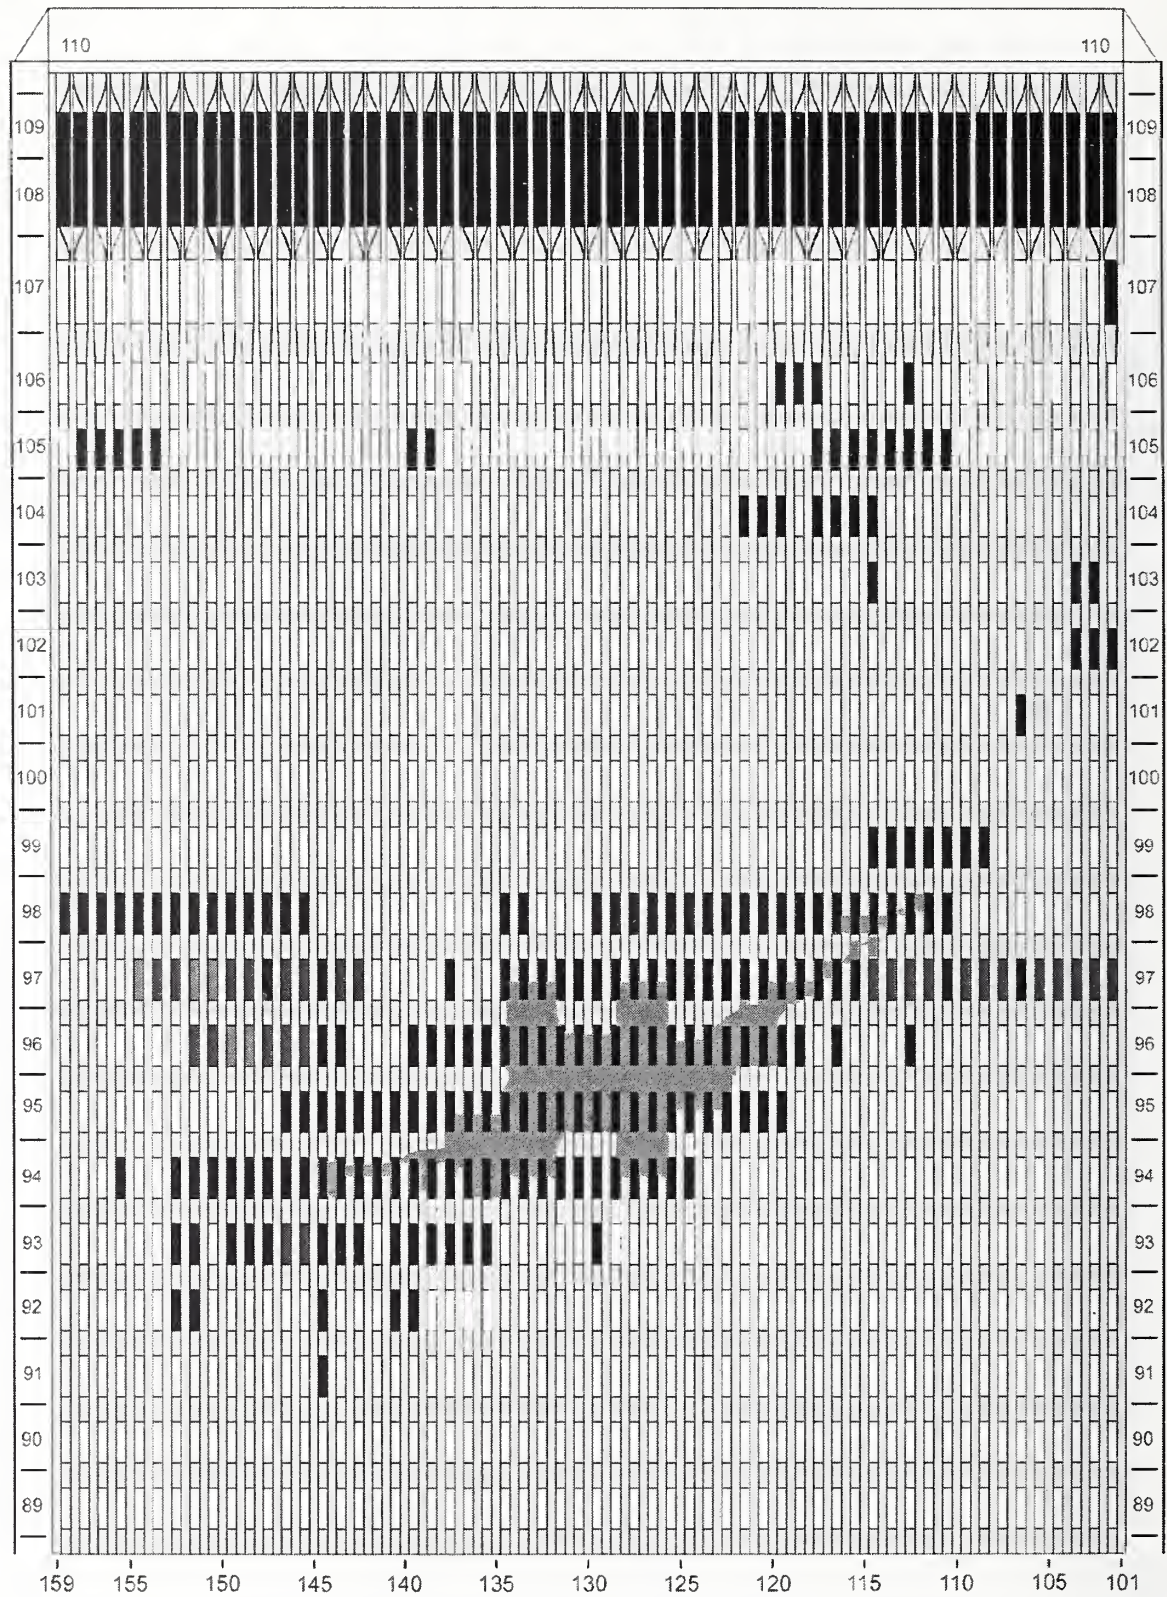
Figure C-19. Diagram of the north face of WTC 1 for floors 89 to 110 at 9:04 a.m. showing the condition of windows and locations of fires.

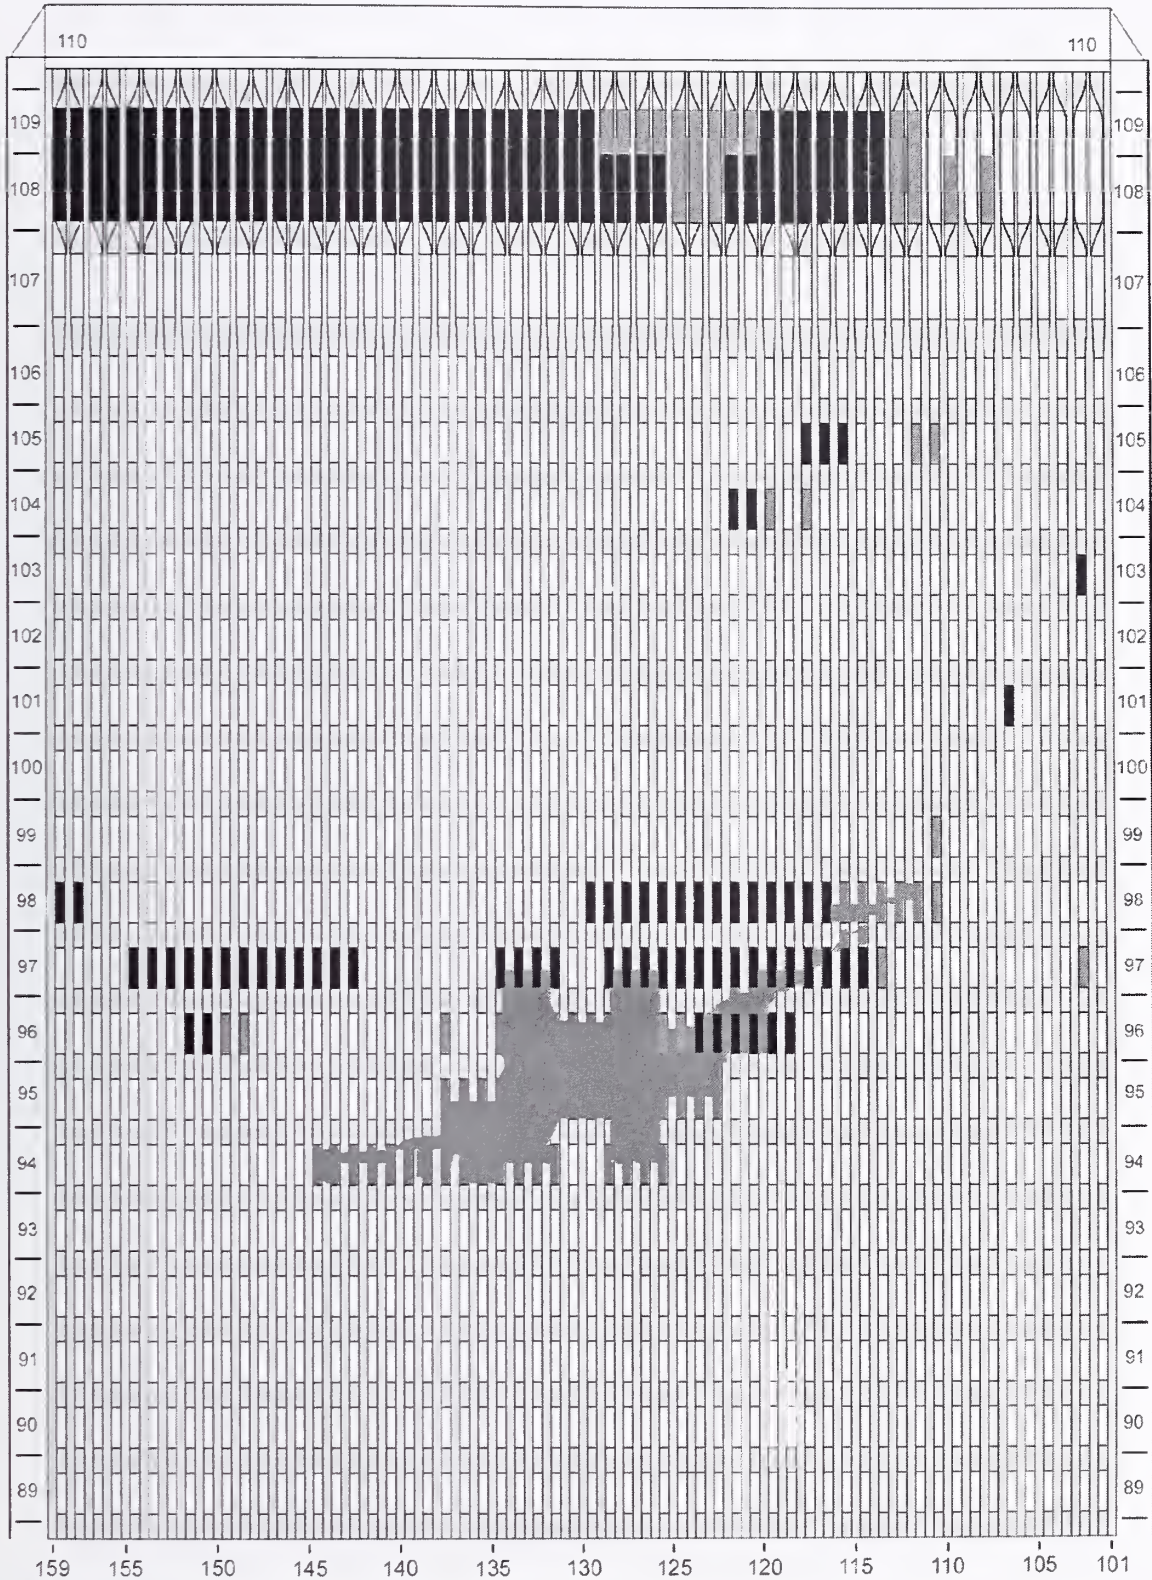
Figure C-20. Diagram of the north face of WTC 1 for floors 89 to 110 at 9:04 a.m. showing windows where smoke was observed and those that were hidden from view.

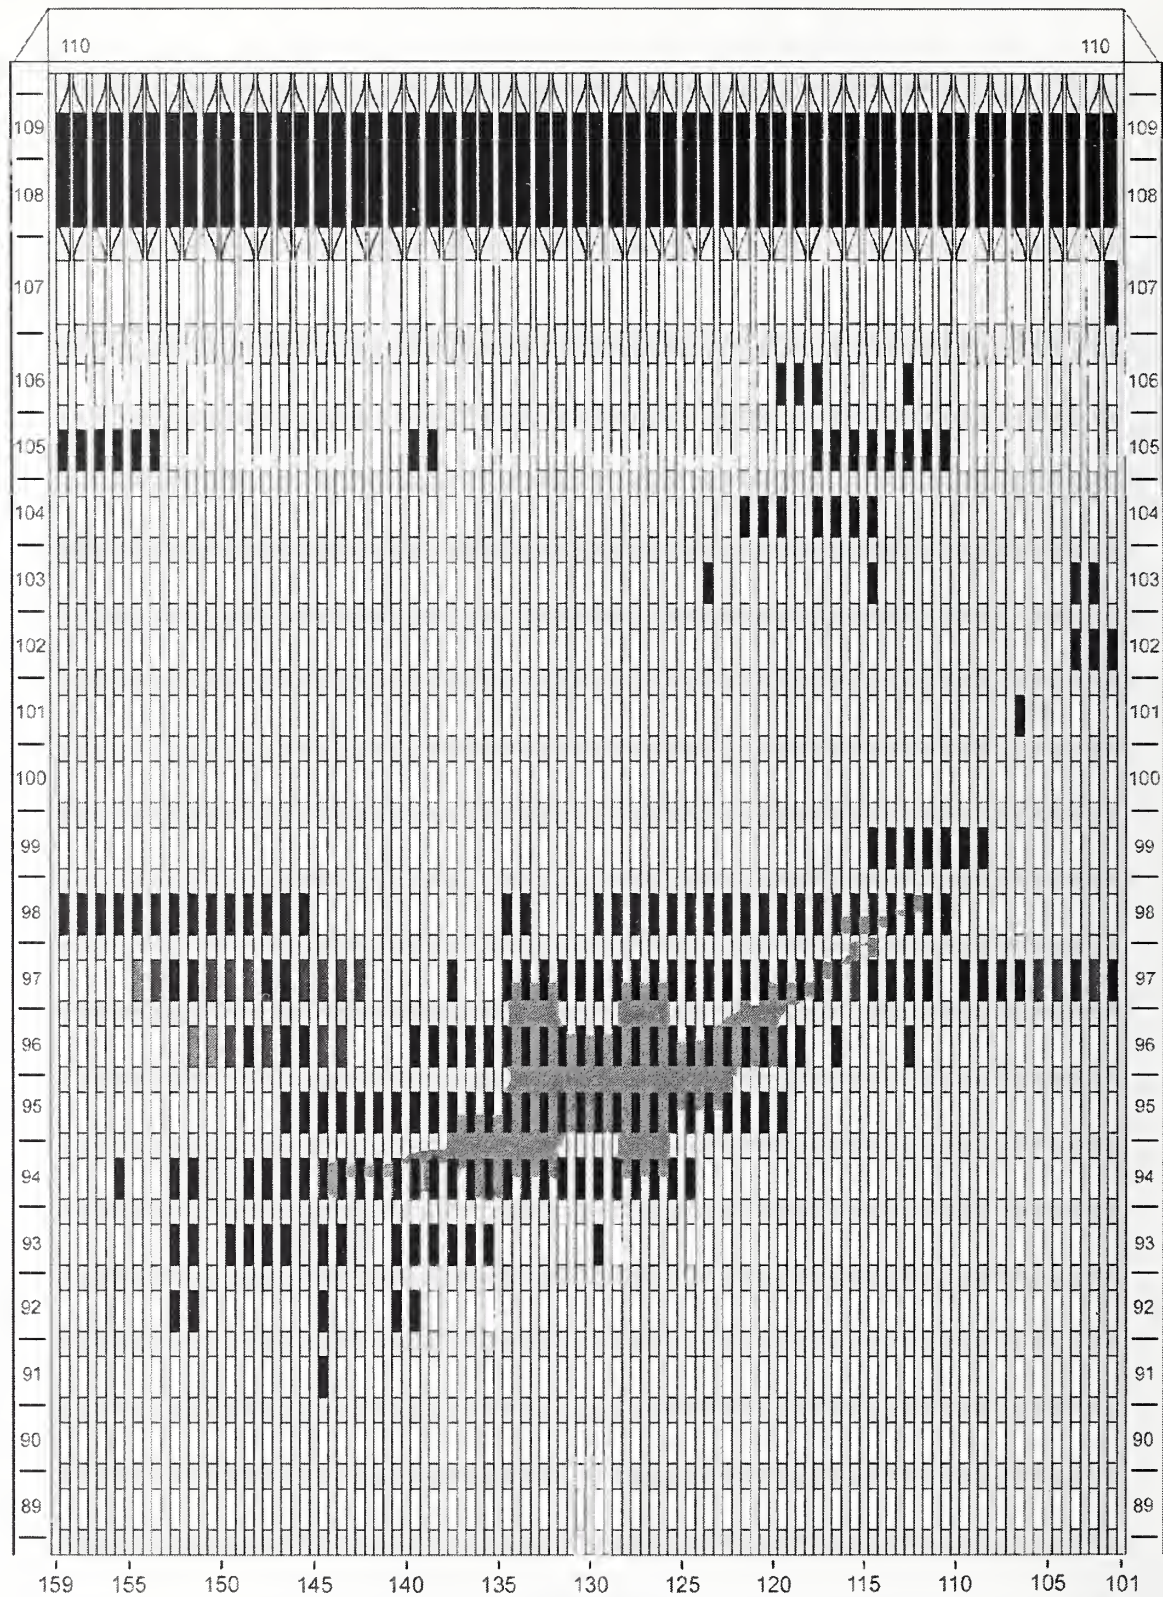
Figure C-21. Diagram of the north face of WTC 1 for floors 89 to 110 at 9:10 a.m. showing the condition of windows and locations of fires.
