**NIST NCSTAR 1-5A
Federal Building and Fire Safety Investigation of
the World Trade Center Disaster**

**Visual Evidence, Damage Estimates,
And Timeline Analysis**

(Chapter 9 - Appendix C)

FIRE BEHAVIOR IN WORLD TRADE CENTER 2

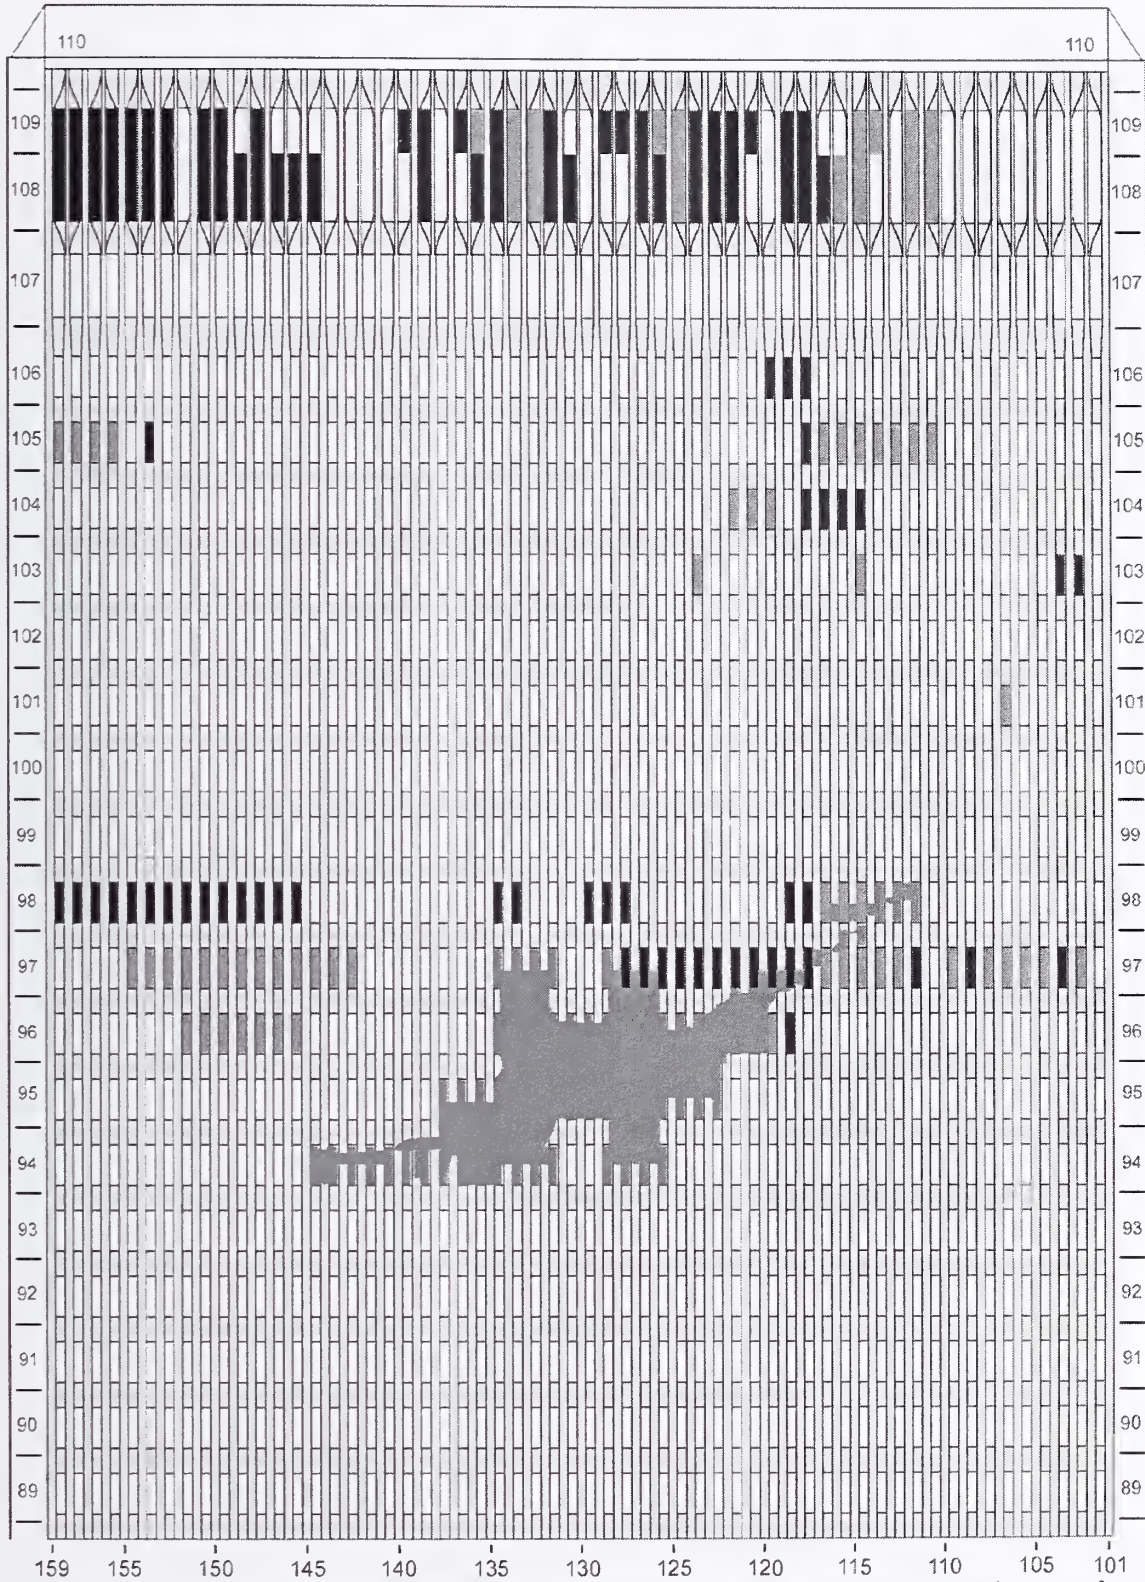
Figure C-22. Diagram of the north face of WTC 1 for floors 89 to 110 at 9:10 a.m. showing windows where smoke was observed and those that were hidden from view.

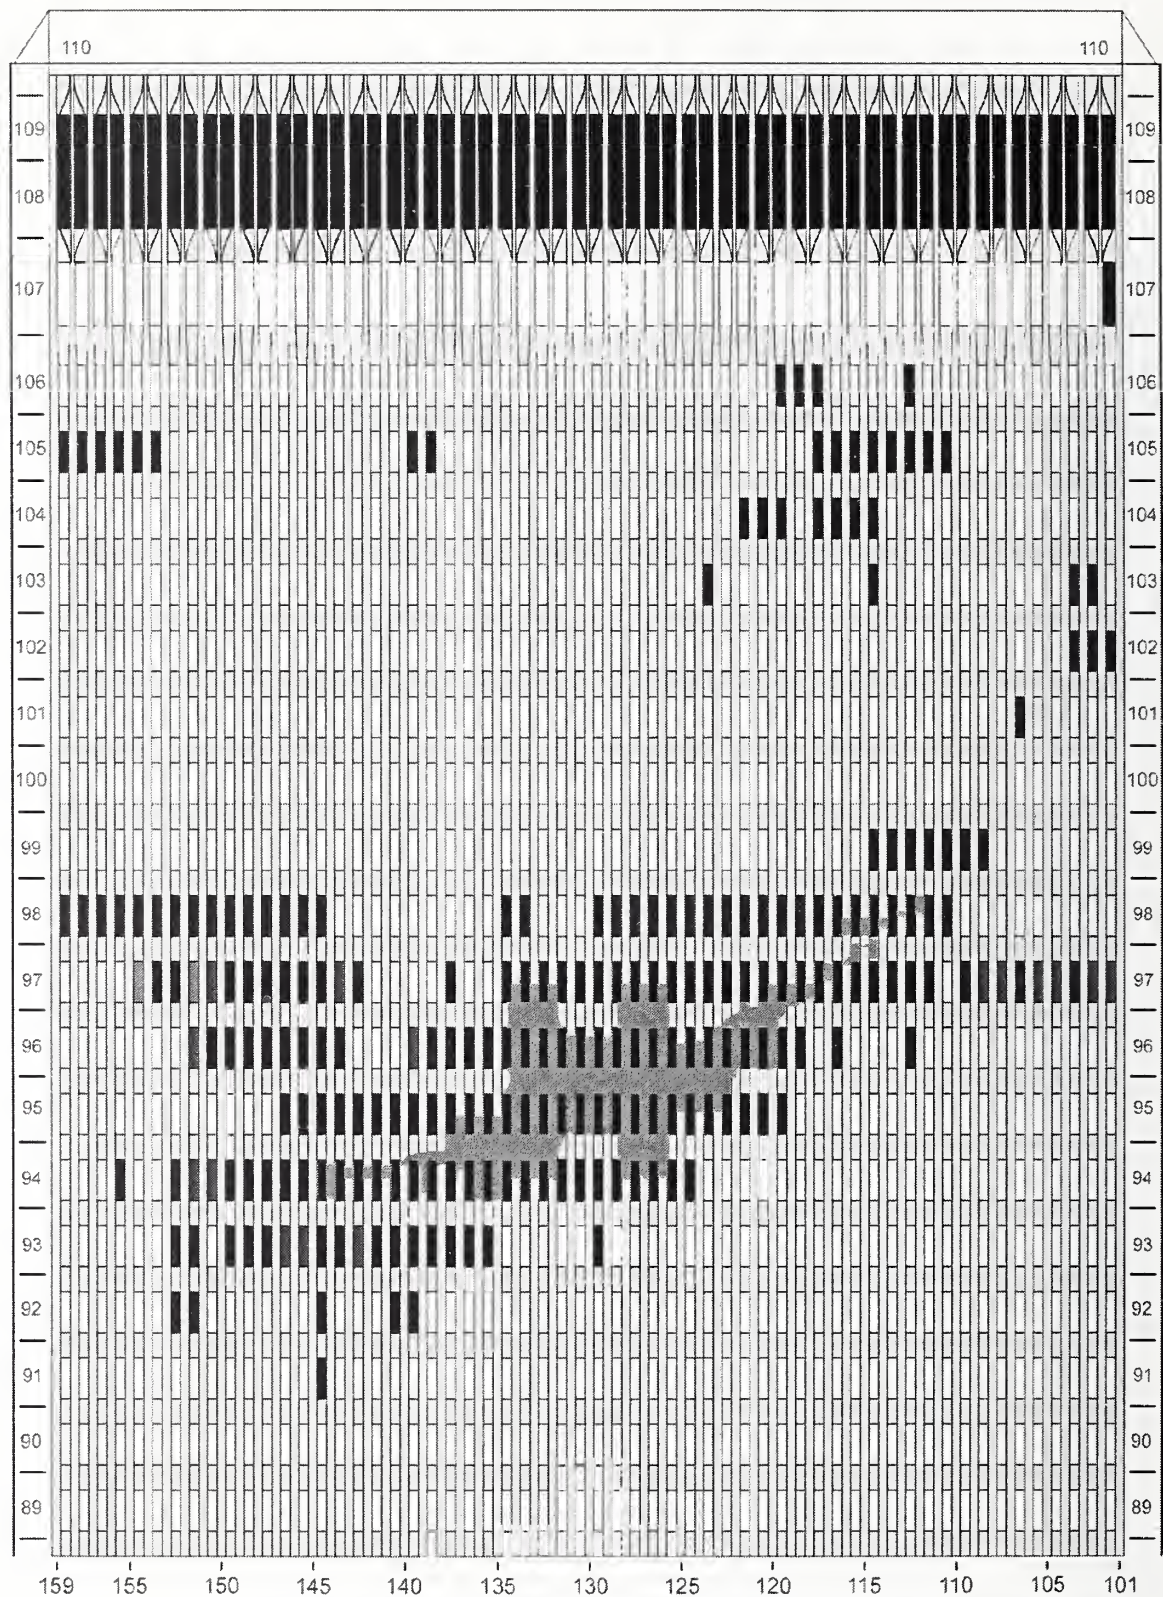
Figure C-23. Diagram of the north face of WTC 1 for floors 89 to 110 at 9:14 a.m. showing the condition of windows and locations of fires.

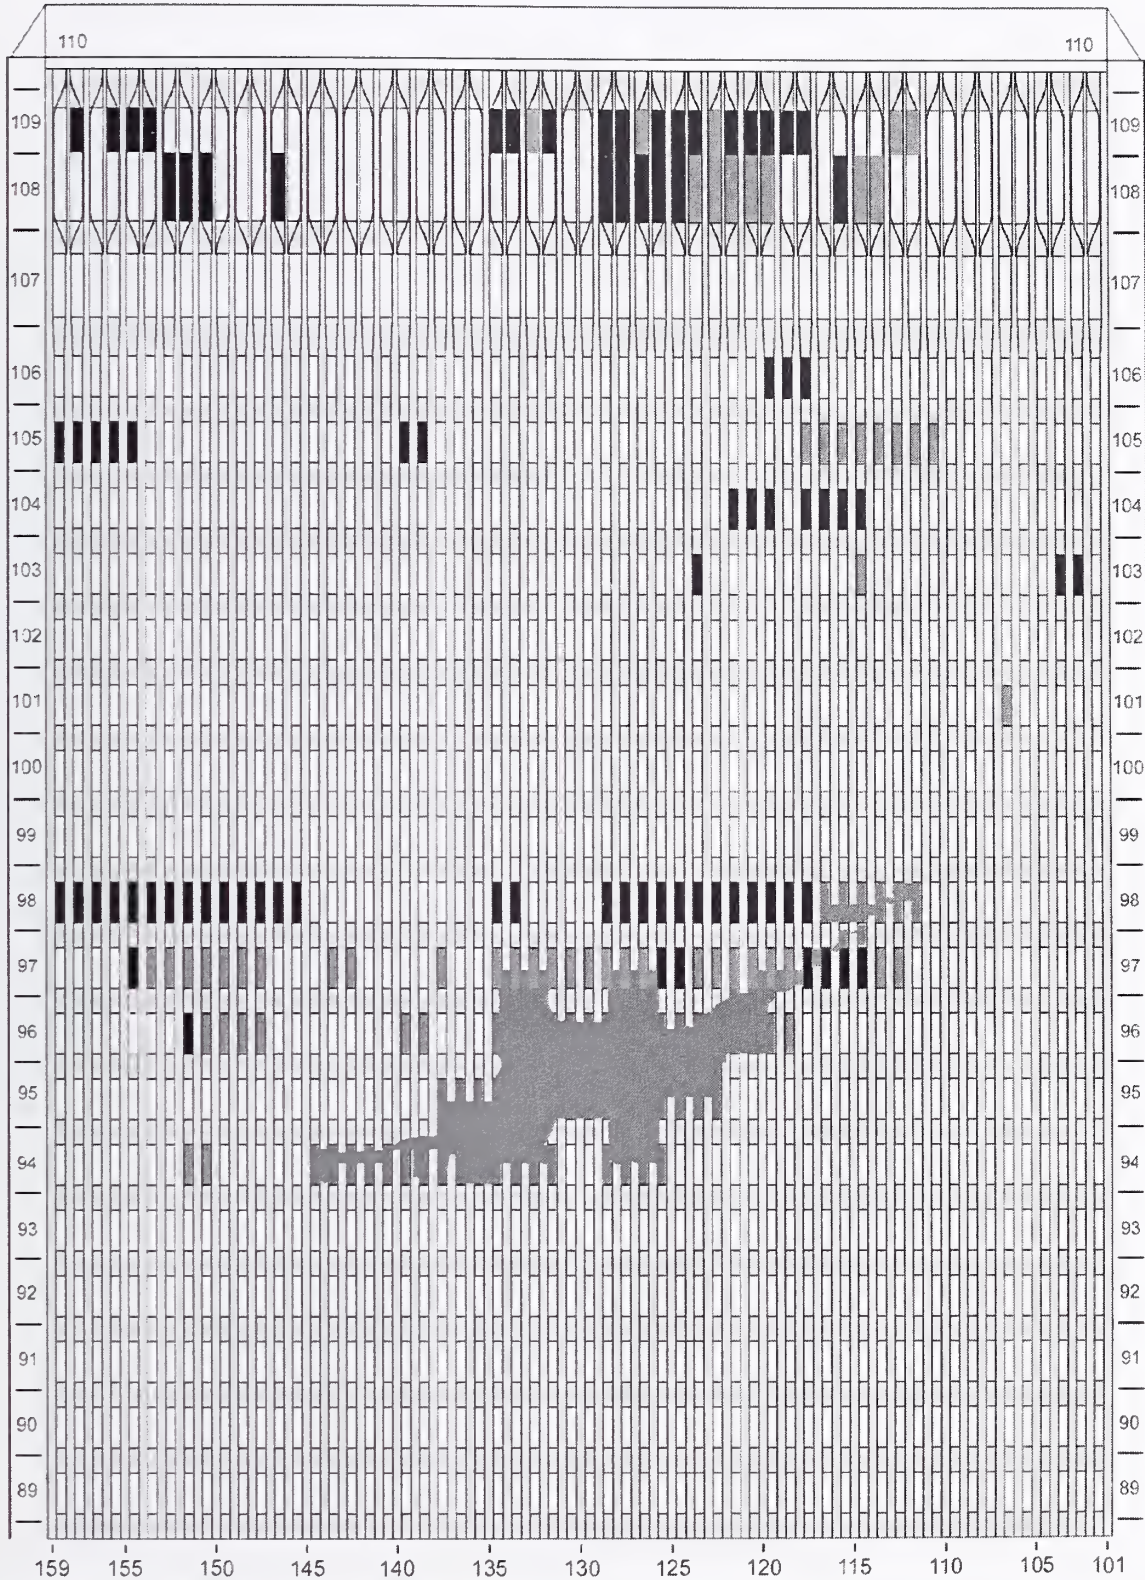
Figure C-24. Diagram of the north face of WTC 1 for floors 89 to 110 at 9:14 a.m. showing windows where smoke was observed and those that were hidden from view.

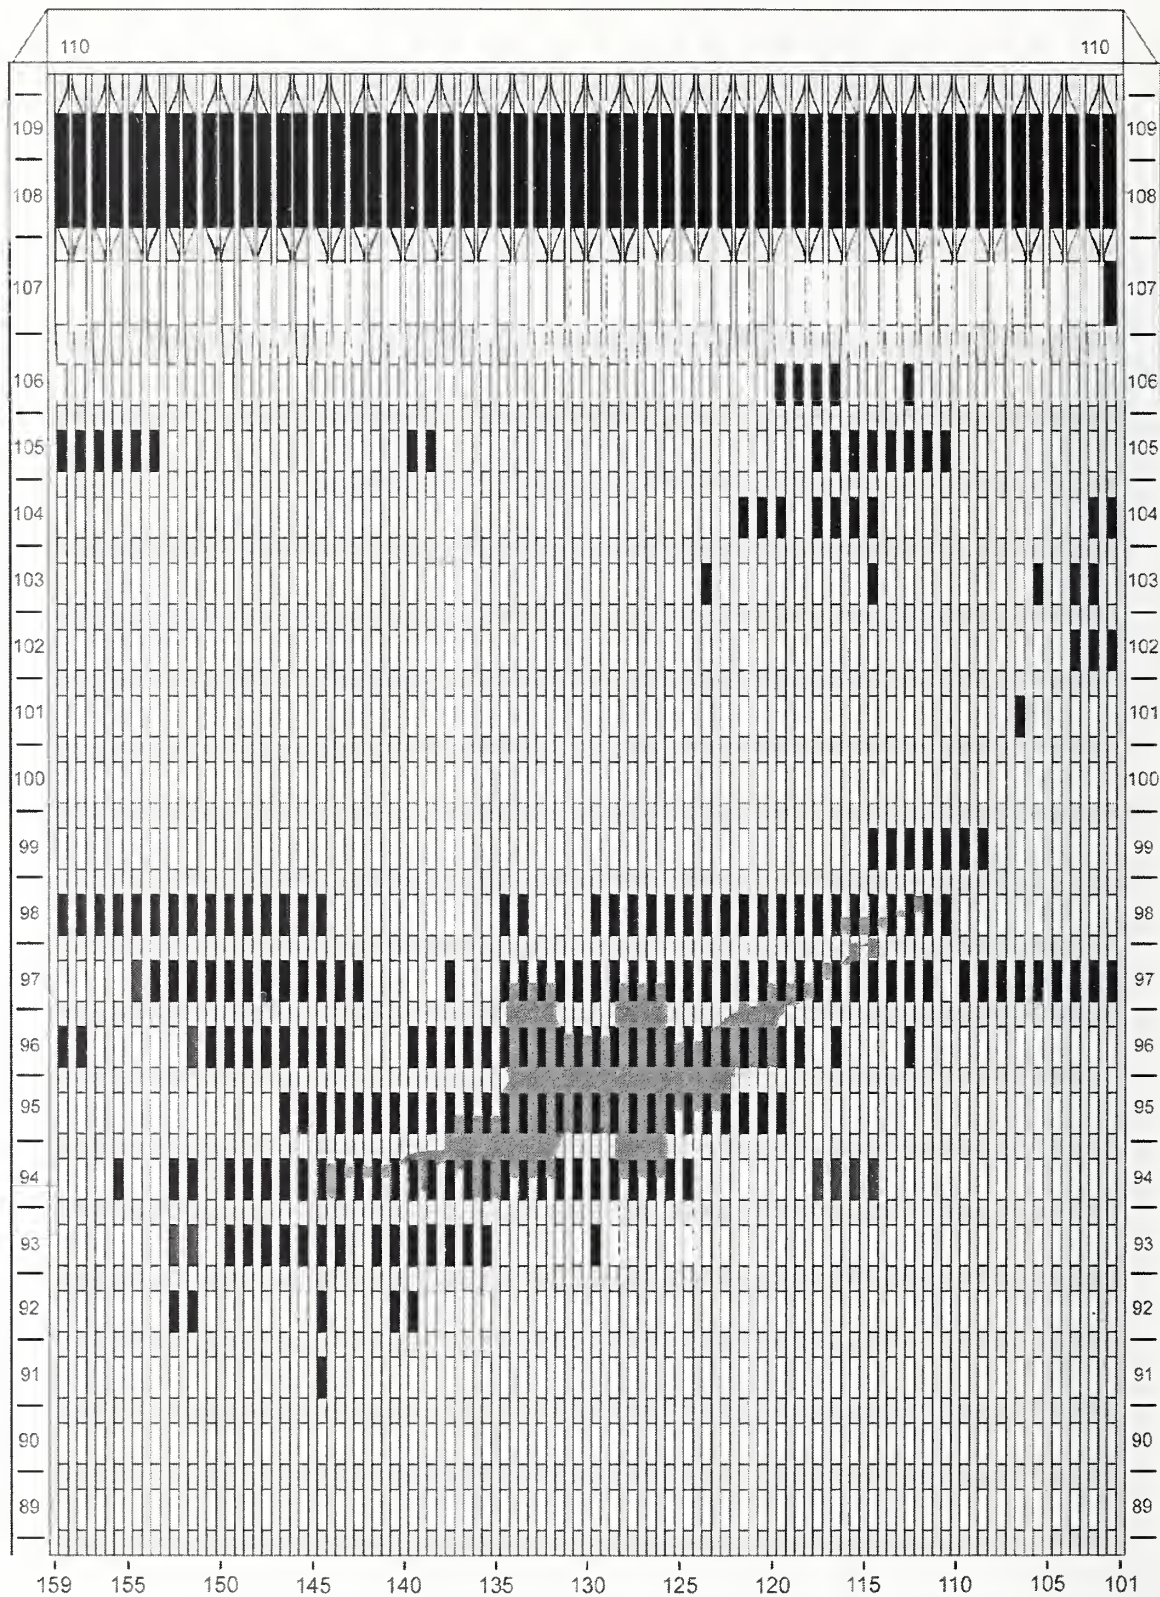
Figure C-25. Diagram of the north face of WTC 1 for floors 89 to 110 at 9:18 a.m. showing the condition of windows and locations of fires.

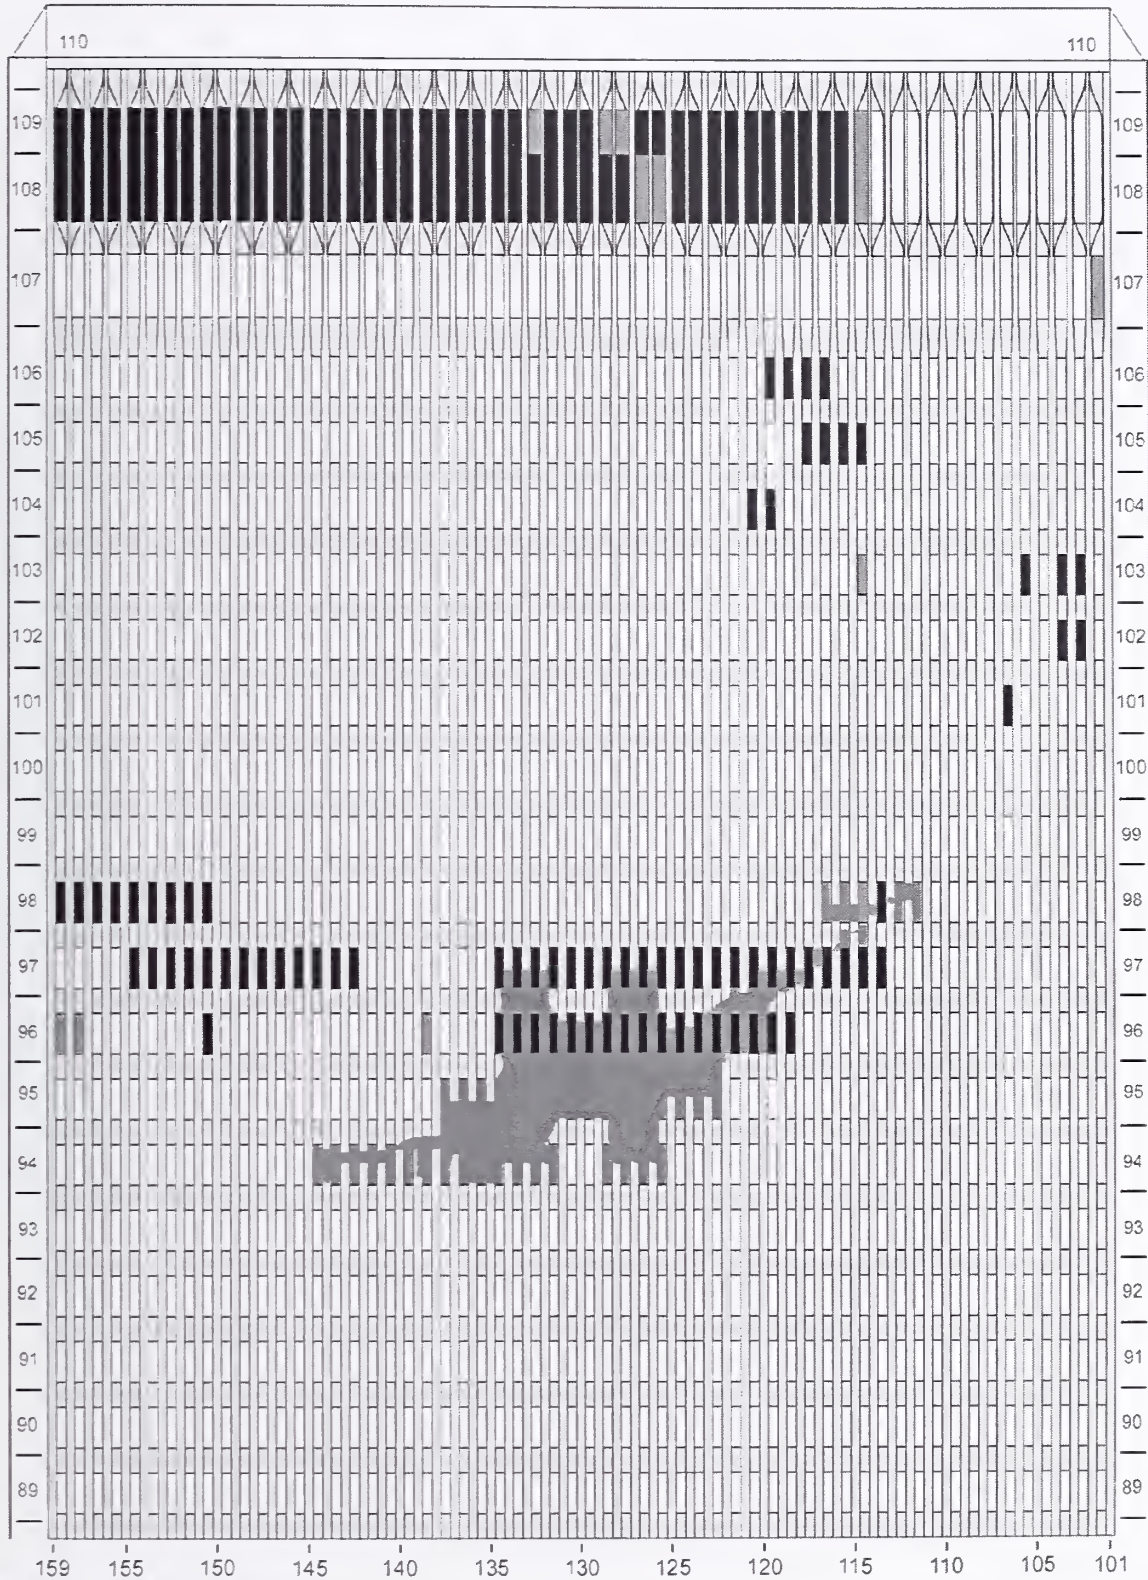
Figure C-26. Diagram of the north face of WTC 1 for floors 89 to 110 at 9:18 a.m. showing windows where smoke was observed and those that were hidden from view.

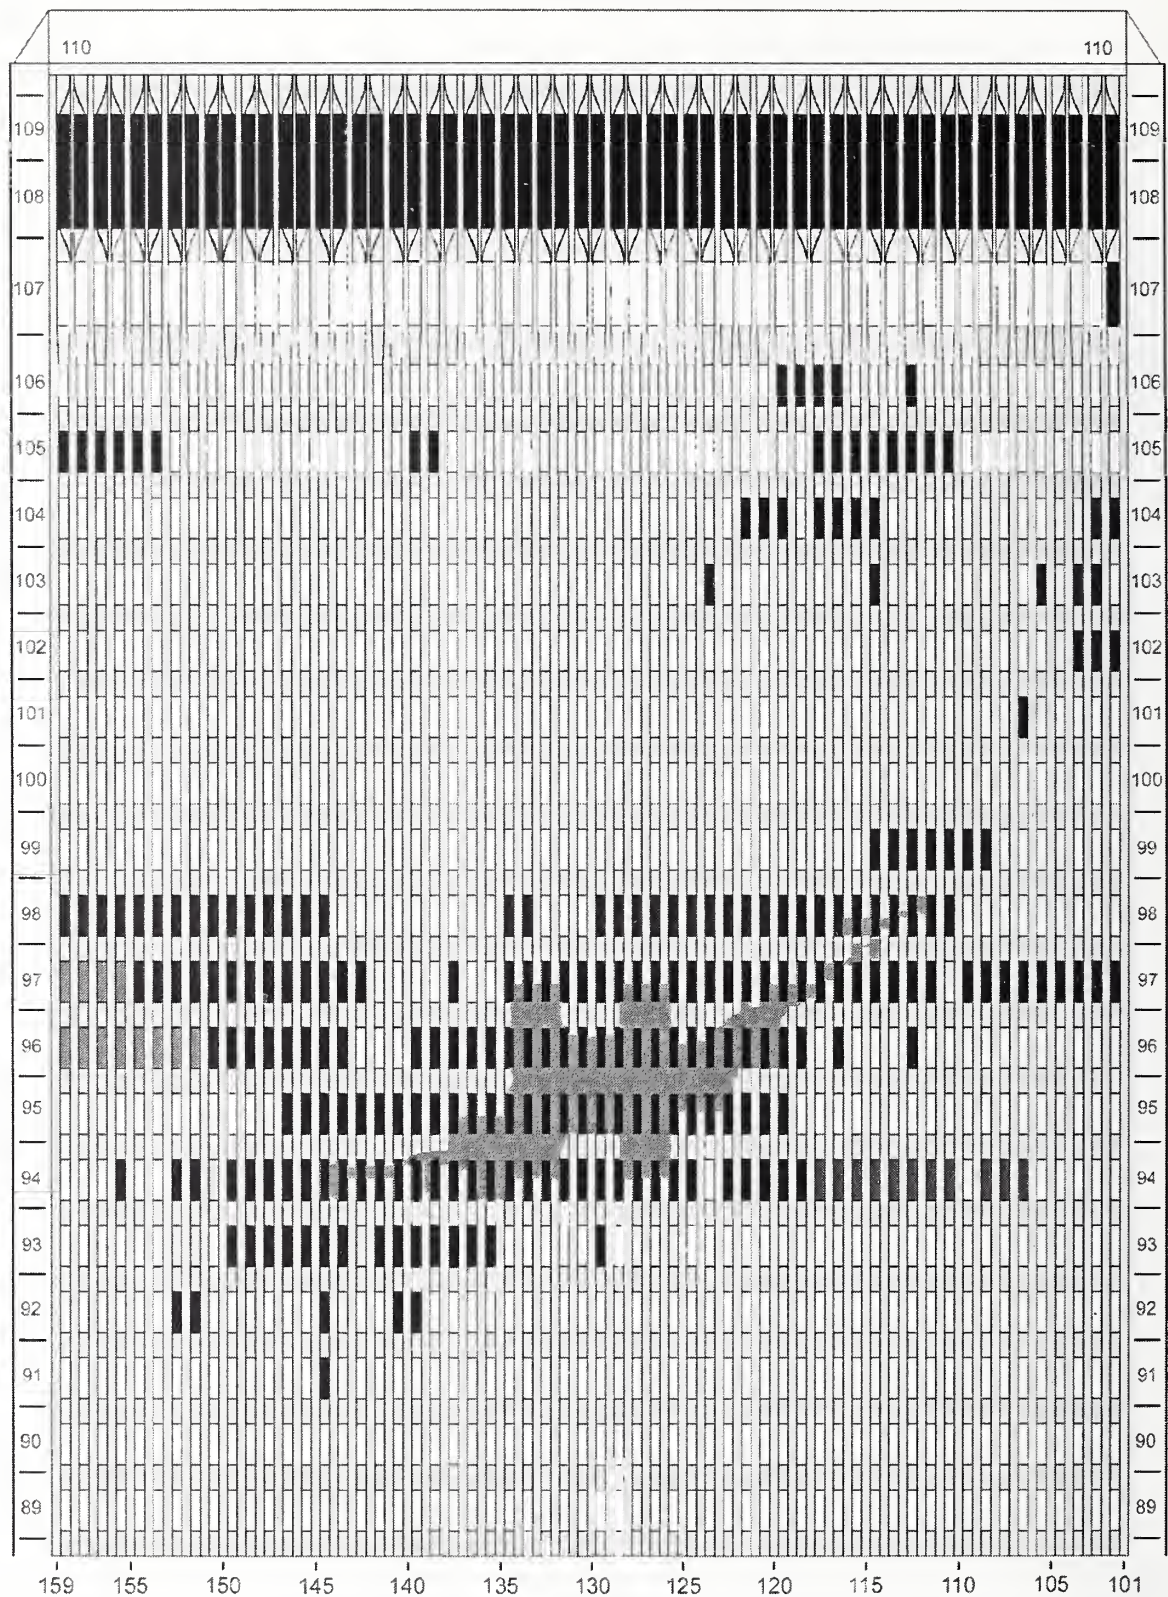
Figure C-27. Diagram of the north face of WTC 1 for floors 89 to 110 at 9:20 a.m. showing the condition of windows and locations of fires.

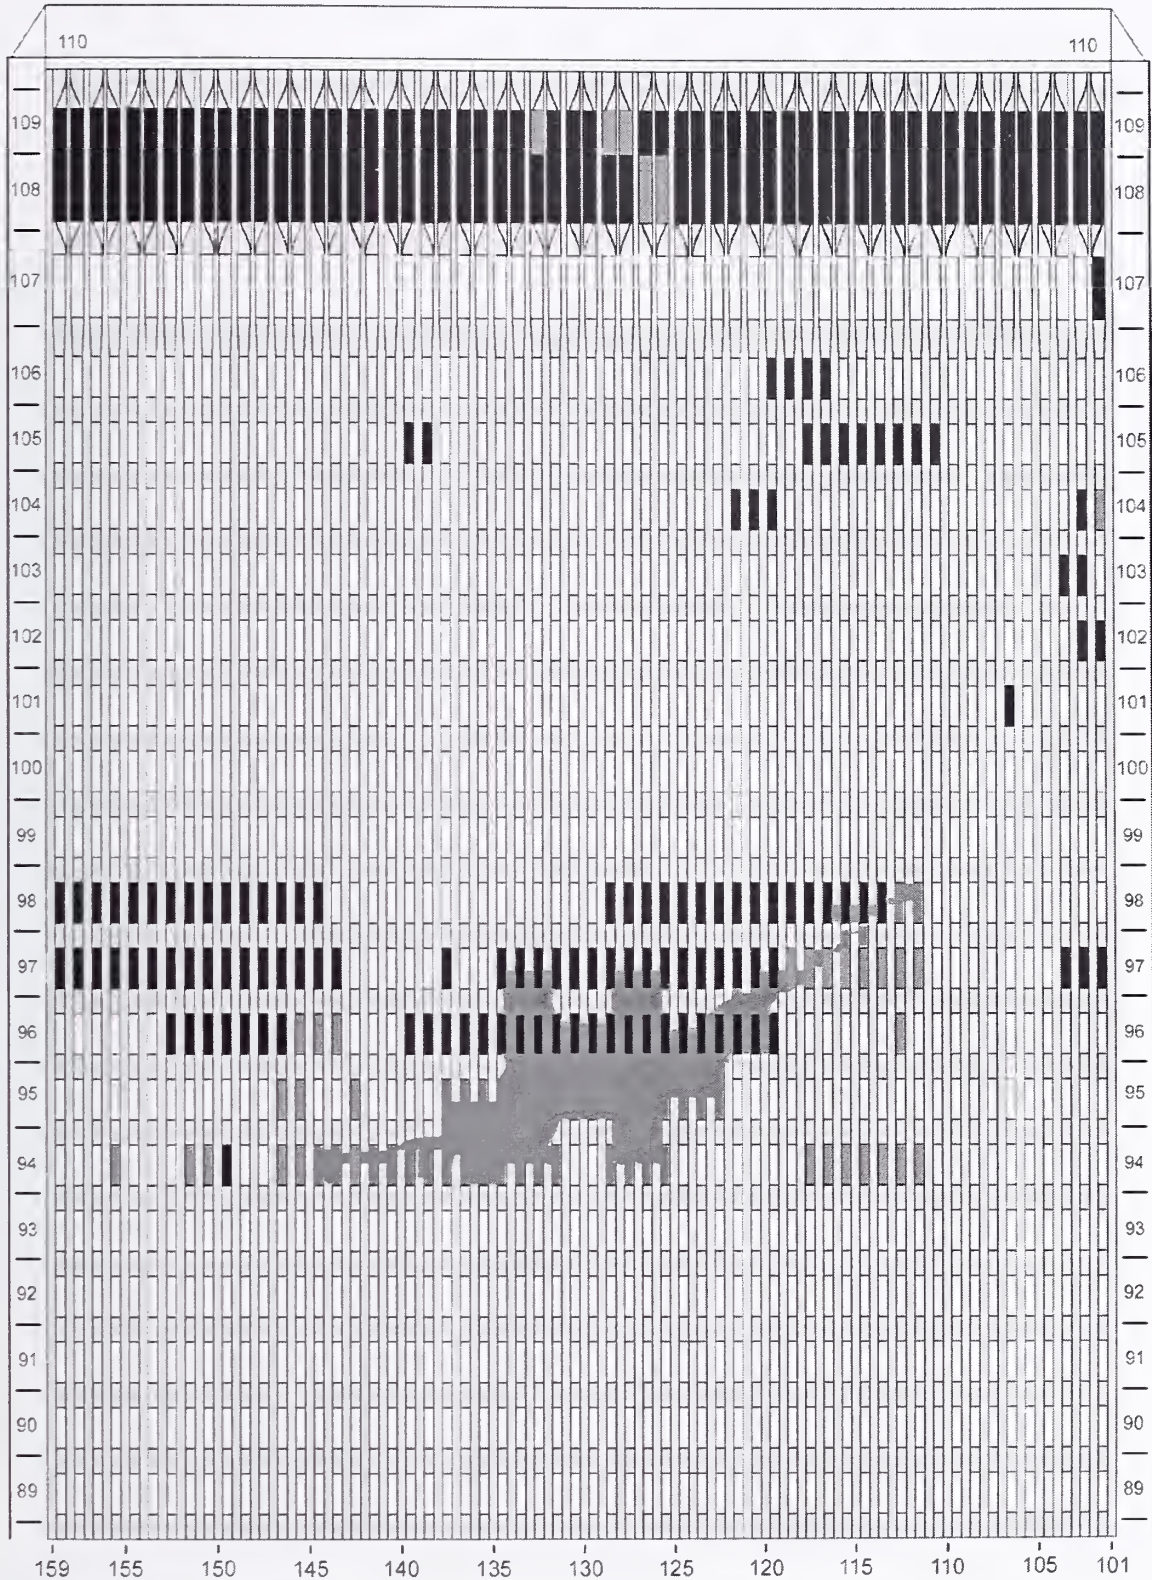
Figure C-28. Diagram of the north face of WTC 1 for floors 89 to 110 at 9:20 a.m. showing windows where smoke was observed and those that were hidden from view.

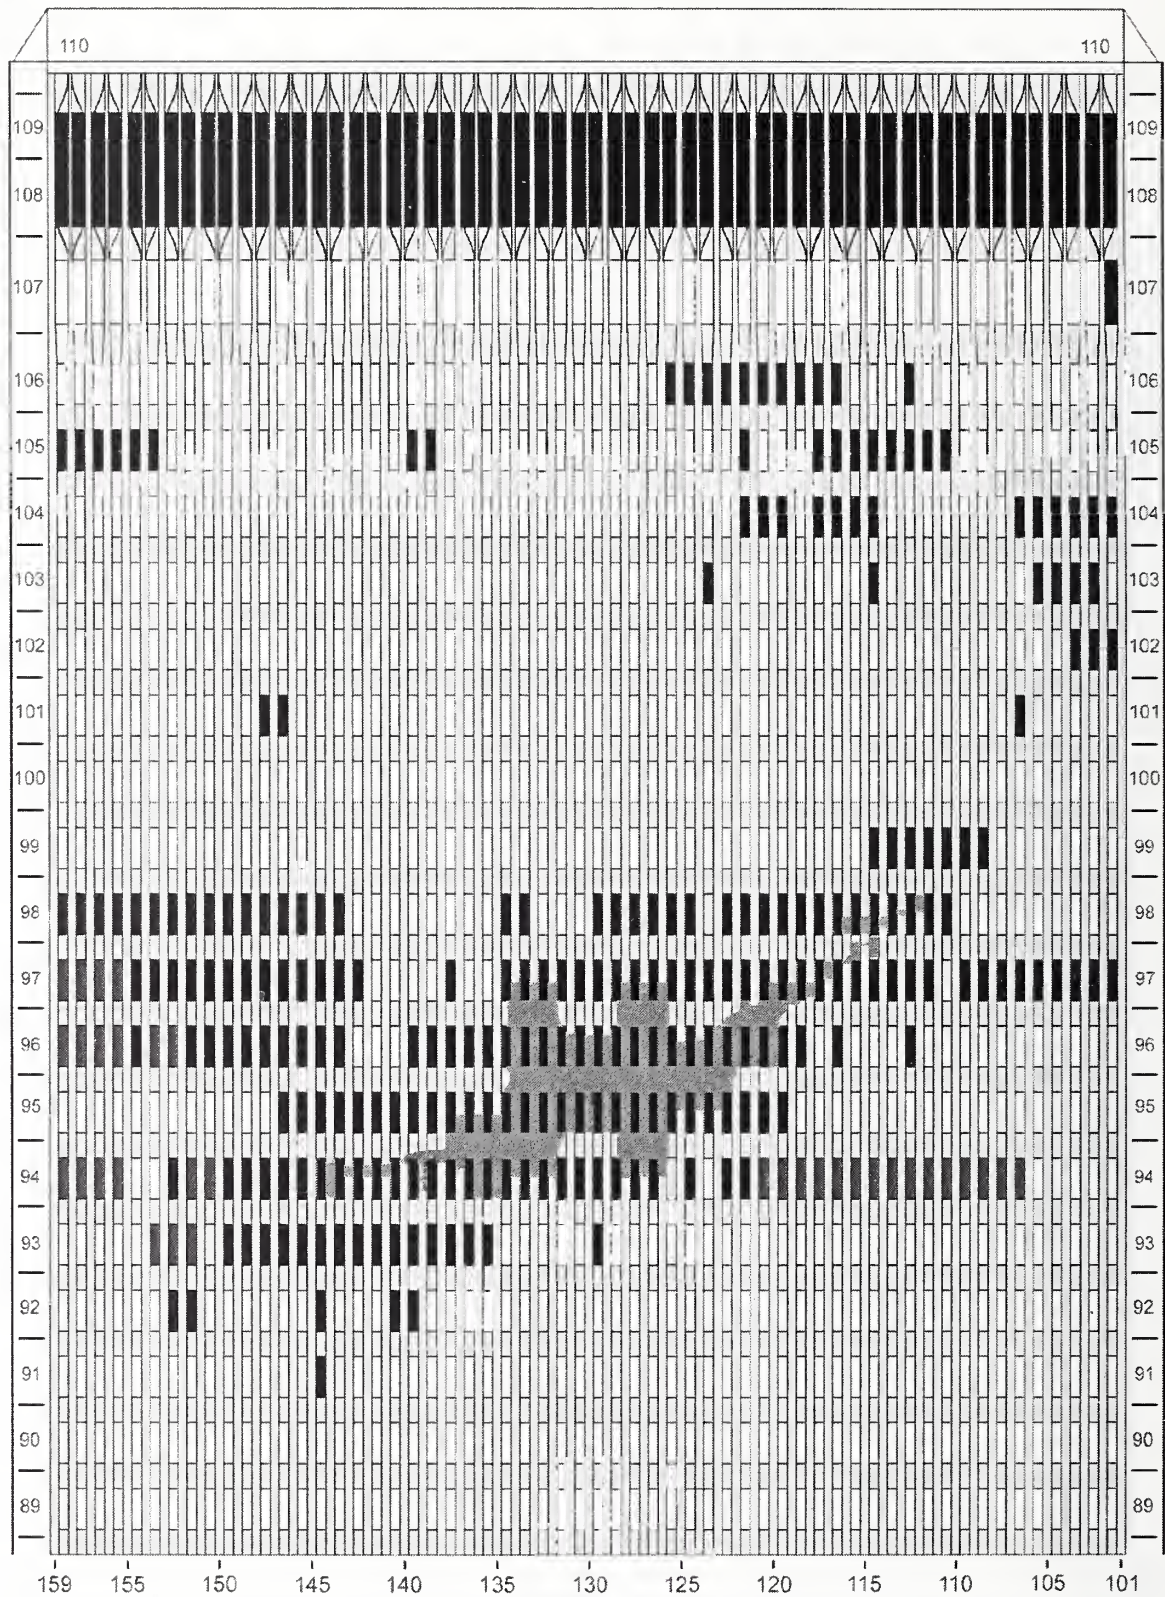
Figure C-29. Diagram of the north face of WTC 1 for floors 89 to 110 at 9:26 a.m. showing the condition of windows and locations of fires.

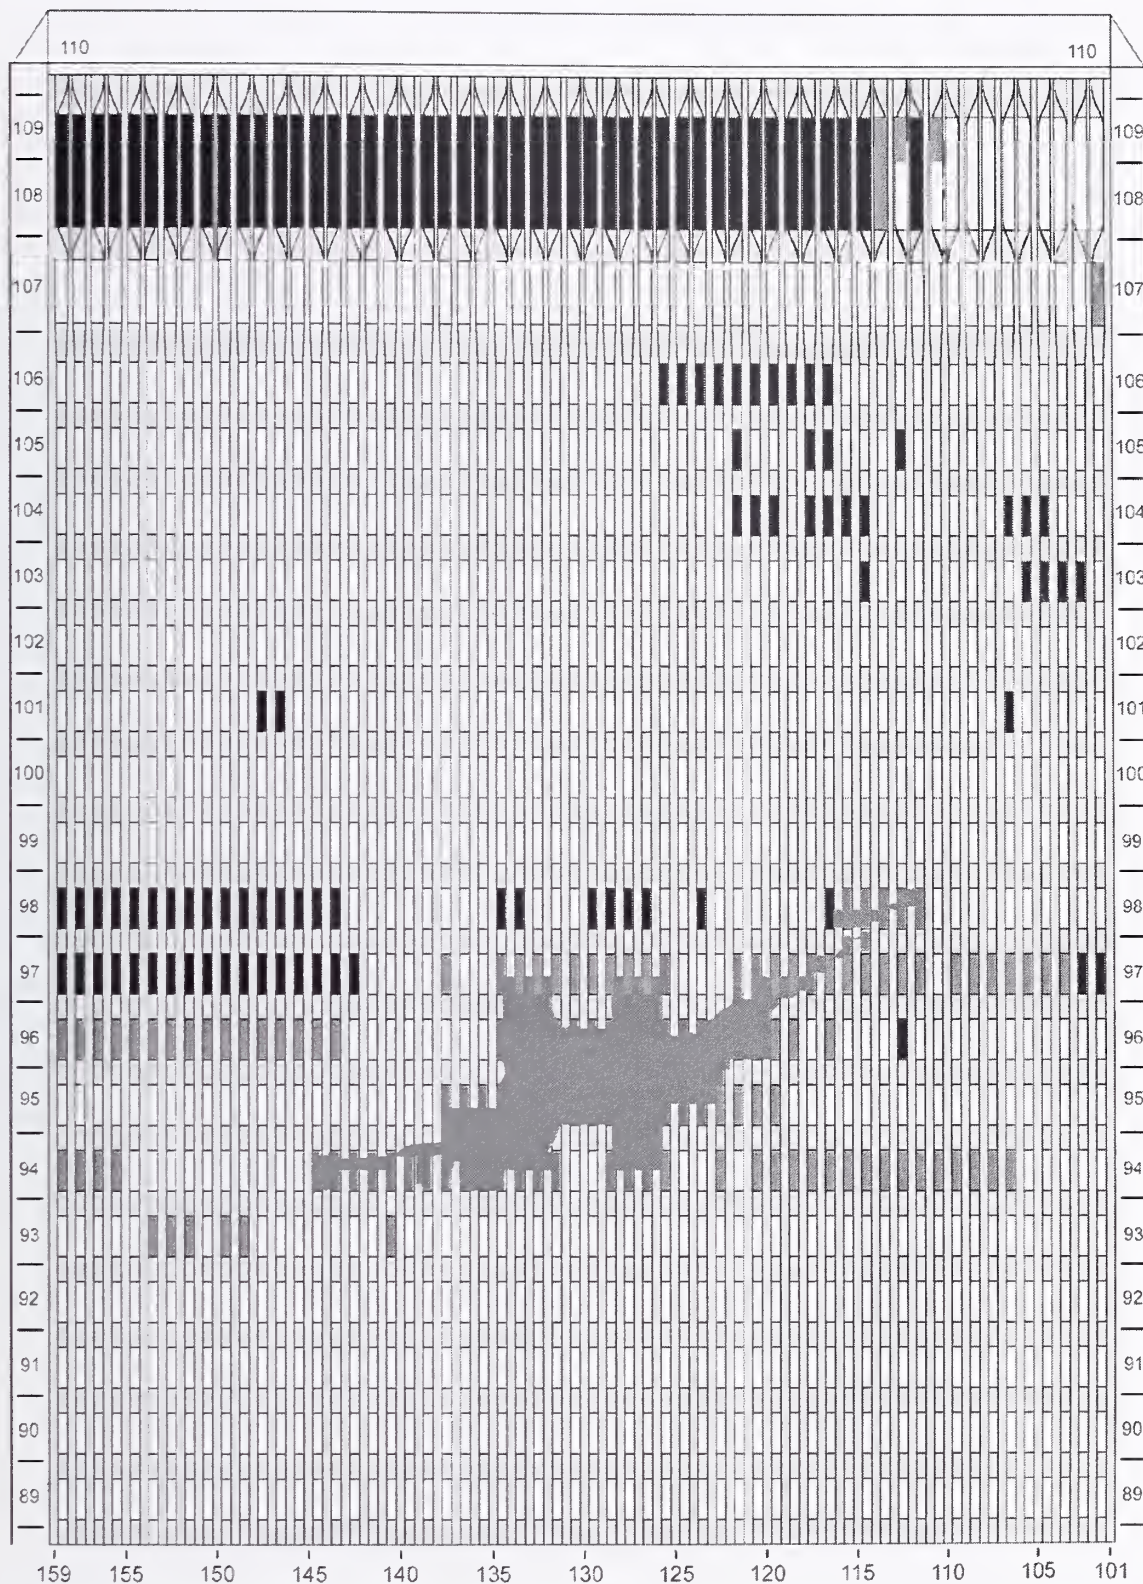
Figure C-30. Diagram of the north face of WTC 1 for floors 89 to 110 at 9:26 a.m. showing windows where smoke was observed and those that were hidden from view.

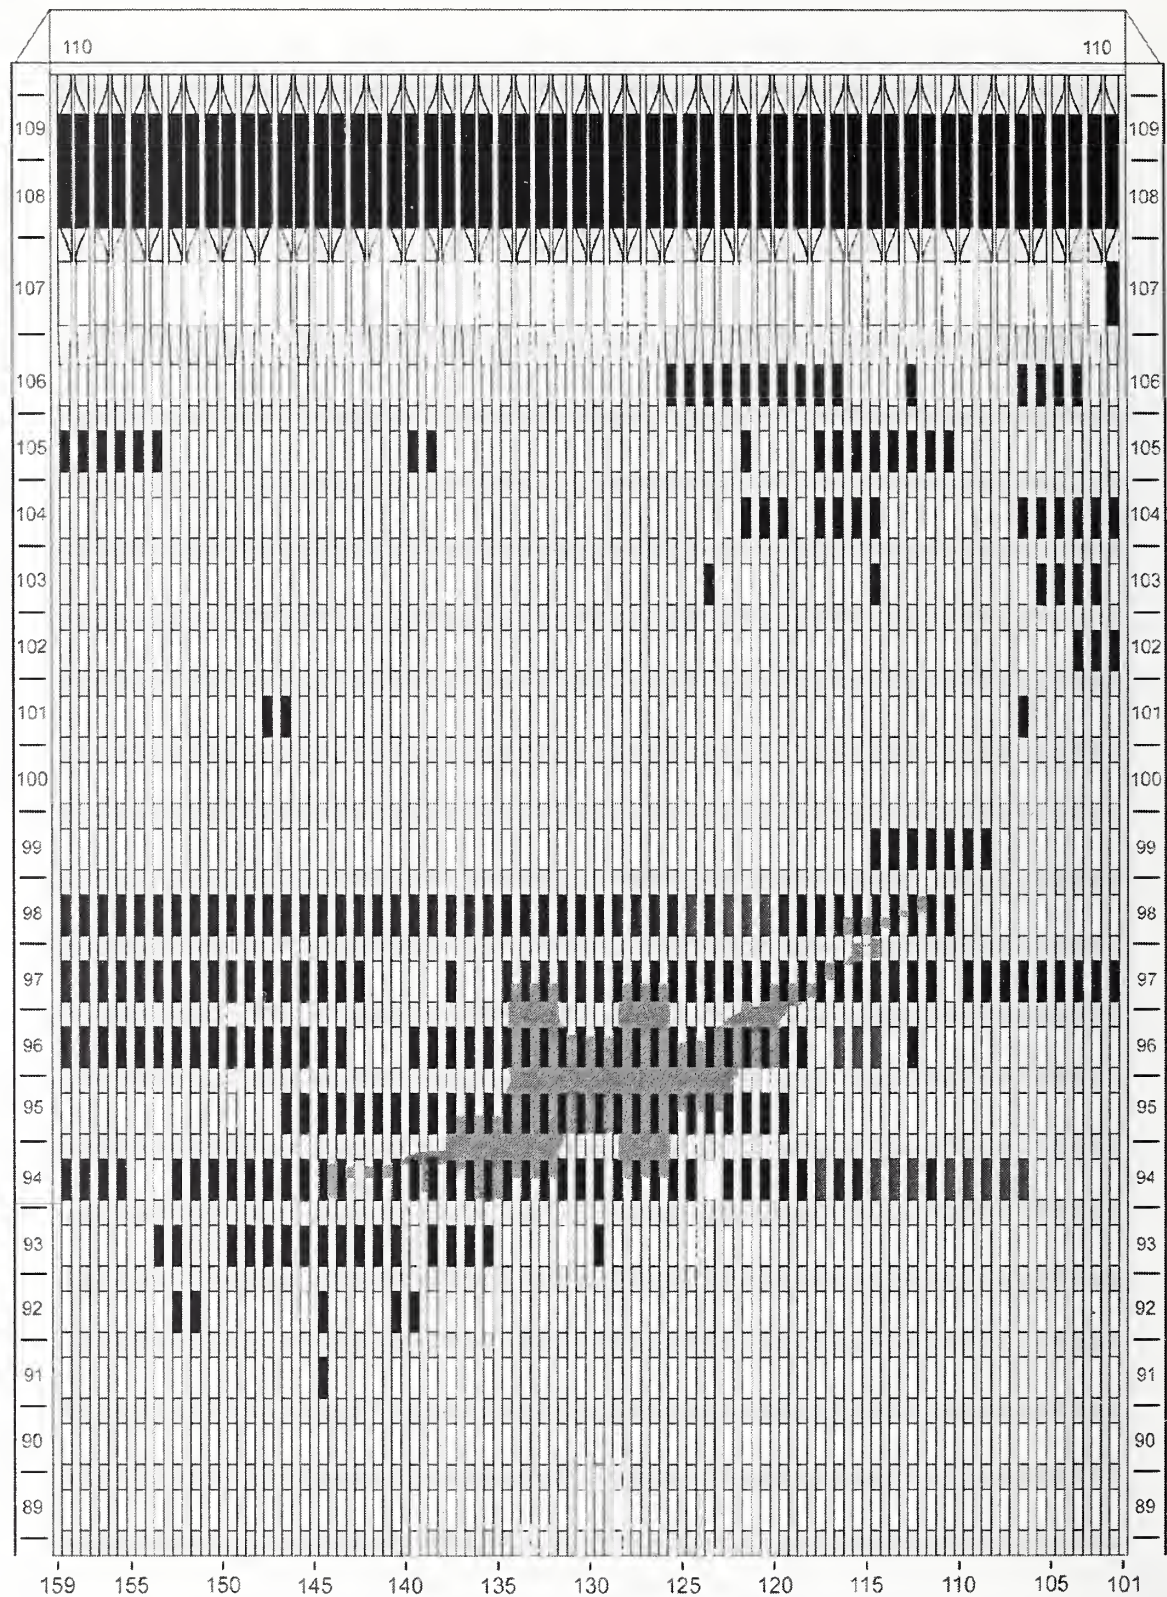
Figure C-31. Diagram of the north face of WTC 1 for floors 89 to 110 at 9:32 a.m. showing the condition of windows and locations of fires.

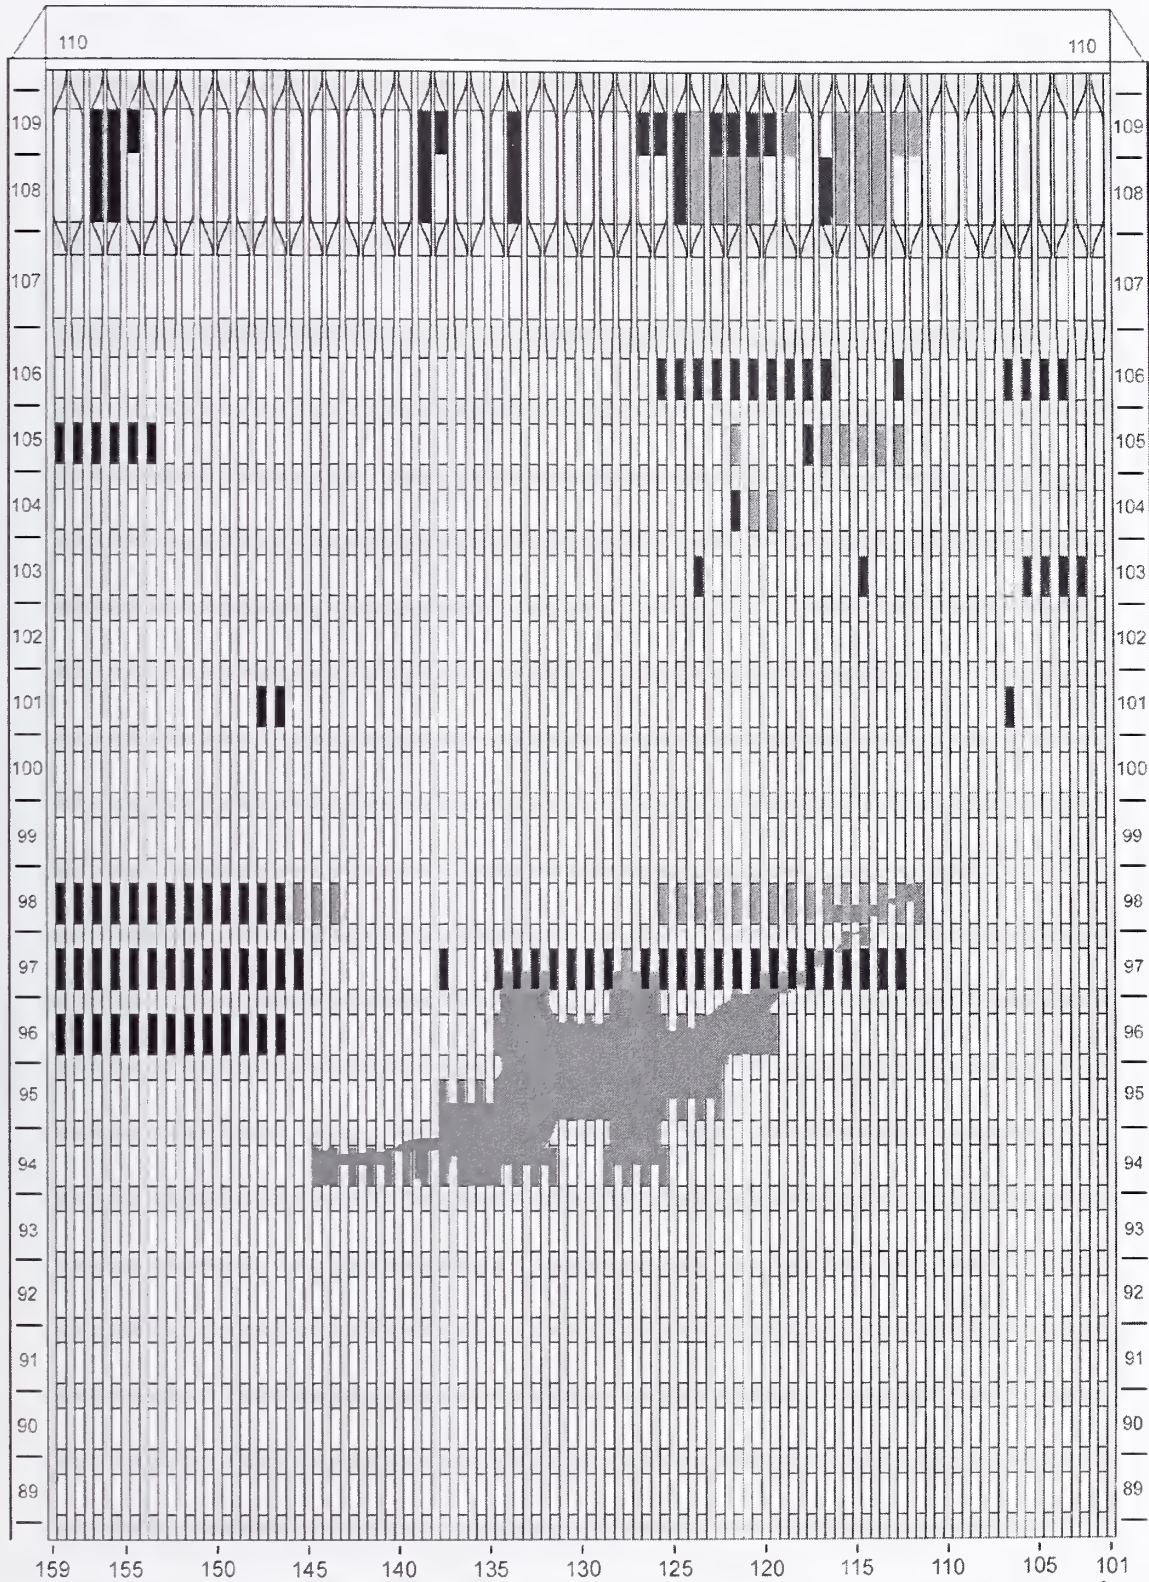
Figure C-32. Diagram of the north face of WTC 1 for floors 89 to 110 at 9:32 a.m. showing windows where smoke was observed and those that were hidden from view.

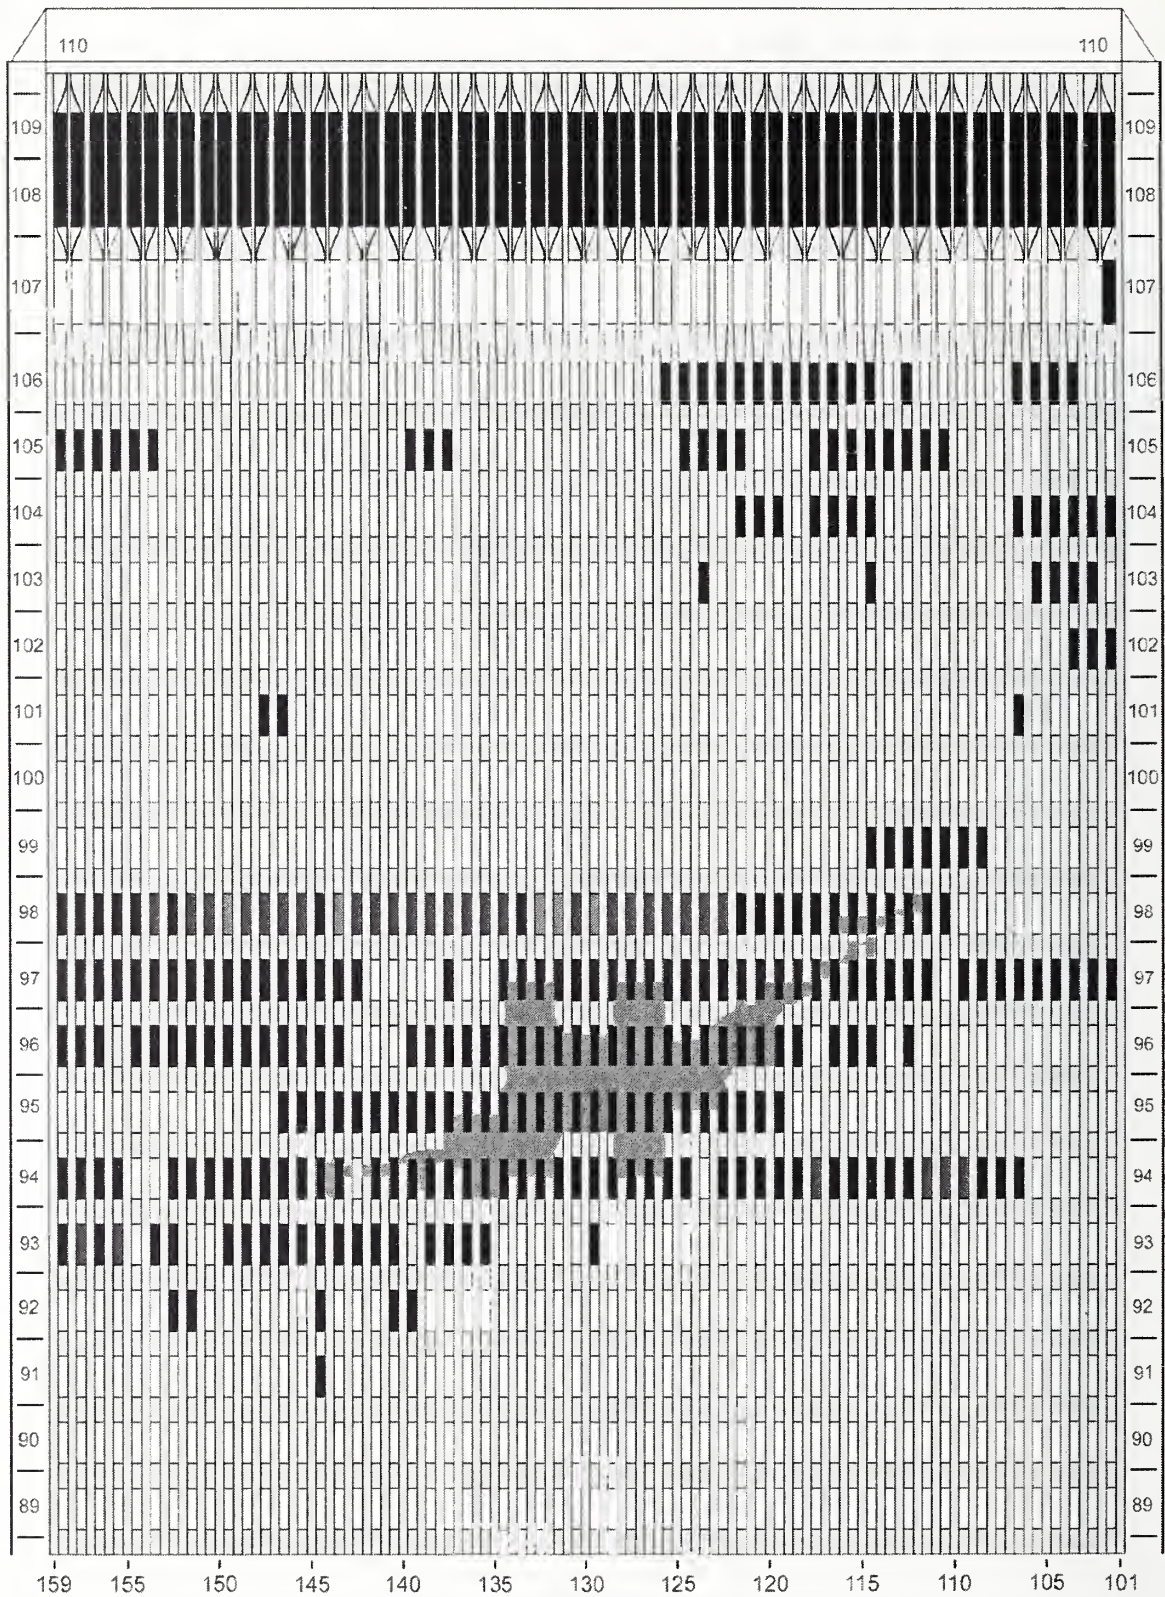
Figure C-33. Diagram of the north face of WTC 1 for floors 89 to 110 at 9:38 a.m. showing the condition of windows and locations of fires.
