**NIST NCSTAR 1-5A
Federal Building and Fire Safety Investigation of
the World Trade Center Disaster**

**Visual Evidence, Damage Estimates,
And Timeline Analysis**

(Chapter 9 - Appendix C)

FIRE BEHAVIOR IN WORLD TRADE CENTER 2

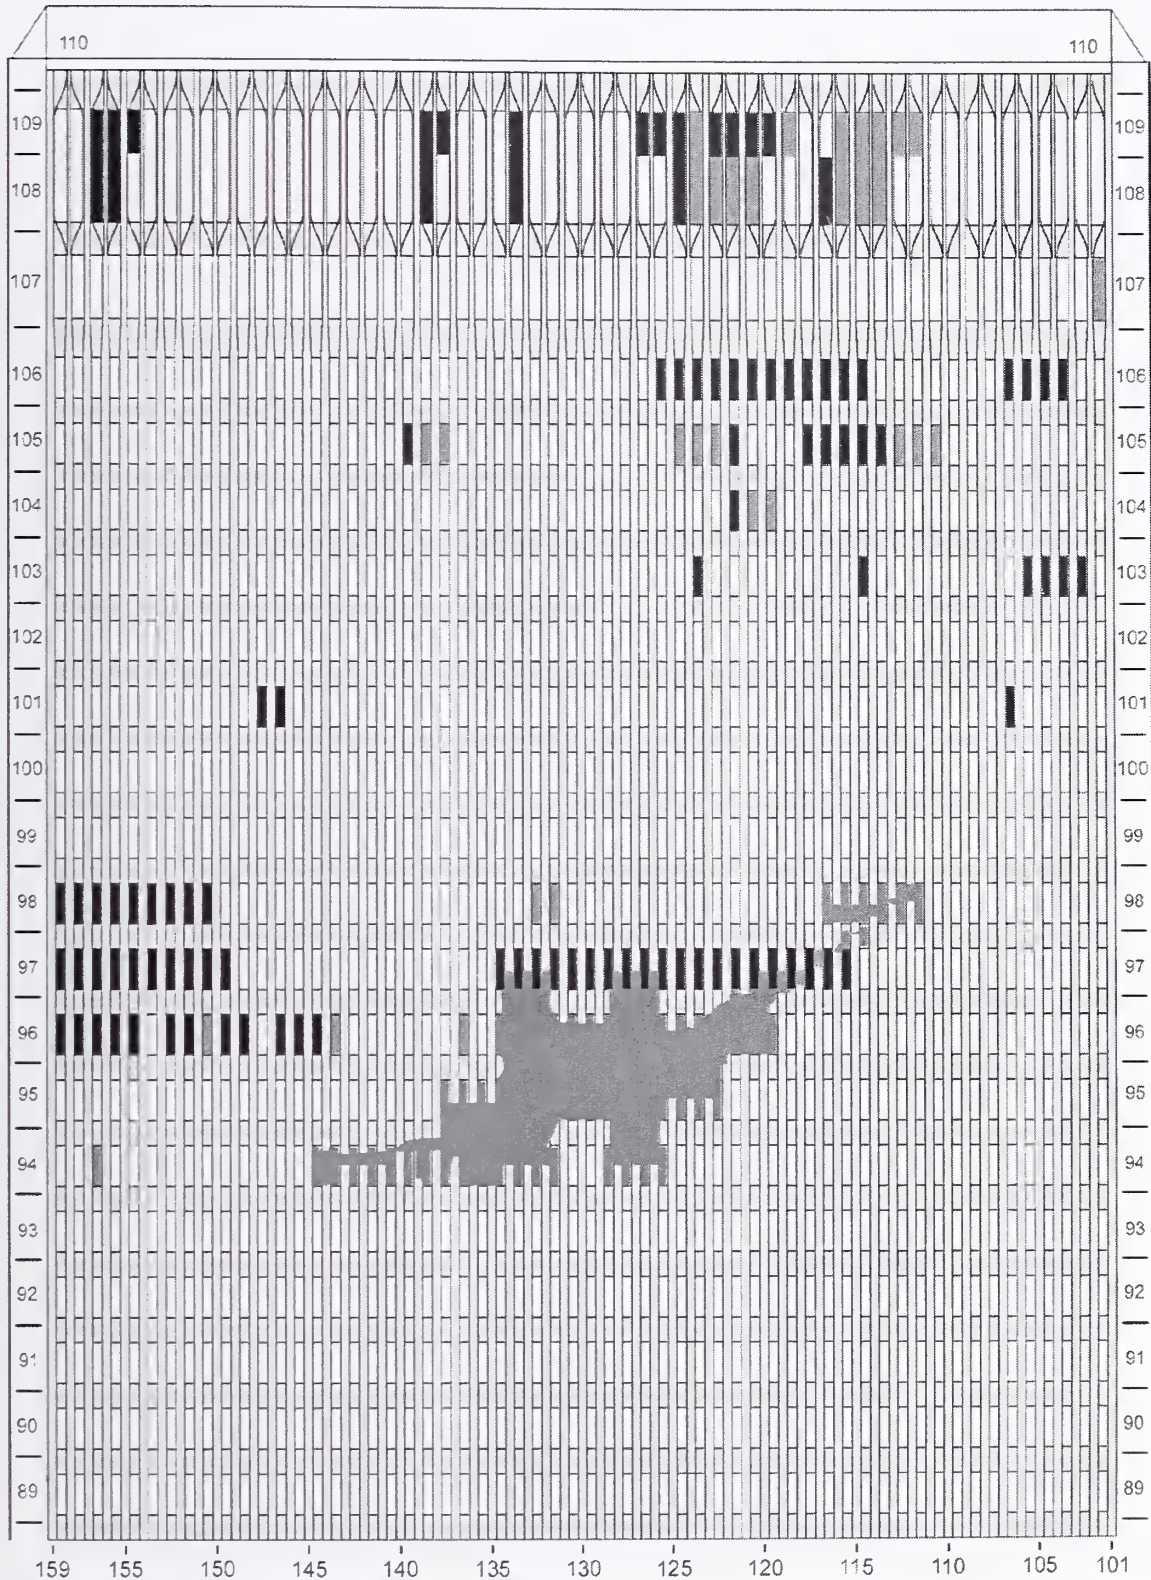
Figure C-34. Diagram of the north face of WTC 1 for floors 89 to 110 at 9:38 a.m. showing windows where smoke was observed and those that were hidden from view.

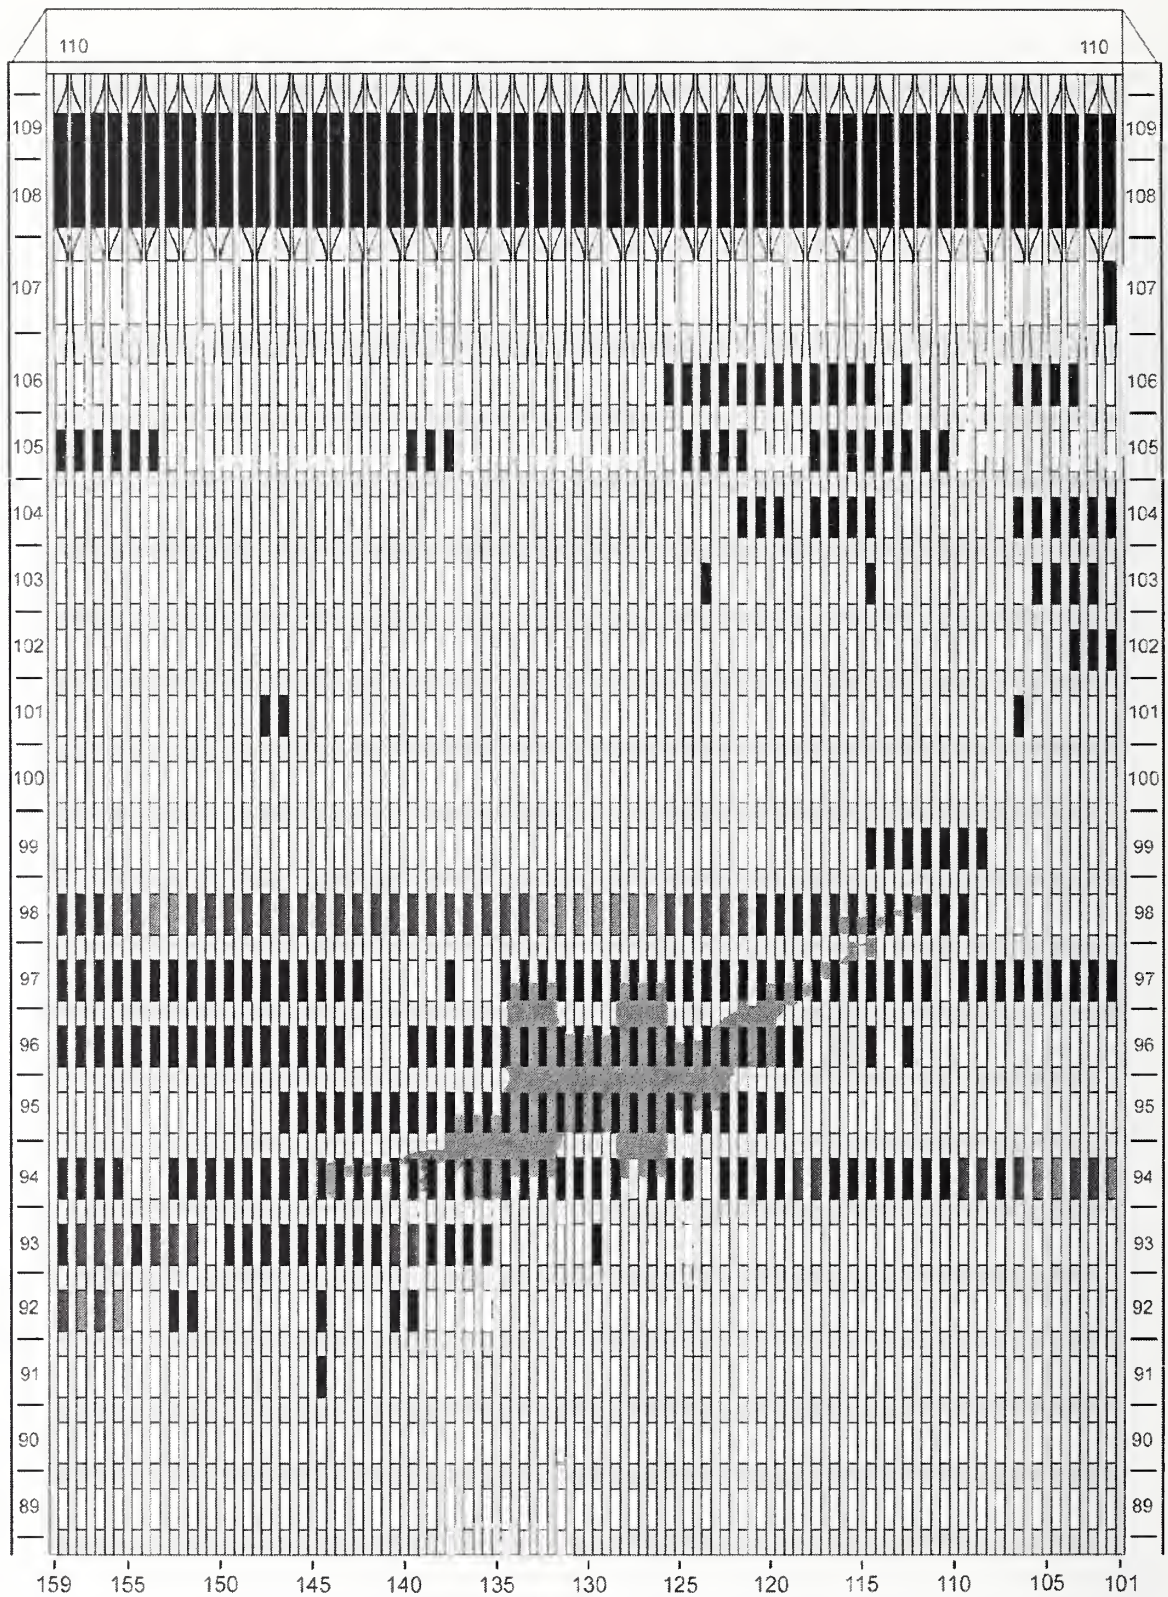
Figure C-35. Diagram of the north face of WTC 1 for floors 89 to 110 at 9:42 a.m. showing the condition of windows and locations of fires.

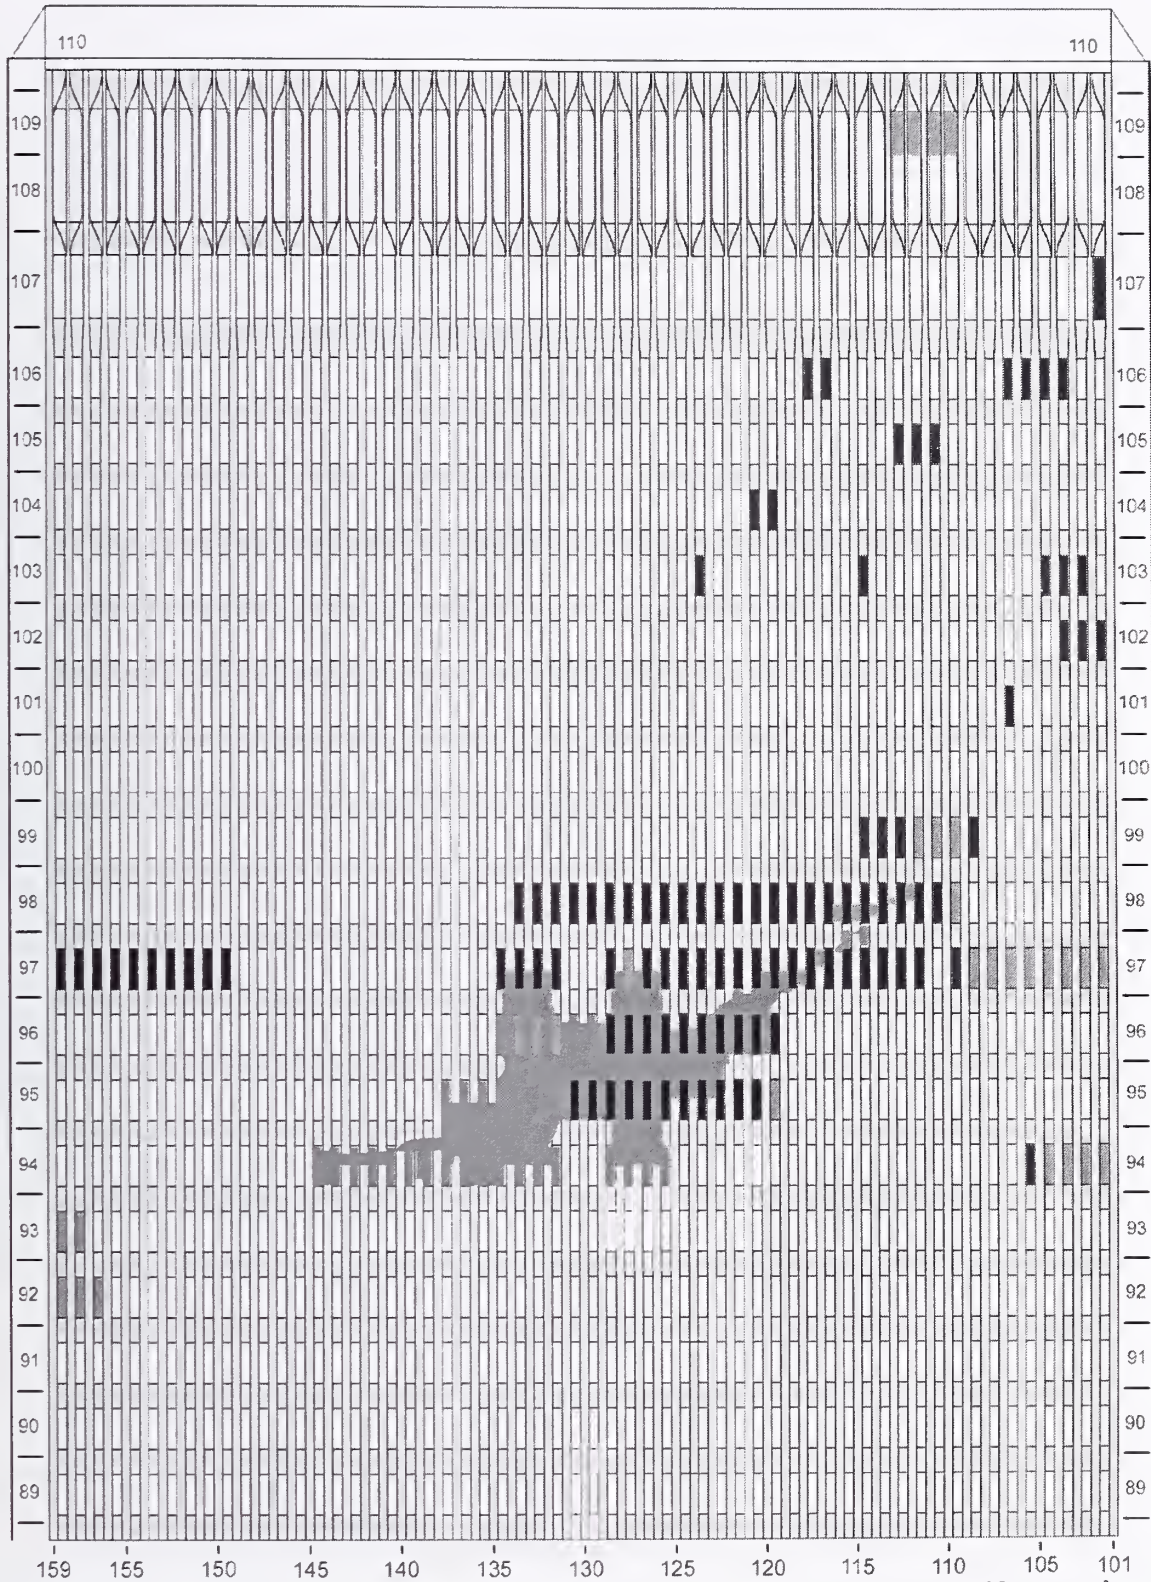
Figure C-36. Diagram of the north face of WTC 1 for floors 89 to 110 at 9:42 a.m. showing windows where smoke was observed and those that were hidden from view.

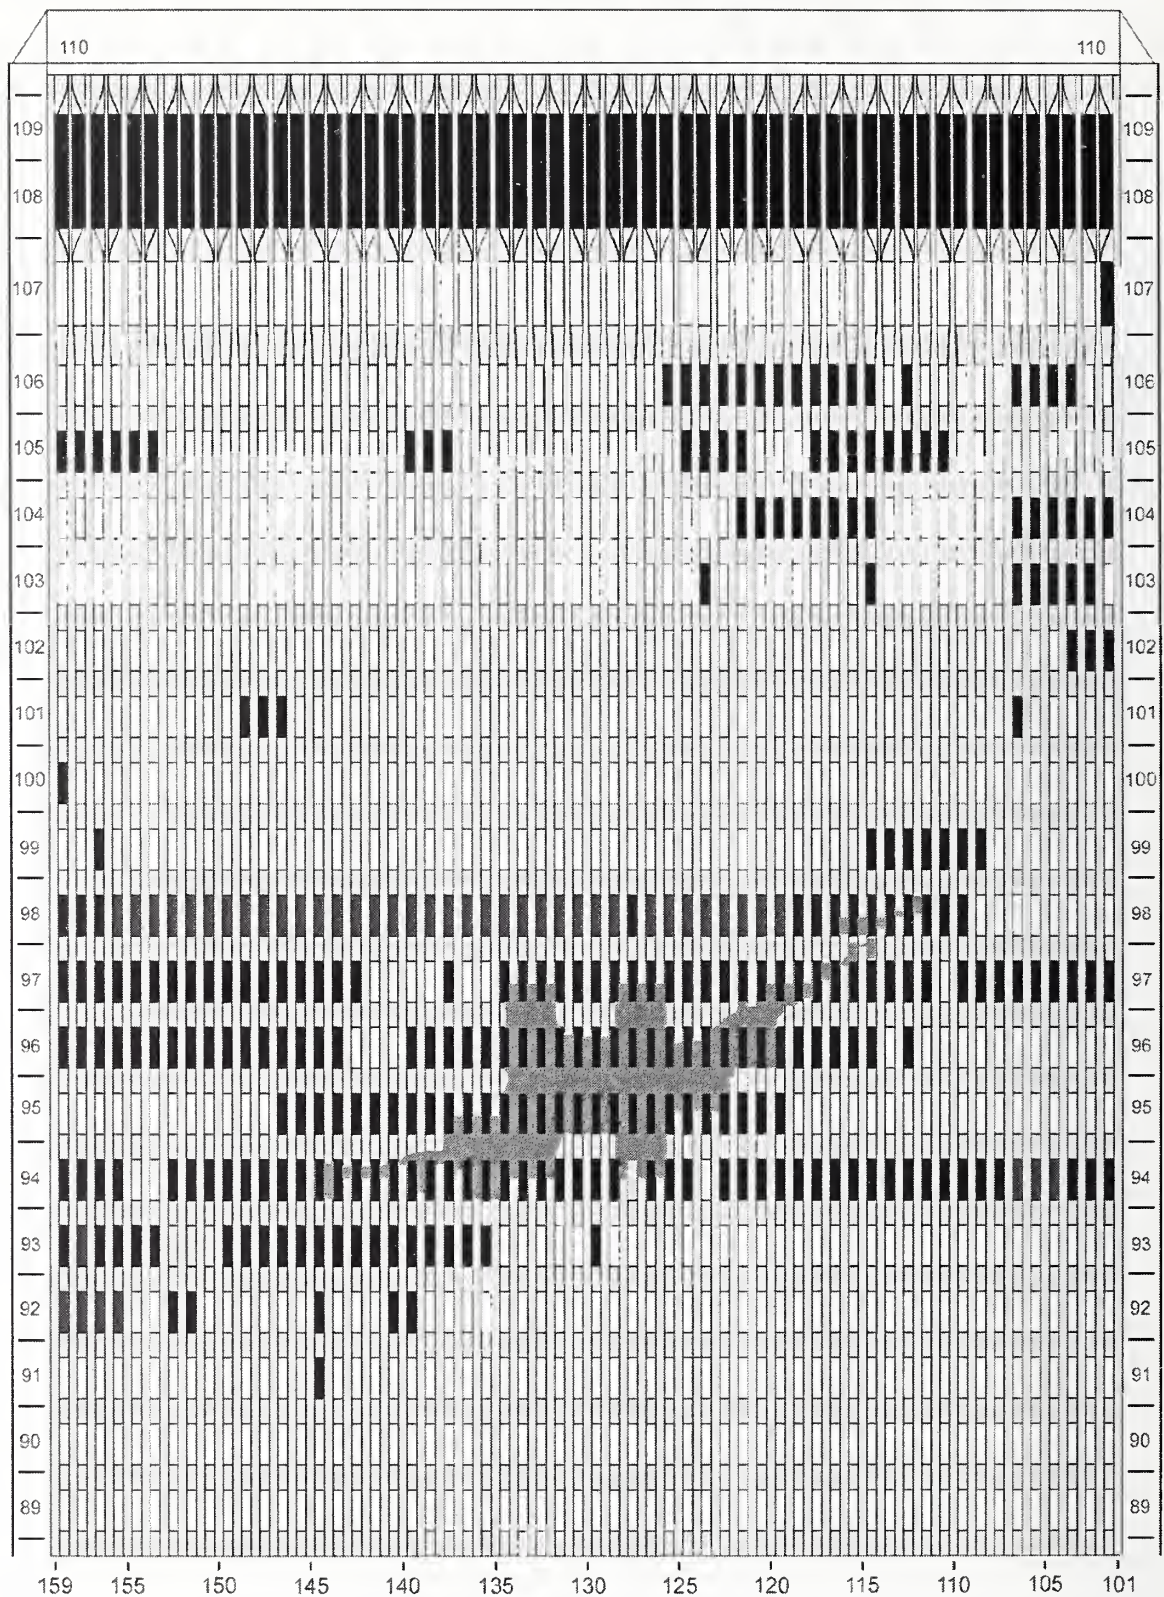
Figure C-37. Diagram of the north face of WTC 1 for floors 89 to 110 at 9:46 a.m. showing the condition of windows and locations of fires.

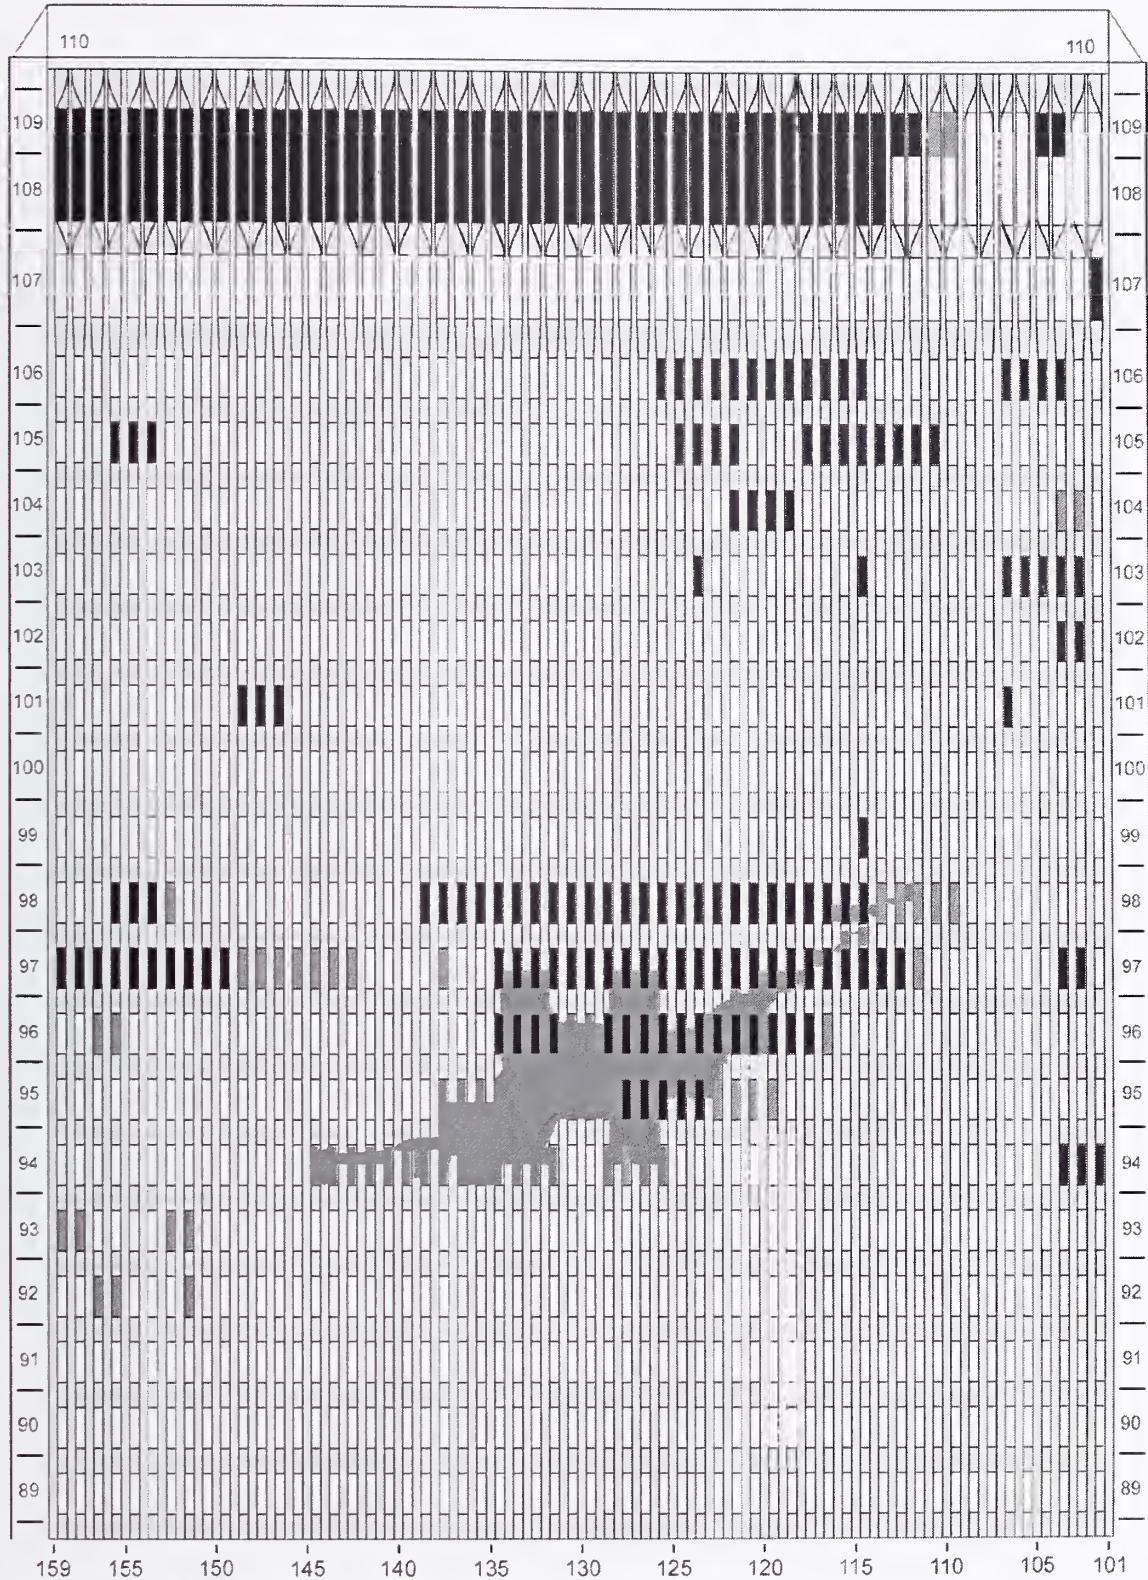
Figure C-38. Diagram of the north face of WTC 1 for floors 89 to 110 at 9:46 a.m. showing windows where smoke was observed and those that were hidden from view.

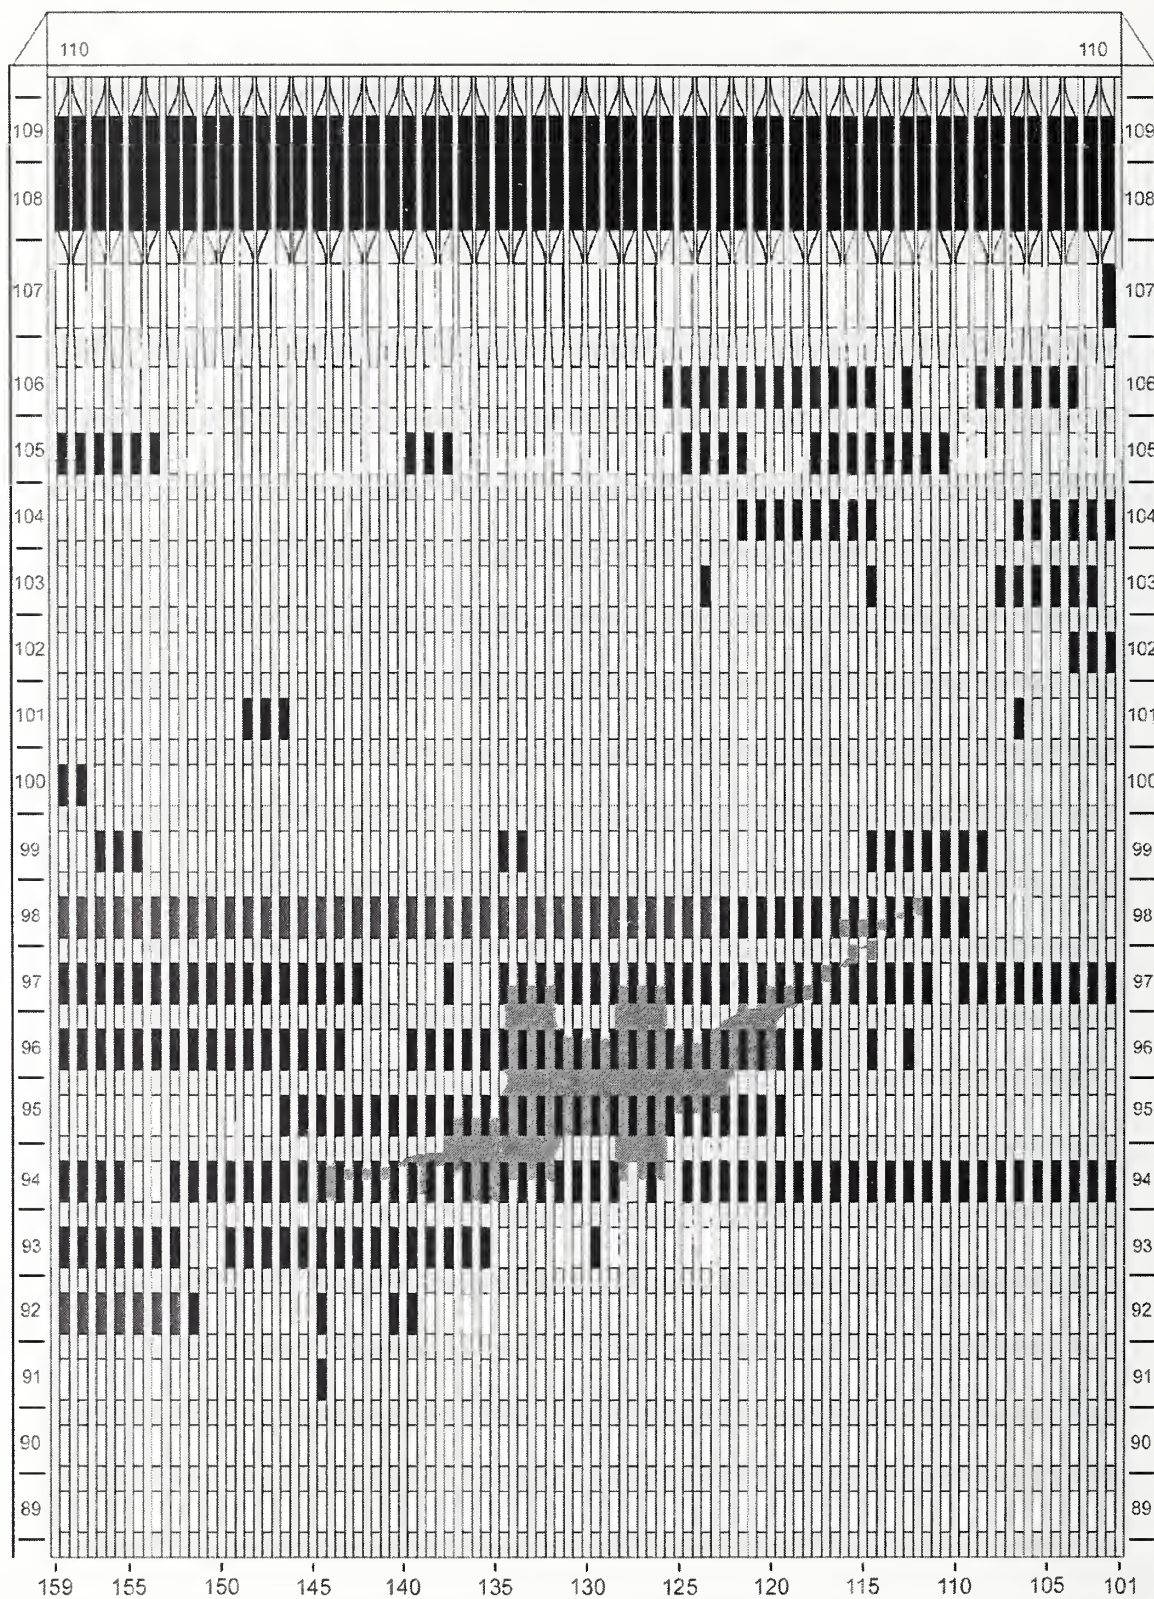
Figure C-39. Diagram of the north face of WTC 1 for floors 89 to 110 at 9:52 a.m. showing the condition of windows and locations of fires.

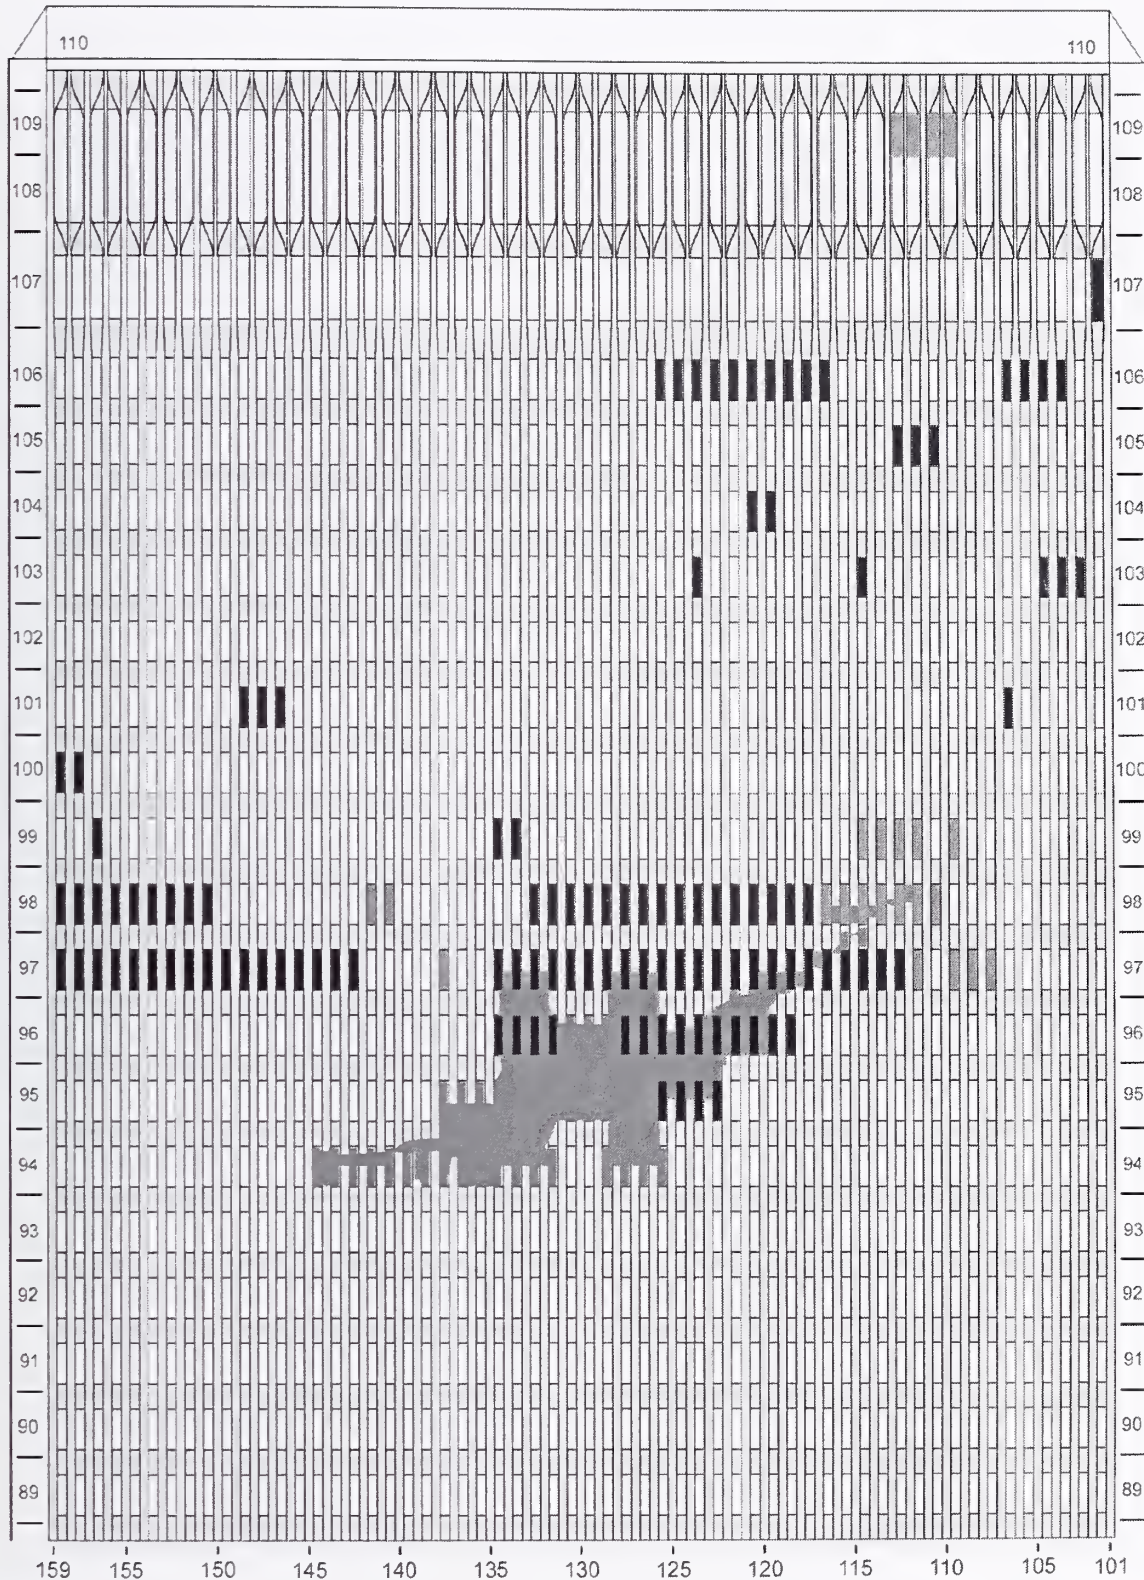
Figure C-40. Diagram of the north face of WTC 1 for floors 89 to 110 at 9:52 a.m. showing windows where smoke was observed and those that were hidden from view.

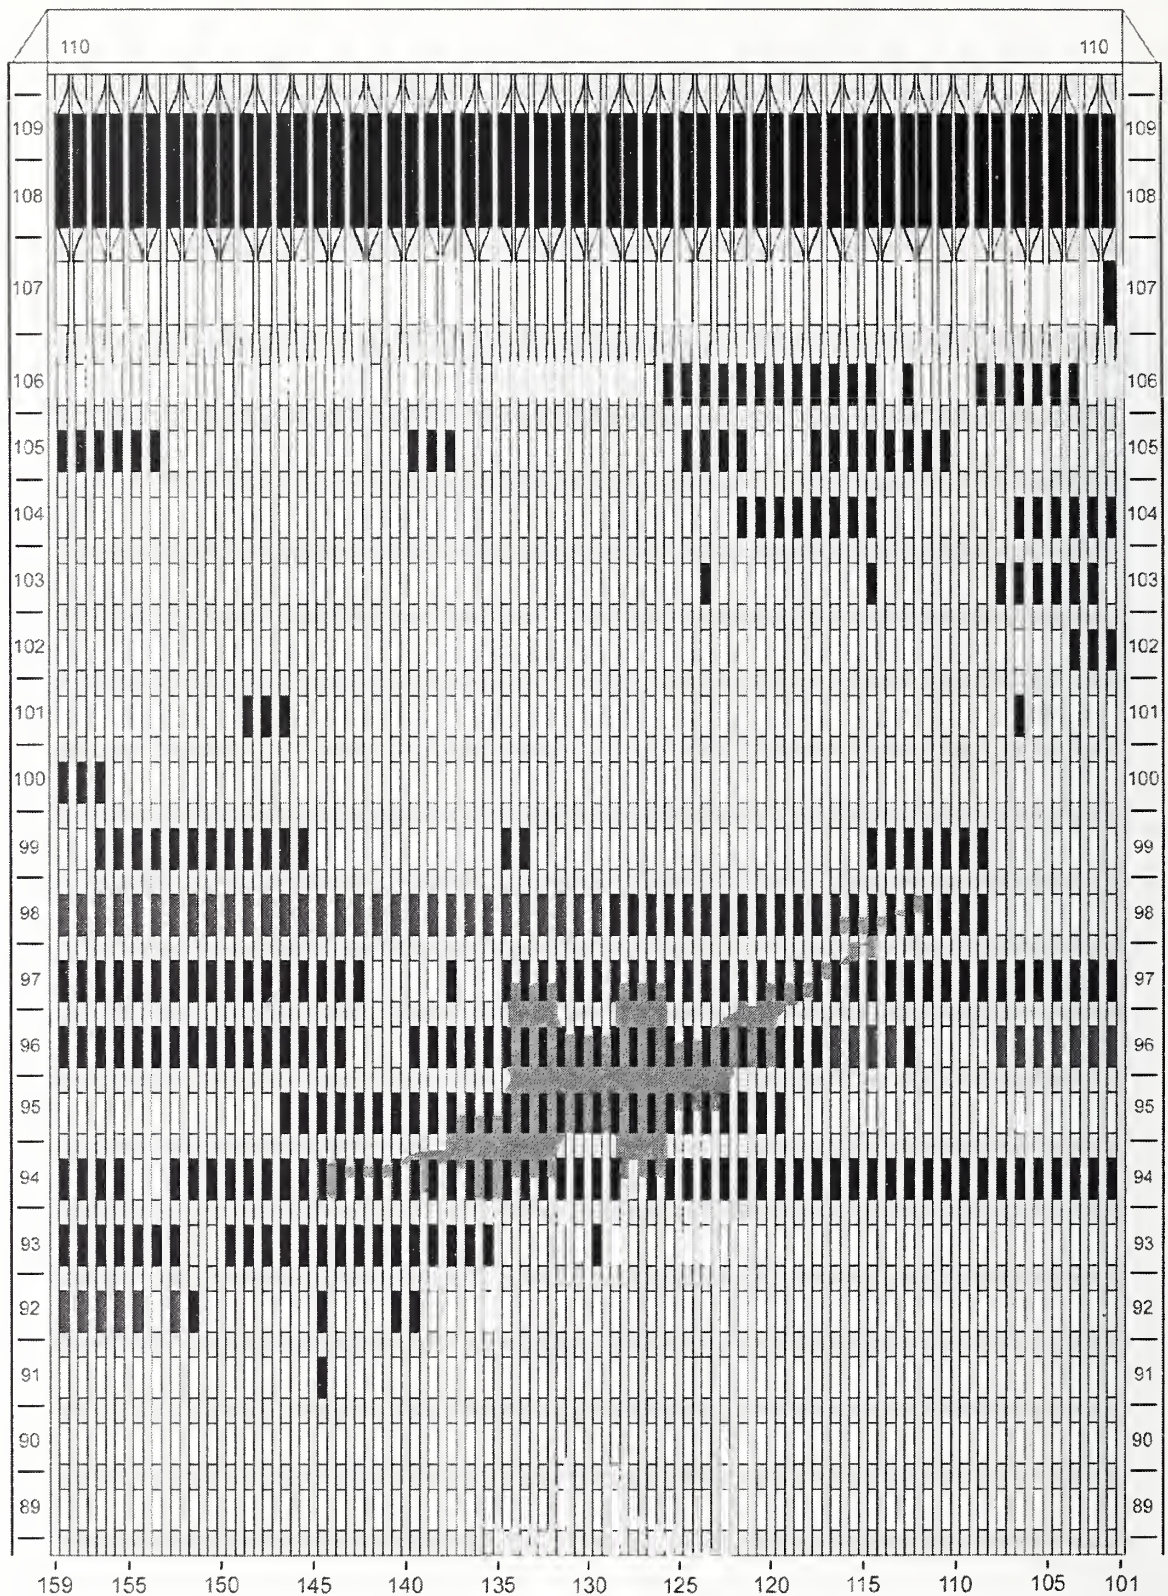
Figure C-41. Diagram of the north face of WTC 1 for floors 89 to 110 at 9:54 a.m. showing the condition of windows and locations of fires.

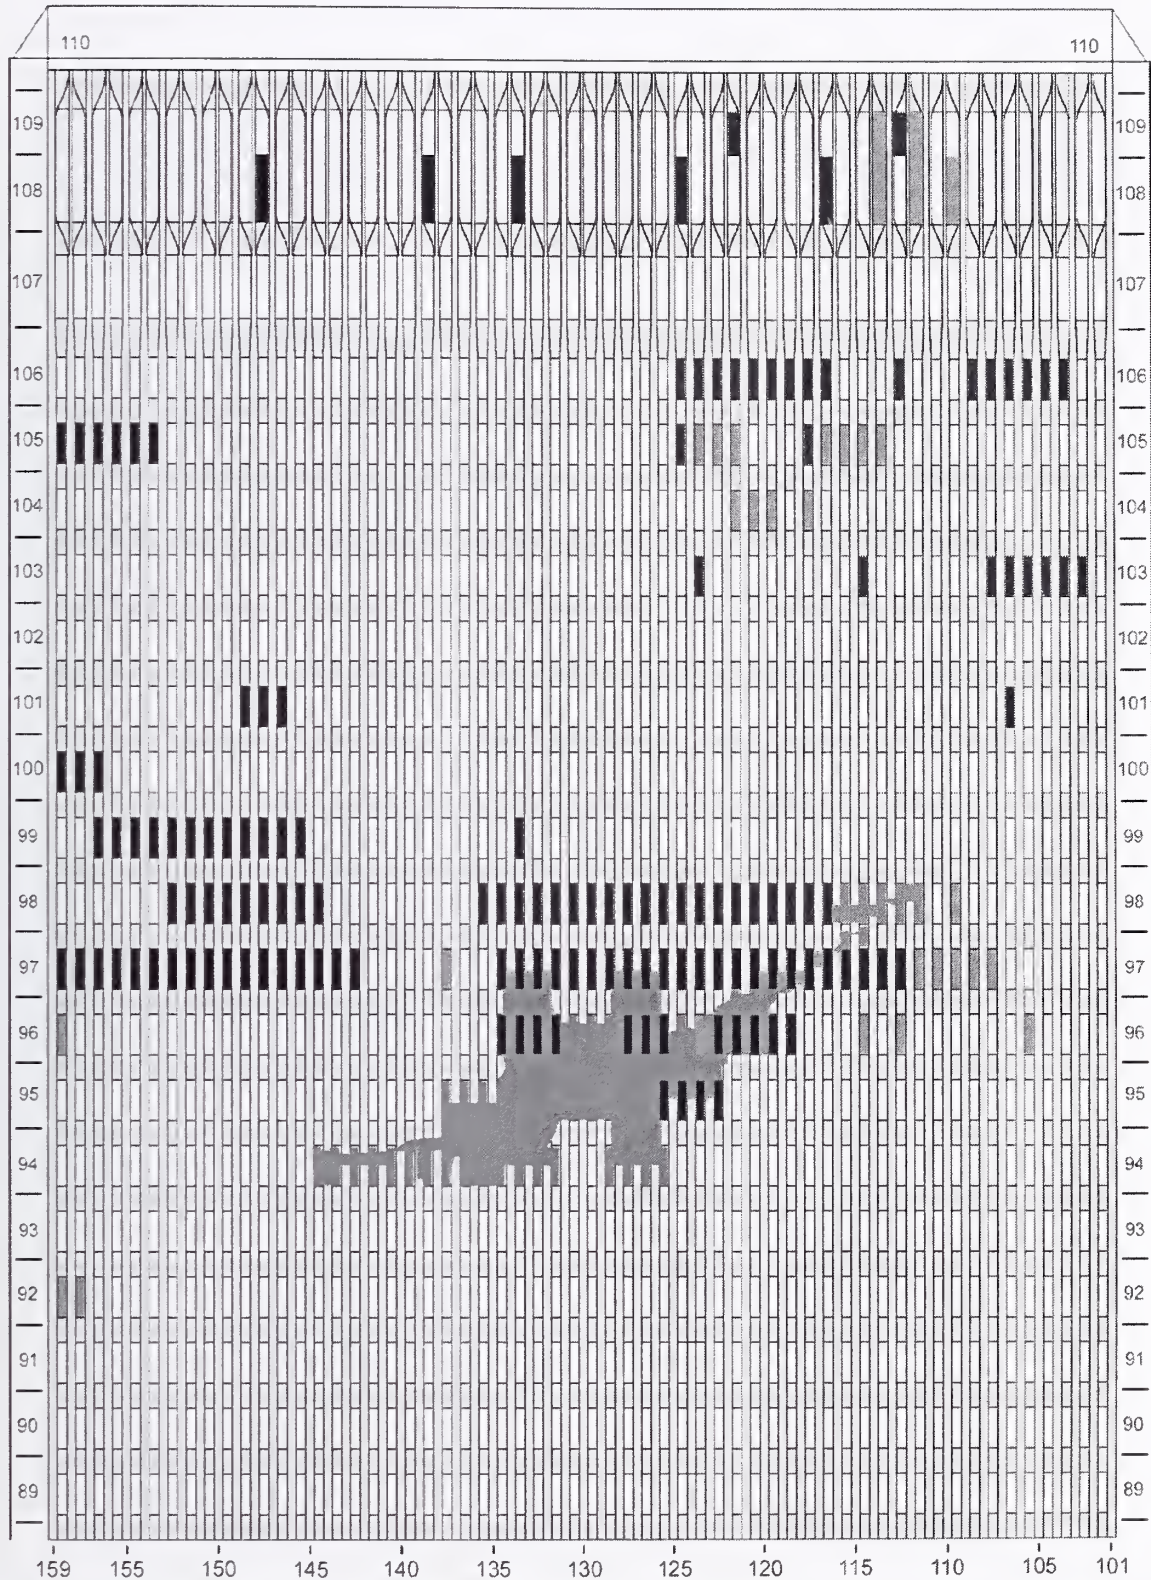
Figure C-42. Diagram of the north face of WTC 1 for floors 89 to 110 at 9:54 a.m. showing windows where smoke was observed and those that were hidden from view.

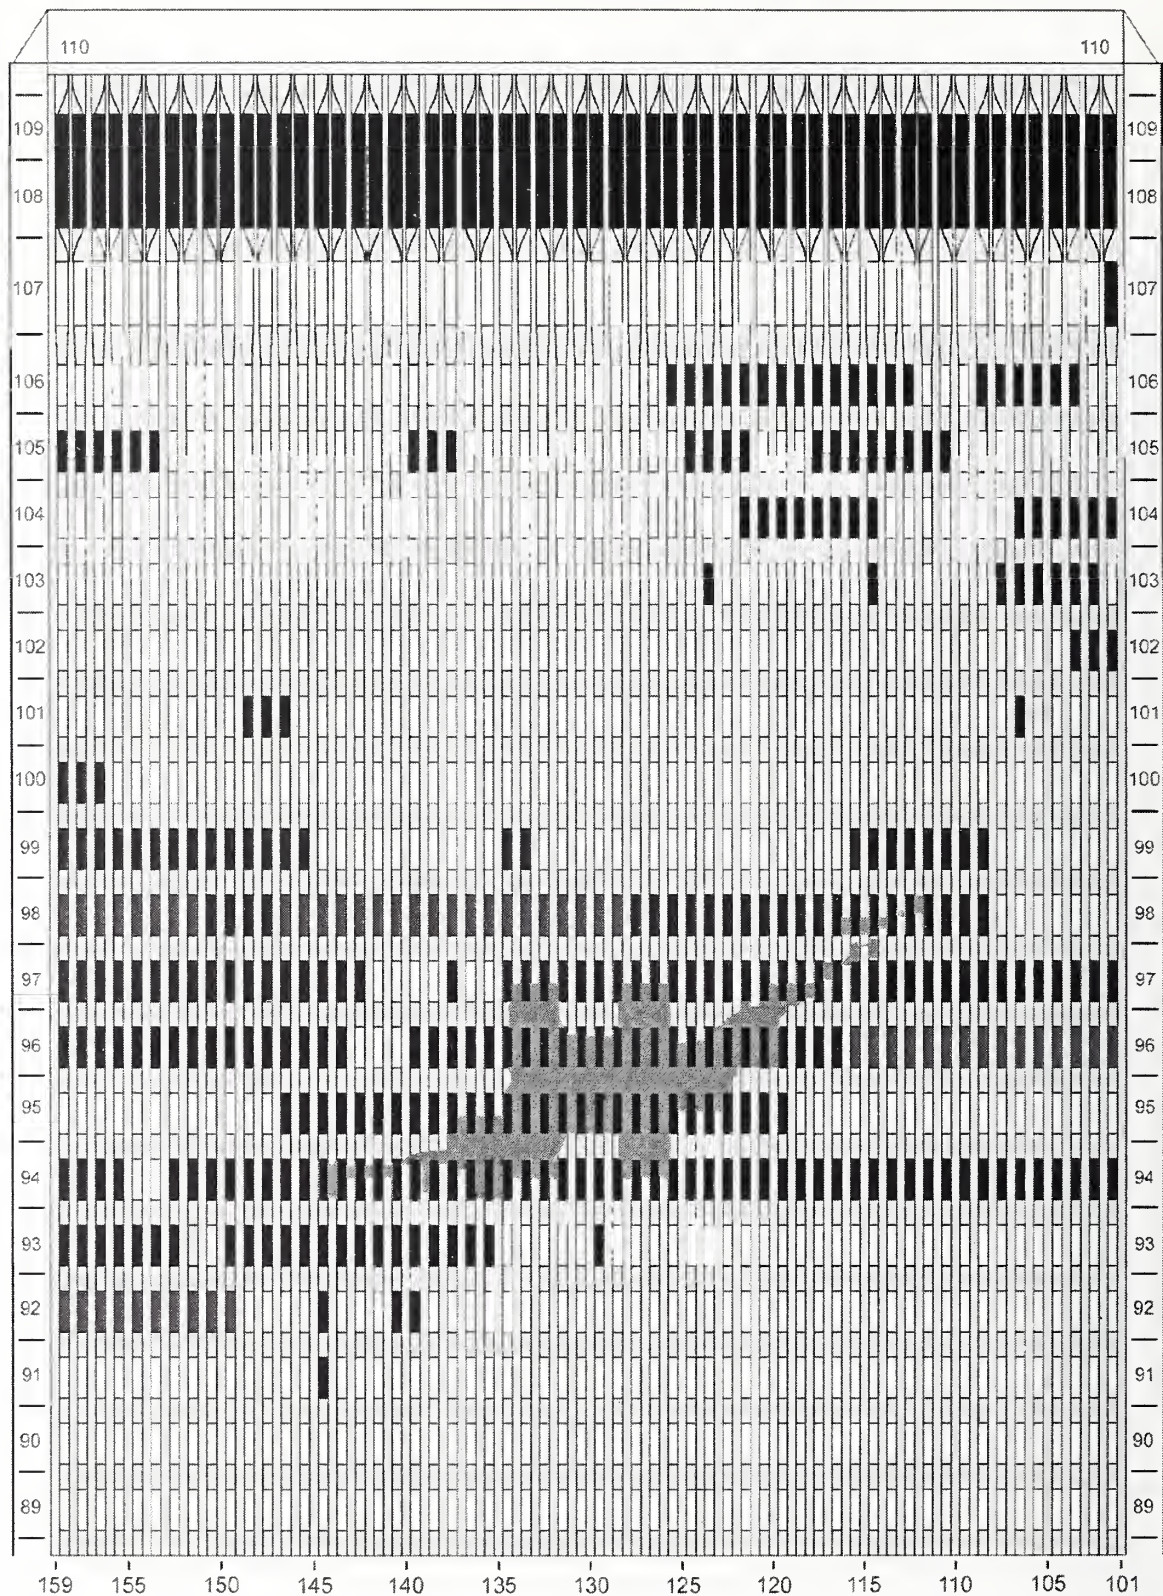
Figure C-43. Diagram of the north face of WTC 1 for floors 89 to 110 at 9:58 a.m. showing the condition of windows and locations of fires.

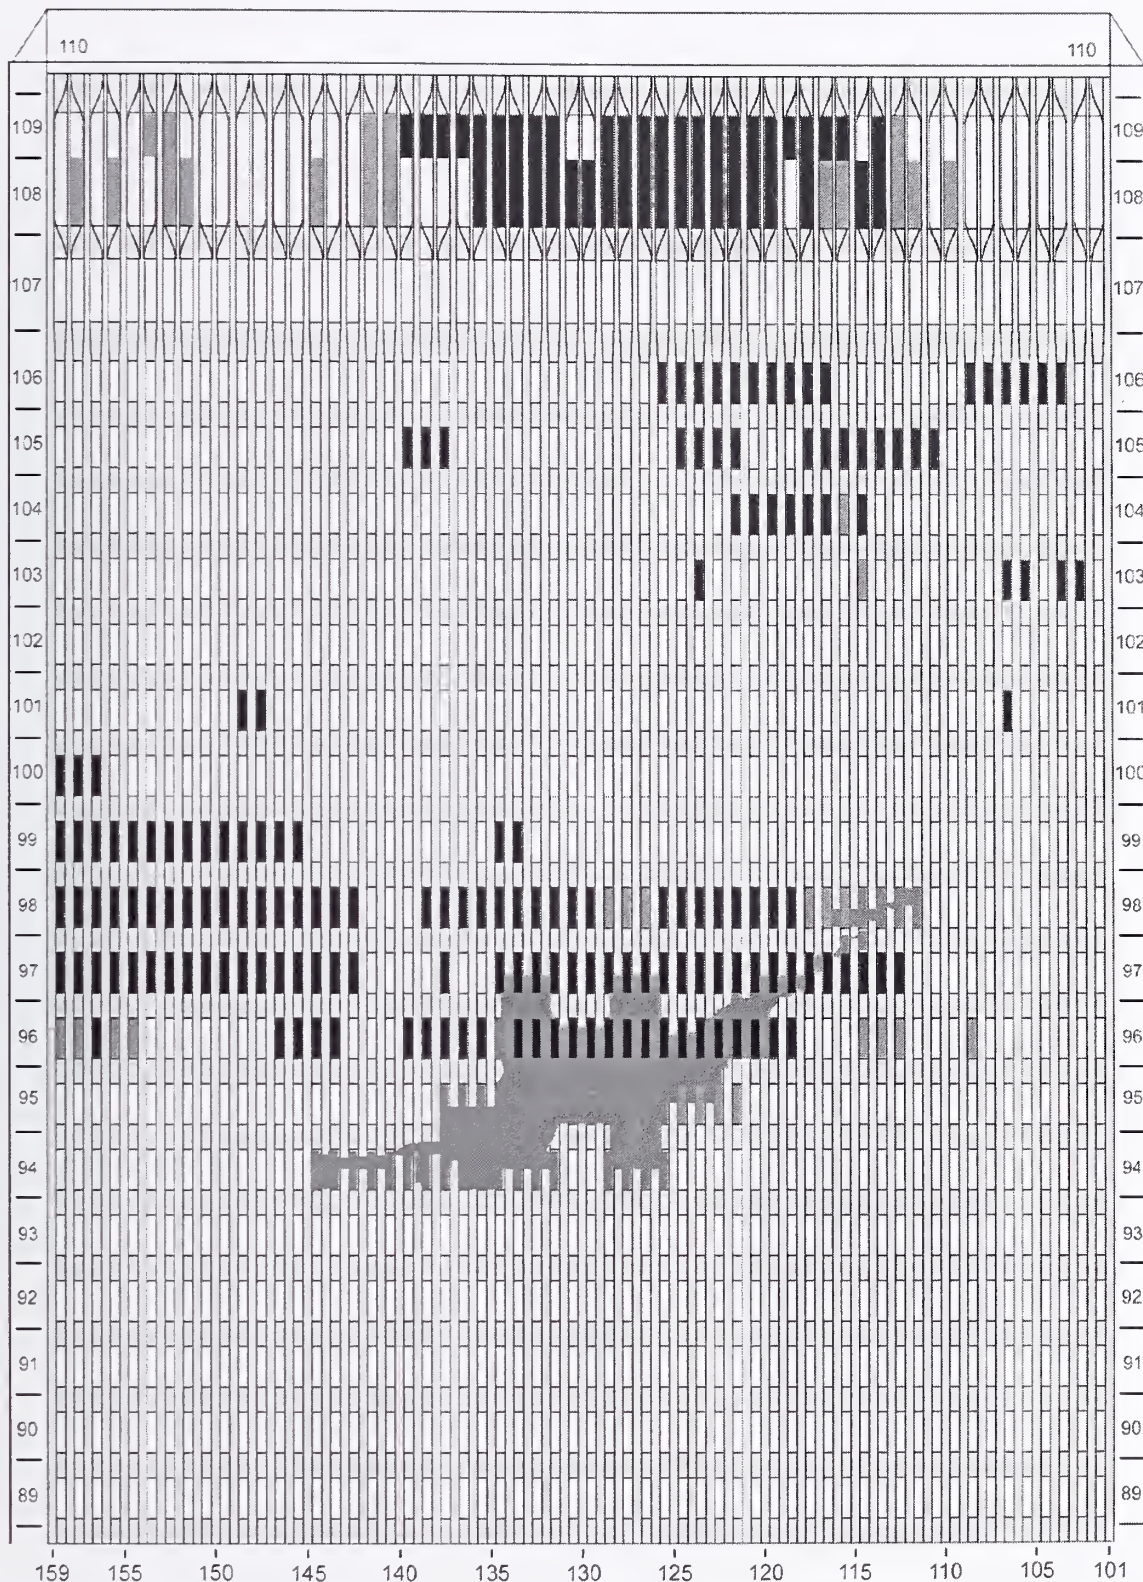
Figure C-44. Diagram of the north face of WTC 1 for floors 89 to 110 at 9:58 a.m. showing windows where smoke was observed and those that were hidden from view.

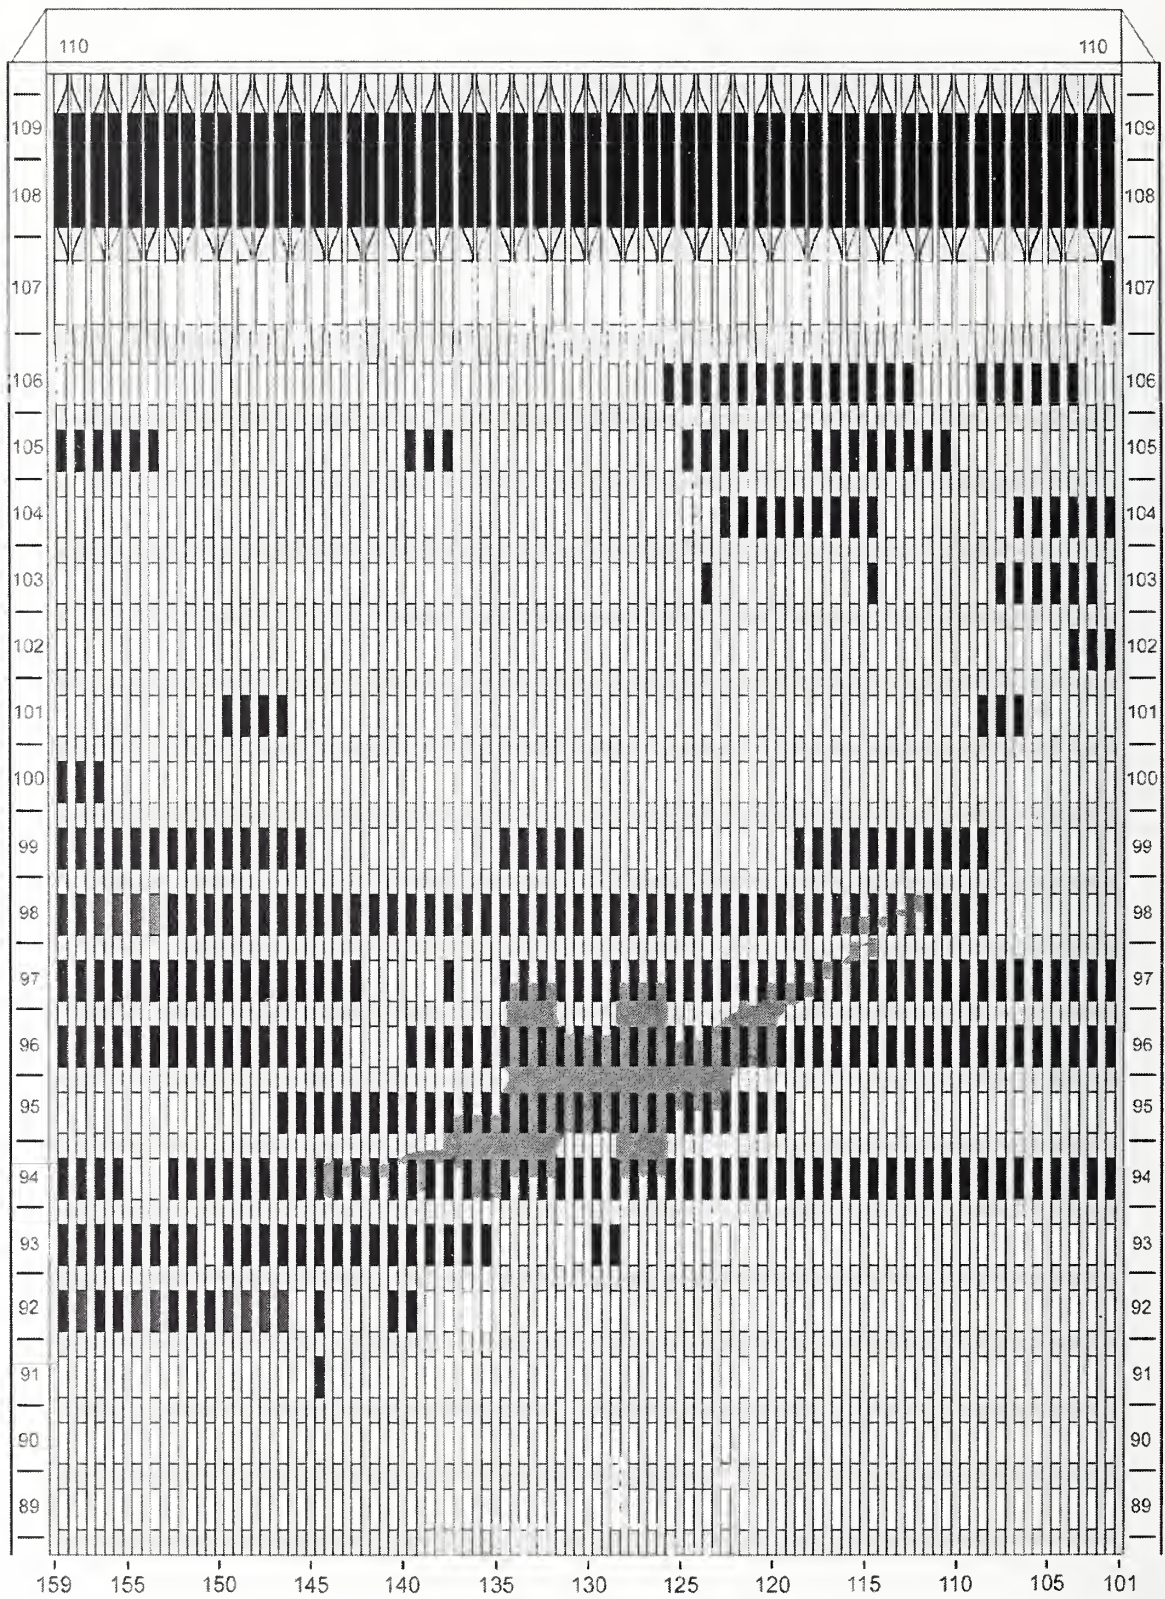
Figure C-45. Diagram of the north face of WTC 1 for floors 89 to 110 at 10:04 a.m. showing the condition of windows and locations of fires.
