**NIST NCSTAR 1-5A
Federal Building and Fire Safety Investigation of
the World Trade Center Disaster**

**Visual Evidence, Damage Estimates,
And Timeline Analysis**

(Chapter 9 - Appendix C)

FIRE BEHAVIOR IN WORLD TRADE CENTER 2

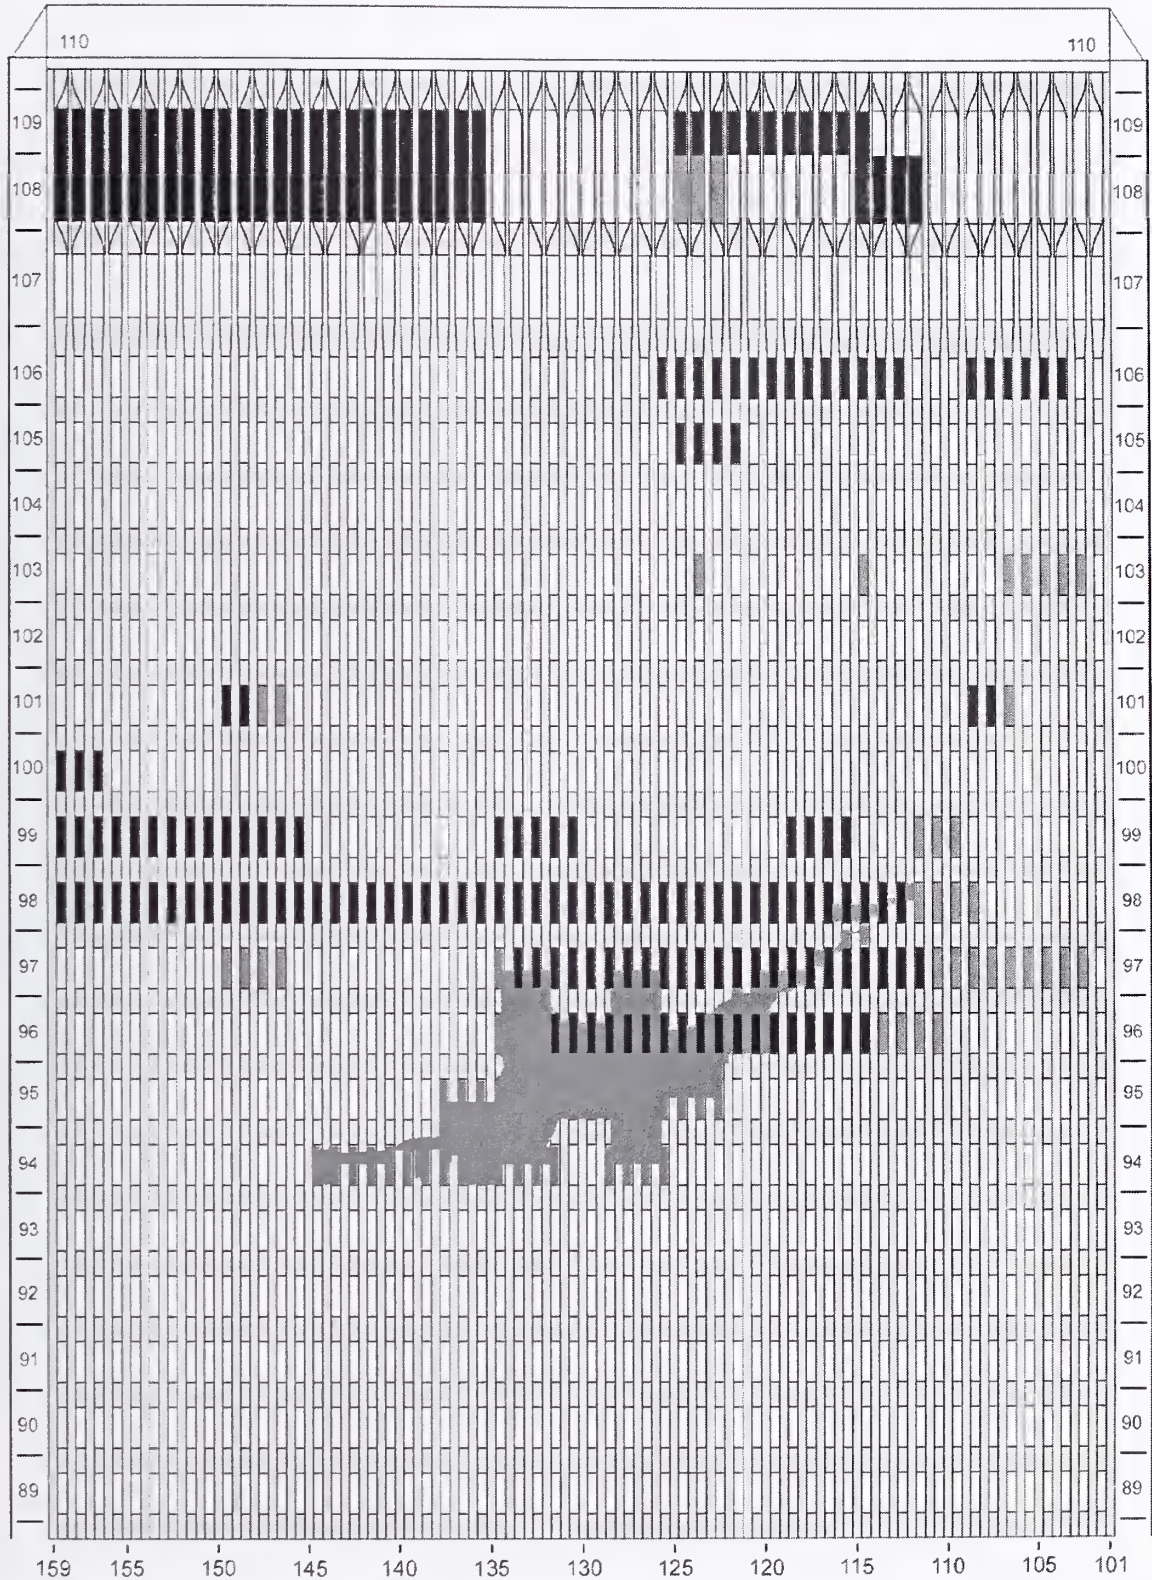
Figure C-46. Diagram of the north face of WTC 1 for floors 89 to 110 at 10:04 a.m. showing windows where smoke was observed and those that were hidden from view.

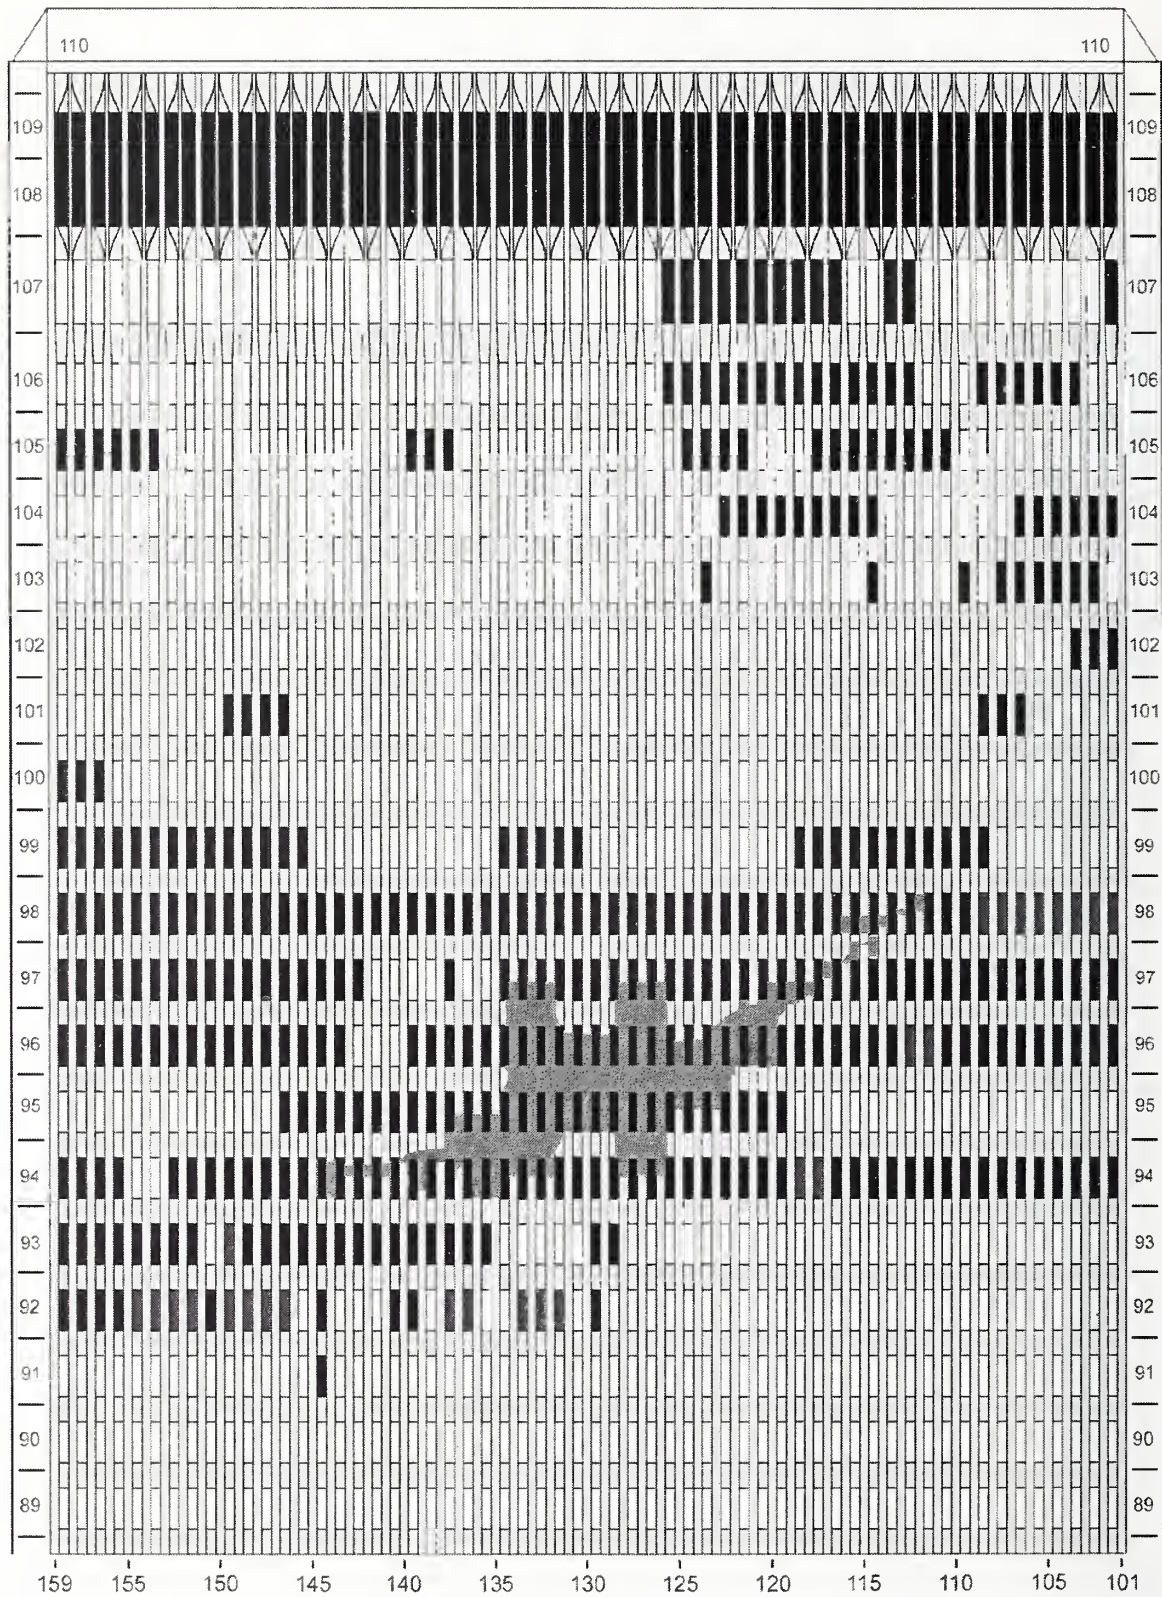
Figure C-47. Diagram of the north face of WTC 1 for floors 89 to 110 at 10:10 a.m. showing the condition of windows and locations of fires.

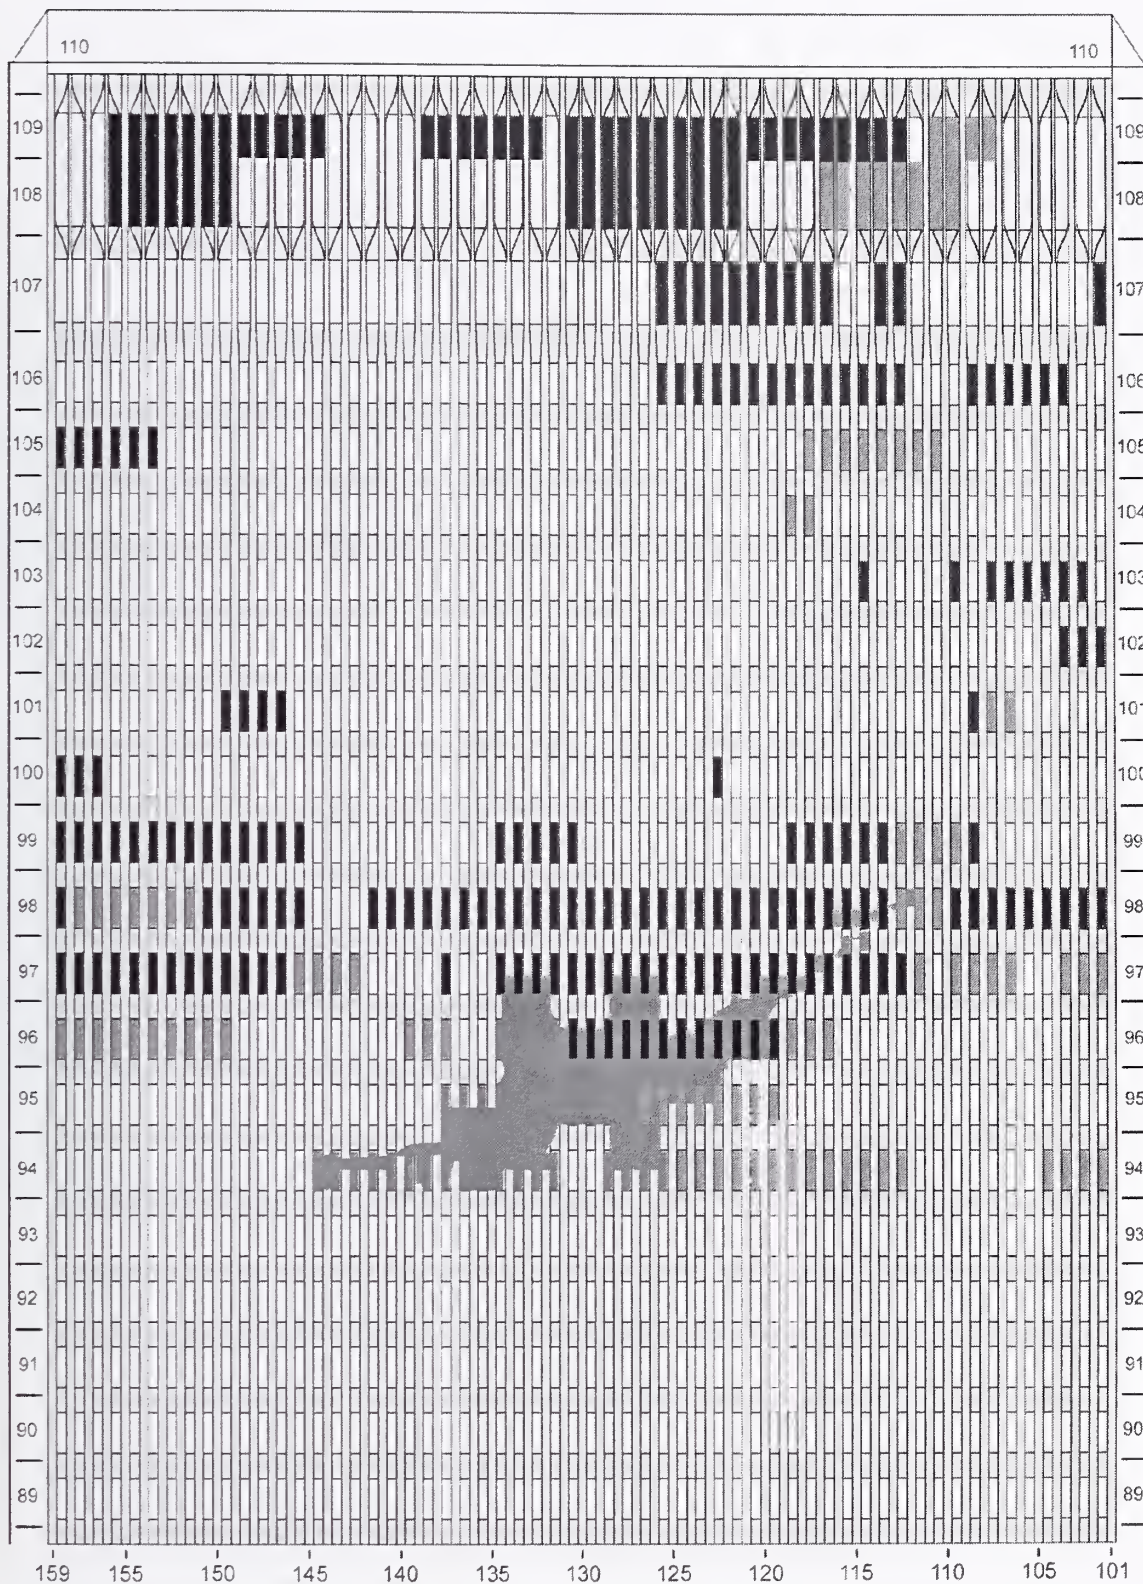
Figure C- 48. Diagram of the north face of WTC 1 for floors 89 to 110 at 10:10 a.m. showing windows where smoke was observed and those that were hidden from view.

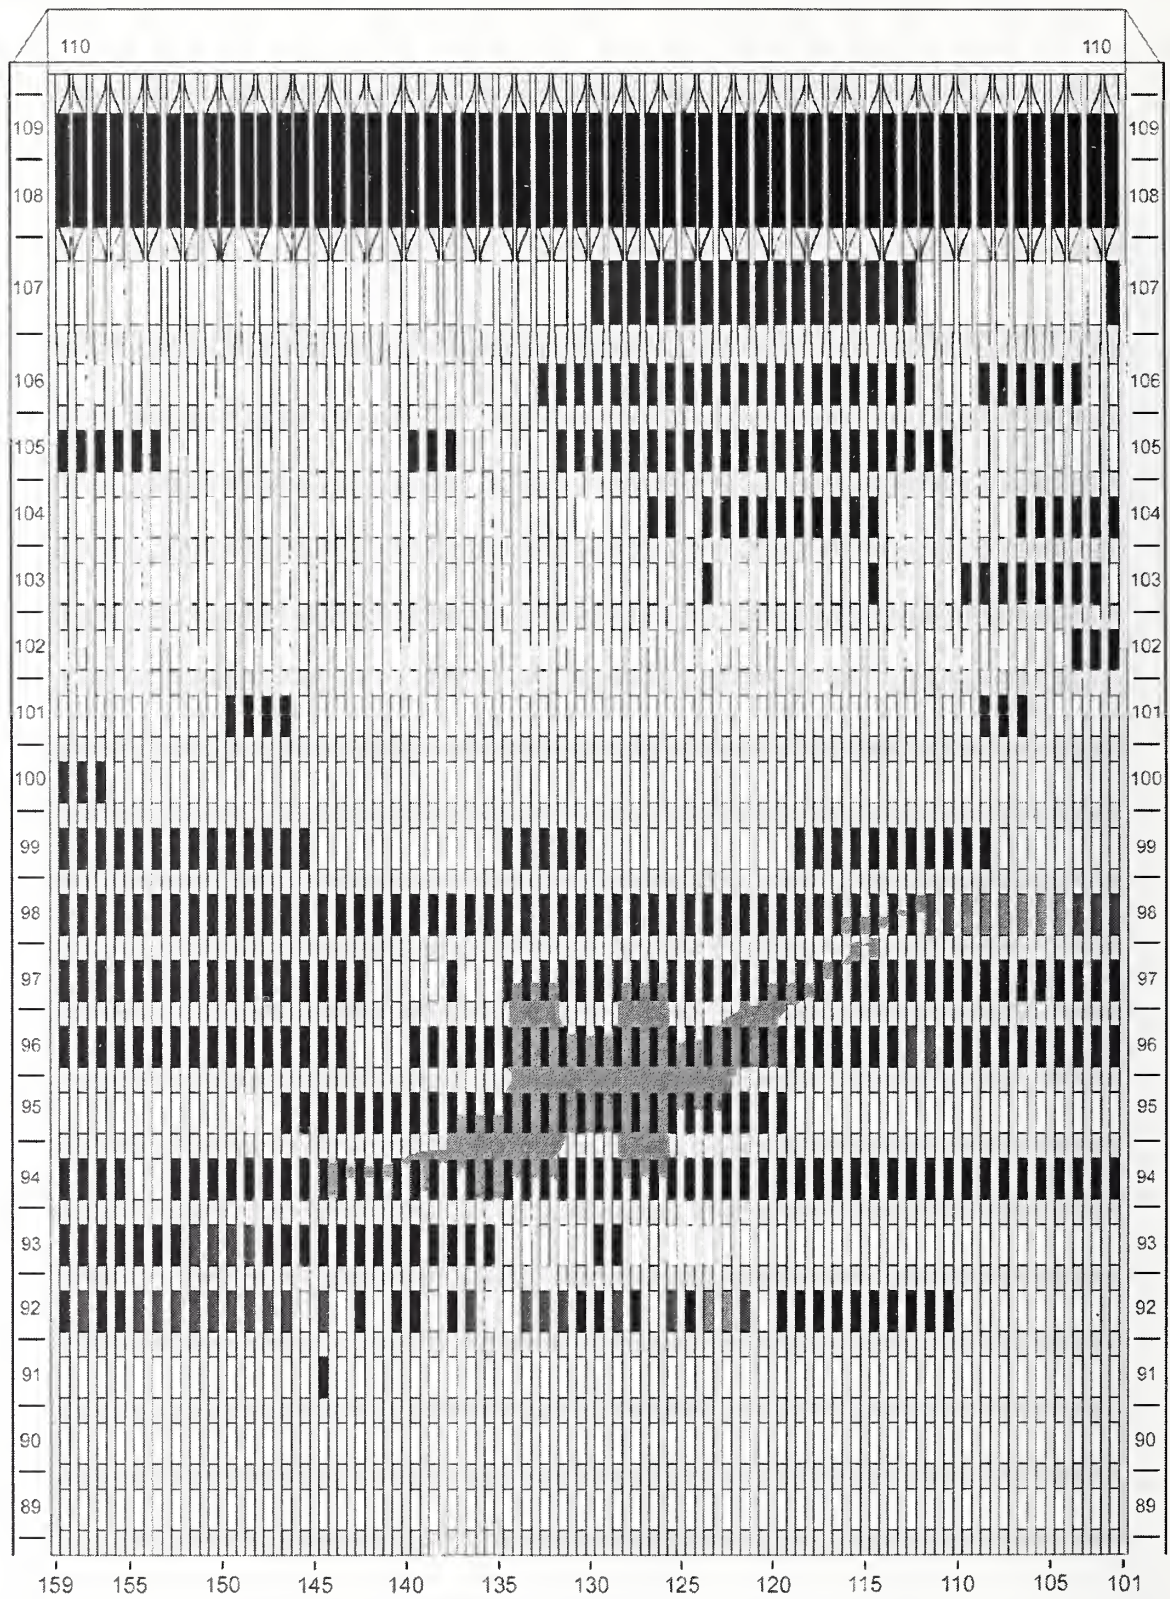
Figure C-49. Diagram of the north face of WTC 1 for floors 89 to 110 at 10:14 a.m. showing the condition of windows and locations of fires.

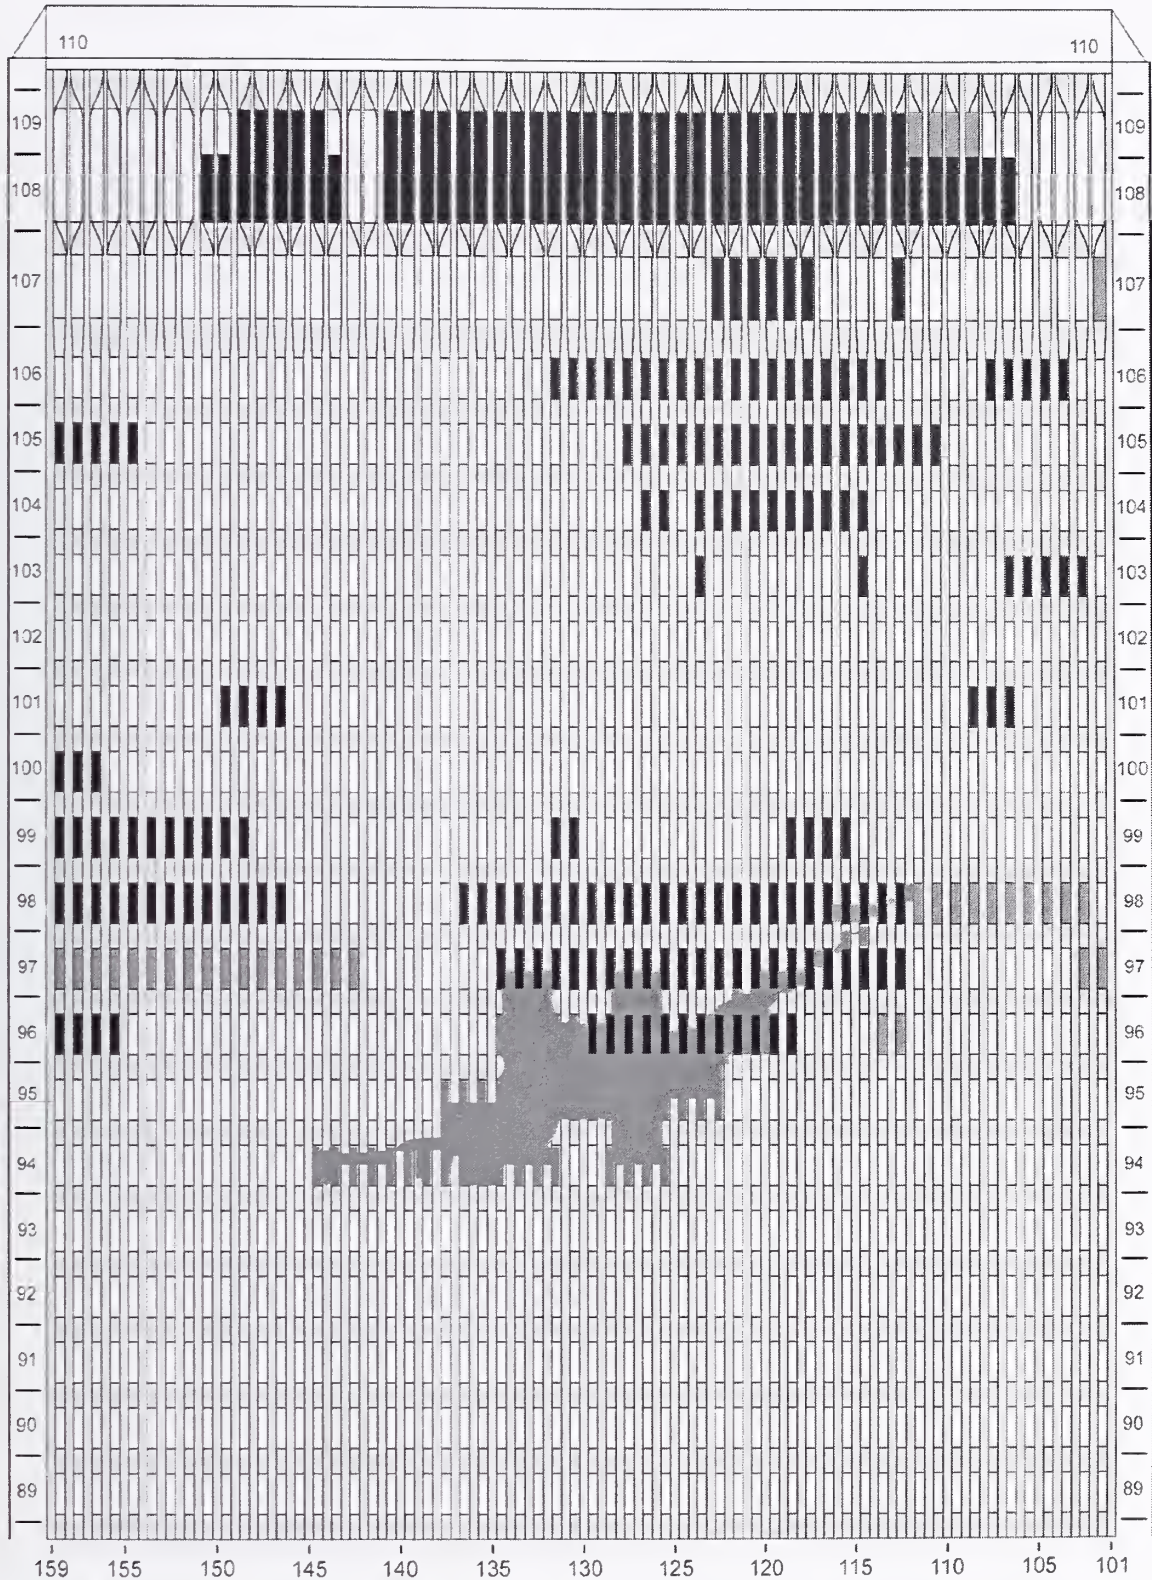
Figure C-50. Diagram of the north face of WTC 1 for floors 89 to 110 at 10:14 a.m. showing windows where smoke was observed and those that were hidden from view.

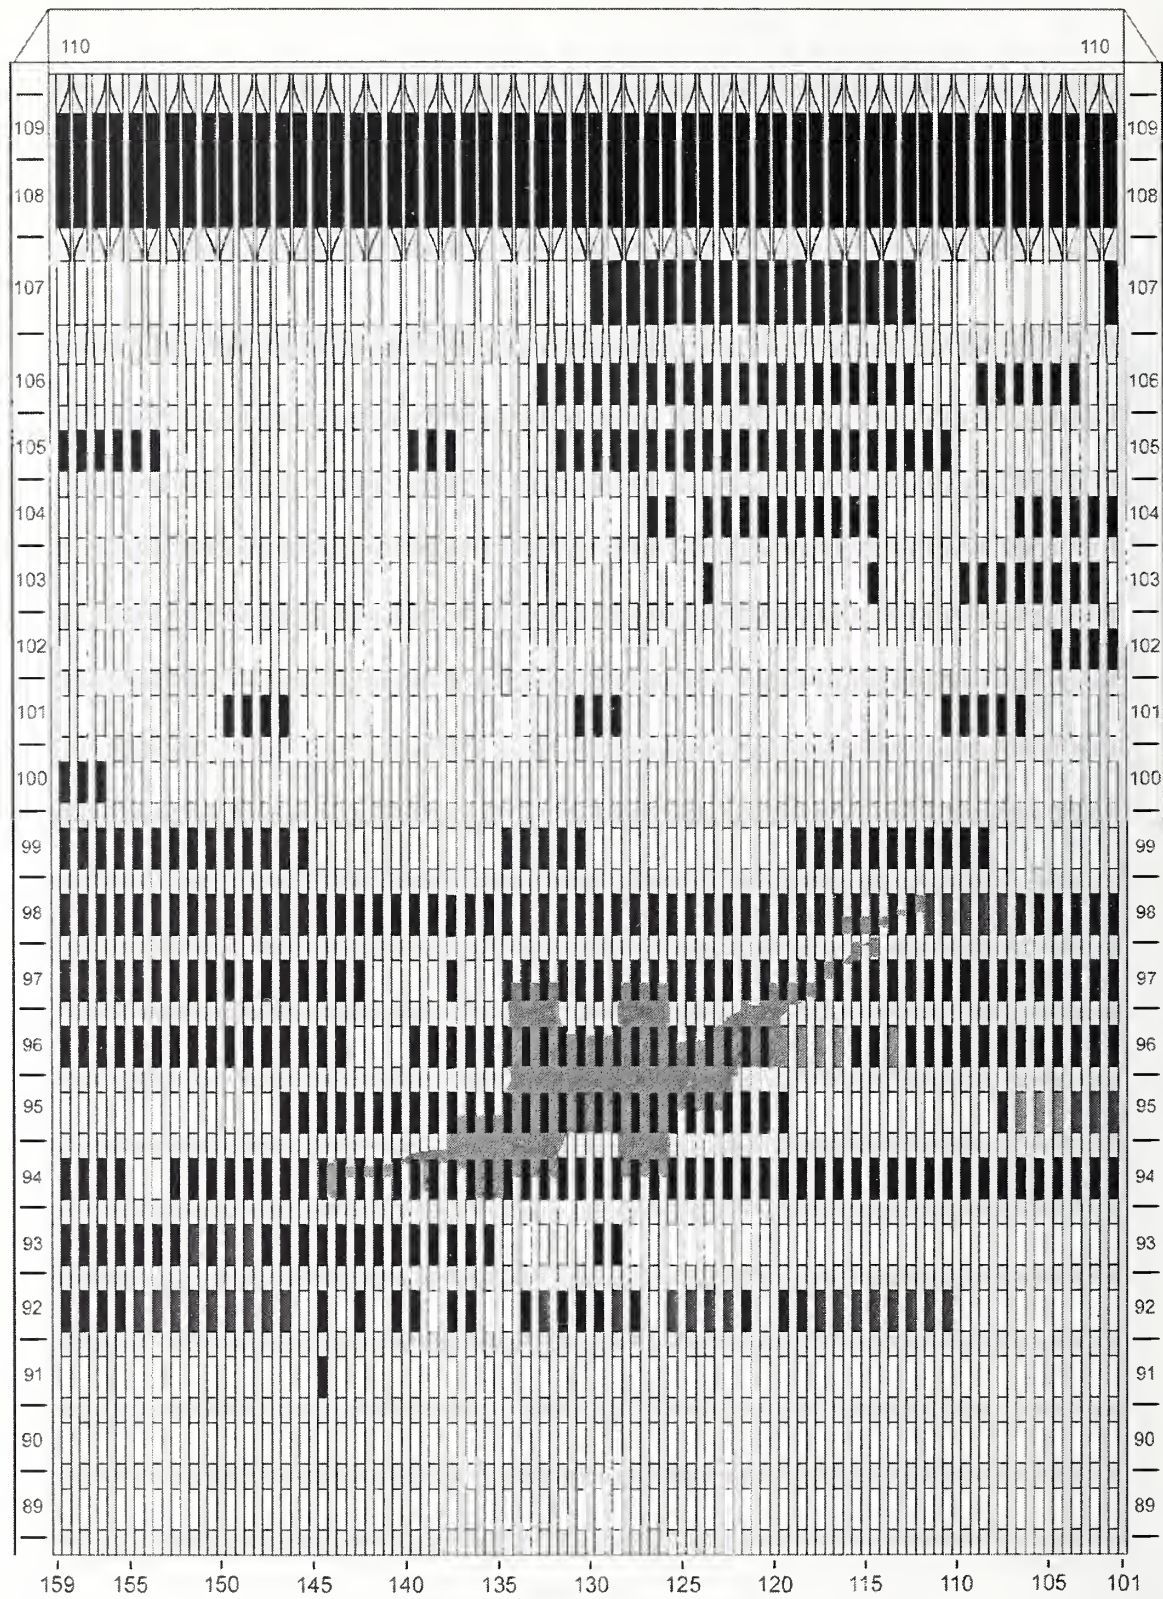
Figure C-51. Diagram of the north face of WTC 1 for floors 89 to 110 at 10:18 a.m. showing the condition of windows and locations of fires.

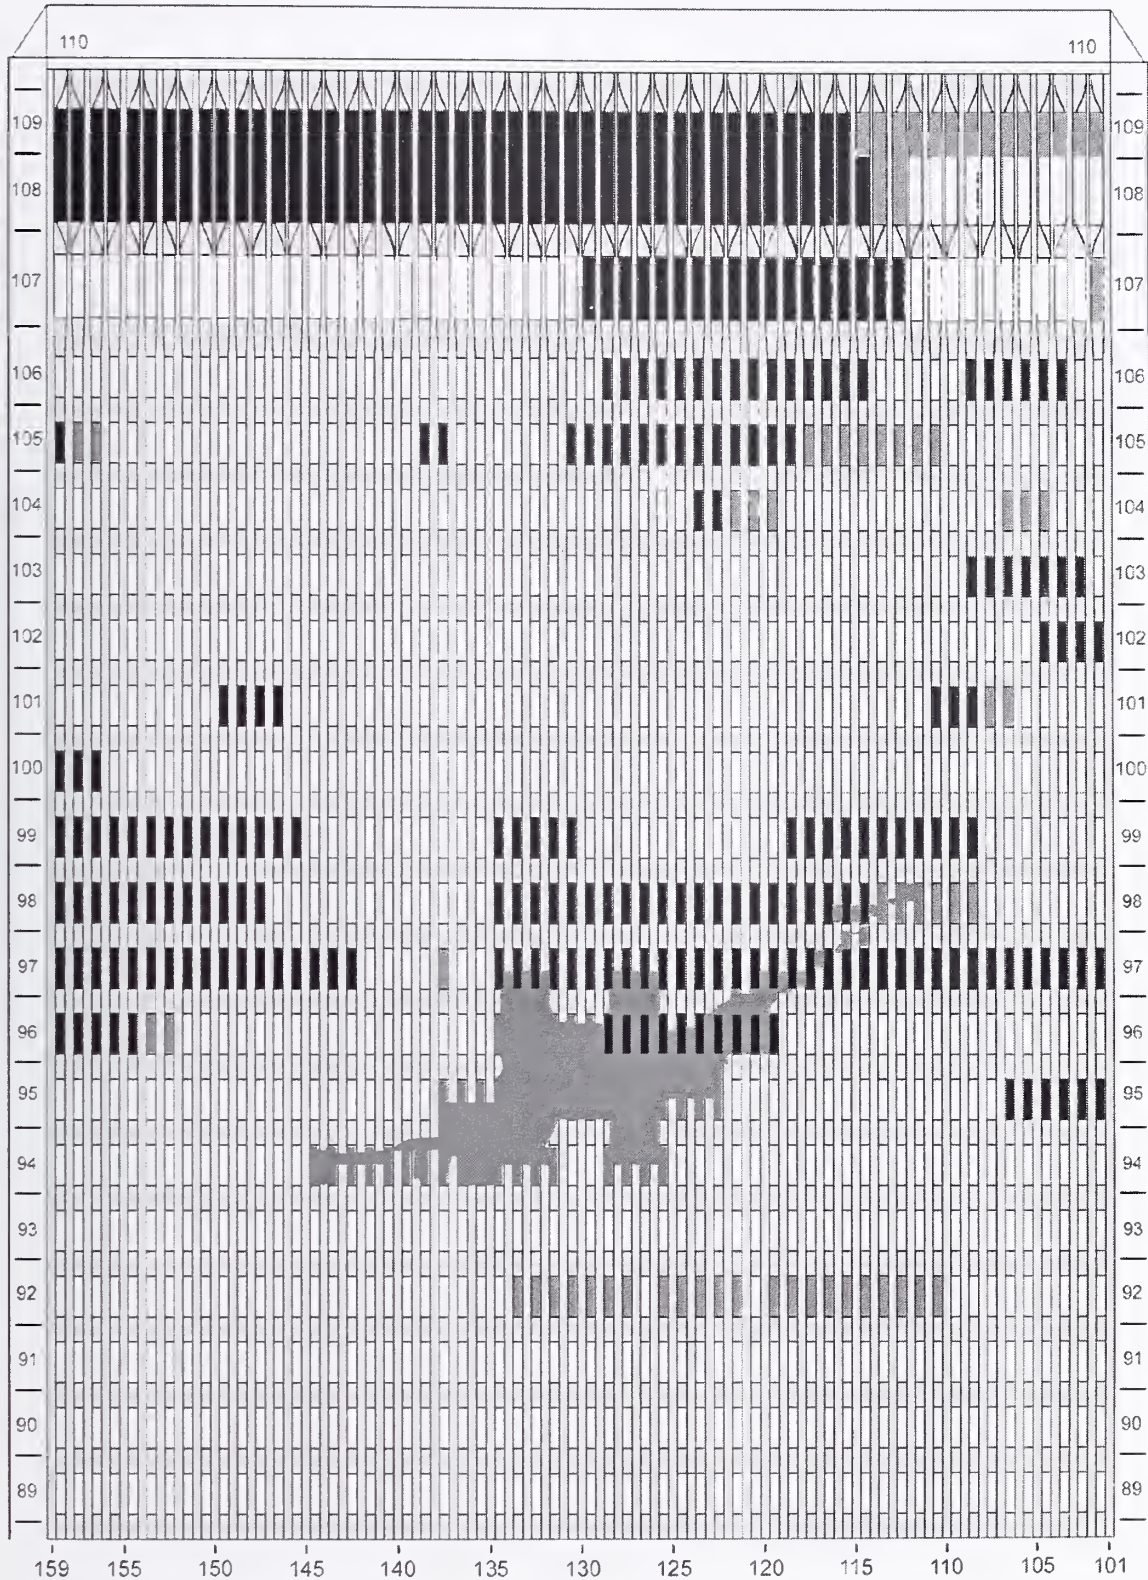
Figure C-52. Diagram of the north face of WTC 1 for floors 89 to 110 at 10:18 a.m. showing windows where smoke was observed and those that were hidden from view.

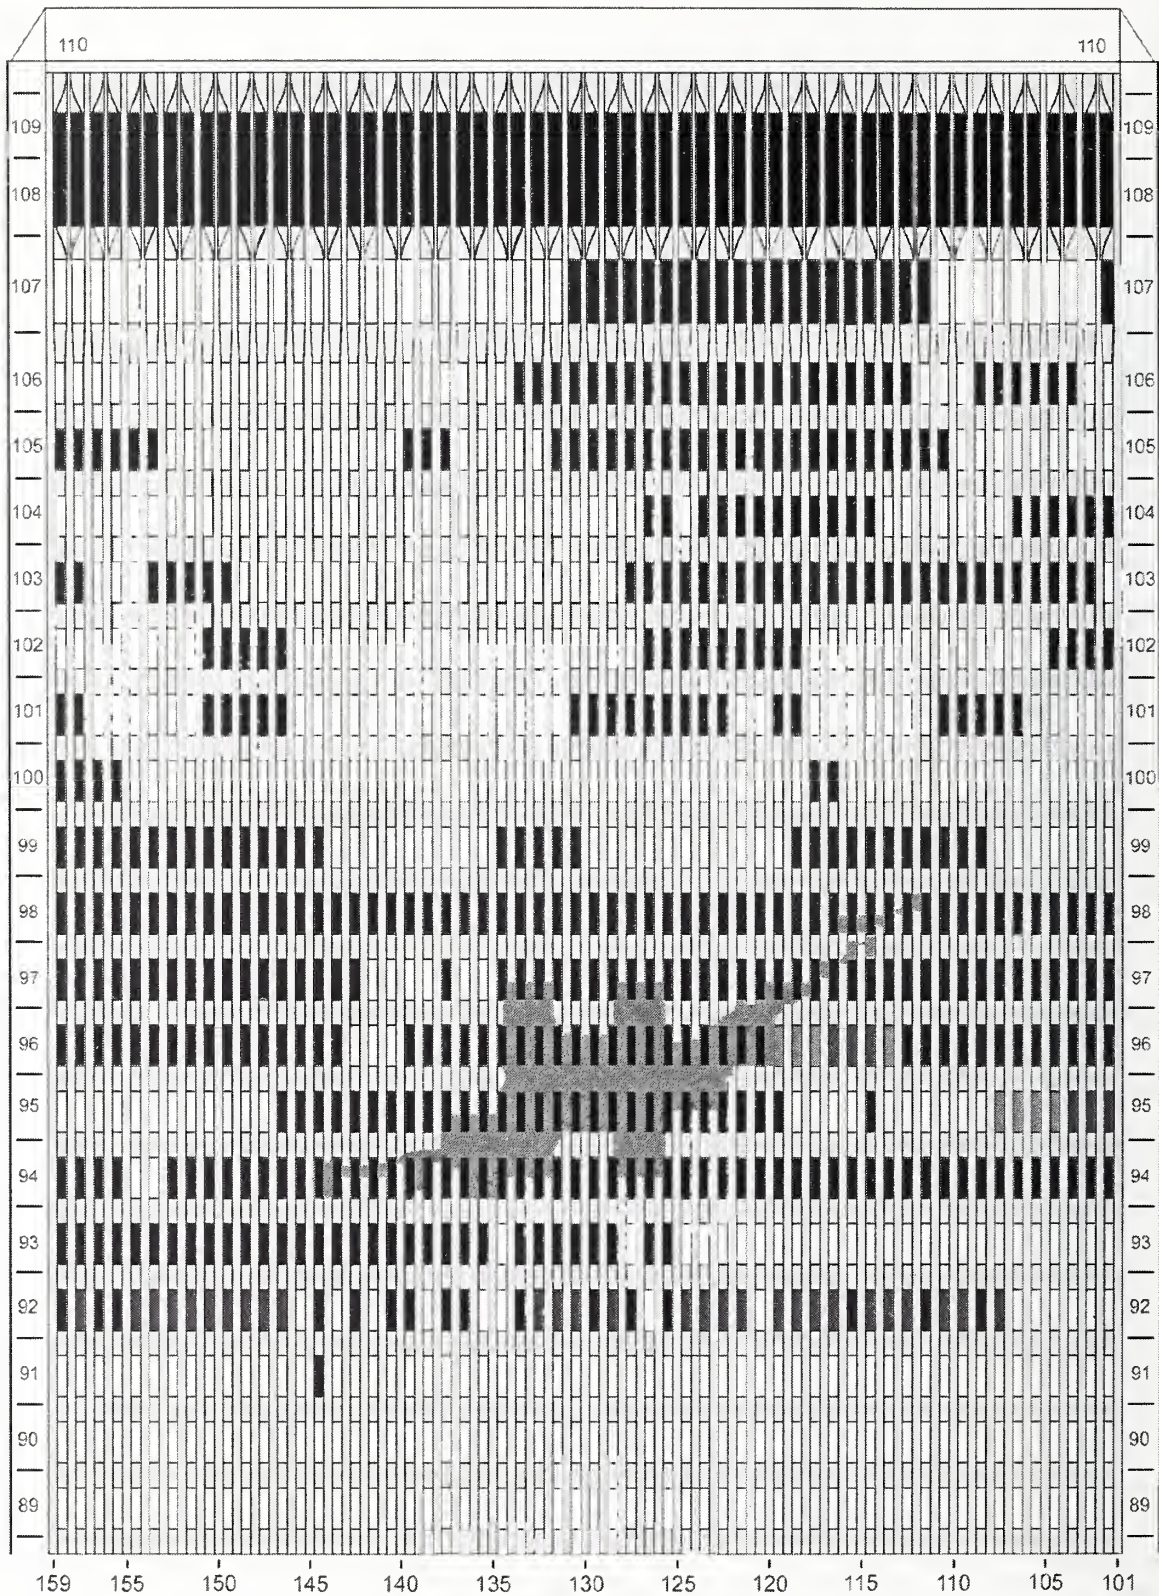
Figure C-53. Diagram of the north face of WTC 1 for floors 89 to 110 at 10:20 a.m. showing the condition of windows and locations of fires.

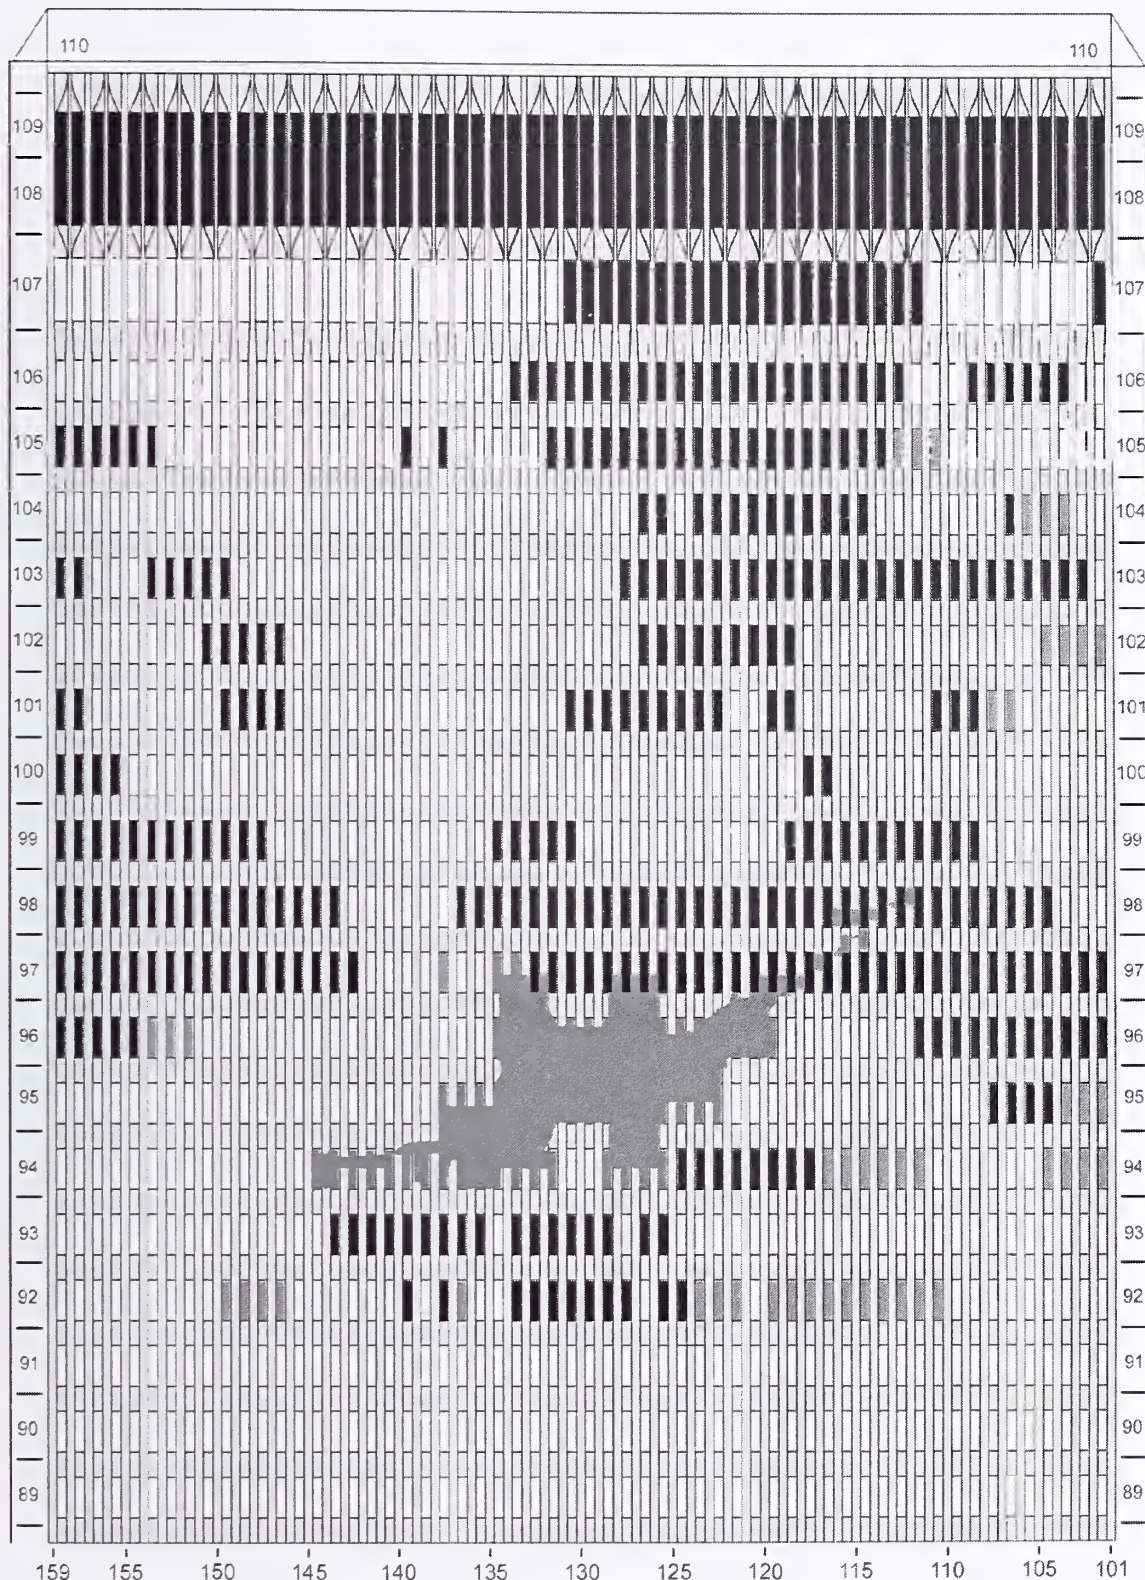
Figure C-54. Diagram of the north face of WTC 1 for floors 89 to 110 at 10:20 a.m. showing windows where smoke was observed and those that were hidden from view.

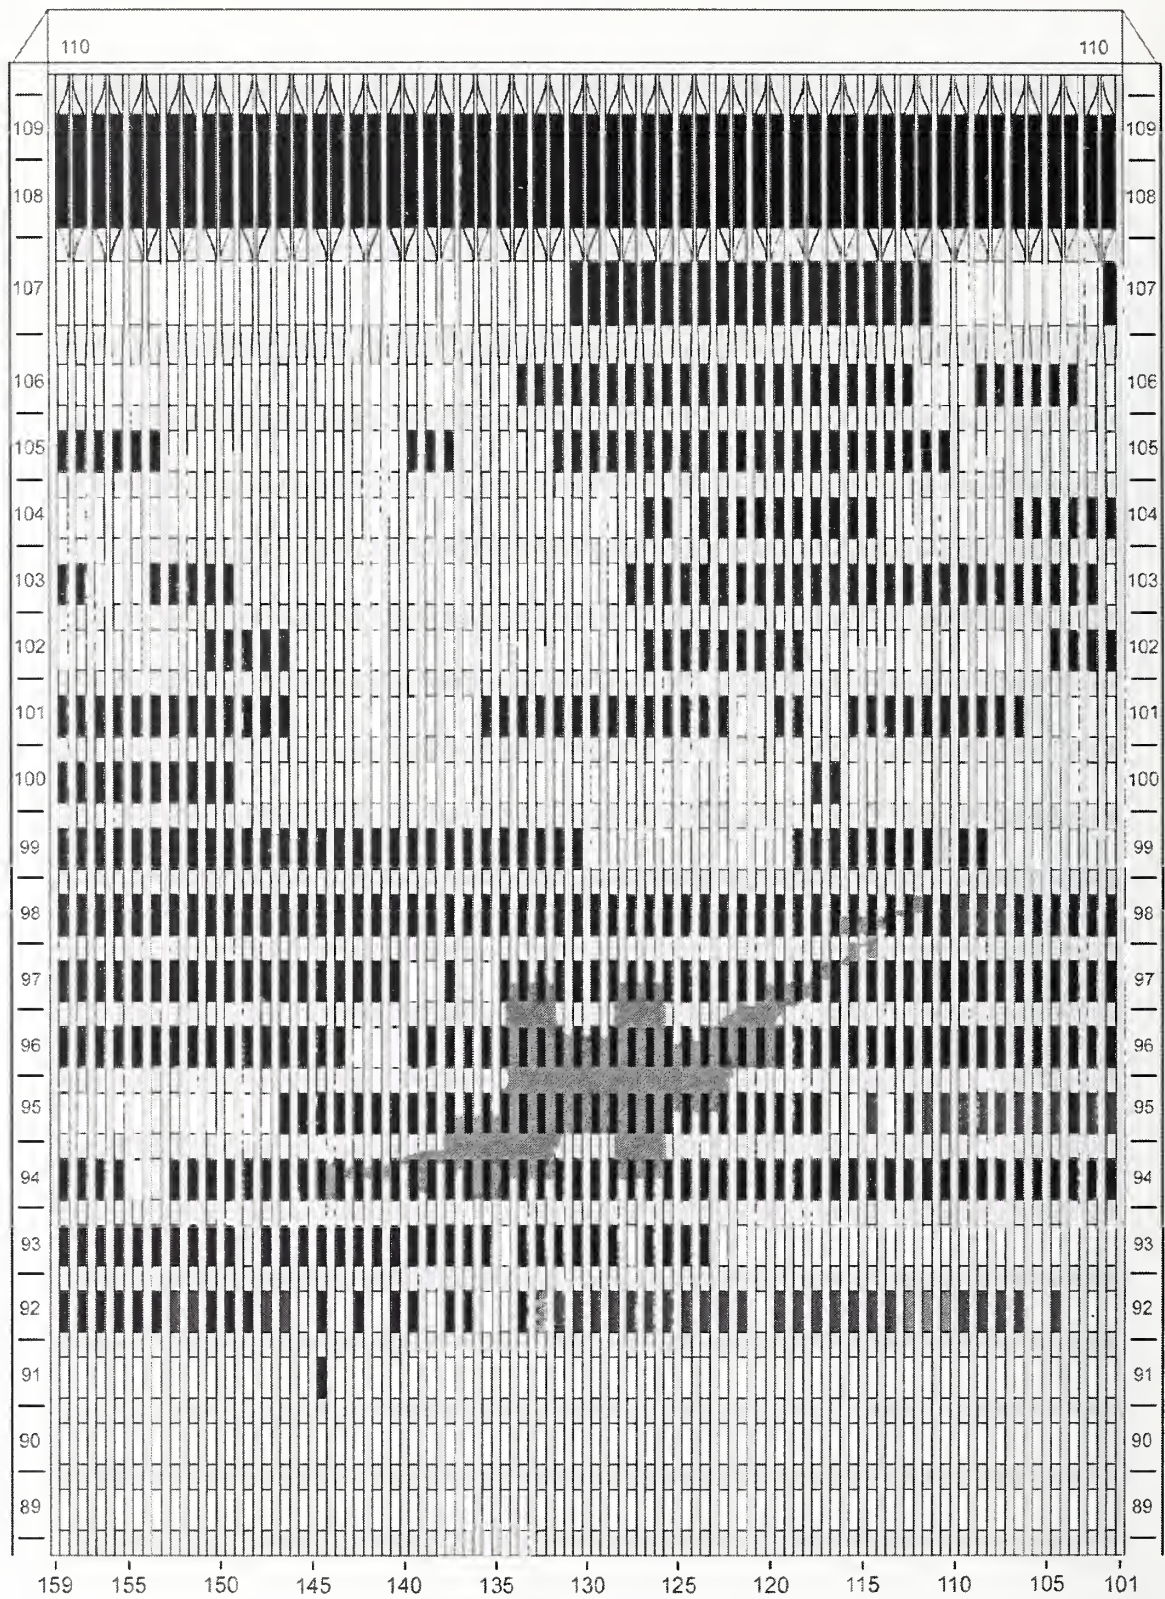
Figure C-55. Diagram of the north face of WTC 1 for floors 89 to 110 at 10:24 a.m. showing the condition of windows and locations of fires.

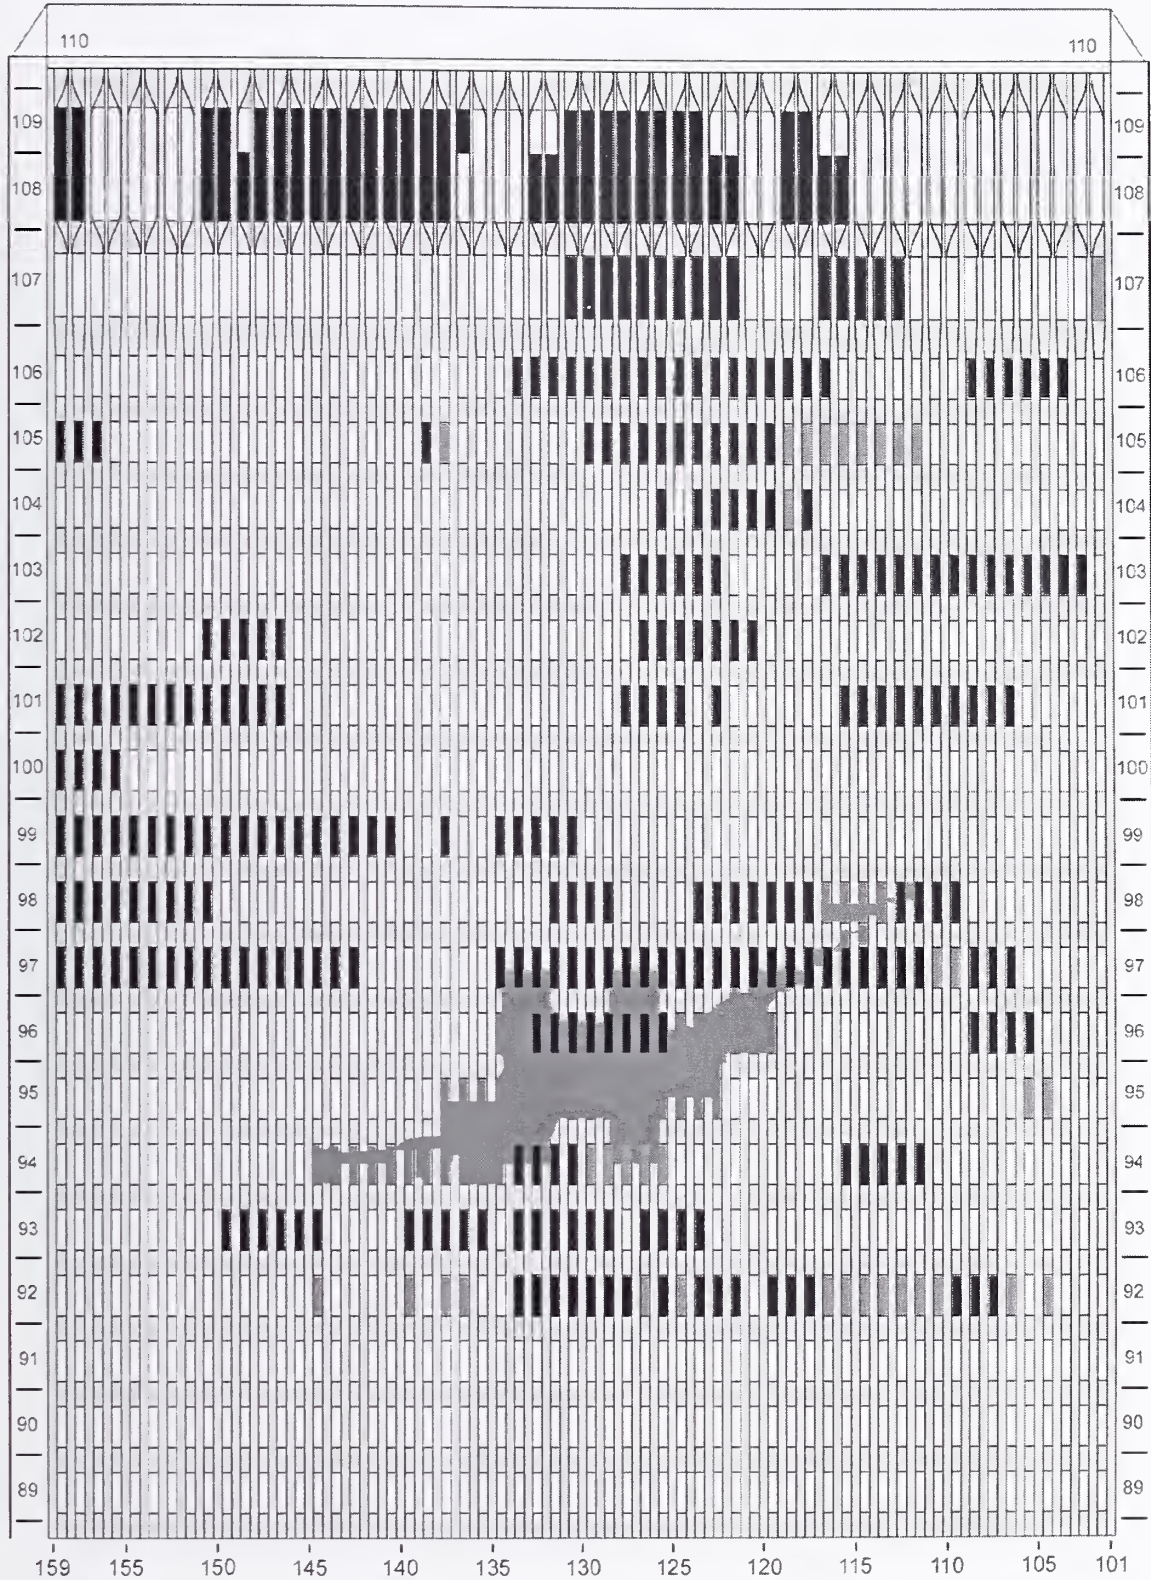
Figure C-56. Diagram of the north face of WTC 1 for floors 89 to 110 at 10:24 a.m. showing windows where smoke was observed and those that were hidden from view.

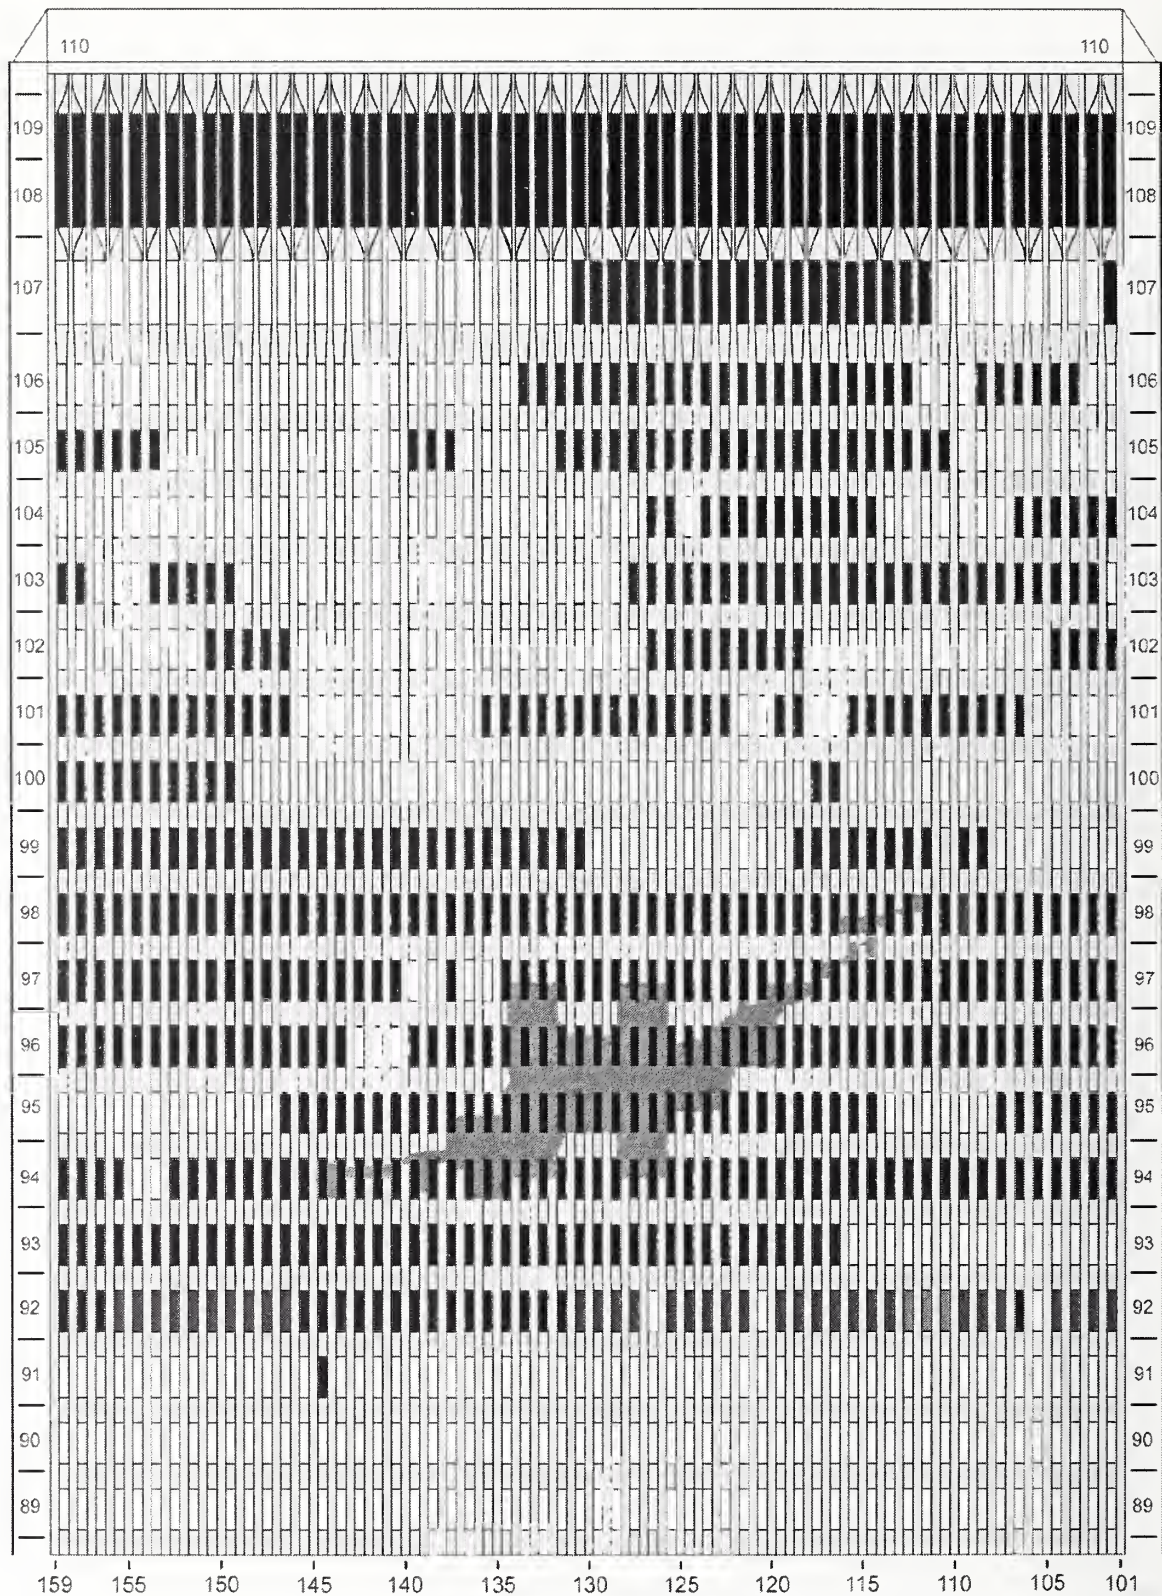
Figure C-57. Diagram of the north face of WTC 1 for floors 89 to 110 at 10:28 a.m. showing the condition of windows and locations of fires.
