**NIST NCSTAR 1-5A
Federal Building and Fire Safety Investigation of
the World Trade Center Disaster**

**Visual Evidence, Damage Estimates,
And Timeline Analysis**

(Chapter 9 - Appendix C)

FIRE BEHAVIOR IN WORLD TRADE CENTER 2

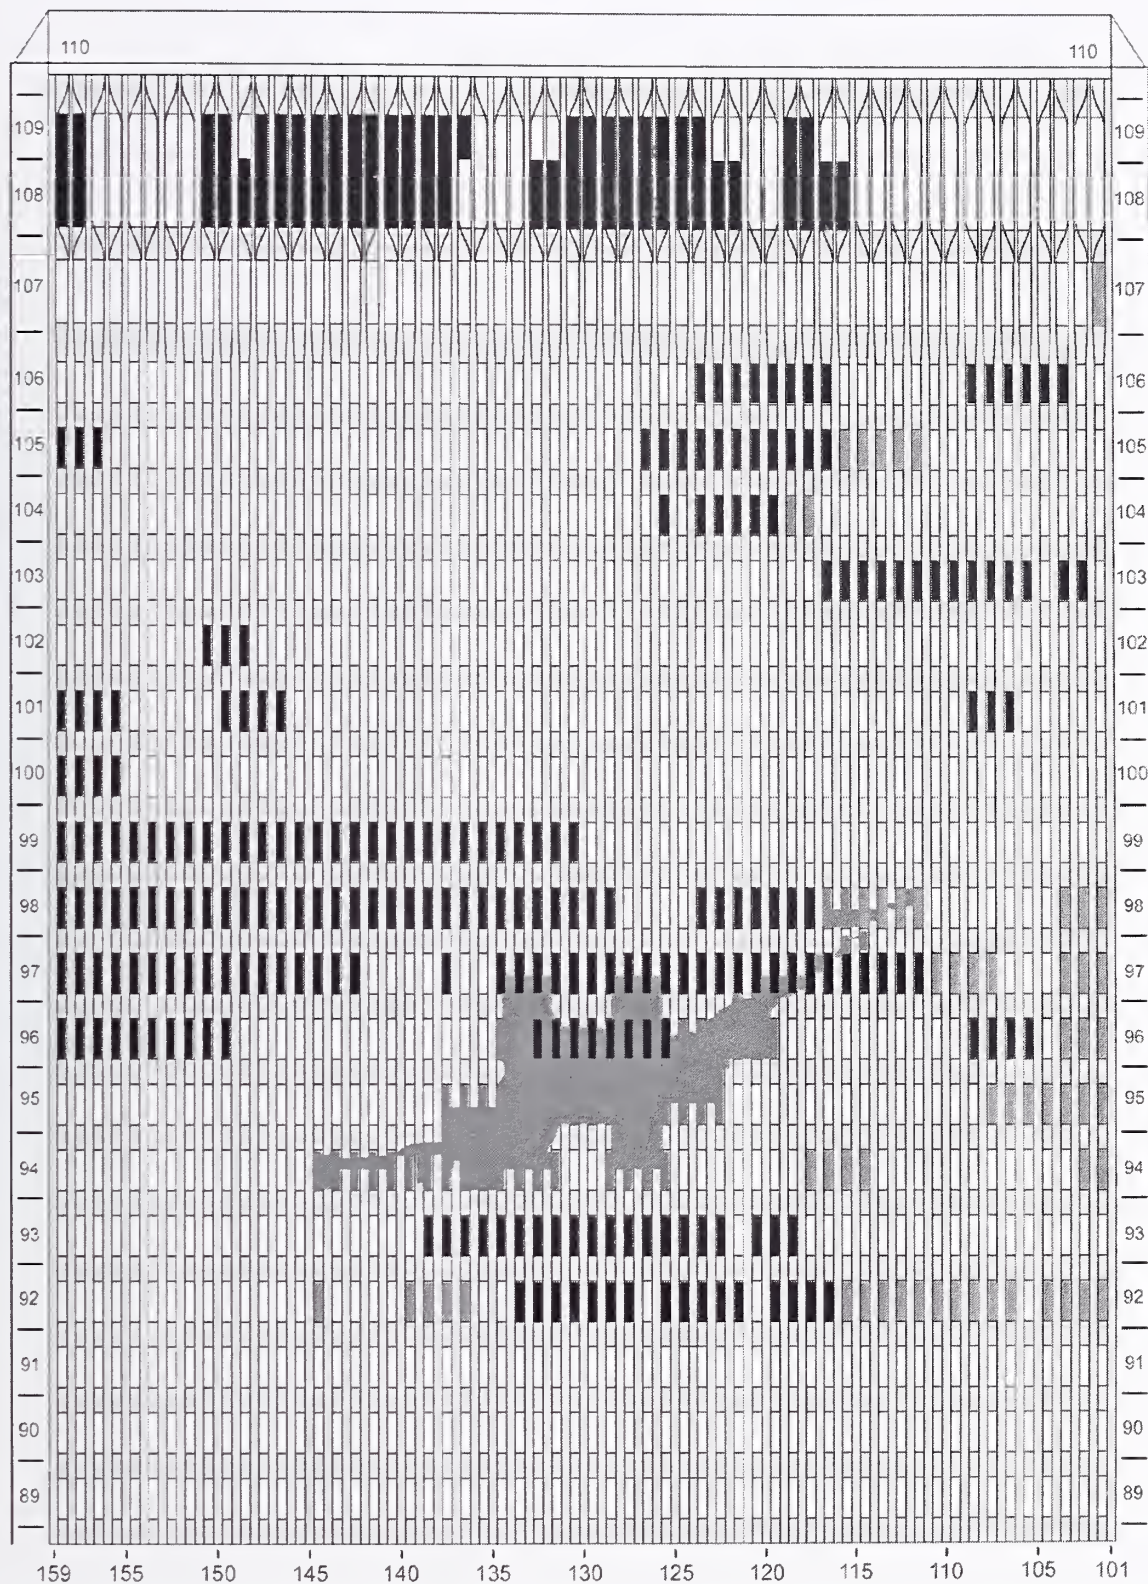
Figure C-58. Diagram of the north face of WTC 1 for floors 89 to 110 at 10:28 a.m. showing windows where smoke was observed and those that were hidden from view.
